PRE-CLEARANCE ECOLOGICAL SURVEY
FOR
PROPOSED ACCESS TRACK ADJACENT TO CONCORD
ZONE SUBSTATION TO FACILITATE
HEAVY VEHICLE ACCESS DURING CONSTRUCTION
AND CONDUIT INSTALLATION BACK OUT TO
GEORGE ST, CONCORD,
TO ENABLE COMMISSIONING OF NEW
SWITCHGEAR

AUSGRID

February 2020

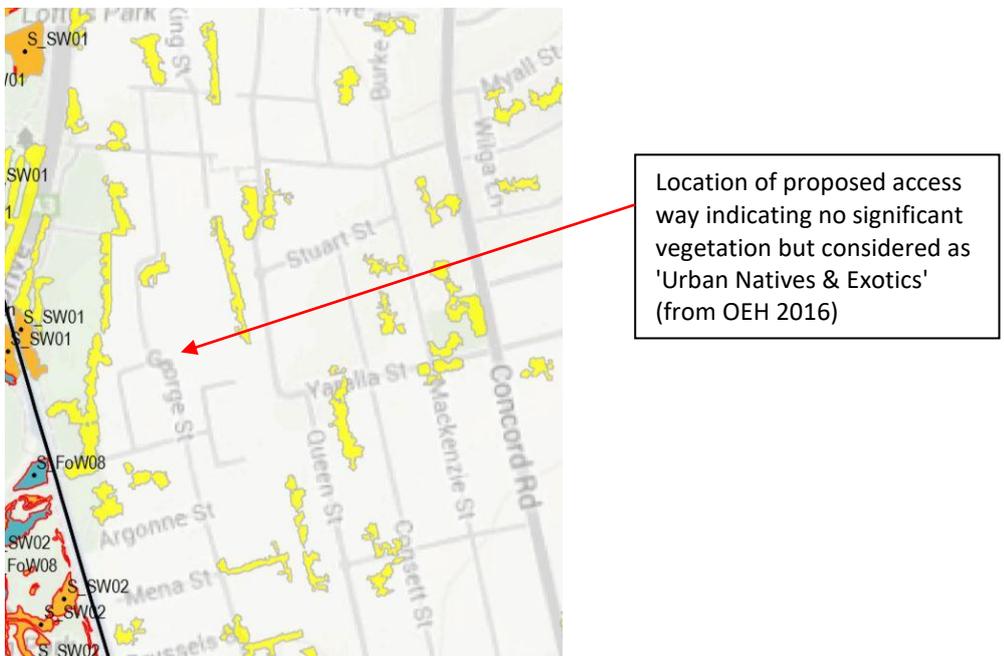
Figure 2 - Location of the proposed site of vegetation clearing (Urban Natives and Exotics shaded in yellow)

There is a discontinuous row of She Oak trees established along the top of the embankment for the length of the access-way (Figure 2). These individuals would mostly require removal to facilitate heavy vehicle access during construction and conduit installation back out to George St, Concord, to enable commissioning of the new switchgear.

The vegetation occurring along the route is a planted discontinuous row of Swamp Oak (*Casuarina glauca*) (considered to include Urban Natives & Exotics; PCT code: 0; OEH 2016) (Figure 2). The row of trees is not mapped in recent mapping by DPIE (2020) nor on the BV Map (2020). Natural habitat for the occurrence of Swamp Oak is not present at the subject site.

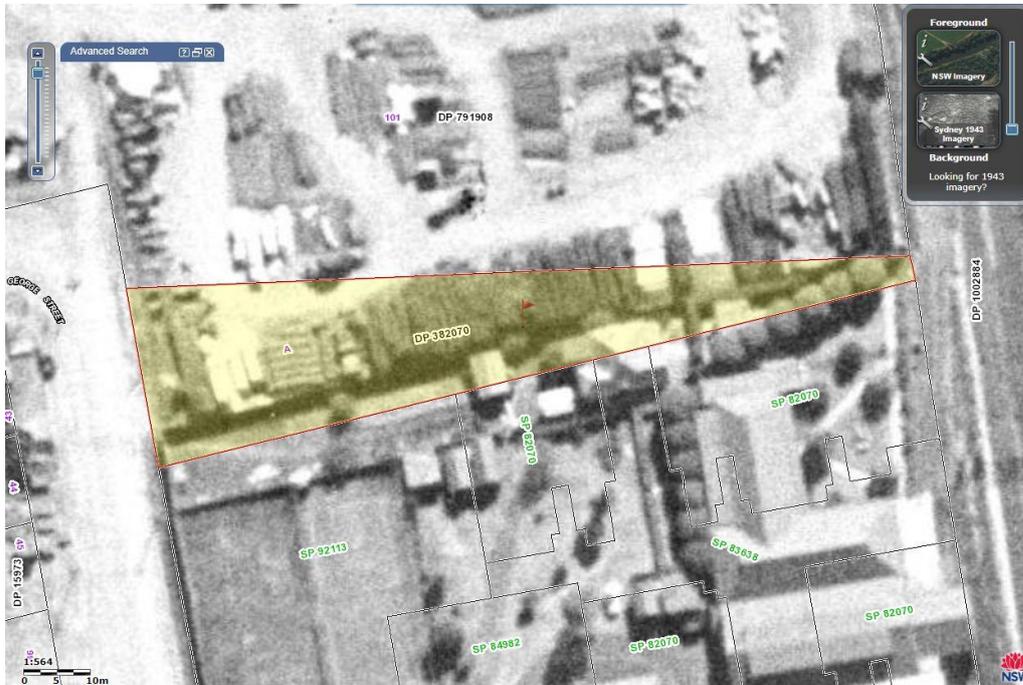
Figure 4 - Aerial image of current location of the Concord Zone Substation taken in 1943 indicating planted hedgerows and container-like structures located within the Ausgrid allotment (bounded by red font) and the cleared area of the current access way to the north of the Ausgrid allotment

The Swamp Oak vegetation occurring along the raised fill embankment has apparently been planted as a screen between the unit block to the south and the Westpac Car Park to the north. Figure 4 is an image of the area taken in 1943 indicating that the landscape at that

time consisted of a cleared area containing tightly packed hedgerows planted in a south-north orientation with container-like man-made structures inter-dispersed among them.

The area where the access track is located was cleared for access at that time but uncertain whether this consisted of raised fill or was located on level ground for access from west to east across the landscape.

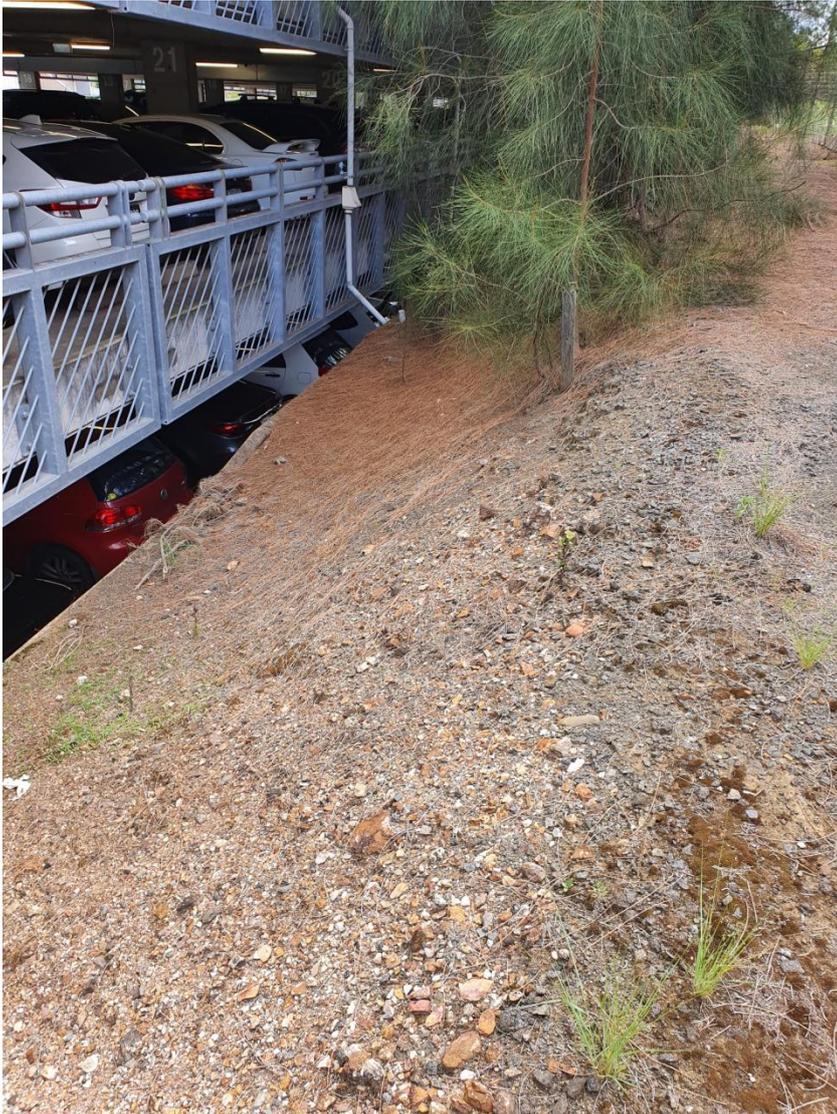
Figure 5 - Image indicating the drop off from the raised level top of the berm and the steep sloping side-slope of the fill to the retaining wall about 1m below the crest.

The Swamp Oak communities occurring naturally on the Cumberland Plain include 'Cumberland Swamp Oak Riparian Forest' that occurs on river-flats of the Cumberland Plain in Western Sydney and 'Estuarine Swamp Oak Forest' that occurs above a tidal influence (OEH 2016). Neither of these habitats occur at the artificial landscape of the raised berm at the current access way which consists largely of soft-fill above a concrete retaining wall (Figure 5).
