Report on  
Geotechnical Assessment

Proposed 132/33 kV Substation  
21 Waterloo Road, Macquarie Park

Prepared for  
Ausgrid

Project 86471.00  
August 2018

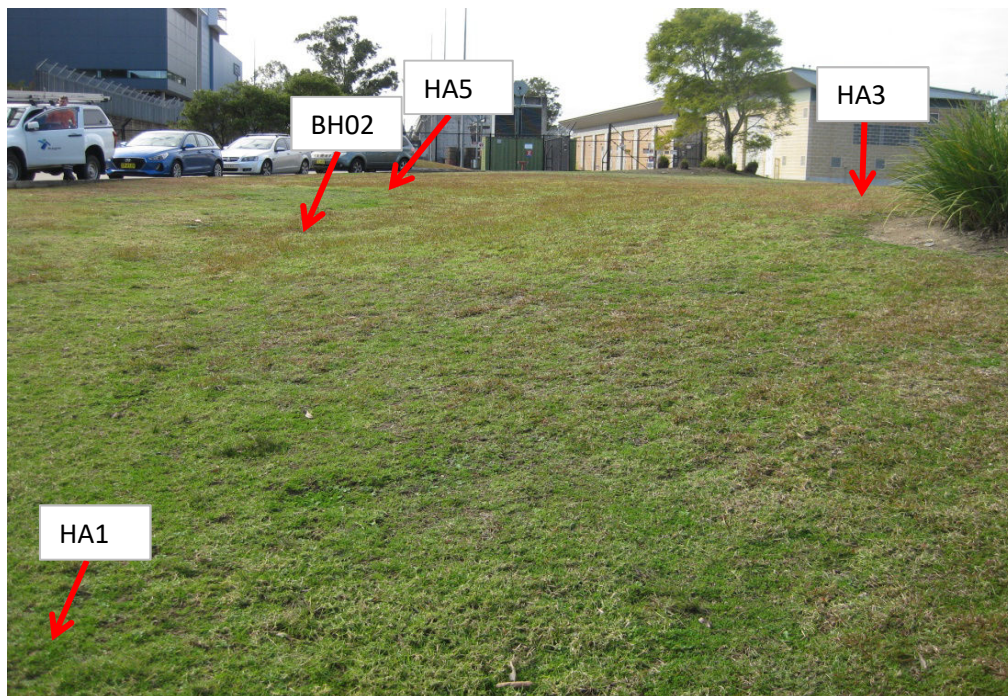
Photo 2 - View north-east towards the existing substation and across the proposed substation footprint. The approximate locations of the tests are indicated as shown.

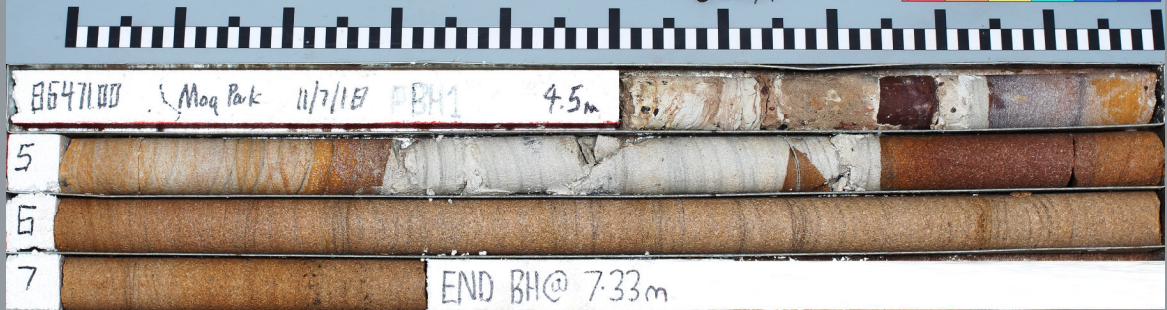
Project No: 86471.00  
BH ID: BH-1  
Depth: 4.50-7.33m  
Core Box No.: Box 1/1

4.5 m – 7.33 m

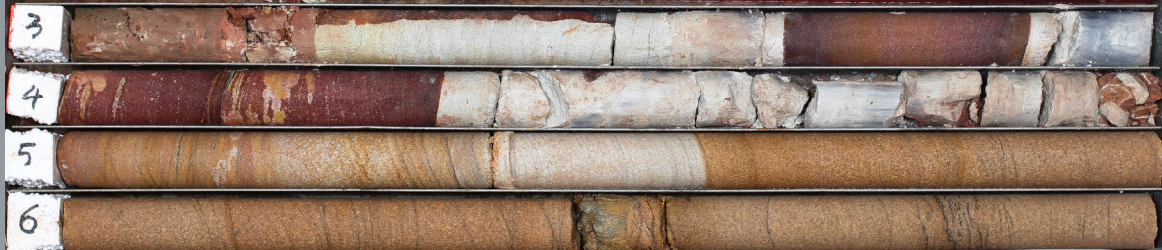
86471.00 - Macq. Park - BH02 - 11/7/18 - Start = 3.00m

3.0m - 7.0m
