Ecological Assessment

the installation of a feeder through

Georges River National Park,

AUSGRID

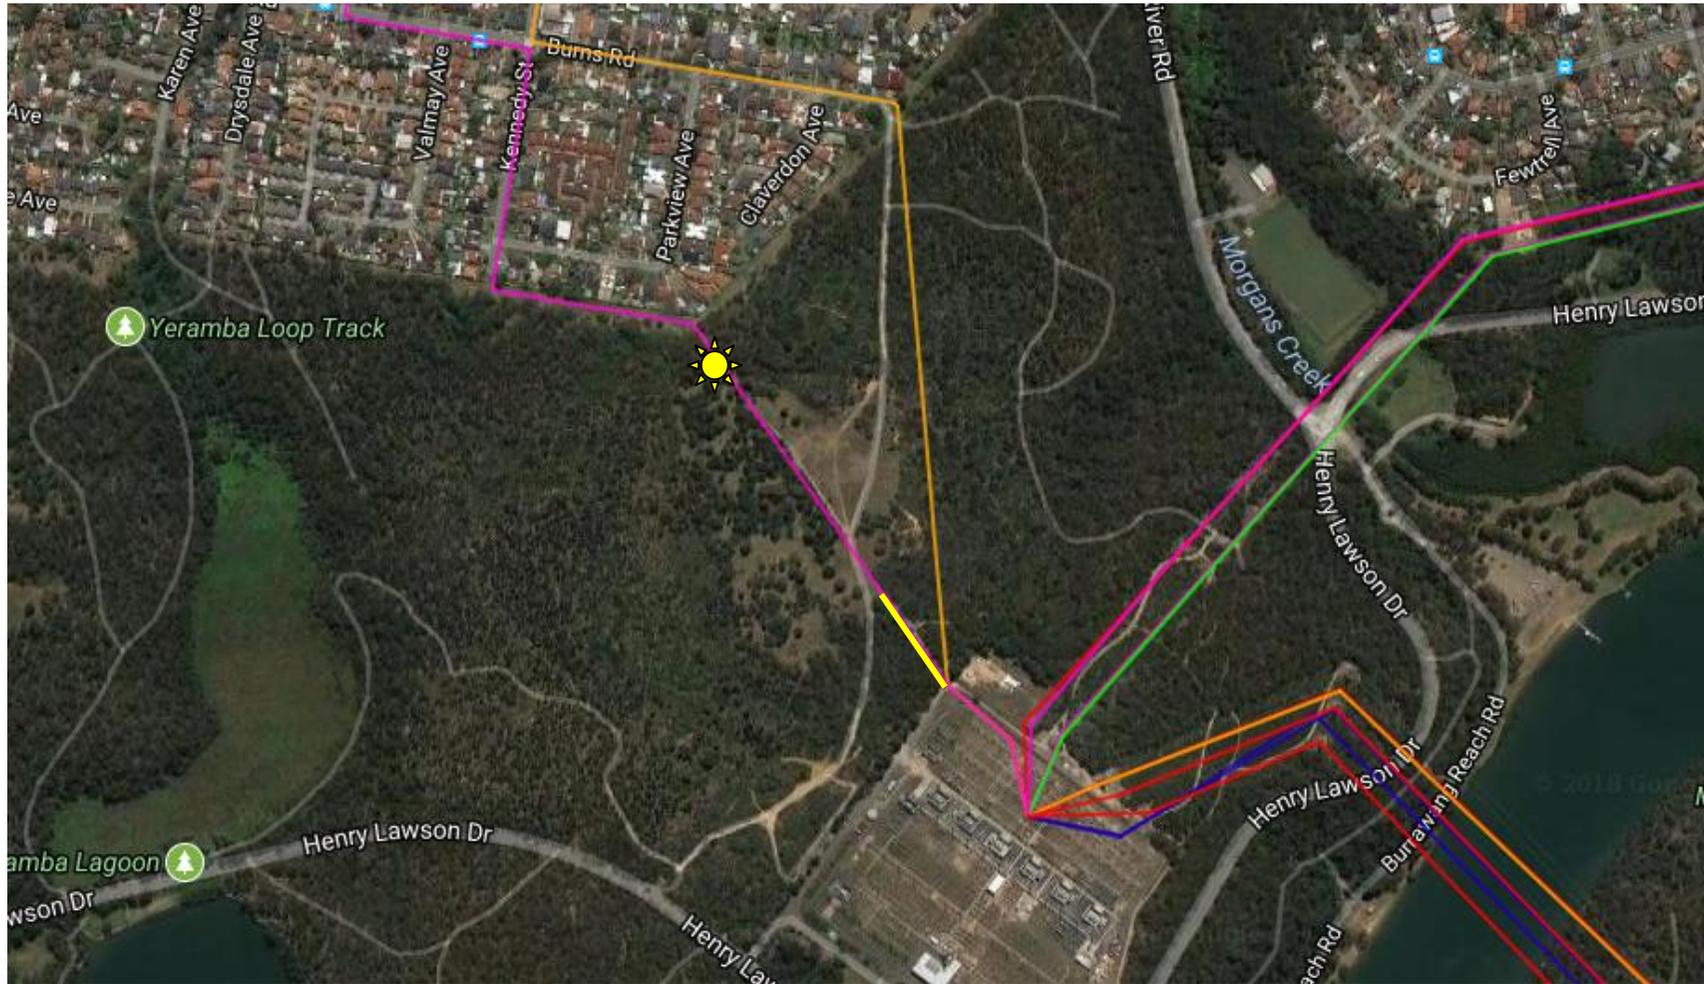
Figure 1 - Aerial image of subject area indicating the proposed route of the feeder from Kennedy Street, Revesby Heights, to the Sydney South Substation (marked in purple outline) requiring some trenching through bushland (bold yellow outline) for the works to occur

Figure 1 is an aerial image that indicates the direction of the feeder from Kennedy Street, Revesby Heights, to the Sydney South Substation located in the Georges River National Park in a local context

10. At the area denoted by the yellow shaded star in Figure 1 (☀) there is an individual of Broad-leaved Scribbly Gum which appears to be a suitable habitat tree (Figure 8) and which is proximal to the line of proposed trenching. This individual should not be impacted and should be retained in good condition. Hand-digging around roots to restrict damage to the structural root zone (SRZ) is recommended to preserve this individual.

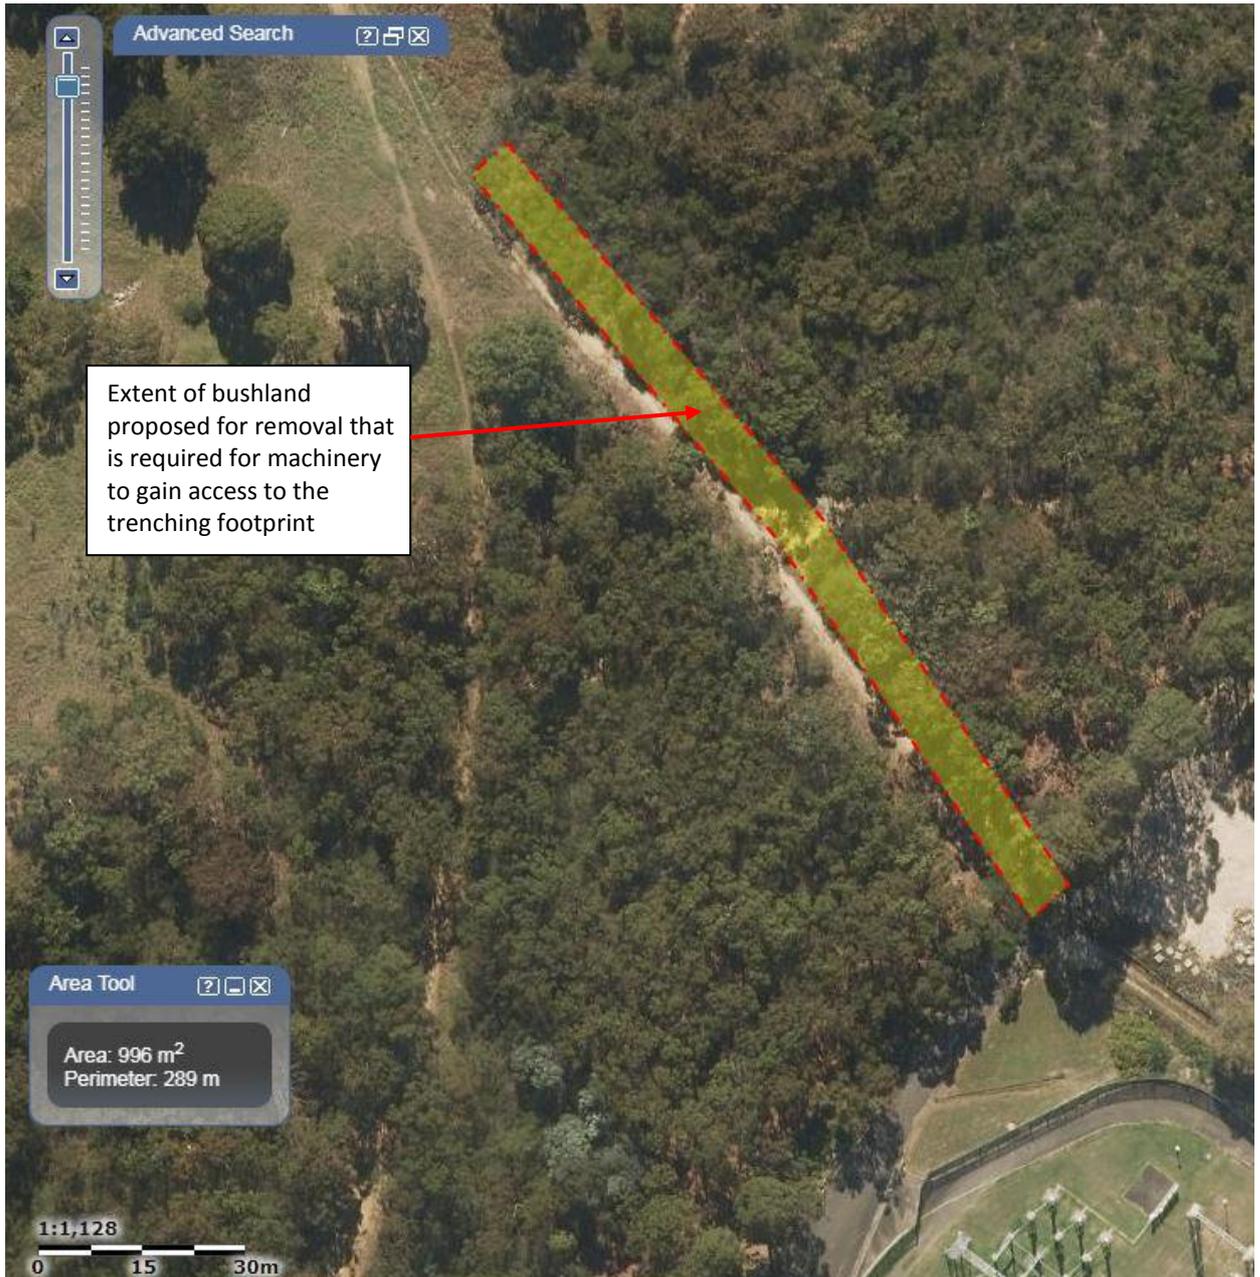
Figure 2 – Proposed area of bushland required to be removed/trimmed for trenching works at Georges River National Park, Revesby Heights, to install the new 132kV line to the substation shown at the south-east section of the image (sourced from SIXmaps OEH 2018).

Figure 2 indicates the extent of the required works that will include the removal of natural bushland vegetation

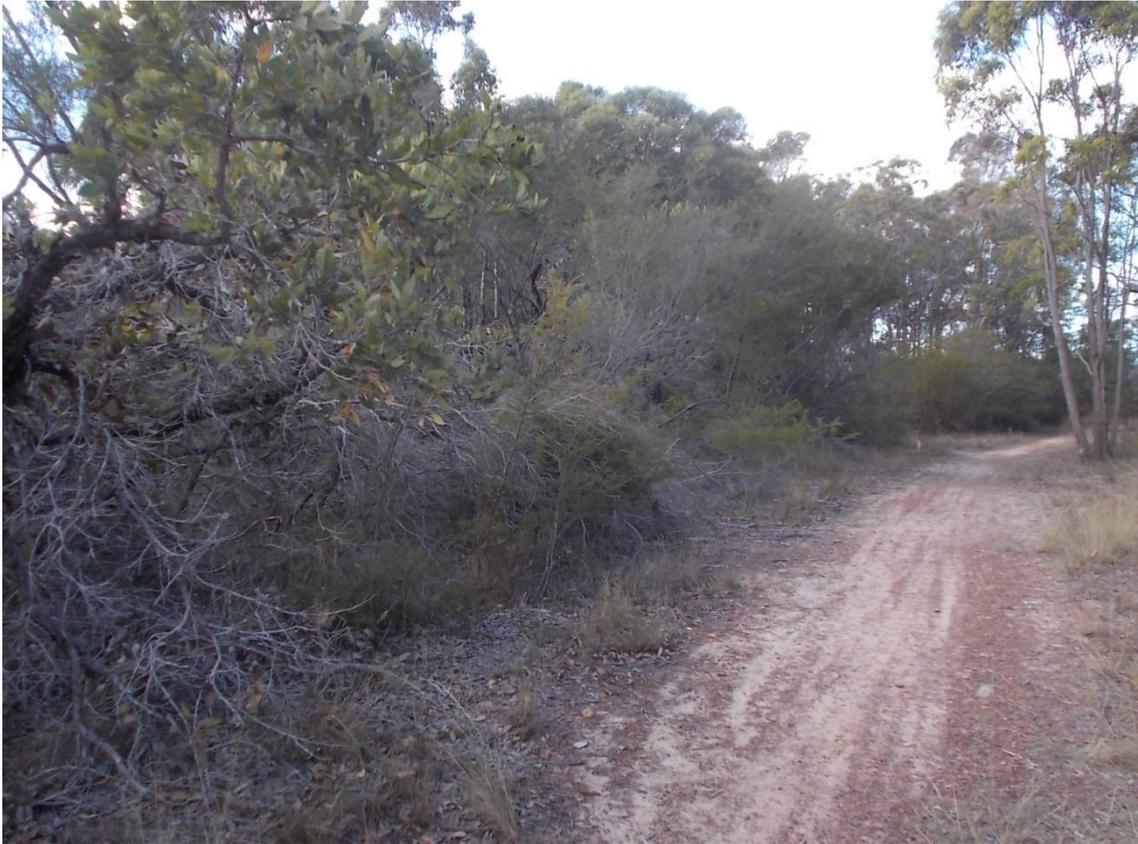
Figure 3 - Indicates the natural low open woodland/scrub vegetation that occurs alongside the access track to the substation, the pink flagged stakes (to centre RHS in image) indicate the centre-line of the Ausgrid easement, the vegetation occurring 5m to the LHS of these stakes is proposed for clearing to allow the trenching works to occur.

Figures 3 & 4 indicates the nature of the open woodland/scrub vegetation through which the trench will traverse,

All trees and other vegetation occurring along the proposed 132kV feeder route (Figures 1, 2 & 3) will require complete removal to allow for the trenching footprint (1m deep by 1m in width), with vegetation to a further distance of 4m into the bushland required to be trimmed to ground level to allow vehicular and machinery access to construct the trench.

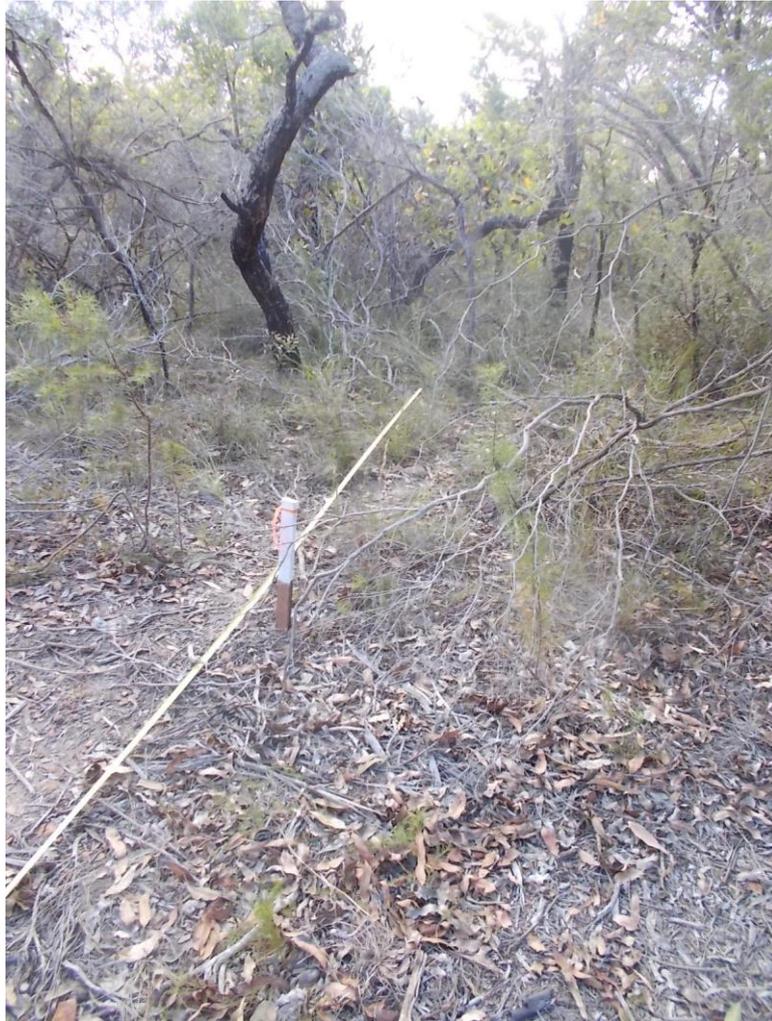
Figure 4 - Indicates the distance of 5m into the bushland from the pink flagged stake that the vegetation will require removing for the works to occur

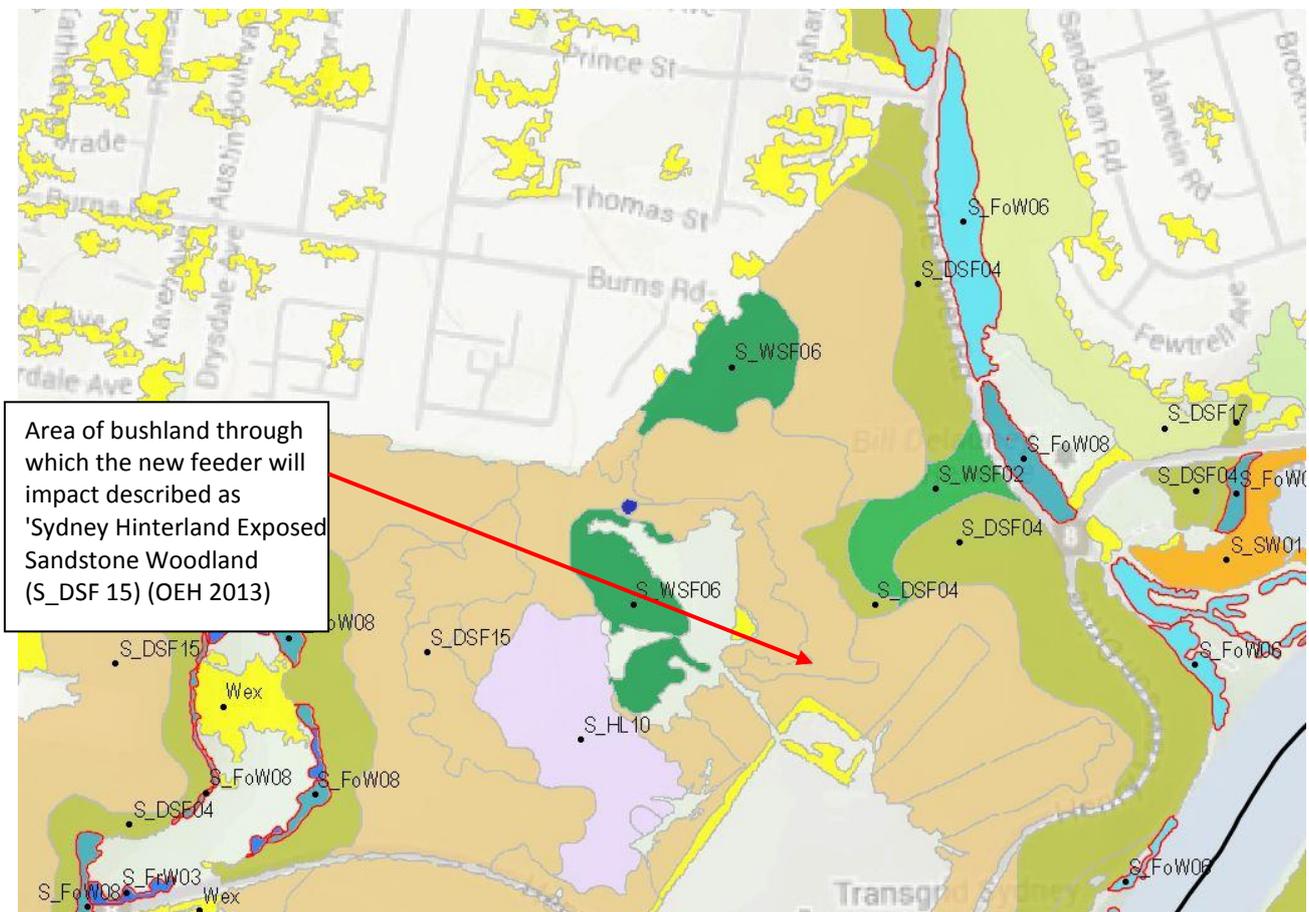
Figure 5 - OEH (2013) vegetation mapping of areas through which the new feeder will be trenced.

The local plant community along which the new feeder traverses is 'Sydney Hinterland Exposed Sandstone Woodland' (Figure 5) (S_DS15; OEH 2013). This community is an exposed sandstone vegetation distributed across the central and north-western Woronora Plateau. It comprises a low-growing woodland with dense shrub layer and open ground layer of forbs, sedges and grasses (OEH 2013).

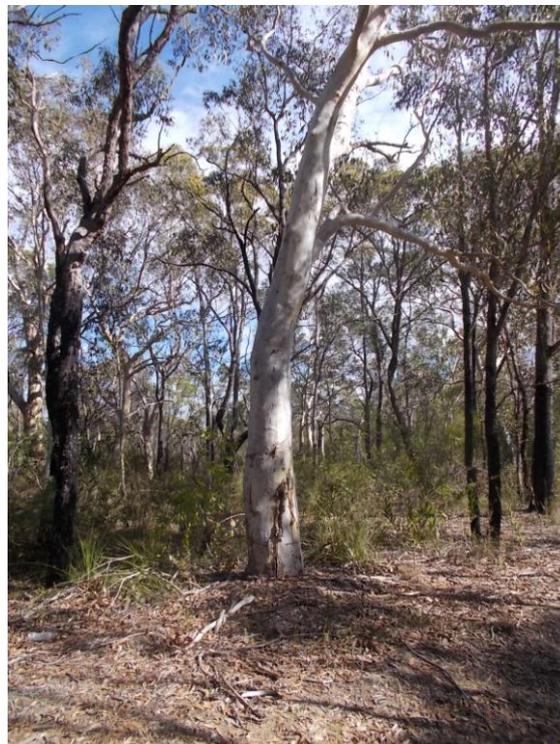
Figure 8 - Individual of Scribbly Gum which it is recommended to conserve by hand-digging around roots where practical.
