## Network Standard

Document No : NW000-S0161

NS211 ANNEXURE G – LV HRC FUSE ASBESTOS PRODUCT GUIDE

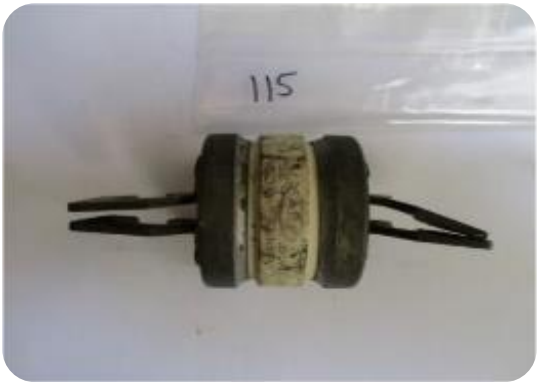
| Manufacturer | Rating | Fuse Body Photographs | Label Markings & Details | Result | Safety Instructions |
|---|---|---|---|---|---|
| AEI | 400 | <br>54287-001-115 | 30600 | <br>Asbestos found | <b>In-Service Fuses:</b><br> If fuse is damaged, cease work and make safe. Contact the Hazmat Hotline - 02 9394 6961.<br> If the fuse is intact, remove the fuse taking care not to damage in accordance with SWMS - AUS008 Removal of Friable Asbestos Containing LV HRC Fuses.<br><b>Stored and Quarantined Fuses:</b><br> Must be disposed of in accordance with SWMS - AUS008 Removal of Friable Asbestos Containing LV HRC Fuses. |

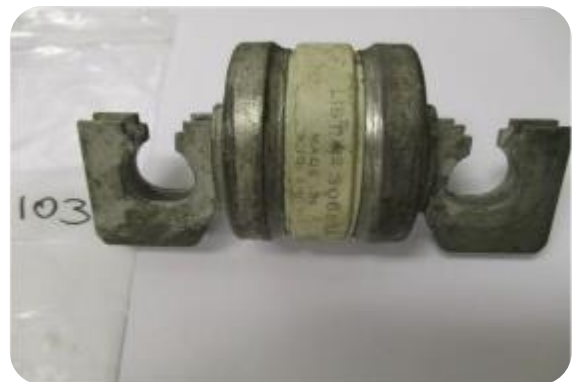
| Manufacturer | Rating | Fuse Body Photographs | Label Markings & Details | Result | Safety Instructions |
|---|---|---|---|---|---|
| AEI | 440 | <br>54287-001-103 | 440AC4F.F List 30655 | <br>Asbestos found | <b>In-Service Fuses:</b><br> If fuse is damaged, cease work and make safe. Contact the Hazmat Hotline - 02 9394 6961.<br> If the fuse is intact, remove the fuse taking care not to damage in accordance with SWMS - AUS008 Removal of Friable Asbestos Containing LV HRC Fuses.<br><b>Stored and Quarantined Fuses:</b><br> Must be disposed of in accordance with SWMS - AUS008 Removal of Friable Asbestos Containing LV HRC Fuses. |

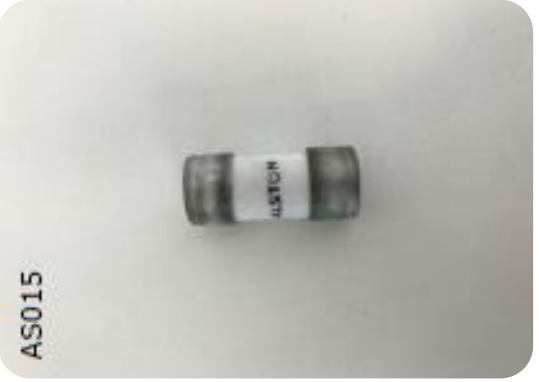
| Manufacturer | Rating | Fuse Body Photographs | Label Markings & Details | Result | Safety Instructions |
|---|---|---|---|---|---|
| Alstom | 45 | <br>AS015<br>P033786.002-AS012 | Alstom - AS2005 - 45Amp, SK45, 20kA/440V AC - 440V - no country - no date | <br>No Asbestos found, exercise caution and follow safety instructions | Where no manufacturer or date information can be confirmed and/or the fuse was manufactured prior to 2003, the <b>fuses should be presumed to contain asbestos and disposed</b> of as asbestos waste in accordance with NS211 - Working with Asbestos and SafeWork NSW Exemption 009/21. |

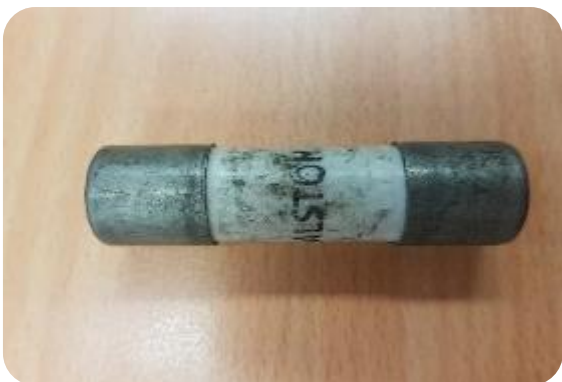
| Manufacturer | Rating | Fuse Body Photographs | Label Markings & Details | Result | Safety Instructions |
|---|---|---|---|---|---|
| Alstom | 60 | <br>OF00053-120718-AS05 | RHF60, 60 AMP, 33kA, 415V AC,<br>BS:1361-1971 | <br>Asbestos<br>found | <b>In-Service Fuses:</b><br> If fuse is damaged, cease work and make safe.<br>Contact the Hazmat Hotline - 02 9394 6961.<br> If the fuse is intact, remove the fuse taking care not to<br>damage in accordance with SWMS - AUS008 Removal of<br>Friable Asbestos Containing LV HRC Fuses.<br><b>Stored and Quarantined Fuses:</b><br> Must be disposed of in accordance with SWMS - AUS008<br>Removal of Friable Asbestos Containing LV HRC Fuses. |

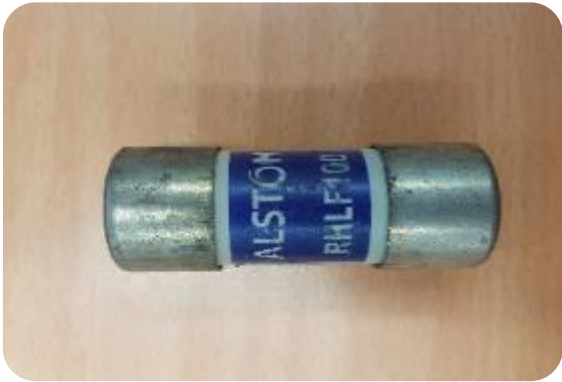
| Manufacturer | Rating | Fuse Body Photographs | Label Markings & Details | Result | Safety Instructions |
|---|---|---|---|---|---|
| Alstom | 100 | <br>OF00053-120718-AS03 | RHLF100, BS1361, 1971, 415V<br>AC, ASTA (20) CERT, made in the<br>UK | <br>No Asbestos<br>found,<br>exercise<br>caution and<br>follow safety<br>instructions | Where no manufacturer or date information can be<br>confirmed and/or the fuse was manufactured prior to 2003,<br>the <b>fuses should be presumed to contain asbestos and<br/>disposed</b> of in accordance with SWMS - AUS008 - Removal<br>of Friable Asbestos Containing LV HRC Fuses. |

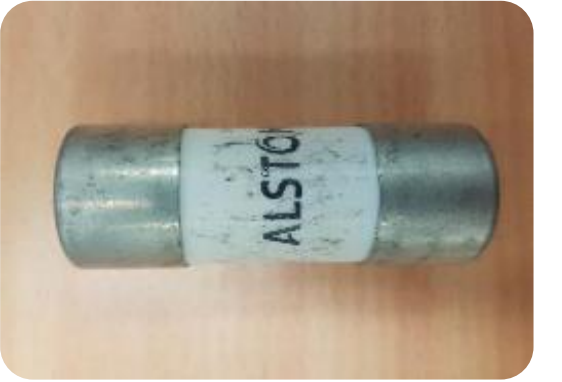
| Manufacturer | Rating | Fuse Body Photographs | Label Markings & Details | Result | Safety Instructions |
|---|---|---|---|---|---|
| Alstom | 100 | <br>OF00053-120718-AS14 | RHLF100, 100AMP, 33kA, 415V<br>AC, BS:1361-1971 | <br>Asbestos<br>found | <b>In-Service Fuses:</b><br> If fuse is damaged, cease work and make safe.<br>Contact the Hazmat Hotline - 02 9394 6961.<br> If the fuse is intact, remove the fuse taking care not to<br>damage in accordance with SWMS - AUS008 Removal of<br>Friable Asbestos Containing LV HRC Fuses.<br><b>Stored and Quarantined Fuses:</b><br> Must be disposed of in accordance with SWMS - AUS008<br>Removal of Friable Asbestos Containing LV HRC Fuses. |

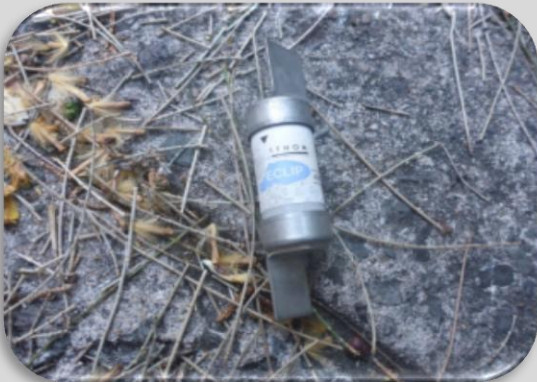
| Manufacturer | Rating | Fuse Body Photographs | Label Markings & Details | Result | Safety Instructions |
|---|---|---|---|---|---|
| Alstom Safeclip | 20 | | Details illegible, possibly 20 Amp)<br><br>2101006/AS004 | <br>No Asbestos found, exercise caution and follow safety instructions | <br>Where no manufacturer or date information can be confirmed and/or the fuse was manufactured prior to 2003, the <b>fuses should be presumed to contain asbestos and disposed</b> of in accordance with SWMS - AUS008 - Removal of Friable Asbestos Containing LV HRC Fuses. |

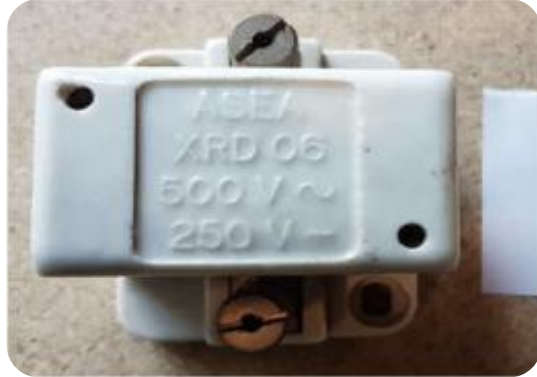
| Manufacturer | Rating | Fuse Body Photographs | Label Markings & Details | Result | Safety Instructions |
|---|---|---|---|---|---|
| ASEA | | | XRD06, 500V~, 250V-, 60327<br><br>P033768.003-AS020 | <br>No Asbestos found, exercise caution and follow safety instructions | <br>Where no manufacturer or date information can be confirmed and/or the fuse was manufactured prior to 2003, the <b>fuses should be presumed to contain asbestos and disposed</b> of in accordance with SWMS - AUS008 - Removal of Friable Asbestos Containing LV HRC Fuses. |

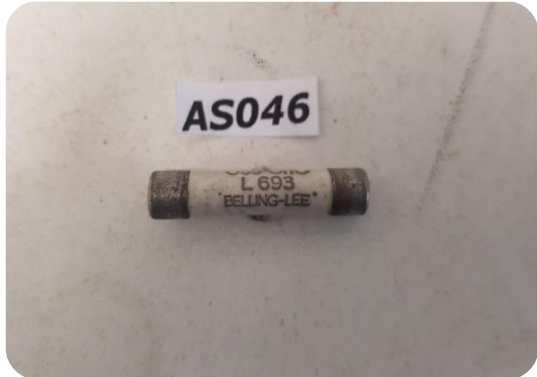
| Manufacturer | Rating | Fuse Body Photographs | Label Markings & Details | Result | Safety Instructions |
|---|---|---|---|---|---|
| Belling-Lee | 2 | | L693 059-0110, 2A<br><br>174783-001-AS046 | <br>No Asbestos found, exercise caution and follow safety instructions | <br>Where no manufacturer or date information can be confirmed and/or the fuse was manufactured prior to 2003, the <b>fuses should be presumed to contain asbestos and disposed</b> of in accordance with SWMS - AUS008 - Removal of Friable Asbestos Containing LV HRC Fuses. |

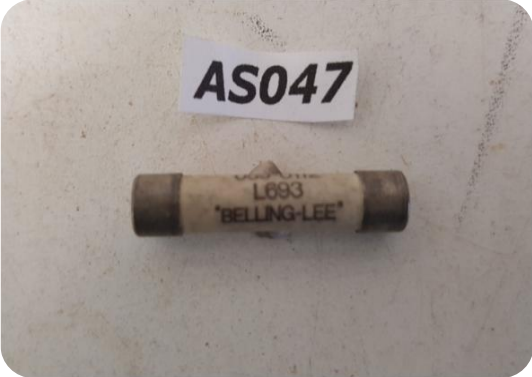
| Manufacturer | Rating | Fuse Body Photographs | Label Markings & Details | Result | Safety Instructions |
|---|---|---|---|---|---|
| Belling-Lee | 5 | | L693 059-0112, 5A | <br>No Asbestos found, exercise caution and follow safety instructions | <br>Where no manufacturer or date information can be confirmed and/or the fuse was manufactured prior to 2003, the <b>fuses should be presumed to contain asbestos and disposed</b> of in accordance with SWMS - AUS008 - Removal of Friable Asbestos Containing LV HRC Fuses. |

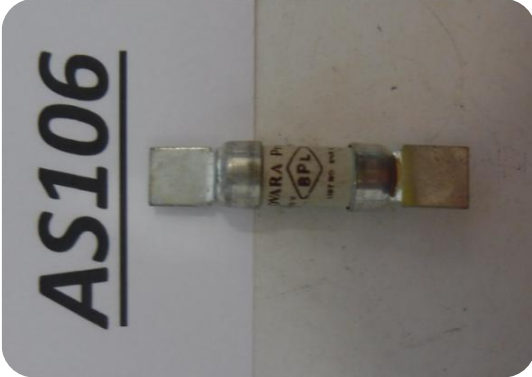
| Manufacturer | Rating | Fuse Body Photographs | Label Markings & Details | Result | Safety Instructions |
|---|---|---|---|---|---|
| Bovara | 2 | | SNS 2, 2A, 90AC, B.S-88, IEC 269 | <br>No Asbestos found, exercise caution and follow safety instructions | <br>Where no manufacturer or date information can be confirmed and/or the fuse was manufactured prior to 2003, the <b>fuses should be presumed to contain asbestos and disposed</b> of in accordance with SWMS - AUS008 - Removal of Friable Asbestos Containing LV HRC Fuses. |

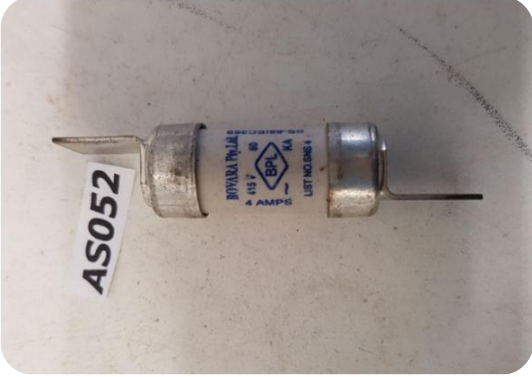
| Manufacturer | Rating | Fuse Body Photographs | Label Markings & Details | Result | Safety Instructions |
|---|---|---|---|---|---|
| Bovara | 4 | | SNS4, 4A, 80kA, BS88, IEC269 | <br>No Asbestos found, exercise caution and follow safety instructions | <br>Where no manufacturer or date information can be confirmed and/or the fuse was manufactured prior to 2003, the <b>fuses should be presumed to contain asbestos and disposed</b> of in accordance with SWMS - AUS008 - Removal of Friable Asbestos Containing LV HRC Fuses. |

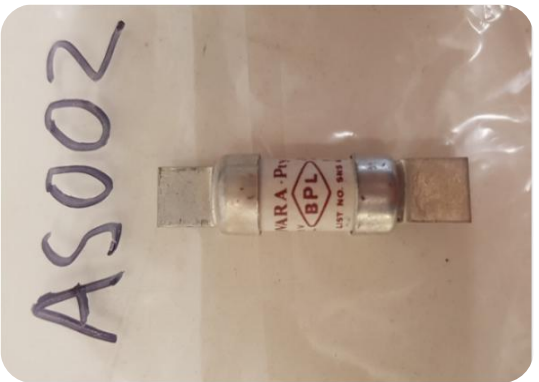
| Manufacturer | Rating | Fuse Body Photographs | Label Markings & Details | Result | Safety Instructions |
|---|---|---|---|---|---|
| Bovara | 6 | | SNS6, 6A, 90kA, BS-88 IEC269 | <br>No Asbestos found, exercise caution and follow safety instructions | Where no manufacturer or date information can be confirmed and/or the fuse was manufactured prior to 2003, the <b>fuses should be presumed to contain asbestos and disposed</b> of in accordance with SWMS - AUS008 - Removal of Friable Asbestos Containing LV HRC Fuses. |

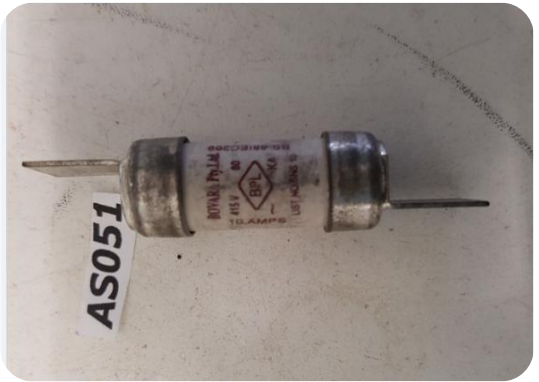
| Manufacturer | Rating | Fuse Body Photographs | Label Markings & Details | Result | Safety Instructions |
|---|---|---|---|---|---|
| Bovara | 10 | | SNS10, 10A, 80kA, BS88 IEC269 | <br>No Asbestos found, exercise caution and follow safety instructions | Where no manufacturer or date information can be confirmed and/or the fuse was manufactured prior to 2003, the <b>fuses should be presumed to contain asbestos and disposed</b> of in accordance with SWMS - AUS008 - Removal of Friable Asbestos Containing LV HRC Fuses. |

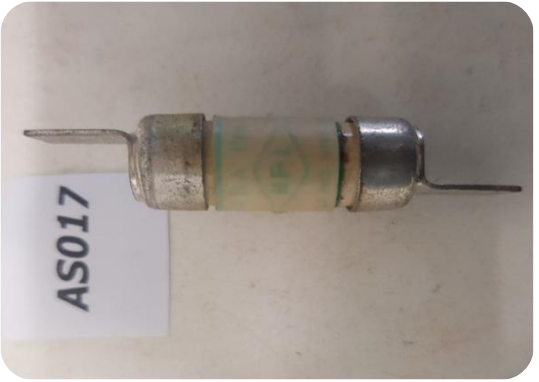
| Manufacturer | Rating | Fuse Body Photographs | Label Markings & Details | Result | Safety Instructions |
|---|---|---|---|---|---|
| Bovara | 10 | | SNS10, 10A, BS88, IEC269, 80kA | <br>Asbestos found | <b>In-Service Fuses:</b><br> If fuse is damaged, cease work and make safe. Contact the Hazmat Hotline - 02 9394 6961.<br> If the fuse is intact, remove the fuse taking care not to damage in accordance with SWMS - AUS008 Removal of Friable Asbestos Containing LV HRC Fuses.<br><b>Stored and Quarantined Fuses:</b><br> Must be disposed of in accordance with SWMS - AUS008 Removal of Friable Asbestos Containing LV HRC Fuses. |

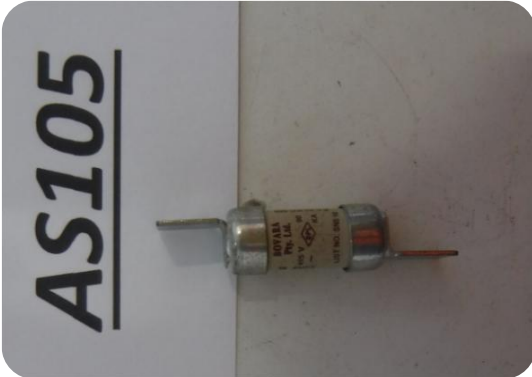
| Manufacturer | Rating | Fuse Body Photographs | Label Markings & Details | Result | Safety Instructions |
|---|---|---|---|---|---|
| Bovara | 16 | | SNS 16, 16A, 90AC, B.S-88, IEC 269 | <br>No Asbestos found, exercise caution and follow safety instructions | <br>Where no manufacturer or date information can be confirmed and/or the fuse was manufactured prior to 2003, the <b>fuses should be presumed to contain asbestos and disposed</b> of in accordance with SWMS - AUS008 - Removal of Friable Asbestos Containing LV HRC Fuses. |

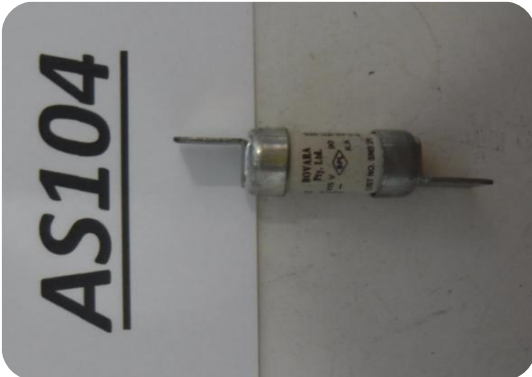
| Manufacturer | Rating | Fuse Body Photographs | Label Markings & Details | Result | Safety Instructions |
|---|---|---|---|---|---|
| Bovara | 20 | | SNS 20, 20A, 90AC, B.S-88, IEC 269 | <br>No Asbestos found, exercise caution and follow safety instructions | <br>Where no manufacturer or date information can be confirmed and/or the fuse was manufactured prior to 2003, the <b>fuses should be presumed to contain asbestos and disposed</b> of in accordance with SWMS - AUS008 - Removal of Friable Asbestos Containing LV HRC Fuses. |

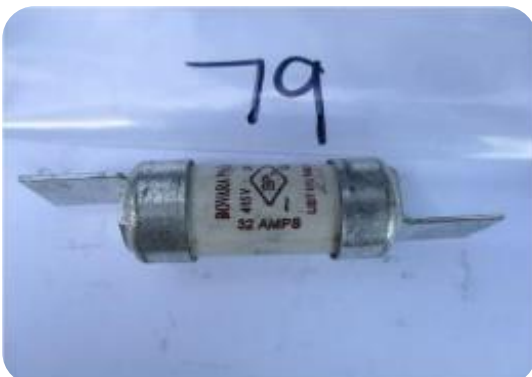
| Manufacturer | Rating | Fuse Body Photographs | Label Markings & Details | Result | Safety Instructions |
|---|---|---|---|---|---|
| Bovara | 32 | | SNS 32 | <br>No Asbestos found, exercise caution and follow safety instructions | <br>Where no manufacturer or date information can be confirmed and/or the fuse was manufactured prior to 2003, the <b>fuses should be presumed to contain asbestos and disposed</b> of in accordance with SWMS - AUS008 - Removal of Friable Asbestos Containing LV HRC Fuses. |

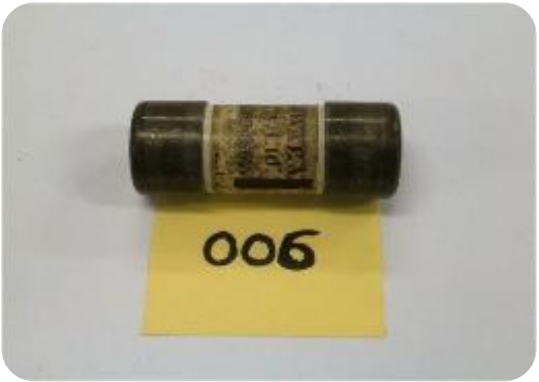
| Manufacturer | Rating | Fuse Body Photographs | Label Markings & Details | Result | Safety Instructions |
|---|---|---|---|---|---|
| Bovara | 80 | | AC80-6.5W, 80A, 80kA, 500V~,<br>55738-001-006 | <br>No Asbestos found,<br>exercise caution and follow safety instructions | Where no manufacturer or date information can be confirmed and/or the fuse was manufactured prior to 2003, the <b>fuses should be presumed to contain asbestos and disposed</b> of in accordance with SWMS - AUS008 - Removal of Friable Asbestos Containing LV HRC Fuses. |

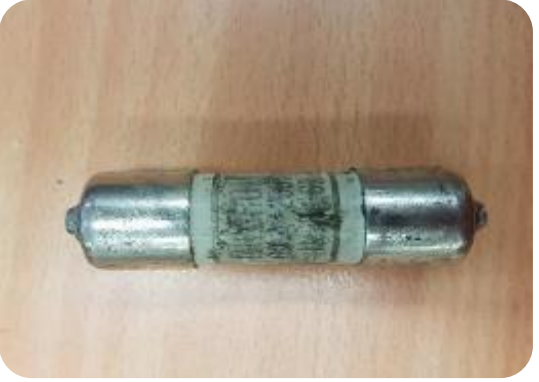
| Manufacturer | Rating | Fuse Body Photographs | Label Markings & Details | Result | Safety Instructions |
|---|---|---|---|---|---|
| Bovara | 80 | | ZR-2-80, AC 80 – 5.0W, 80A, 500 V~, IEC269-AS2005<br>OF00053-120718-AS09 | <br>No Asbestos found,<br>exercise caution and follow safety instructions | Where no manufacturer or date information can be confirmed and/or the fuse was manufactured prior to 2003, the <b>fuses should be presumed to contain asbestos and disposed</b> of in accordance with SWMS - AUS008 - Removal of Friable Asbestos Containing LV HRC Fuses. |

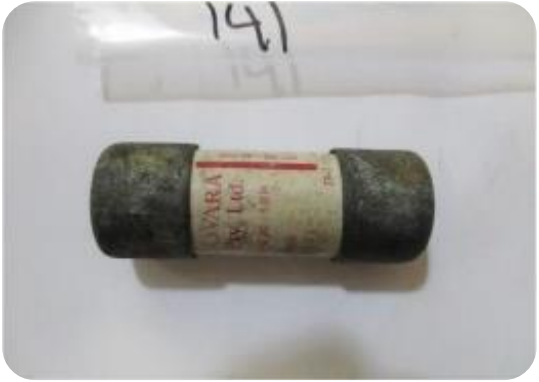
| Manufacturer | Rating | Fuse Body Photographs | Label Markings & Details | Result | Safety Instructions |
|---|---|---|---|---|---|
| Bovara | 100 | | ZR-2-100<br>54287-001-141 | <br>No Asbestos found,<br>exercise caution and follow safety instructions | Where no manufacturer or date information can be confirmed and/or the fuse was manufactured prior to 2003, the <b>fuses should be presumed to contain asbestos and disposed</b> of in accordance with SWMS - AUS008 - Removal of Friable Asbestos Containing LV HRC Fuses. |

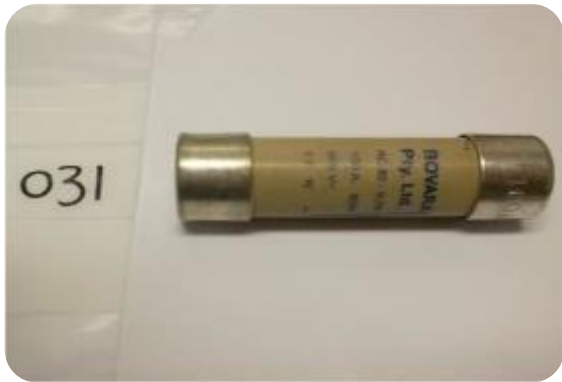
| Manufacturer | Rating | Fuse Body Photographs | Label Markings & Details | Result | Safety Instructions |
|---|---|---|---|---|---|
| Bovara | 100 | | AC80-6.0W, 100A, 80kA, 500V~, FF'R', 110430 | <br>No Asbestos found,<br>exercise caution and follow safety instructions | Where no manufacturer or date information can be confirmed and/or the fuse was manufactured prior to 2003, the <b>fuses should be presumed to contain asbestos and disposed</b> of in accordance with SWMS - AUS008 - Removal of Friable Asbestos Containing LV HRC Fuses. |

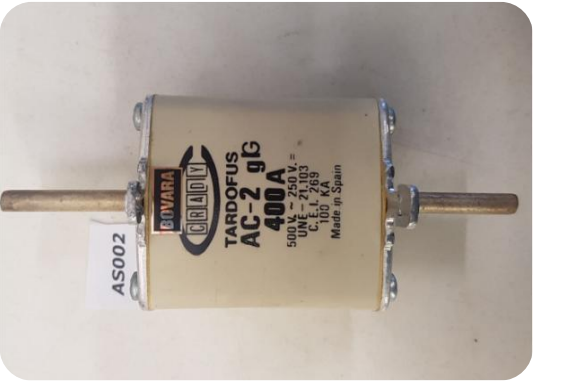
| Manufacturer | Rating | Fuse Body Photographs | Label Markings & Details | Result | Safety Instructions |
|---|---|---|---|---|---|
| Bovara | 400 | | Tardofus AZ-2 glg, UNE-21.103, C.E.I. 269, 100kA, 199395 | <br>No Asbestos found,<br>exercise caution and follow safety instructions | Where no manufacturer or date information can be confirmed and/or the fuse was manufactured prior to 2003, the <b>fuses should be presumed to contain asbestos and disposed</b> of in accordance with SWMS - AUS008 - Removal of Friable Asbestos Containing LV HRC Fuses. |

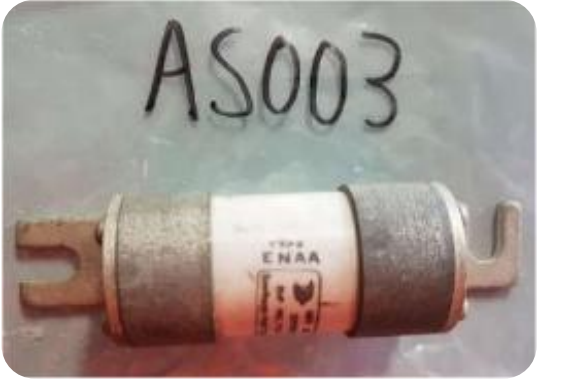
| Manufacturer | Rating | Fuse Body Photographs | Label Markings & Details | Result | Safety Instructions |
|---|---|---|---|---|---|
| Bowthorpe Australia | 80 | | TYPE ENAA, 80A, WFF, ACS CERTIFIED (label worn) | <br>Asbestos found | <b>In-Service Fuses:</b><br> If fuse is damaged, cease work and make safe. Contact the Hazmat Hotline - 02 9394 6961.<br> If the fuse is intact, remove the fuse taking care not to damage in accordance with SWMS - AUS008 Removal of Friable Asbestos Containing LV HRC Fuses.<br><b>Stored and Quarantined Fuses:</b><br> Must be disposed of in accordance with SWMS - AUS008 Removal of Friable Asbestos Containing LV HRC Fuses. |

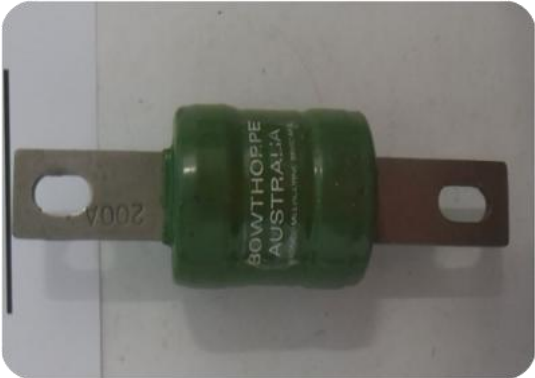
| Manufacturer | Rating | Fuse Body Photographs | Label Markings & Details | Result | Safety Instructions |
|---|---|---|---|---|---|
| Bowthorpe Australia | 200 | | EA0, 200A<br>168273-101 | <br>No Asbestos found, exercise caution and follow safety instructions | <br>Where no manufacturer or date information can be confirmed and/or the fuse was manufactured prior to 2003, the <b>fuses should be presumed to contain asbestos and disposed</b> of in accordance with SWMS - AUS008 - Removal of Friable Asbestos Containing LV HRC Fuses. |

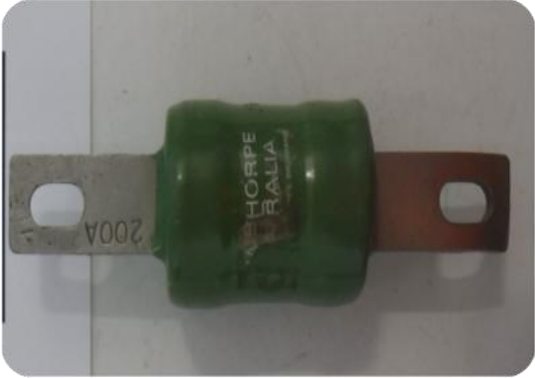
| Manufacturer | Rating | Fuse Body Photographs | Label Markings & Details | Result | Safety Instructions |
|---|---|---|---|---|---|
| Bowthorpe Australia | 200 | | EA0, 200A<br>168273-103 | <br>No Asbestos found, exercise caution and follow safety instructions | <br>Where no manufacturer or date information can be confirmed and/or the fuse was manufactured prior to 2003, the <b>fuses should be presumed to contain asbestos and disposed</b> of in accordance with SWMS - AUS008 - Removal of Friable Asbestos Containing LV HRC Fuses. |

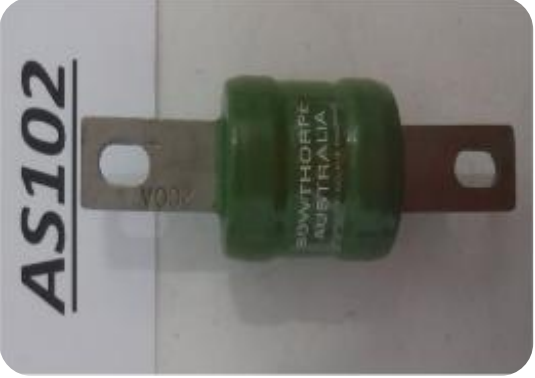
| Manufacturer | Rating | Fuse Body Photographs | Label Markings & Details | Result | Safety Instructions |
|---|---|---|---|---|---|
| Bowthorpe Australia | 200 | | EA0, 200A<br>168273-102 | <br>No Asbestos found, exercise caution and follow safety instructions | <br>Where no manufacturer or date information can be confirmed and/or the fuse was manufactured prior to 2003, the <b>fuses should be presumed to contain asbestos and disposed</b> of in accordance with SWMS - AUS008 - Removal of Friable Asbestos Containing LV HRC Fuses. |

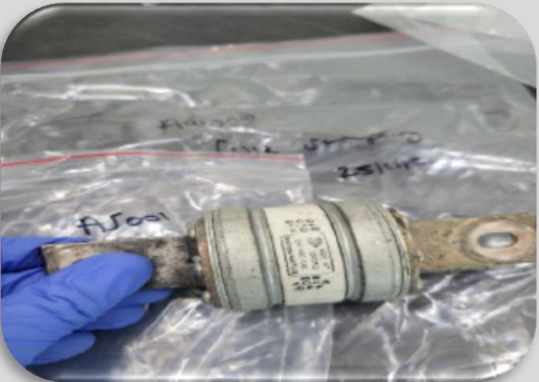
| Manufacturer | Rating | Fuse Body Photographs | Label Markings & Details | Result | Safety Instructions |
|---|---|---|---|---|---|
| Bowthorpe Australia | 400 | | 440V 400A fuse Type EED<br>211124/AS001 | <br>Asbestos found | <b>In-Service Fuses:</b><br> If fuse is damaged, cease work and make safe. Contact the Hazmat Hotline - 02 9394 6961.<br> If the fuse is intact, remove the fuse taking care not to damage in accordance with SWMS - AUS008 Removal of Friable Asbestos Containing LV HRC Fuses.<br><b>Stored and Quarantined Fuses:</b><br> Must be disposed of in accordance with SWMS - AUS008 Removal of Friable Asbestos Containing LV HRC Fuses. |

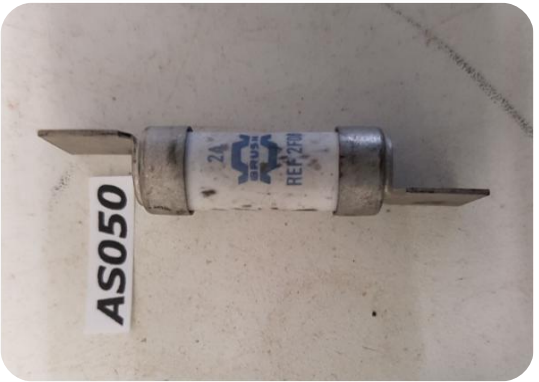
| Manufacturer | Rating | Fuse Body Photographs | Label Markings & Details | Result | Safety Instructions |
|---|---|---|---|---|---|
| Brush | 2 | | 2F06, 2A, 250VDC, B.S.88: Pt 1<br>174783-001-AS050 | <br>Asbestos found | <b>In-Service Fuses:</b><br> If fuse is damaged, cease work and make safe. Contact the Hazmat Hotline - 02 9394 6961.<br> If the fuse is intact, remove the fuse taking care not to damage in accordance with SWMS - AUS008 Removal of Friable Asbestos Containing LV HRC Fuses.<br><b>Stored and Quarantined Fuses:</b><br> Must be disposed of in accordance with SWMS - AUS008 Removal of Friable Asbestos Containing LV HRC Fuses. |

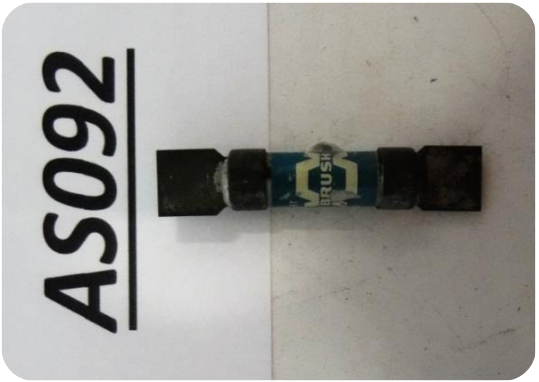
| Manufacturer | Rating | Fuse Body Photographs | Label Markings & Details | Result | Safety Instructions |
|---|---|---|---|---|---|
| Brush | 10 | | F06, 10A, AC80, B.S 88, Q1<br>168273-92 | <br>Asbestos found | <b>In-Service Fuses:</b><br> If fuse is damaged, cease work and make safe. Contact the Hazmat Hotline - 02 9394 6961.<br> If the fuse is intact, remove the fuse taking care not to damage in accordance with SWMS - AUS008 Removal of Friable Asbestos Containing LV HRC Fuses.<br><b>Stored and Quarantined Fuses:</b><br> Must be disposed of in accordance with SWMS - AUS008 Removal of Friable Asbestos Containing LV HRC Fuses. |

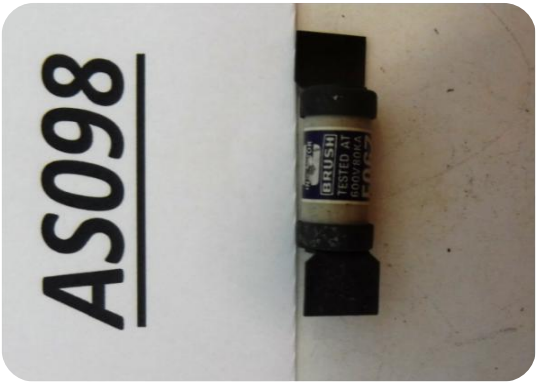
| Manufacturer | Rating | Fuse Body Photographs | Label Markings & Details | Result | Safety Instructions |
|---|---|---|---|---|---|
| Brush | 15 | | F0KZ, 15A, AC80, B.S 88, Class Q1, 415V | <br>Asbestos found | <b>In-Service Fuses:</b><br> If fuse is damaged, cease work and make safe. Contact the Hazmat Hotline - 02 9394 6961.<br> If the fuse is intact, remove the fuse taking care not to damage in accordance with SWMS - AUS008 Removal of Friable Asbestos Containing LV HRC Fuses.<br><b>Stored and Quarantined Fuses:</b><br> Must be disposed of in accordance with SWMS - AUS008 Removal of Friable Asbestos Containing LV HRC Fuses. |

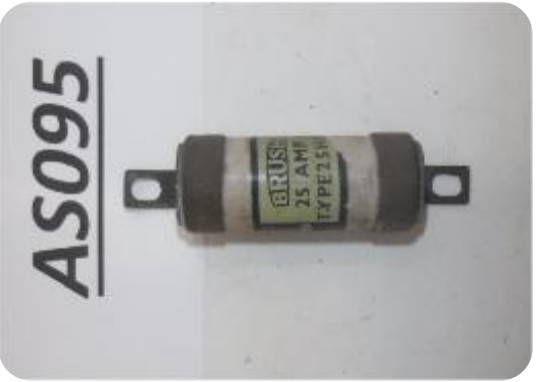
| Manufacturer | Rating | Fuse Body Photographs | Label Markings & Details | Result | Safety Instructions |
|---|---|---|---|---|---|
| Brush | 25 | | 25H07, 25A, AC5, B.S 88 | <br>Asbestos found | <b>In-Service Fuses:</b><br> If fuse is damaged, cease work and make safe. Contact the Hazmat Hotline - 02 9394 6961.<br> If the fuse is intact, remove the fuse taking care not to damage in accordance with SWMS - AUS008 Removal of Friable Asbestos Containing LV HRC Fuses.<br><b>Stored and Quarantined Fuses:</b><br> Must be disposed of in accordance with SWMS - AUS008 Removal of Friable Asbestos Containing LV HRC Fuses. |

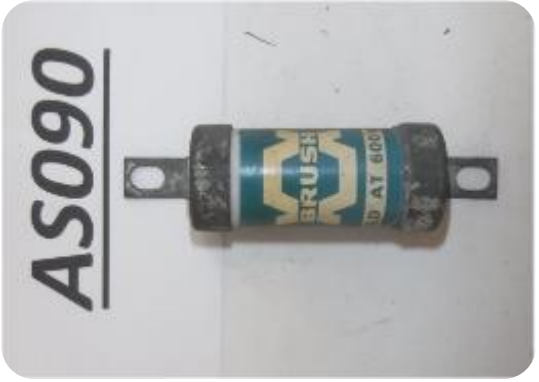
| Manufacturer | Rating | Fuse Body Photographs | Label Markings & Details | Result | Safety Instructions |
|---|---|---|---|---|---|
| Brush | 30 | | 30H07, 30A, AC80, B.S 88, Q1, 500V | <br>Asbestos found | <b>In-Service Fuses:</b><br> If fuse is damaged, cease work and make safe. Contact the Hazmat Hotline - 02 9394 6961.<br> If the fuse is intact, remove the fuse taking care not to damage in accordance with SWMS - AUS008 Removal of Friable Asbestos Containing LV HRC Fuses.<br><b>Stored and Quarantined Fuses:</b><br> Must be disposed of in accordance with SWMS - AUS008 Removal of Friable Asbestos Containing LV HRC Fuses. |

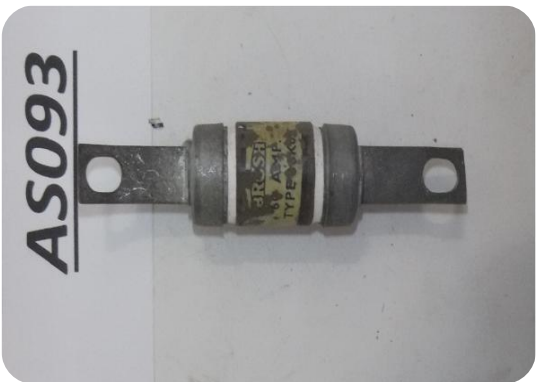
| Manufacturer | Rating | Fuse Body Photographs | Label Markings & Details | Result | Safety Instructions |
|---|---|---|---|---|---|
| Brush | 30 | <br>168273-93 | 60K08, 60A, AC5 (Label worn) | <br>Asbestos found | <b>In-Service Fuses:</b><br> If fuse is damaged, cease work and make safe. Contact the Hazmat Hotline - 02 9394 6961.<br> If the fuse is intact, remove the fuse taking care not to damage in accordance with SWMS - AUS008 Removal of Friable Asbestos Containing LV HRC Fuses.<br><b>Stored and Quarantined Fuses:</b><br> Must be disposed of in accordance with SWMS - AUS008 Removal of Friable Asbestos Containing LV HRC Fuses. |

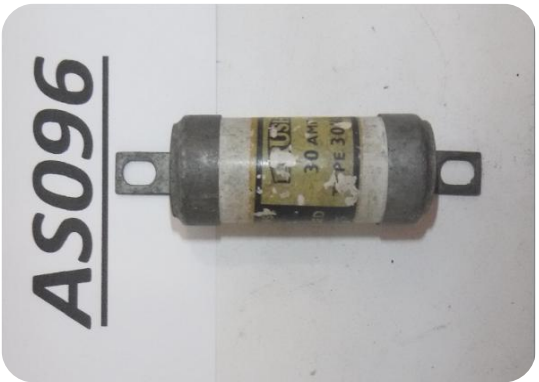
| Manufacturer | Rating | Fuse Body Photographs | Label Markings & Details | Result | Safety Instructions |
|---|---|---|---|---|---|
| Brush | 30 | <br>168273-96 | 30H07, 30A, AC5, B.S 88 | <br>Asbestos found | <b>In-Service Fuses:</b><br> If fuse is damaged, cease work and make safe. Contact the Hazmat Hotline - 02 9394 6961.<br> If the fuse is intact, remove the fuse taking care not to damage in accordance with SWMS - AUS008 Removal of Friable Asbestos Containing LV HRC Fuses.<br><b>Stored and Quarantined Fuses:</b><br> Must be disposed of in accordance with SWMS - AUS008 Removal of Friable Asbestos Containing LV HRC Fuses. |

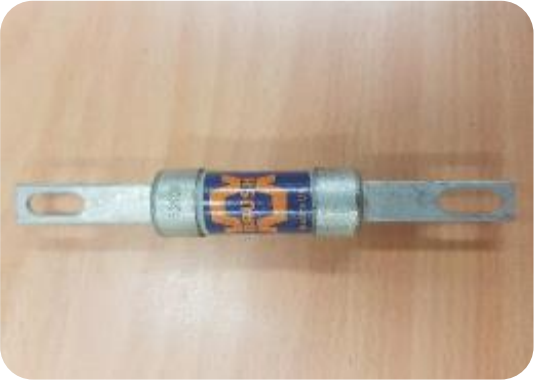
| Manufacturer | Rating | Fuse Body Photographs | Label Markings & Details | Result | Safety Instructions |
|---|---|---|---|---|---|
| Brush | 40 | <br>OF00053-120718-AS25 | 63K09, BS88:1, 660V a.c. 80kA, 250V d.c. 40kA, Q1, made in U.K. | <br>Asbestos found | <b>In-Service Fuses:</b><br> If fuse is damaged, cease work and make safe. Contact the Hazmat Hotline - 02 9394 6961.<br> If the fuse is intact, remove the fuse taking care not to damage in accordance with SWMS - AUS008 Removal of Friable Asbestos Containing LV HRC Fuses.<br><b>Stored and Quarantined Fuses:</b><br> Must be disposed of in accordance with SWMS - AUS008 Removal of Friable Asbestos Containing LV HRC Fuses. |

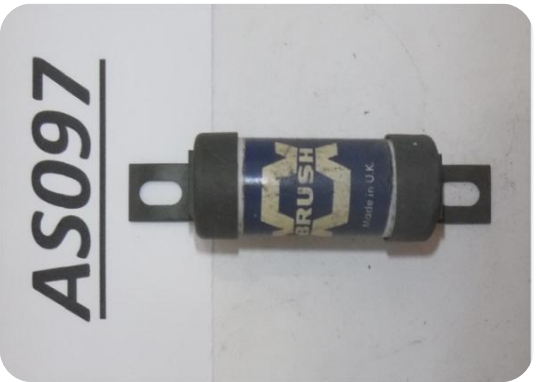
| Manufacturer | Rating | Fuse Body Photographs | Label Markings & Details | Result | Safety Instructions |
|---|---|---|---|---|---|
| Brush | 50 | | 50K07, 50A, AC80, B.S 88, Q1 | <br>Asbestos found | <b>In-Service Fuses:</b><br> If fuse is damaged, cease work and make safe. Contact the Hazmat Hotline - 02 9394 6961.<br> If the fuse is intact, remove the fuse taking care not to damage in accordance with SWMS - AUS008 Removal of Friable Asbestos Containing LV HRC Fuses.<br><b>Stored and Quarantined Fuses:</b><br> Must be disposed of in accordance with SWMS - AUS008 Removal of Friable Asbestos Containing LV HRC Fuses. |

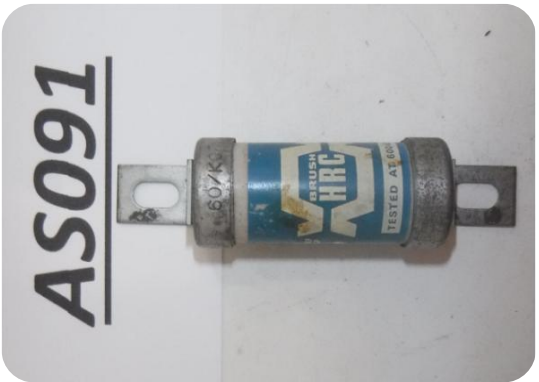
| Manufacturer | Rating | Fuse Body Photographs | Label Markings & Details | Result | Safety Instructions |
|---|---|---|---|---|---|
| Brush | 60 | | 60K06, 60A, AC80, B.S 88, Q1, 415V | <br>No Asbestos found, exercise caution and follow safety instructions | Where no manufacturer or date information can be confirmed and/or the fuse was manufactured prior to 2003, the <b>fuses should be presumed to contain asbestos and disposed</b> of in accordance with SWMS - AUS008 - Removal of Friable Asbestos Containing LV HRC Fuses. |

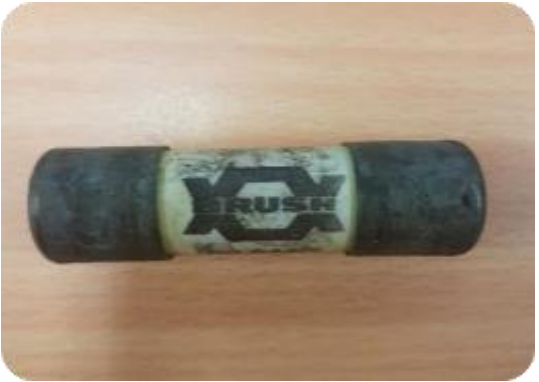
| Manufacturer | Rating | Fuse Body Photographs | Label Markings & Details | Result | Safety Instructions |
|---|---|---|---|---|---|
| Brush | 60 | | 60KR71A, 60 AMP, ASTA (20) Certified, 415V, BS1361, 1971 | <br>No Asbestos found, exercise caution and follow safety instructions | Where no manufacturer or date information can be confirmed and/or the fuse was manufactured prior to 2003, the <b>fuses should be presumed to contain asbestos and disposed</b> of in accordance with SWMS - AUS008 - Removal of Friable Asbestos Containing LV HRC Fuses. |

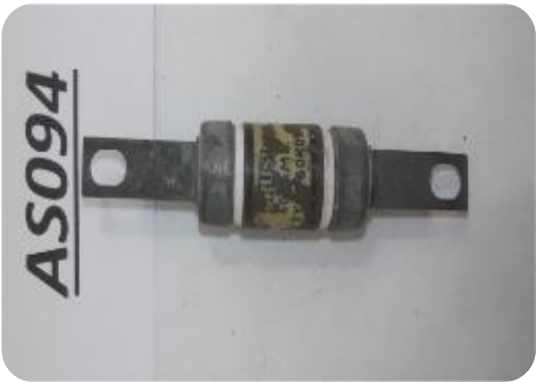
| Manufacturer | Rating | Fuse Body Photographs | Label Markings & Details | Result | Safety Instructions |
|---|---|---|---|---|---|
| Brush | 60 | | 60K08, 60A, AC5, B.S 88 (label worn)<br>168273-94 | <br>Asbestos found | <b>In-Service Fuses:</b><br> If fuse is damaged, cease work and make safe. Contact the Hazmat Hotline - 02 9394 6961.<br> If the fuse is intact, remove the fuse taking care not to damage in accordance with SWMS - AUS008 Removal of Friable Asbestos Containing LV HRC Fuses.<br><b>Stored and Quarantined Fuses:</b><br> Must be disposed of in accordance with SWMS - AUS008 Removal of Friable Asbestos Containing LV HRC Fuses. |

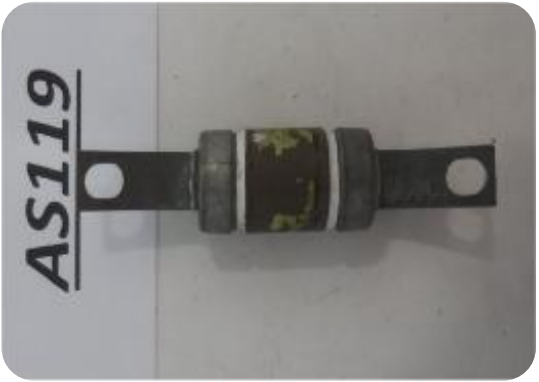
| Manufacturer | Rating | Fuse Body Photographs | Label Markings & Details | Result | Safety Instructions |
|---|---|---|---|---|---|
| Brush | 80 | | 80K09, 80A<br>168273-68 | <br>Asbestos found | <b>In-Service Fuses:</b><br> If fuse is damaged, cease work and make safe. Contact the Hazmat Hotline - 02 9394 6961.<br> If the fuse is intact, remove the fuse taking care not to damage in accordance with SWMS - AUS008 Removal of Friable Asbestos Containing LV HRC Fuses.<br><b>Stored and Quarantined Fuses:</b><br> Must be disposed of in accordance with SWMS - AUS008 Removal of Friable Asbestos Containing LV HRC Fuses. |

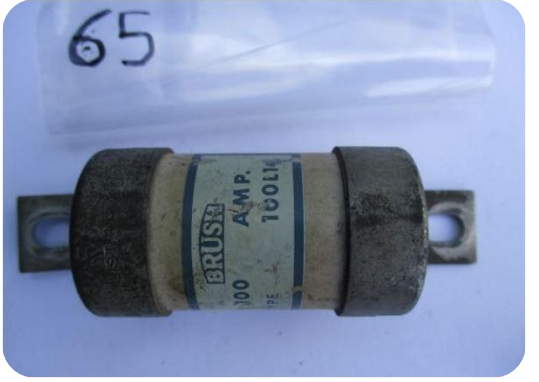
| Manufacturer | Rating | Fuse Body Photographs | Label Markings & Details | Result | Safety Instructions |
|---|---|---|---|---|---|
| Brush | 100 | | Type 100L14<br>54287-001-065 | <br>Asbestos found | <b>In-Service Fuses:</b><br> If fuse is damaged, cease work and make safe. Contact the Hazmat Hotline - 02 9394 6961.<br> If the fuse is intact, remove the fuse taking care not to damage in accordance with SWMS - AUS008 Removal of Friable Asbestos Containing LV HRC Fuses.<br><b>Stored and Quarantined Fuses:</b><br> Must be disposed of in accordance with SWMS - AUS008 Removal of Friable Asbestos Containing LV HRC Fuses. |

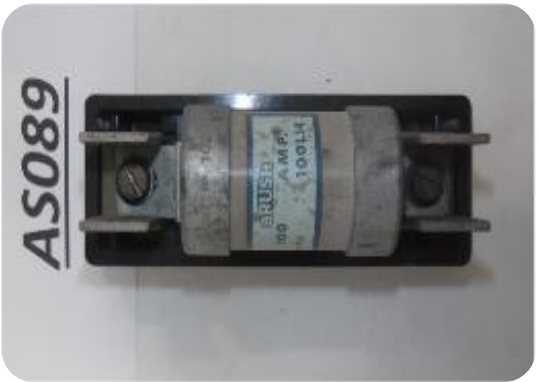
| Manufacturer | Rating | Fuse Body Photographs | Label Markings & Details | Result | Safety Instructions |
|---|---|---|---|---|---|
| Brush | 100 | | 100L14, 100A, B.S 88, AC 5 | <br>Asbestos found | <b>In-Service Fuses:</b><br> If fuse is damaged, cease work and make safe. Contact the Hazmat Hotline - 02 9394 6961.<br> If the fuse is intact, remove the fuse taking care not to damage in accordance with SWMS - AUS008 Removal of Friable Asbestos Containing LV HRC Fuses.<br><b>Stored and Quarantined Fuses:</b><br> Must be disposed of in accordance with SWMS - AUS008 Removal of Friable Asbestos Containing LV HRC Fuses. |

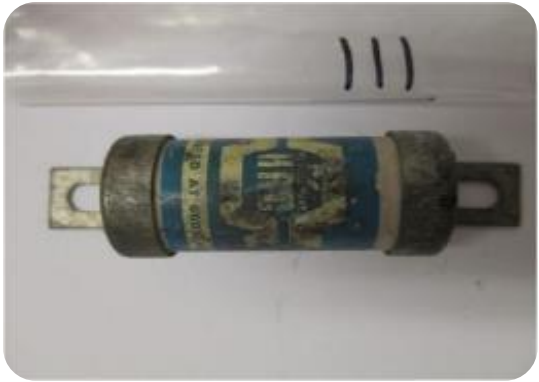
| Manufacturer | Rating | Fuse Body Photographs | Label Markings & Details | Result | Safety Instructions |
|---|---|---|---|---|---|
| Brush | 400 | | AC80 400A | <br>No Asbestos found, exercise caution and follow safety instructions | Where no manufacturer or date information can be confirmed and/or the fuse was manufactured prior to 2003, the <b>fuses should be presumed to contain asbestos and disposed</b> of in accordance with SWMS - AUS008 - Removal of Friable Asbestos Containing LV HRC Fuses. |

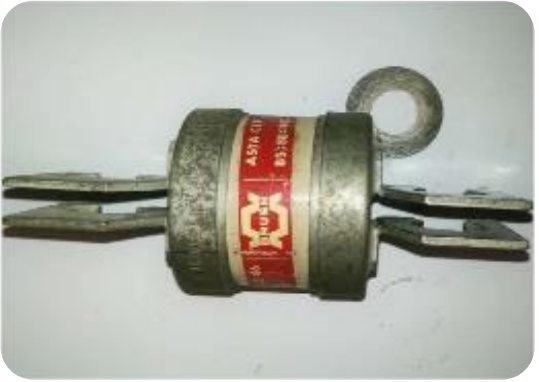
| Manufacturer | Rating | Fuse Body Photographs | Label Markings & Details | Result | Safety Instructions |
|---|---|---|---|---|---|
| Brush | 400 | | 415AC 46, Q1, Asta Cert, 400PJ30 | <br>Asbestos found | <b>In-Service Fuses:</b><br> If fuse is damaged, cease work and make safe. Contact the Hazmat Hotline - 02 9394 6961.<br> If the fuse is intact, remove the fuse taking care not to damage in accordance with SWMS - AUS008 Removal of Friable Asbestos Containing LV HRC Fuses.<br><b>Stored and Quarantined Fuses:</b><br> Must be disposed of in accordance with SWMS - AUS008 Removal of Friable Asbestos Containing LV HRC Fuses. |

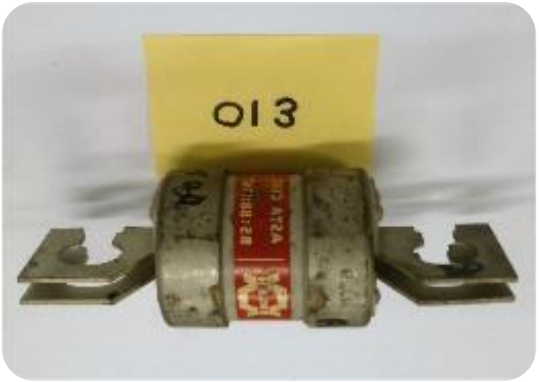
| Manufacturer | Rating | Fuse Body Photographs | Label Markings & Details | Result | Safety Instructions |
|---|---|---|---|---|---|
| Brush | 415 | | 415AC 46, Q1, Asta Cert, 80 MJ29 | <br>Asbestos found | <b>In-Service Fuses:</b><br> If fuse is damaged, cease work and make safe. Contact the Hazmat Hotline - 02 9394 6961.<br> If the fuse is intact, remove the fuse taking care not to damage in accordance with SWMS - AUS008 Removal of Friable Asbestos Containing LV HRC Fuses.<br><b>Stored and Quarantined Fuses:</b><br> Must be disposed of in accordance with SWMS - AUS008 Removal of Friable Asbestos Containing LV HRC Fuses. |

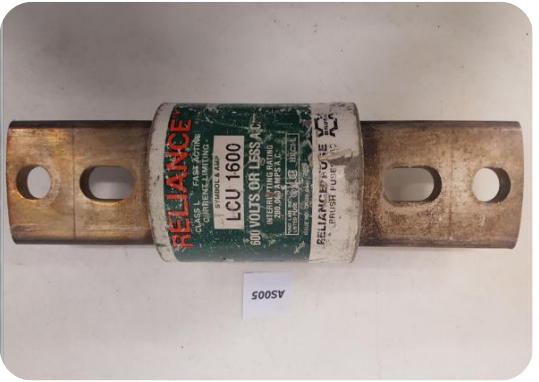
| Manufacturer | Rating | Fuse Body Photographs | Label Markings & Details | Result | Safety Instructions |
|---|---|---|---|---|---|
| Brush | 1600 | | Reliance Fuse, LCU 1600, DK0966, 200,000 A A.c, HRCI-L, Class L | <br>No Asbestos found, exercise caution and follow safety instructions | Where no manufacturer or date information can be confirmed and/or the fuse was manufactured prior to 2003, the <b>fuses should be presumed to contain asbestos and disposed</b> of in accordance with SWMS - AUS008 - Removal of Friable Asbestos Containing LV HRC Fuses. |

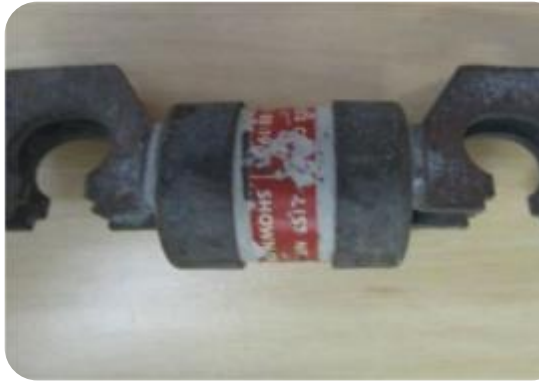
| Manufacturer | Rating | Fuse Body Photographs | Label Markings & Details | Result | Safety Instructions |
|---|---|---|---|---|---|
| Brush | | | 300MJ31, Asta Cert | <br>Asbestos found | <b>In-Service Fuses:</b><br> If fuse is damaged, cease work and make safe. Contact the Hazmat Hotline - 02 9394 6961.<br> If the fuse is intact, remove the fuse taking care not to damage in accordance with SWMS - AUS008 Removal of Friable Asbestos Containing LV HRC Fuses.<br><b>Stored and Quarantined Fuses:</b><br> Must be disposed of in accordance with SWMS - AUS008 Removal of Friable Asbestos Containing LV HRC Fuses. |

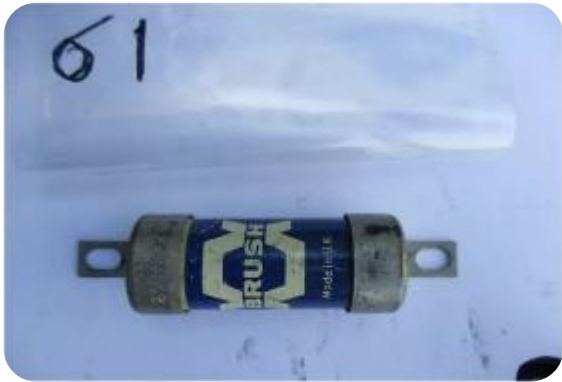
| Manufacturer | Rating | Fuse Body Photographs | Label Markings & Details | Result | Safety Instructions |
|---|---|---|---|---|---|
| Brush | | | 25H07 | <br>Asbestos found | <b>In-Service Fuses:</b><br> If fuse is damaged, cease work and make safe. Contact the Hazmat Hotline - 02 9394 6961.<br> If the fuse is intact, remove the fuse taking care not to damage in accordance with SWMS - AUS008 Removal of Friable Asbestos Containing LV HRC Fuses.<br><b>Stored and Quarantined Fuses:</b><br> Must be disposed of in accordance with SWMS - AUS008 Removal of Friable Asbestos Containing LV HRC Fuses. |

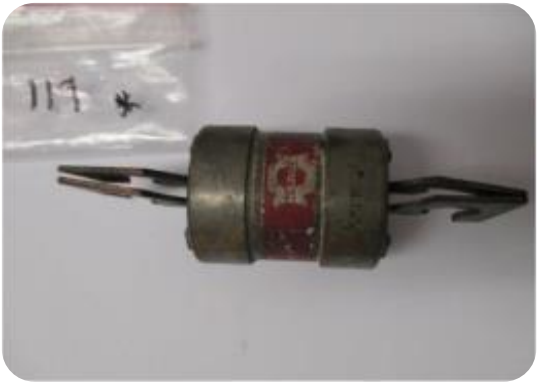
| Manufacturer | Rating | Fuse Body Photographs | Label Markings & Details | Result | Safety Instructions |
|---|---|---|---|---|---|
| Brush | | | 8-MJ29 | <br>Asbestos found | <b>In-Service Fuses:</b><br> If fuse is damaged, cease work and make safe. Contact the Hazmat Hotline - 02 9394 6961.<br> If the fuse is intact, remove the fuse taking care not to damage in accordance with SWMS - AUS008 Removal of Friable Asbestos Containing LV HRC Fuses.<br><b>Stored and Quarantined Fuses:</b><br> Must be disposed of in accordance with SWMS - AUS008 Removal of Friable Asbestos Containing LV HRC Fuses. |

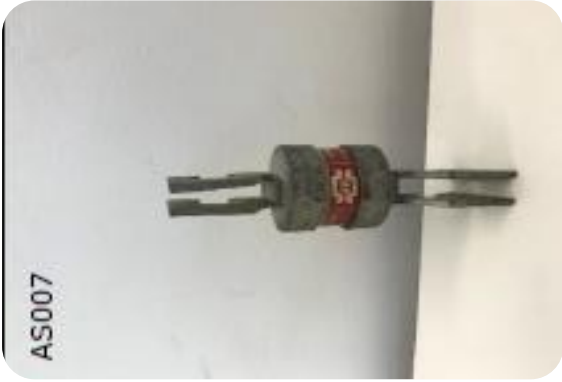
| Manufacturer | Rating | Fuse Body Photographs | Label Markings & Details | Result | Safety Instructions |
|---|---|---|---|---|---|
| Brush | | | Brush HRC - HRC Fuse - Class Q1, BS: 88: 1967, ASTA certified, 415 AC 46 - 415V - no country - no date | <br>No Asbestos found, exercise caution and follow safety instructions | Where no manufacturer or date information can be confirmed and/or the fuse was manufactured prior to 2003, the <b>fuses should be presumed to contain asbestos and disposed</b> of in accordance with SWMS - AUS008 - Removal of Friable Asbestos Containing LV HRC Fuses. |

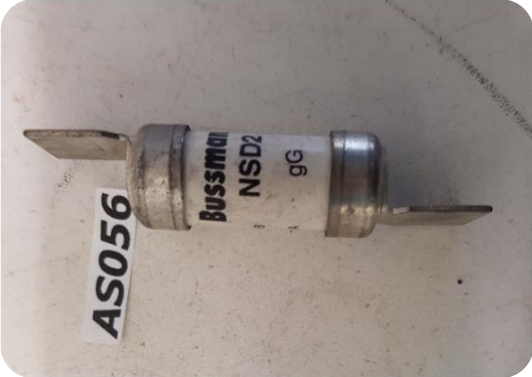
| Manufacturer | Rating | Fuse Body Photographs | Label Markings & Details | Result | Safety Instructions |
|---|---|---|---|---|---|
| Bussmann | 2 | | NSD2, 2A, 80kA, BS88.6:1988, gG | <br>Current Stock Item | ✓ May be used as normal.<br>✓ When disposing of LV HRC Fuses treat all fuses as asbestos waste. |

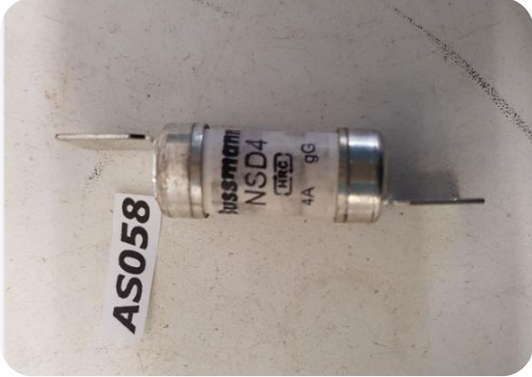
| Manufacturer | Rating | Fuse Body Photographs | Label Markings & Details | Result | Safety Instructions |
|---|---|---|---|---|---|
| Bussmann | 4 | | NSD4, 4A, 80kA, Asta 20 cert, BS 88.6 : 1988, gG | <br>Current Stock Item | ✓ May be used as normal.<br>✓ When disposing of LV HRC Fuses treat all fuses as asbestos waste. |

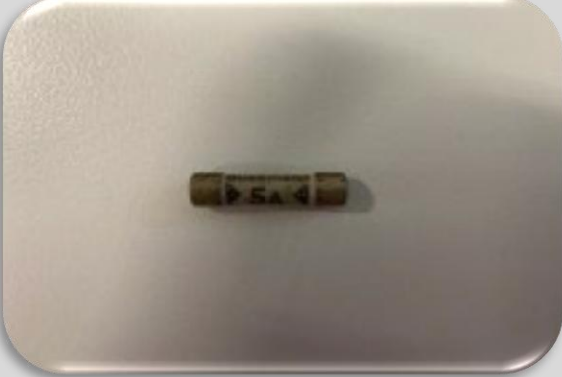
| Manufacturer | Rating | Fuse Body Photographs | Label Markings & Details | Result | Safety Instructions |
|---|---|---|---|---|---|
| Bussmann | 5 | | 5A | <br>No Asbestos found, exercise caution and follow safety instructions | Where no manufacturer or date information can be confirmed and/or the fuse was manufactured prior to 2003, the <b>fuses should be presumed to contain asbestos and disposed</b> of in accordance with SWMS - AUS008 - Removal of Friable Asbestos Containing LV HRC Fuses. |

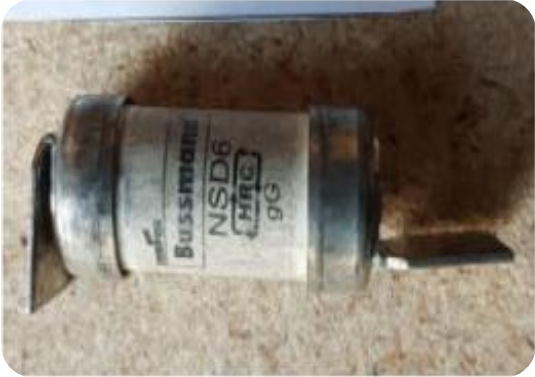
| Manufacturer | Rating | Fuse Body Photographs | Label Markings & Details | Result | Safety Instructions |
|---|---|---|---|---|---|
| Bussmann | 6 | <br>PO33768.003-AS016 | NSD6, HRC, gG, 6A,<br>BS88.6:1988, 550Vac 80kA,<br>Made in India | ✓<br>Current<br>Stock Item | ✓ May be used as normal.<br>✓ When disposing of LV HRC Fuses treat all fuses as asbestos waste. |

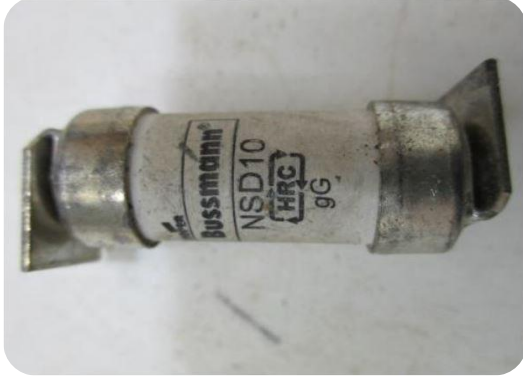
| Manufacturer | Rating | Fuse Body Photographs | Label Markings & Details | Result | Safety Instructions |
|---|---|---|---|---|---|
| Bussmann | 10 | <br>54087-001-035 | NSD10 GG 10a | ⚠<br>No<br>Asbestos<br>found,<br>exercise<br>caution and<br>follow<br>safety<br>instructions | ⚠ Where no manufacturer or date information can be confirmed and/or the fuse was manufactured prior to 2003, the <b>fuses should be presumed to contain asbestos and disposed</b> of in accordance with SWMS - AUS008 - Removal of Friable Asbestos Containing LV HRC Fuses. |

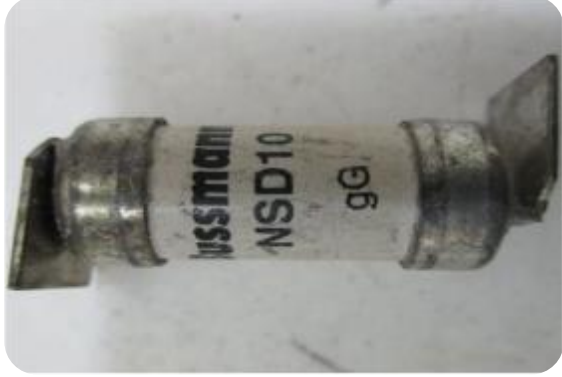
| Manufacturer | Rating | Fuse Body Photographs | Label Markings & Details | Result | Safety Instructions |
|---|---|---|---|---|---|
| Bussmann | 10 | <br>54287-001-034 | NSD10 GG 10a | ✓<br>Current<br>Stock Item | ✓ May be used as normal.<br>✓ When disposing of LV HRC Fuses treat all fuses as asbestos waste. |

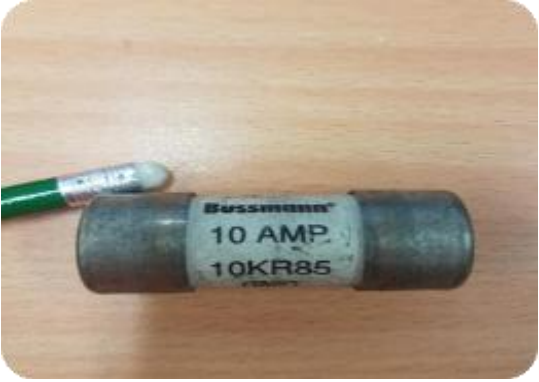
| Manufacturer | Rating | Fuse Body Photographs | Label Markings & Details | Result | Safety Instructions |
|---|---|---|---|---|---|
| Bussmann | 10 | | 10KR85, 10 AMP, 415V,<br>BS1361, 1971, 3.3W, made in<br>India<br><br>OF00053-120718-AS06 | ✓<br><br>Current<br>Stock Item | ✓ May be used as normal.<br>✓ When disposing of LV HRC Fuses treat all fuses as<br>asbestos waste. |

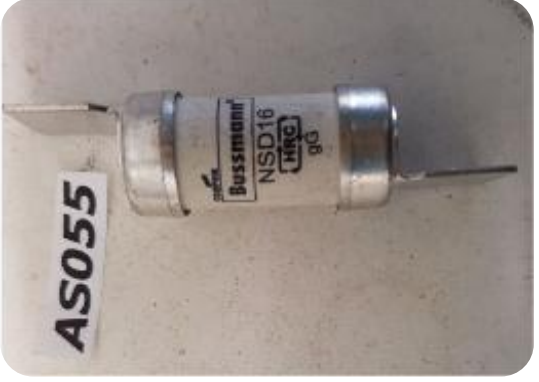
| Manufacturer | Rating | Fuse Body Photographs | Label Markings & Details | Result | Safety Instructions |
|---|---|---|---|---|---|
| Bussmann | 16 | | NSD16, 16A, 80kA, gG,<br>BS88.6:1988<br><br>174783-001-AS055 | ✓<br><br>Current<br>Stock Item | ✓ May be used as normal.<br>✓ When disposing of LV HRC Fuses treat all fuses as<br>asbestos waste. |

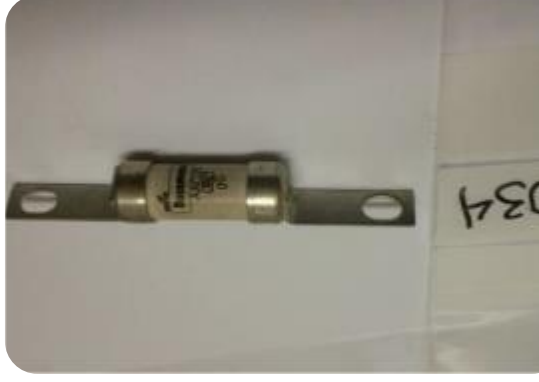
| Manufacturer | Rating | Fuse Body Photographs | Label Markings & Details | Result | Safety Instructions |
|---|---|---|---|---|---|
| Bussmann | 16 | | AA025, HRC, gG, 550V ac, 80kA,<br>Asta Cert<br><br>54287-002-034 | ✓<br><br>Current<br>Stock Item | ✓ May be used as normal.<br>✓ When disposing of LV HRC Fuses treat all fuses as<br>asbestos waste. |

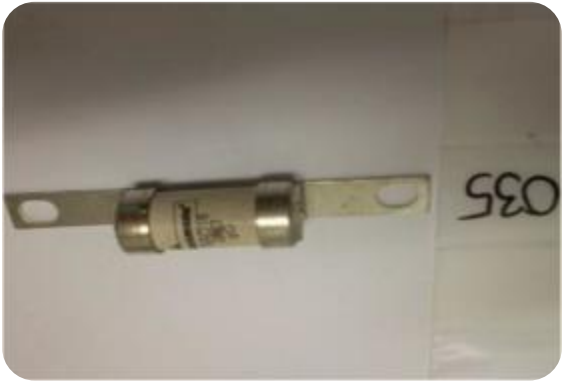
| Manufacturer | Rating | Fuse Body Photographs | Label Markings & Details | Result | Safety Instructions |
|---|---|---|---|---|---|
| Bussmann | 16 | <br>54287-002-035 | AA016, HRC, gG, Asta 20 Cert | ✓<br>Current<br>Stock Item | ✓ May be used as normal.<br>✓ When disposing of LV HRC Fuses treat all fuses as asbestos waste. |
