## Network Standard

Document No : NW000-S0161

NS211 ANNEXURE G – LV HRC FUSE ASBESTOS PRODUCT GUIDE

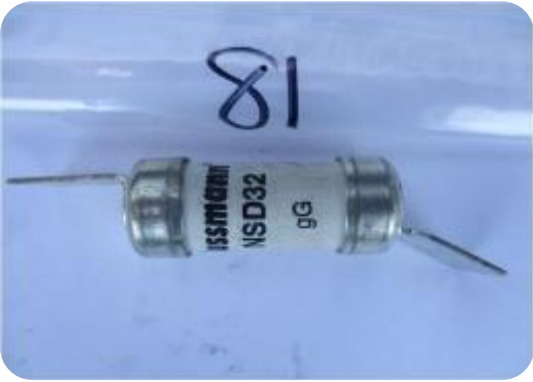
| Manufacturer | Rating | Fuse Body Photographs | Label Markings & Details | Result | Safety Instructions |
|---|---|---|---|---|---|
| Bussmann | 32 | <br>54287-001-081 | NSD32 GG 32A | ✓<br>Current<br>Stock Item | ✓ May be used as normal.<br>✓ When disposing of LV HRC Fuses treat all fuses as asbestos waste. |

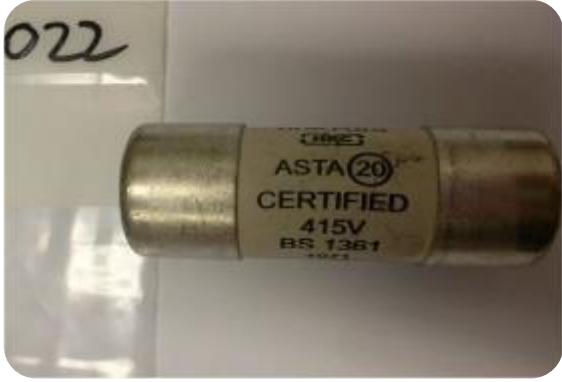
| Manufacturer | Rating | Fuse Body Photographs | Label Markings & Details | Result | Safety Instructions |
|---|---|---|---|---|---|
| Bussmann | 60 | <br>54287-002-022 | 60KR85, HRC, Asta 20 cert,<br>415V, 4.5W | ✓<br>Current<br>Stock Item | ✓ May be used as normal.<br>✓ When disposing of LV HRC Fuses treat all fuses as asbestos waste. |

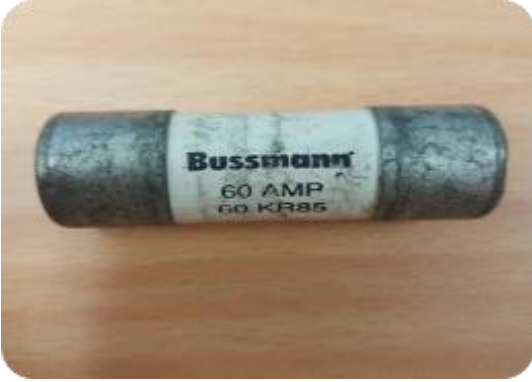
| Manufacturer | Rating | Fuse Body Photographs | Label Markings & Details | Result | Safety Instructions |
|---|---|---|---|---|---|
| Bussmann | 60 | <br>OF00053-120718-AS02 | 60KR85, 60AMP, ATSA (20)<br>Certified, 415V, BS1361, 1971,<br>15W | ✓<br>Current<br>Stock Item | ✓ May be used as normal.<br>✓ When disposing of LV HRC Fuses treat all fuses as<br>asbestos waste. |

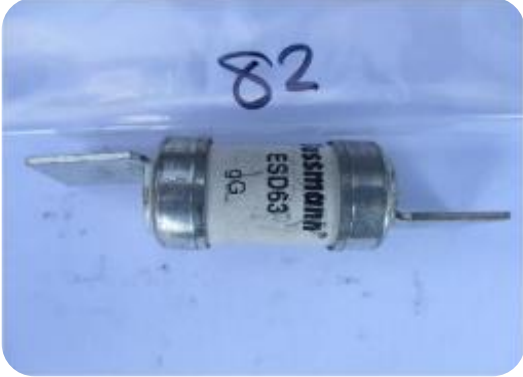
| Manufacturer | Rating | Fuse Body Photographs | Label Markings & Details | Result | Safety Instructions |
|---|---|---|---|---|---|
| Bussmann | 63 | <br>54087-001-082 | ESD63 GG 63A | ⚠<br>No<br>Asbestos<br>found,<br>exercise<br>caution and<br>follow<br>safety<br>instructions | ⚠ Where no manufacturer or date information can be<br>confirmed and/or the fuse was manufactured prior to 2003,<br>the <b>fuses should be presumed to contain asbestos and<br/>disposed</b> of in accordance with SWMS - AUS008 - Removal<br>of Friable Asbestos Containing LV HRC Fuses. |

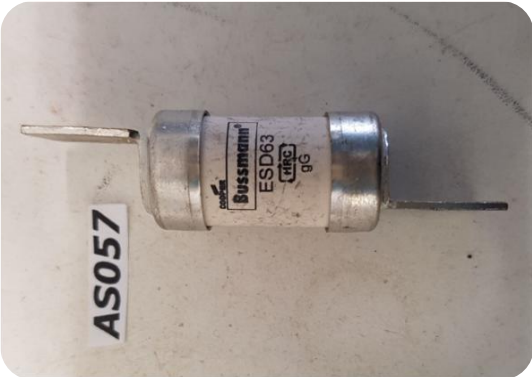
| Manufacturer | Rating | Fuse Body Photographs | Label Markings & Details | Result | Safety Instructions |
|---|---|---|---|---|---|
| Bussmann | 63 | <br>174783-001-AS057 | ESD63, 63A, 80kA, BS88.6:<br>1988, Asta 20 cert, gG | ✓<br>Current<br>Stock Item | ✓ May be used as normal.<br>✓ When disposing of LV HRC Fuses treat all fuses as<br>asbestos waste. |

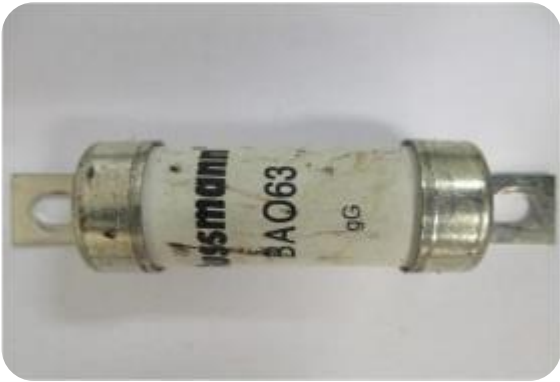
| Manufacturer | Rating | Fuse Body Photographs | Label Markings & Details | Result | Safety Instructions |
|---|---|---|---|---|---|
| Bussmann | 63 | <br>54287-001-033 | BAO63 gg 63A | ✓<br>Current Stock Item | ✓ May be used as normal.<br>✓ When disposing of LV HRC Fuses treat all fuses as asbestos waste. |

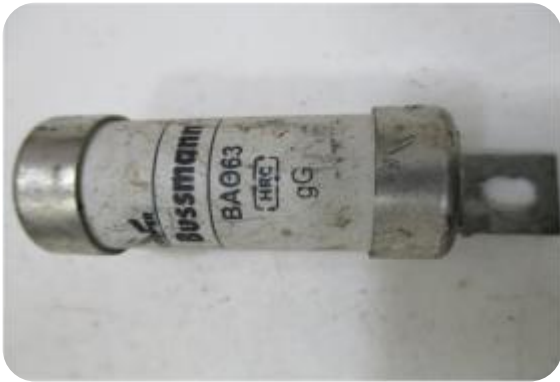
| Manufacturer | Rating | Fuse Body Photographs | Label Markings & Details | Result | Safety Instructions |
|---|---|---|---|---|---|
| Bussmann | 63 | <br>54287-001-044 | BAO63 gg 63A | ✓<br>Current Stock Item | ✓ May be used as normal.<br>✓ When disposing of LV HRC Fuses treat all fuses as asbestos waste. |

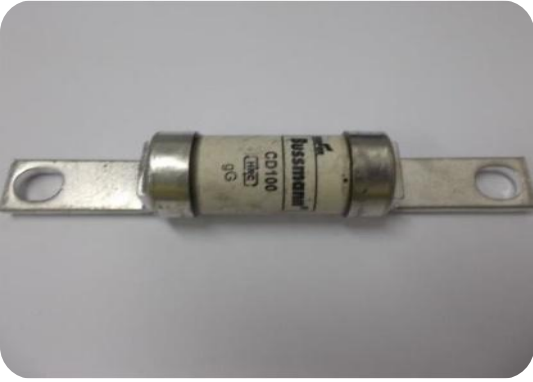
| Manufacturer | Rating | Fuse Body Photographs | Label Markings & Details | Result | Safety Instructions |
|---|---|---|---|---|---|
| Bussmann | 100 | <br>54287-002-007 | CD100, HRC gG, 500V ac, 80kA, Asta 20 cert | ✓<br>No Asbestos found | ✓ May be used as normal.<br>✓ When disposing of LV HRC Fuses treat all fuses as asbestos waste. |

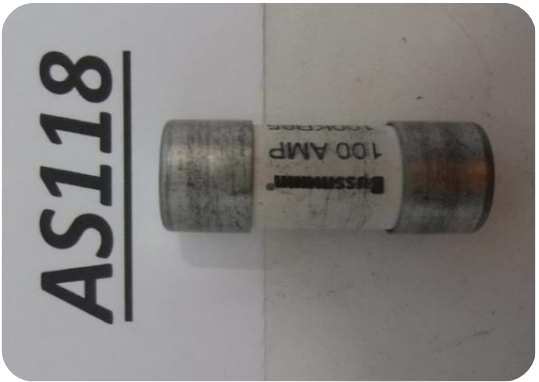
| Manufacturer | Rating | Fuse Body Photographs | Label Markings & Details | Result | Safety Instructions |
|---|---|---|---|---|---|
| Bussmann | 100 | | 100KR85, 100A, BS 1361, 6.1W | <br>No Asbestos found, exercise caution and follow safety instructions | <br>Where no manufacturer or date information can be confirmed and/or the fuse was manufactured prior to 2003, the <b>fuses should be presumed to contain asbestos and disposed</b> of in accordance with SWMS - AUS008 - Removal of Friable Asbestos Containing LV HRC Fuses. |

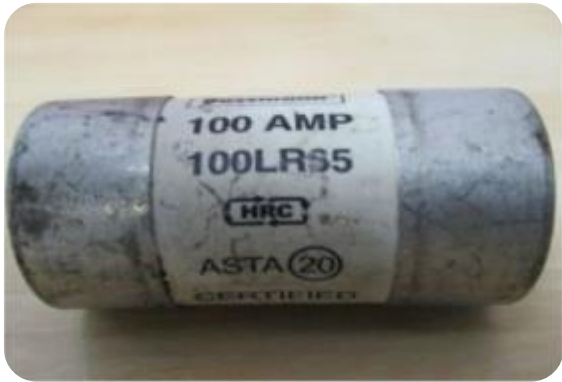
| Manufacturer | Rating | Fuse Body Photographs | Label Markings & Details | Result | Safety Instructions |
|---|---|---|---|---|---|
| Bussmann | 100 | | 100LRS5, HRC | <br>Current Stock Item | <br>May be used as normal.<br><br>When disposing of LV HRC Fuses treat all fuses as asbestos waste. |

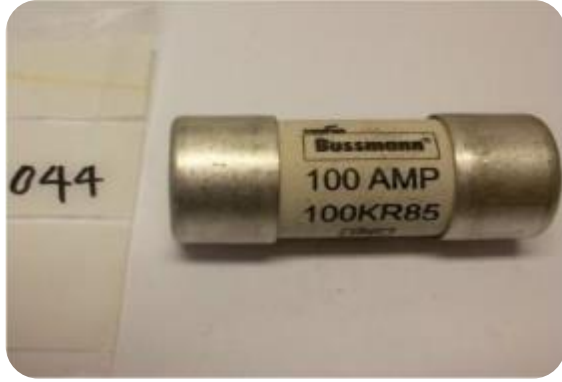
| Manufacturer | Rating | Fuse Body Photographs | Label Markings & Details | Result | Safety Instructions |
|---|---|---|---|---|---|
| Bussmann | 100 | | 100KR85, HRC, 415V, 6.1W | <br>Current Stock Item | <br>May be used as normal.<br><br>When disposing of LV HRC Fuses treat all fuses as asbestos waste. |

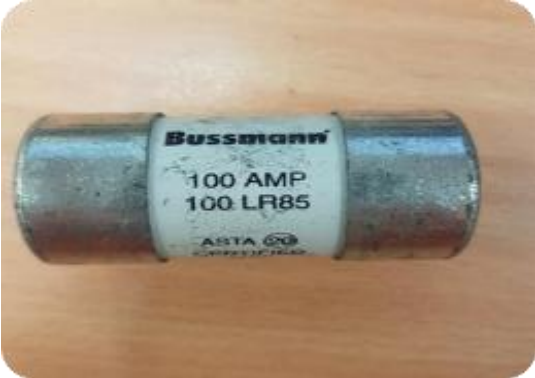
| Manufacturer | Rating | Fuse Body Photographs | Label Markings & Details | Result | Safety Instructions |
|---|---|---|---|---|---|
| Bussmann | 100 | | 100LR85, 100 AMP, ASTA (20)<br>Certified, 415V, BS1361, 1971,<br>5.0W | <br>Current<br>Stock Item | ✓ May be used as normal.<br>✓ When disposing of LV HRC Fuses treat all fuses as<br>asbestos waste. |

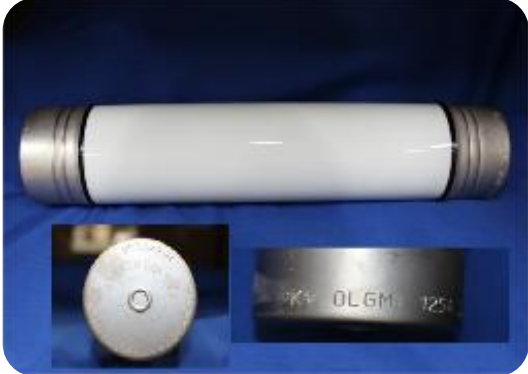
| Manufacturer | Rating | Fuse Body Photographs | Label Markings & Details | Result | Safety Instructions |
|---|---|---|---|---|---|
| Bussmann | 125 | | Bussman OLGMA | <br>Current<br>Stock Item<br>No. 182560 | ✓ May be used as normal.<br>✓ When disposing of LV HRC Fuses treat all fuses as<br>asbestos waste. |

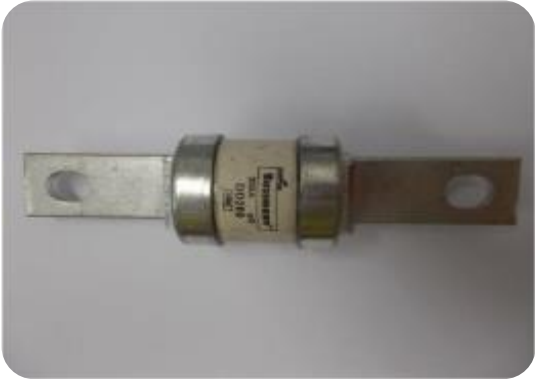
| Manufacturer | Rating | Fuse Body Photographs | Label Markings & Details | Result | Safety Instructions |
|---|---|---|---|---|---|
| Bussmann | 200 | | gG, DD200, HRC, Asta 20 cert,<br>415V, 80kA | <br>Current<br>Stock Item | ✓ May be used as normal.<br>✓ When disposing of LV HRC Fuses treat all fuses as<br>asbestos waste. |

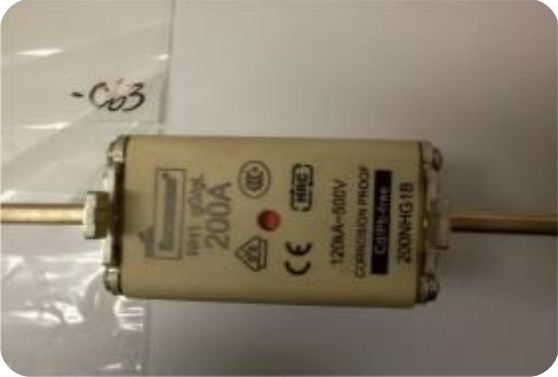
| Manufacturer | Rating | Fuse Body Photographs | Label Markings & Details | Result | Safety Instructions |
|---|---|---|---|---|---|
| Bussmann | 200 | | NH1, gG/gL, 200A, 120kA, 500V,<br>200NHG1B, 47/13 | <br>Current<br>Stock Item | ✓ May be used as normal.<br>✓ When disposing of LV HRC Fuses treat all fuses as asbestos waste. |

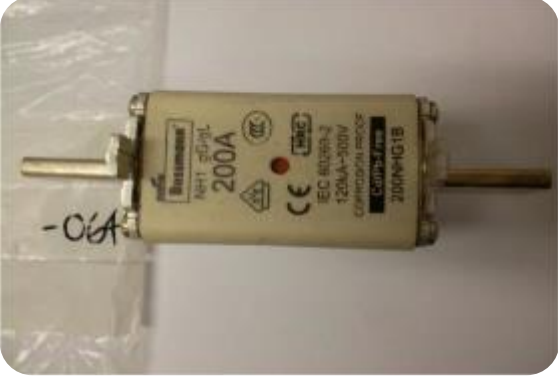
| Manufacturer | Rating | Fuse Body Photographs | Label Markings & Details | Result | Safety Instructions |
|---|---|---|---|---|---|
| Bussmann | 200 | | NH1, gG/gL, 200A, 120kA, 500V,<br>200NHG1B, 23/15 | <br>Current<br>Stock Item | ✓ May be used as normal.<br>✓ When disposing of LV HRC Fuses treat all fuses as asbestos waste. |

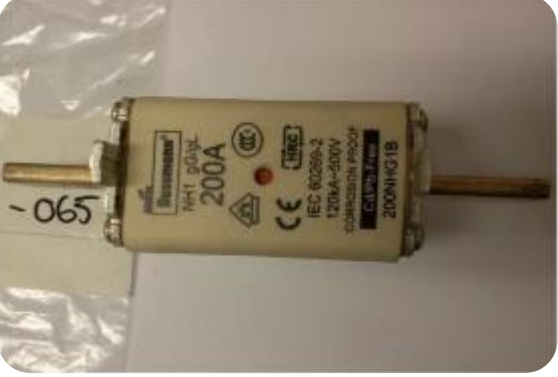
| Manufacturer | Rating | Fuse Body Photographs | Label Markings & Details | Result | Safety Instructions |
|---|---|---|---|---|---|
| Bussmann | 200 | | NH1, gG/gL, 200A, 120kA, 500V,<br>200NHG1B, 19/15 | <br>Current<br>Stock Item | ✓ May be used as normal.<br>✓ When disposing of LV HRC Fuses treat all fuses as asbestos waste. |

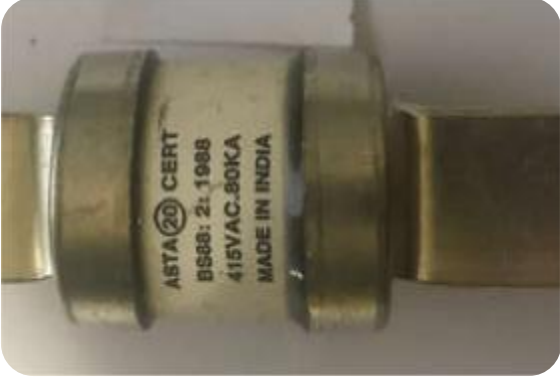
| Manufacturer | Rating | Fuse Body Photographs | Label Markings & Details | Result | Safety Instructions |
|---|---|---|---|---|---|
| Bussmann | 200 | <br>PO33786.002-AS003 | 200A, gG, DD200 HRC, ASTA 20 CERT, BS88:2:1988, 415VAC.80KA, Made in India | ✓<br>Current Stock Item | ✓ May be used as normal.<br>✓ When disposing of LV HRC Fuses treat all fuses as asbestos waste. |

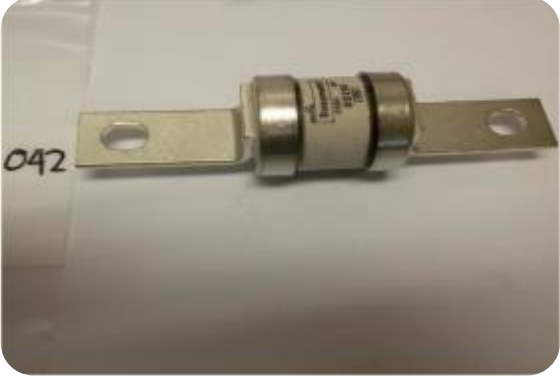
| Manufacturer | Rating | Fuse Body Photographs | Label Markings & Details | Result | Safety Instructions |
|---|---|---|---|---|---|
| Bussmann | 250 | <br>54287-002-042 | gG, ED250, Asta 20 cert, 415V, 80kA | ✓<br>Current Stock Item | ✓ May be used as normal.<br>✓ When disposing of LV HRC Fuses treat all fuses as asbestos waste. |

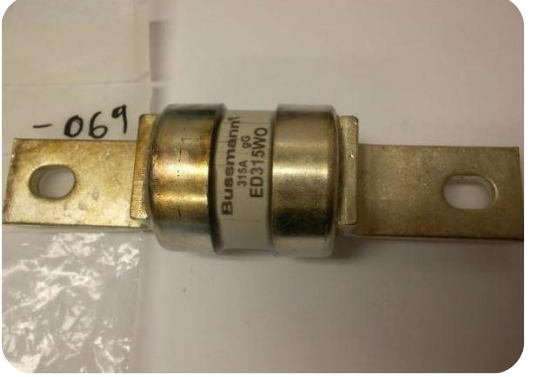
| Manufacturer | Rating | Fuse Body Photographs | Label Markings & Details | Result | Safety Instructions |
|---|---|---|---|---|---|
| Bussmann | 315 | <br>54287-002-069 | gG, ED315WO, Asta 20 cert, 415V, 80kA | ⚠<br>No Asbestos found, exercise caution and follow safety instructions | ⚠ Where no manufacturer or date information can be confirmed and/or the fuse was manufactured prior to 2003, the <b>fuses should be presumed to contain asbestos and disposed</b> of in accordance with SWMS - AUS008 - Removal of Friable Asbestos Containing LV HRC Fuses. |

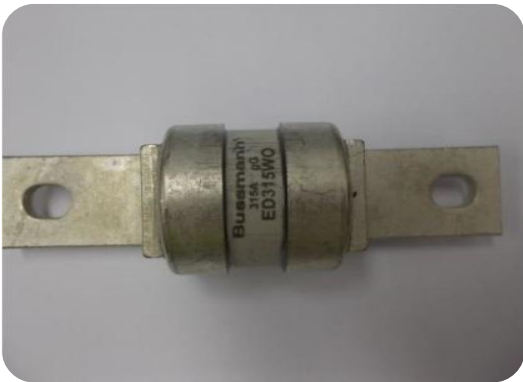
| Manufacturer | Rating | Fuse Body Photographs | Label Markings & Details | Result | Safety Instructions |
|---|---|---|---|---|---|
| Bussmann | 315 | | gG, ED315WO, Asta 20 cert,<br>415V, 80kA | <br>No<br>Asbestos<br>found,<br>exercise<br>caution and<br>follow<br>safety<br>instructions | Where no manufacturer or date information can be confirmed and/or the fuse was manufactured prior to 2003, the <b>fuses should be presumed to contain asbestos and disposed</b> of in accordance with SWMS - AUS008 - Removal of Friable Asbestos Containing LV HRC Fuses. |

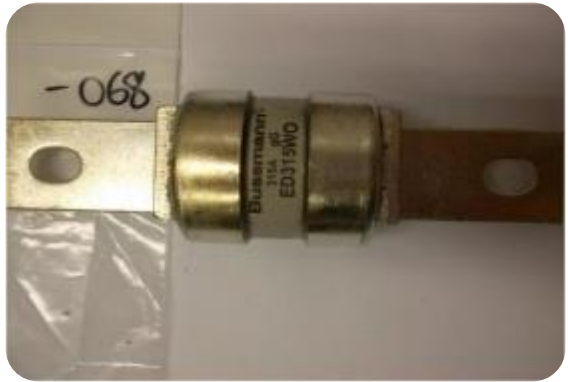
| Manufacturer | Rating | Fuse Body Photographs | Label Markings & Details | Result | Safety Instructions |
|---|---|---|---|---|---|
| Bussmann | 315 | | gG, ED315WO, Asta 20 cert,<br>415V, 80kA | <br>Current<br>Stock Item | May be used as normal.<br> When disposing of LV HRC Fuses treat all fuses as asbestos waste. |

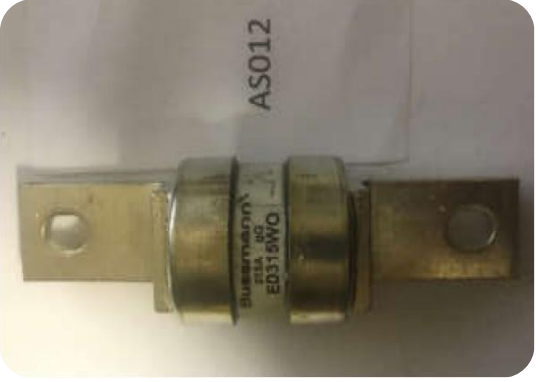
| Manufacturer | Rating | Fuse Body Photographs | Label Markings & Details | Result | Safety Instructions |
|---|---|---|---|---|---|
| Bussmann | 315 | | 315A, Gg, ED315WO, ASTA 20<br>CERT, BS88 : 2 : 1988,<br>415AC.80kA | <br>Current<br>Stock Item | May be used as normal.<br> When disposing of LV HRC Fuses treat all fuses as asbestos waste. |

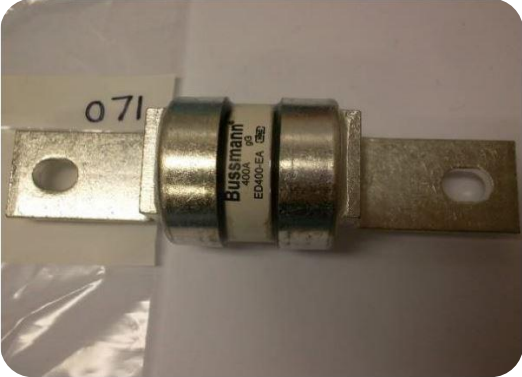
| Manufacturer | Rating | Fuse Body Photographs | Label Markings & Details | Result | Safety Instructions |
|---|---|---|---|---|---|
| Bussmann | 400 | <br>54287-002-071 | gG, ED400EA, HRC, 415V, 80kA | ! | |

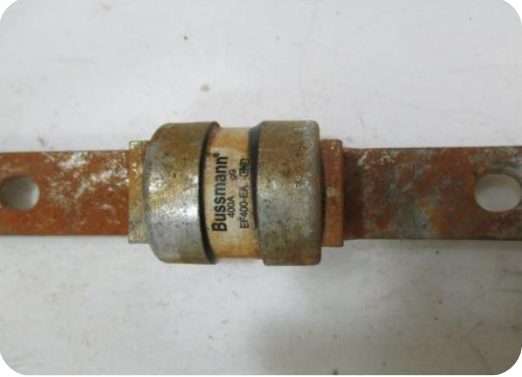
| Manufacturer | Rating | Fuse Body Photographs | Label Markings & Details | Result | Safety Instructions |
|---|---|---|---|---|---|
| Bussmann | 400 | <br>54087-001-028 | gG, EF400EA | ! | |

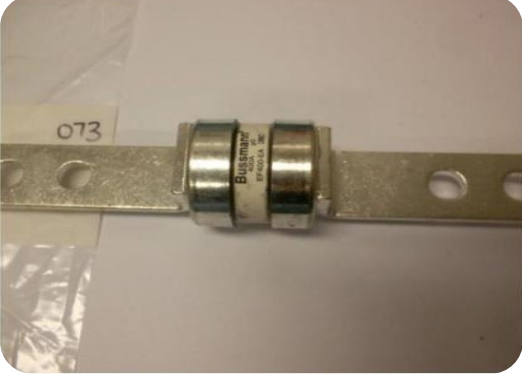
| Manufacturer | Rating | Fuse Body Photographs | Label Markings & Details | Result | Safety Instructions |
|---|---|---|---|---|---|
| Bussmann | 400 | <br>54287-002-073 | gG, EF400EA, HRC, 415V, 80kA | ! | |

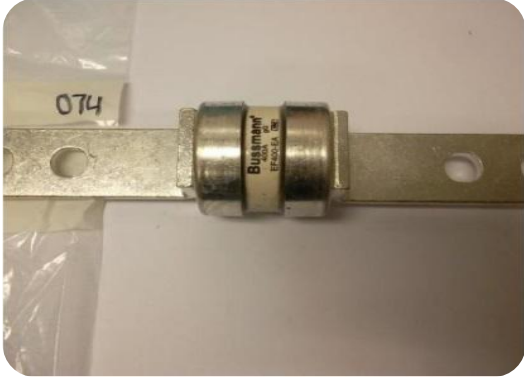
| Manufacturer | Rating | Fuse Body Photographs | Label Markings & Details | Result | Safety Instructions |
|---|---|---|---|---|---|
| Bussmann | 400 | | gG, EF400EA, HRC, 415V, 80kA<br>54287-002-074 | ⚠ | |

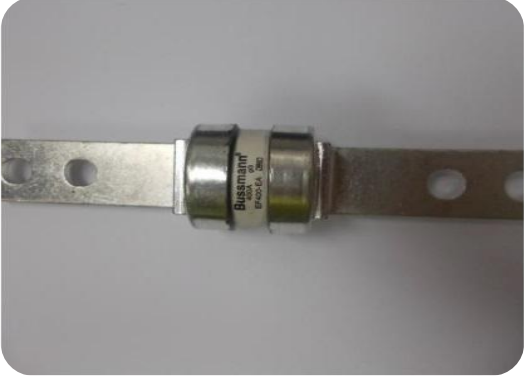
| Manufacturer | Rating | Fuse Body Photographs | Label Markings & Details | Result | Safety Instructions |
|---|---|---|---|---|---|
| Bussmann | 400 | | gG, EF400EA, HRC, 415V, 80kA<br>54287-002-001 | ⚠ | |

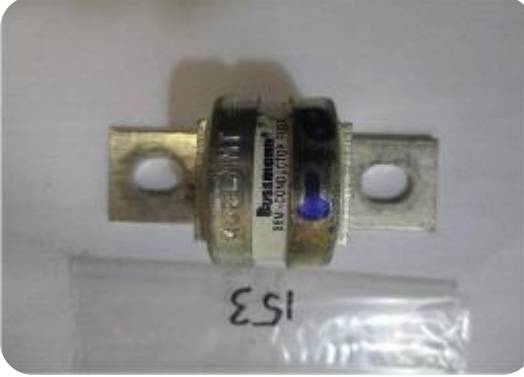
| Manufacturer | Rating | Fuse Body Photographs | Label Markings & Details | Result | Safety Instructions |
|---|---|---|---|---|---|
| Bussmann | 400 | | 400LMMT<br>54287-001-153 | ✓<br>Current Stock Item | <ul style="list-style-type: none"> <li>✓ May be used as normal.</li> <li>✓ When disposing of LV HRC Fuses treat all fuses as asbestos waste.</li> </ul> |

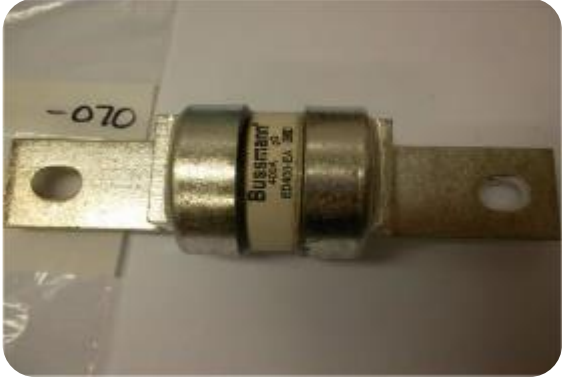
| Manufacturer | Rating | Fuse Body Photographs | Label Markings & Details | Result | Safety Instructions |
|---|---|---|---|---|---|
| Bussmann | 400 | | gG, ED400EA, HRC, 415V, 80kA | <br>Current Stock Item | ✓ May be used as normal.<br>✓ When disposing of LV HRC Fuses treat all fuses as asbestos waste. |

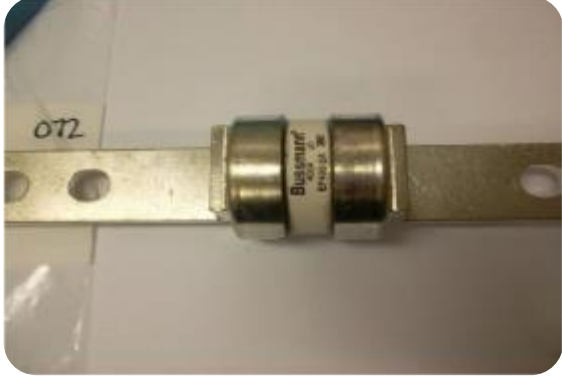
| Manufacturer | Rating | Fuse Body Photographs | Label Markings & Details | Result | Safety Instructions |
|---|---|---|---|---|---|
| Bussmann | 400 | | gG, EF400EA, HRC, 415V, 80kA | <br>Current Stock Item | ✓ May be used as normal.<br>✓ When disposing of LV HRC Fuses treat all fuses as asbestos waste. |

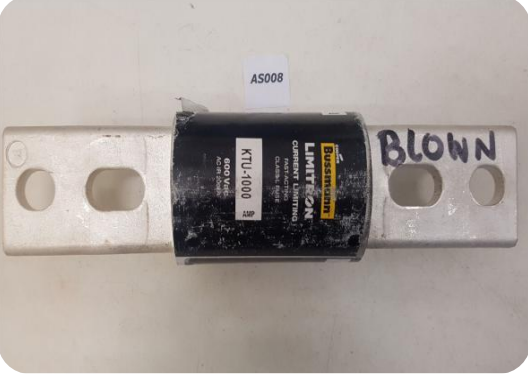
| Manufacturer | Rating | Fuse Body Photographs | Label Markings & Details | Result | Safety Instructions |
|---|---|---|---|---|---|
| Bussmann | 1000 | | TKTU-1000, Limitron, 0035308, 1000A, Class L, current limiting, AS IR200kA, UL 600Vac IR 200 kA, CSA 600Vac IR200kA | <br>Current Stock Item | ✓ May be used as normal.<br>✓ When disposing of LV HRC Fuses treat all fuses as asbestos waste. |

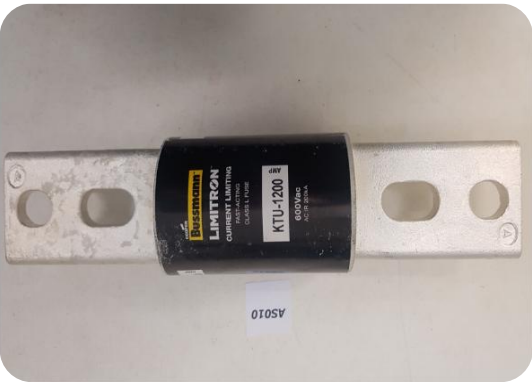
| Manufacturer | Rating | Fuse Body Photographs | Label Markings & Details | Result | Safety Instructions |
|---|---|---|---|---|---|
| Bussmann | 1200 | <br>174102-001-AS010 | KTU-1200A, ND87-82, Limitron, 1200A, current limiting, UL 600Vac IR 200kA, CSA 600Vac IR 200kA, Class L | ✓<br>Current Stock Item | ✓ May be used as normal.<br>✓ When disposing of LV HRC Fuses treat all fuses as asbestos waste. |

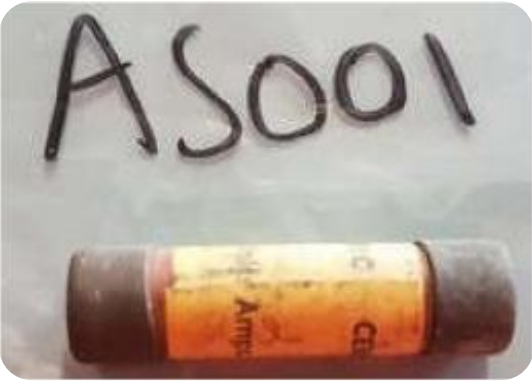
| Manufacturer | Rating | Fuse Body Photographs | Label Markings & Details | Result | Safety Instructions |
|---|---|---|---|---|---|
| Century Electric | 2 | <br>P033768.003 - AS001 | 2A, | ⚠<br>No Asbestos found, exercise caution and follow safety instructions | ⚠ Where no manufacturer or date information can be confirmed and/or the fuse was manufactured prior to 2003, the <b>fuses should be presumed to contain asbestos and disposed</b> of in accordance with SWMS - AUS008 - Removal of Friable Asbestos Containing LV HRC Fuses. |

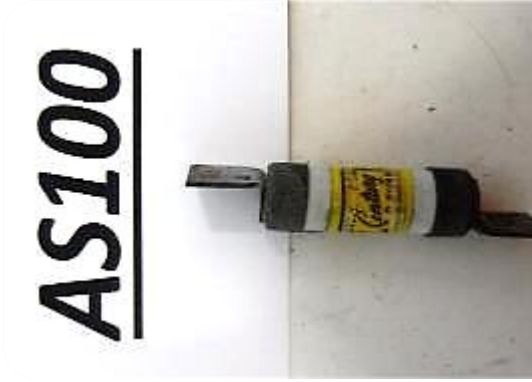
| Manufacturer | Rating | Fuse Body Photographs | Label Markings & Details | Result | Safety Instructions |
|---|---|---|---|---|---|
| Century Electric | 10 | <br>168273-100 | MN, 10A, AC5, Q type | ⚠<br>No Asbestos found, exercise caution and follow safety instructions | ⚠ Where no manufacturer or date information can be confirmed and/or the fuse was manufactured prior to 2003, the <b>fuses should be presumed to contain asbestos and disposed</b> of in accordance with SWMS - AUS008 - Removal of Friable Asbestos Containing LV HRC Fuses. |

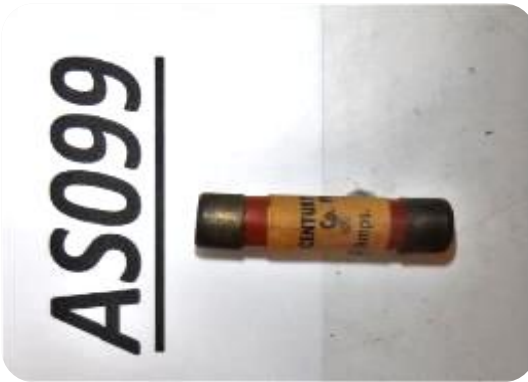
| Manufacturer | Rating | Fuse Body Photographs | Label Markings & Details | Result | Safety Instructions |
|---|---|---|---|---|---|
| Century Electric | | | no markings, no other markings | <br>No Asbestos found, exercise caution and follow safety instructions | <br>Where no manufacturer or date information can be confirmed and/or the fuse was manufactured prior to 2003, the <b>fuses should be presumed to contain asbestos and disposed</b> of in accordance with SWMS - AUS008 - Removal of Friable Asbestos Containing LV HRC Fuses. |

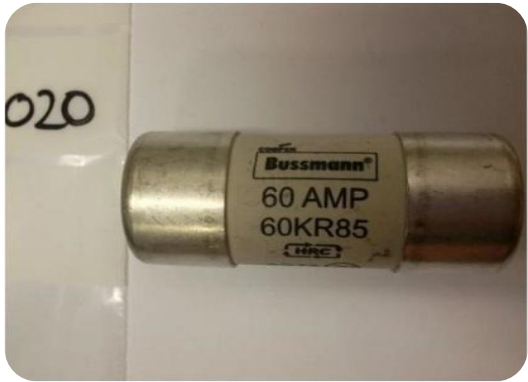
| Manufacturer | Rating | Fuse Body Photographs | Label Markings & Details | Result | Safety Instructions |
|---|---|---|---|---|---|
| Cooper Bussmann | 60 | | 60KR85, HRC, Asta 20 cert, 415V, 4.5W, | <br>No Asbestos found, exercise caution and follow safety instructions | <br>Where no manufacturer or date information can be confirmed and/or the fuse was manufactured prior to 2003, the <b>fuses should be presumed to contain asbestos and disposed</b> of in accordance with SWMS - AUS008 - Removal of Friable Asbestos Containing LV HRC Fuses. |

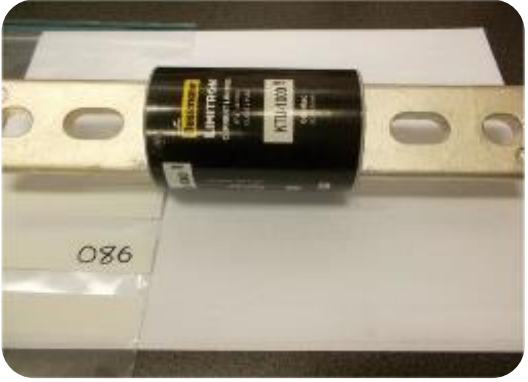
| Manufacturer | Rating | Fuse Body Photographs | Label Markings & Details | Result | Safety Instructions |
|---|---|---|---|---|---|
| Cooper Bussmann | 1000 | | LIMITRON Class L Fuse, KTU1000A, 600V ac, 200ka, ND87-82, X19 | <br>No Asbestos found, exercise caution and follow safety instructions | <br>Where no manufacturer or date information can be confirmed and/or the fuse was manufactured prior to 2003, the <b>fuses should be presumed to contain asbestos and disposed</b> of in accordance with SWMS - AUS008 - Removal of Friable Asbestos Containing LV HRC Fuses. |

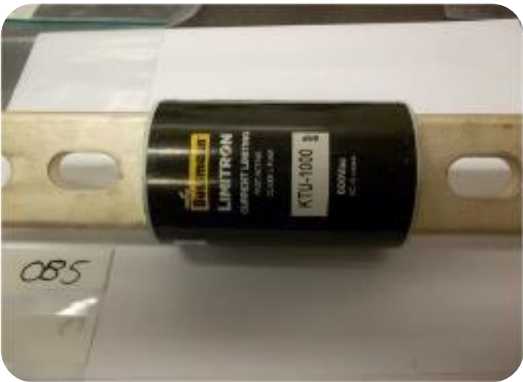
| Manufacturer | Rating | Fuse Body Photographs | Label Markings & Details | Result | Safety Instructions |
|---|---|---|---|---|---|
| Cooper Bussmann | 1000 | <br>54287-002-085 | LIMITRON Class L Fuse,<br>KTU1000A, 600V ac, 200ka,<br>ND87-82, X42 | <br>No<br>Asbestos<br>found,<br>exercise<br>caution and<br>follow<br>safety<br>instructions | <br>Where no manufacturer or date information can be confirmed and/or the fuse was manufactured prior to 2003, the <b>fuses should be presumed to contain asbestos and disposed</b> of in accordance with SWMS - AUS008 - Removal of Friable Asbestos Containing LV HRC Fuses. |

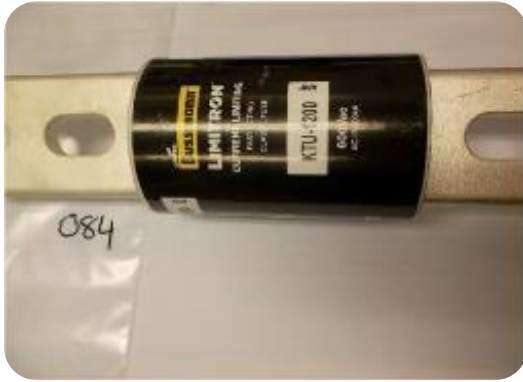
| Manufacturer | Rating | Fuse Body Photographs | Label Markings & Details | Result | Safety Instructions |
|---|---|---|---|---|---|
| Cooper Bussmann | 1200 | <br>54287-002-084 | LIMITRON Class L Fuse,<br>KTU1200A, 600V ac, 200ka,<br>0020166, Y38 | <br>No<br>Asbestos<br>found,<br>exercise<br>caution and<br>follow<br>safety<br>instructions | <br>Where no manufacturer or date information can be confirmed and/or the fuse was manufactured prior to 2003, the <b>fuses should be presumed to contain asbestos and disposed</b> of in accordance with SWMS - AUS008 - Removal of Friable Asbestos Containing LV HRC Fuses. |

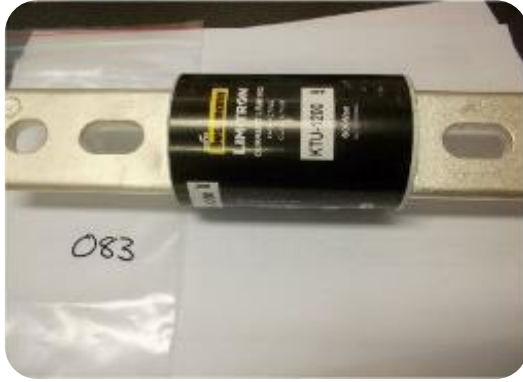
| Manufacturer | Rating | Fuse Body Photographs | Label Markings & Details | Result | Safety Instructions |
|---|---|---|---|---|---|
| Cooper Bussmann | 1200 | <br>54287-002-083 | LIMITRON Class L Fuse,<br>KTU1200A, 600V ac, 200ka,<br>ND87-82, X43 | <br>No<br>Asbestos<br>found,<br>exercise<br>caution and<br>follow<br>safety<br>instructions | <br>Where no manufacturer or date information can be confirmed and/or the fuse was manufactured prior to 2003, the <b>fuses should be presumed to contain asbestos and disposed</b> of in accordance with SWMS - AUS008 - Removal of Friable Asbestos Containing LV HRC Fuses. |

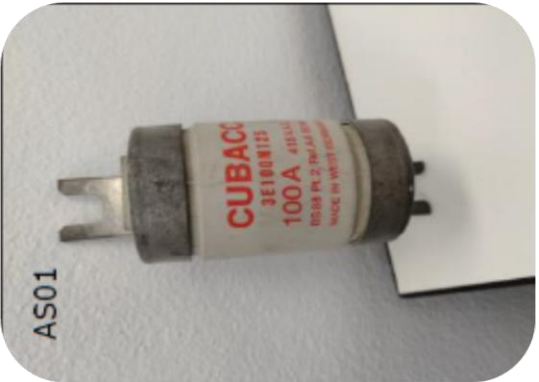
| Manufacturer | Rating | Fuse Body Photographs | Label Markings & Details | Result | Safety Instructions |
|---|---|---|---|---|---|
| Cubacc | 100 | | 3E100M125, 100A 415 V.A.C.<br>BS88. Pt.2 Ref A4 West<br>Germany<br><br>PO34596.001/C0002 | <br><br>No Asbestos found,<br>exercise caution and follow safety instructions | Where no manufacturer or date information can be confirmed and/or the fuse was manufactured prior to 2003, the <b>fuses should be presumed to contain asbestos and disposed</b> of in accordance with SWMS - AUS008 - Removal of Friable Asbestos Containing LV HRC Fuses. |

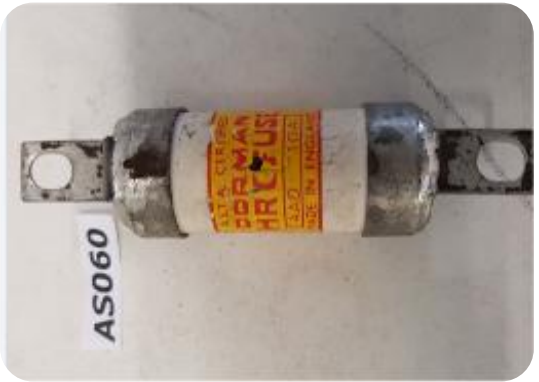
| Manufacturer | Rating | Fuse Body Photographs | Label Markings & Details | Result | Safety Instructions |
|---|---|---|---|---|---|
| Dorman | 10 | | AA0, 10A, AC5, 460VDC4, BS 88,<br>Class Q, Asta certified,<br><br>174783-001-AS060 | <br><br>Asbestos found | <b>In-Service Fuses:</b><br> If fuse is damaged, cease work and make safe. Contact the Hazmat Hotline - 02 9394 6961.<br> If the fuse is intact, remove the fuse taking care not to damage in accordance with SWMS - AUS008 Removal of Friable Asbestos Containing LV HRC Fuses.<br><b>Stored and Quarantined Fuses:</b><br> Must be disposed of in accordance with SWMS - AUS008 Removal of Friable Asbestos Containing LV HRC Fuses. |

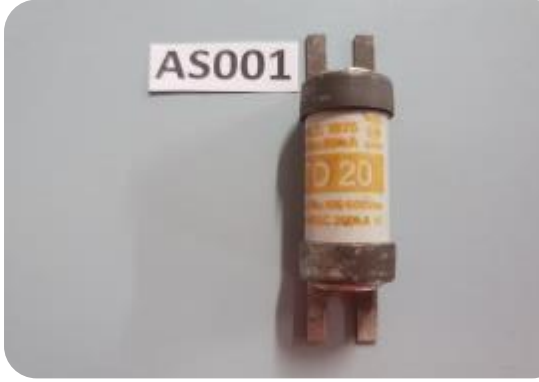
| Manufacturer | Rating | Fuse Body Photographs | Label Markings & Details | Result | Safety Instructions |
|---|---|---|---|---|---|
| Dorman | 20 | | NITD 20, Q1, BS88.2:1975,<br>C22.2, No106, 80kA, 20A, HRC<br>H-MISC, 200kA, IEC269-2,<br>AS2005-2<br><br>PO33786.002-AS012 | <br><br>No Asbestos found,<br>exercise caution and follow safety instructions | Where no manufacturer or date information can be confirmed and/or the fuse was manufactured prior to 2003, the <b>fuses should be presumed to contain asbestos and disposed</b> of in accordance with SWMS - AUS008 - Removal of Friable Asbestos Containing LV HRC Fuses. |

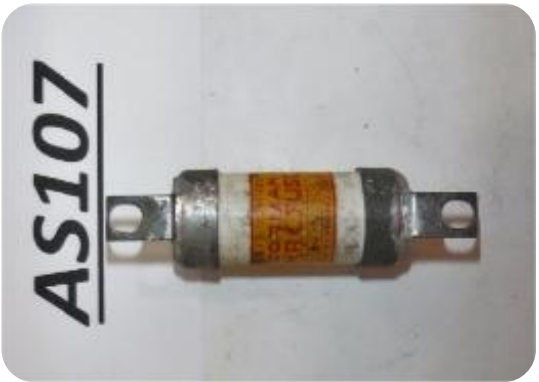
| Manufacturer | Rating | Fuse Body Photographs | Label Markings & Details | Result | Safety Instructions |
|---|---|---|---|---|---|
| Dorman | 30 | <br>168273-107 | AA0, 30A, B.S.88, AC5, 460DC40, Class Q | <br>Asbestos found | <b>In-Service Fuses:</b><br> If fuse is damaged, cease work and make safe. Contact the Hazmat Hotline - 02 9394 6961.<br> If the fuse is intact, remove the fuse taking care not to damage in accordance with SWMS - AUS008 Removal of Friable Asbestos Containing LV HRC Fuses.<br><b>Stored and Quarantined Fuses:</b><br> Must be disposed of in accordance with SWMS - AUS008 Removal of Friable Asbestos Containing LV HRC Fuses. |

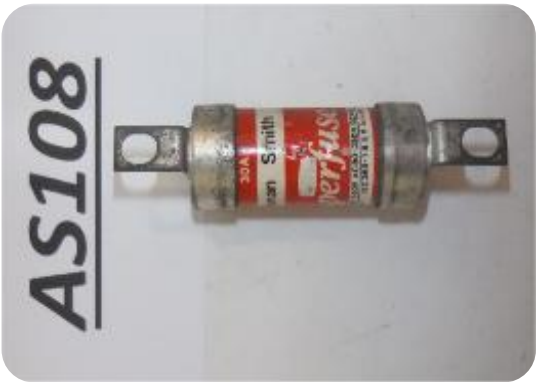
| Manufacturer | Rating | Fuse Body Photographs | Label Markings & Details | Result | Safety Instructions |
|---|---|---|---|---|---|
| Dorman | 30 | <br>168273-108 | AA030A, 30A, B.S.88, AC80, 250DC40, Class Q1, IEC 269-1 8.5.8 | <br>Asbestos found | <b>In-Service Fuses:</b><br> If fuse is damaged, cease work and make safe. Contact the Hazmat Hotline - 02 9394 6961.<br> If the fuse is intact, remove the fuse taking care not to damage in accordance with SWMS - AUS008 Removal of Friable Asbestos Containing LV HRC Fuses.<br><b>Stored and Quarantined Fuses:</b><br> Must be disposed of in accordance with SWMS - AUS008 Removal of Friable Asbestos Containing LV HRC Fuses. |

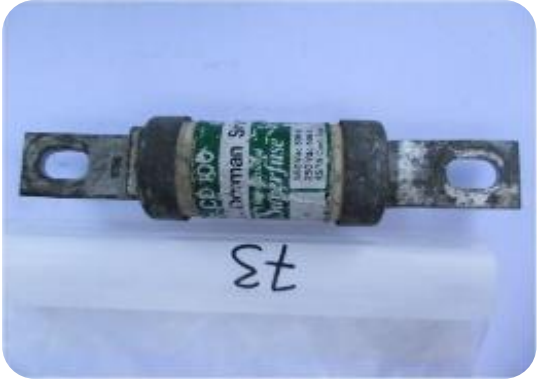
| Manufacturer | Rating | Fuse Body Photographs | Label Markings & Details | Result | Safety Instructions |
|---|---|---|---|---|---|
| Dorman | 100 | <br>54287-001-073 | Smith CD100 Q1 100A | <br>Asbestos found | <b>In-Service Fuses:</b><br> If fuse is damaged, cease work and make safe. Contact the Hazmat Hotline - 02 9394 6961.<br> If the fuse is intact, remove the fuse taking care not to damage in accordance with SWMS - AUS008 Removal of Friable Asbestos Containing LV HRC Fuses.<br><b>Stored and Quarantined Fuses:</b><br> Must be disposed of in accordance with SWMS - AUS008 Removal of Friable Asbestos Containing LV HRC Fuses. |

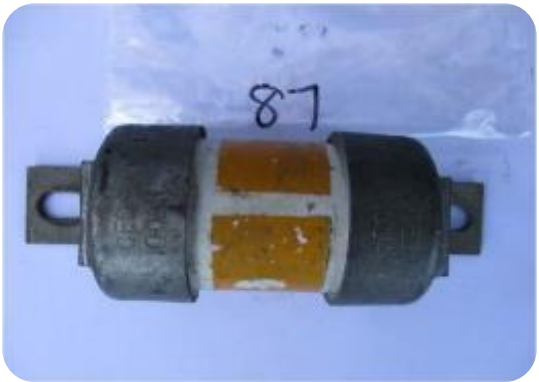
| Manufacturer | Rating | Fuse Body Photographs | Label Markings & Details | Result | Safety Instructions |
|---|---|---|---|---|---|
| Dorman | 100 | <br>54287-001-087 | 100 A DC4 Class Q | <br>Asbestos found | <b>In-Service Fuses:</b><br> If fuse is damaged, cease work and make safe. Contact the Hazmat Hotline - 02 9394 6961.<br> If the fuse is intact, remove the fuse taking care not to damage in accordance with SWMS - AUS008 Removal of Friable Asbestos Containing LV HRC Fuses.<br><b>Stored and Quarantined Fuses:</b><br> Must be disposed of in accordance with SWMS - AUS008 Removal of Friable Asbestos Containing LV HRC Fuses. |

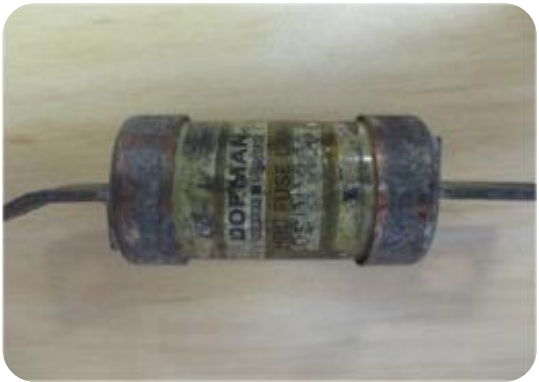
| Manufacturer | Rating | Fuse Body Photographs | Label Markings & Details | Result | Safety Instructions |
|---|---|---|---|---|---|
| Dorman | 200 | <br>54287-001-023 | Hawker Siddley, OSDD200 CLASS Q1 | <br>No Asbestos found, exercise caution and follow safety instructions | Where no manufacturer or date information can be confirmed and/or the fuse was manufactured prior to 2003, the <b>fuses should be presumed to contain asbestos and disposed</b> of in accordance with SWMS - AUS008 - Removal of Friable Asbestos Containing LV HRC Fuses. |

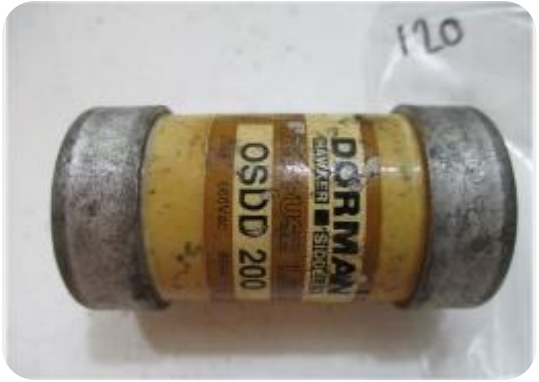
| Manufacturer | Rating | Fuse Body Photographs | Label Markings & Details | Result | Safety Instructions |
|---|---|---|---|---|---|
| Dorman | 200 | <br>54287-001-120 | Hawker Siddeley OSDD200 | <br>No Asbestos found, exercise caution and follow safety instructions | Where no manufacturer or date information can be confirmed and/or the fuse was manufactured prior to 2003, the <b>fuses should be presumed to contain asbestos and disposed</b> of in accordance with SWMS - AUS008 - Removal of Friable Asbestos Containing LV HRC Fuses. |

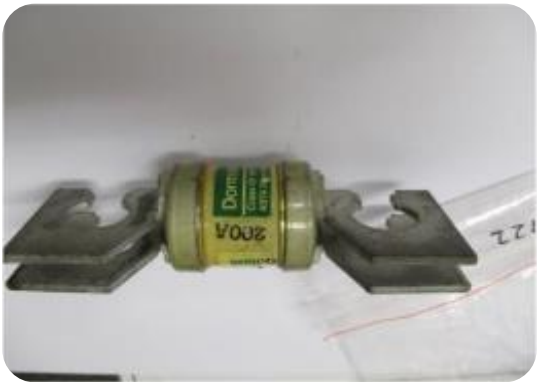
| Manufacturer | Rating | Fuse Body Photographs | Label Markings & Details | Result | Safety Instructions |
|---|---|---|---|---|---|
| Dorman | 200 | <br>54287-001-122 | Smith Cat No jsds | <br>Asbestos found | <b>In-Service Fuses:</b><br> If fuse is damaged, cease work and make safe. Contact the Hazmat Hotline - 02 9394 6961.<br> If the fuse is intact, remove the fuse taking care not to damage in accordance with SWMS - AUS008 Removal of Friable Asbestos Containing LV HRC Fuses.<br><b>Stored and Quarantined Fuses:</b><br> Must be disposed of in accordance with SWMS - AUS008 Removal of Friable Asbestos Containing LV HRC Fuses. |

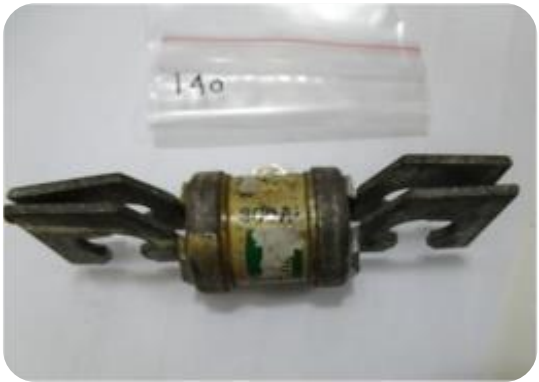
| Manufacturer | Rating | Fuse Body Photographs | Label Markings & Details | Result | Safety Instructions |
|---|---|---|---|---|---|
| Dorman | 300 | <br>54287-001-140 | Smith AC80 | <br>Asbestos found | <b>In-Service Fuses:</b><br> If fuse is damaged, cease work and make safe. Contact the Hazmat Hotline - 02 9394 6961.<br> If the fuse is intact, remove the fuse taking care not to damage in accordance with SWMS - AUS008 Removal of Friable Asbestos Containing LV HRC Fuses.<br><b>Stored and Quarantined Fuses:</b><br> Must be disposed of in accordance with SWMS - AUS008 Removal of Friable Asbestos Containing LV HRC Fuses. |

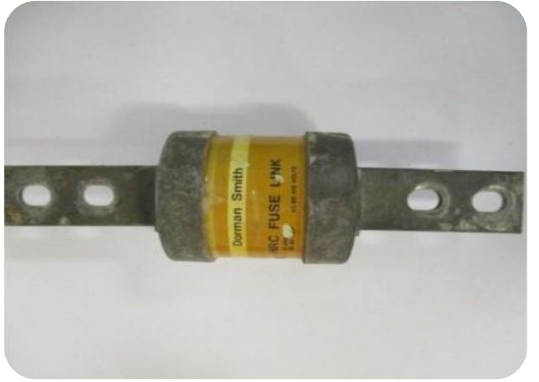
| Manufacturer | Rating | Fuse Body Photographs | Label Markings & Details | Result | Safety Instructions |
|---|---|---|---|---|---|
| Dorman | 400 | <br>54087-001-049 | Smith OSEF 400 | <br>Asbestos found | <b>In-Service Fuses:</b><br> If fuse is damaged, cease work and make safe. Contact the Hazmat Hotline - 02 9394 6961.<br> If the fuse is intact, remove the fuse taking care not to damage in accordance with SWMS - AUS008 Removal of Friable Asbestos Containing LV HRC Fuses.<br><b>Stored and Quarantined Fuses:</b><br> Must be disposed of in accordance with SWMS - AUS008 Removal of Friable Asbestos Containing LV HRC Fuses. |

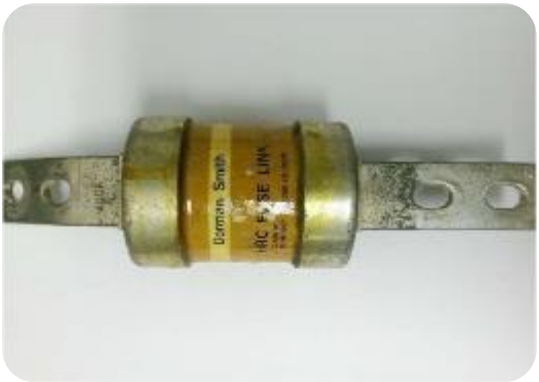
| Manufacturer | Rating | Fuse Body Photographs | Label Markings & Details | Result | Safety Instructions |
|---|---|---|---|---|---|
| Dorman | 400 | | Smith OSEF 400, HRC Fuse link, ac80, 415 V | <br>Asbestos found | <b>In-Service Fuses:</b><br> If fuse is damaged, cease work and make safe. Contact the Hazmat Hotline - 02 9394 6961.<br> If the fuse is intact, remove the fuse taking care not to damage in accordance with SWMS - AUS008 Removal of Friable Asbestos Containing LV HRC Fuses.<br><b>Stored and Quarantined Fuses:</b><br> Must be disposed of in accordance with SWMS - AUS008 Removal of Friable Asbestos Containing LV HRC Fuses. |

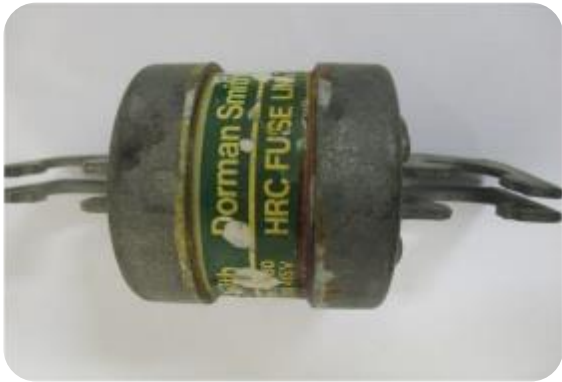
| Manufacturer | Rating | Fuse Body Photographs | Label Markings & Details | Result | Safety Instructions |
|---|---|---|---|---|---|
| Dorman | 400 | | Smith 400A Class Q1 Bs.88:part 5 | <br>Asbestos found | <b>In-Service Fuses:</b><br> If fuse is damaged, cease work and make safe. Contact the Hazmat Hotline - 02 9394 6961.<br> If the fuse is intact, remove the fuse taking care not to damage in accordance with SWMS - AUS008 Removal of Friable Asbestos Containing LV HRC Fuses.<br><b>Stored and Quarantined Fuses:</b><br> Must be disposed of in accordance with SWMS - AUS008 Removal of Friable Asbestos Containing LV HRC Fuses. |

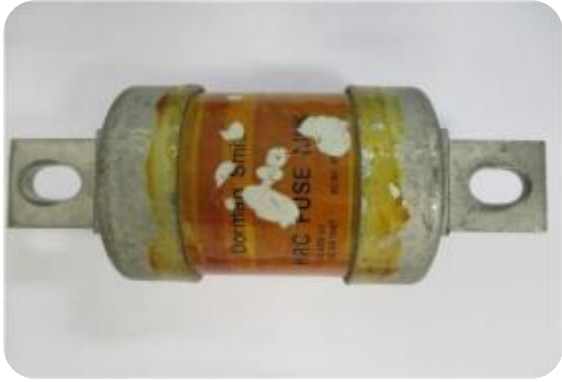
| Manufacturer | Rating | Fuse Body Photographs | Label Markings & Details | Result | Safety Instructions |
|---|---|---|---|---|---|
| Dorman | 400 | | Smith OSED 400 | <br>Asbestos found | <b>In-Service Fuses:</b><br> If fuse is damaged, cease work and make safe. Contact the Hazmat Hotline - 02 9394 6961.<br> If the fuse is intact, remove the fuse taking care not to damage in accordance with SWMS - AUS008 Removal of Friable Asbestos Containing LV HRC Fuses.<br><b>Stored and Quarantined Fuses:</b><br> Must be disposed of in accordance with SWMS - AUS008 Removal of Friable Asbestos Containing LV HRC Fuses. |

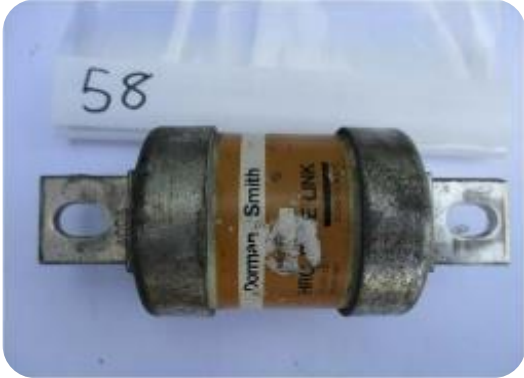
| Manufacturer | Rating | Fuse Body Photographs | Label Markings & Details | Result | Safety Instructions |
|---|---|---|---|---|---|
| Dorman | 400 | | Smith AC80 400A | <br>Asbestos found | <b>In-Service Fuses:</b><br> If fuse is damaged, cease work and make safe. Contact the Hazmat Hotline - 02 9394 6961.<br> If the fuse is intact, remove the fuse taking care not to damage in accordance with SWMS - AUS008 Removal of Friable Asbestos Containing LV HRC Fuses.<br><b>Stored and Quarantined Fuses:</b><br> Must be disposed of in accordance with SWMS - AUS008 Removal of Friable Asbestos Containing LV HRC Fuses. |

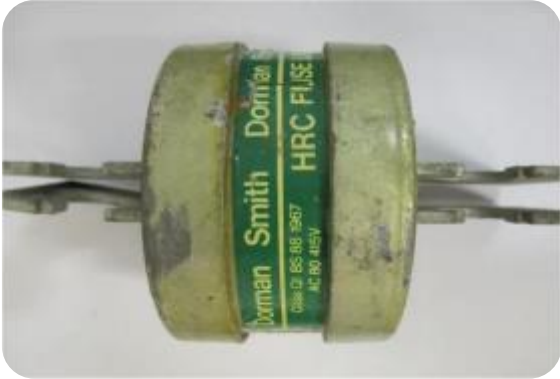
| Manufacturer | Rating | Fuse Body Photographs | Label Markings & Details | Result | Safety Instructions |
|---|---|---|---|---|---|
| Dorman | 500 | | Smith 500A class Q1 BS 88.1967 | <br>Asbestos found | <b>In-Service Fuses:</b><br> If fuse is damaged, cease work and make safe. Contact the Hazmat Hotline - 02 9394 6961.<br> If the fuse is intact, remove the fuse taking care not to damage in accordance with SWMS - AUS008 Removal of Friable Asbestos Containing LV HRC Fuses.<br><b>Stored and Quarantined Fuses:</b><br> Must be disposed of in accordance with SWMS - AUS008 Removal of Friable Asbestos Containing LV HRC Fuses. |

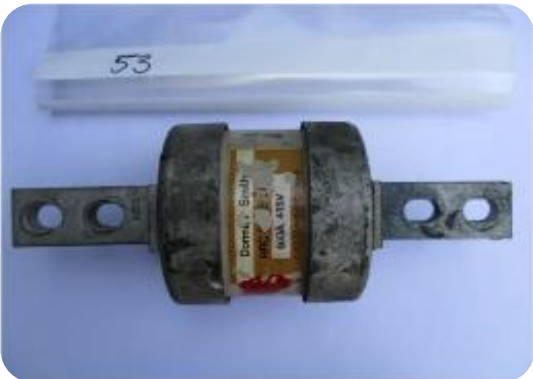
| Manufacturer | Rating | Fuse Body Photographs | Label Markings & Details | Result | Safety Instructions |
|---|---|---|---|---|---|
| Dorman | 600 | | Smith SGF600 | <br>Asbestos found | <b>In-Service Fuses:</b><br> If fuse is damaged, cease work and make safe. Contact the Hazmat Hotline - 02 9394 6961.<br> If the fuse is intact, remove the fuse taking care not to damage in accordance with SWMS - AUS008 Removal of Friable Asbestos Containing LV HRC Fuses.<br><b>Stored and Quarantined Fuses:</b><br> Must be disposed of in accordance with SWMS - AUS008 Removal of Friable Asbestos Containing LV HRC Fuses. |

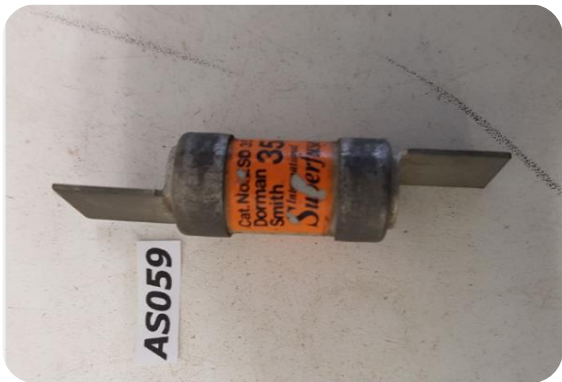
| Manufacturer | Rating | Fuse Body Photographs | Label Markings & Details | Result | Safety Instructions |
|---|---|---|---|---|---|
| Dorman | 35 | <br>174783-001-AS059 | ESD35, 35A, 80kA, 250VDC40kA, Asta 20 cert, BS 88:1975, Q1, AS2005.1:1981, IEC 269.1: 1973, International Super Fuse | <br>No Asbestos found, exercise caution and follow safety instructions | Where no manufacturer or date information can be confirmed and/or the fuse was manufactured prior to 2003, the <b>fuses should be presumed to contain asbestos and disposed</b> of in accordance with SWMS - AUS008 - Removal of Friable Asbestos Containing LV HRC Fuses. |

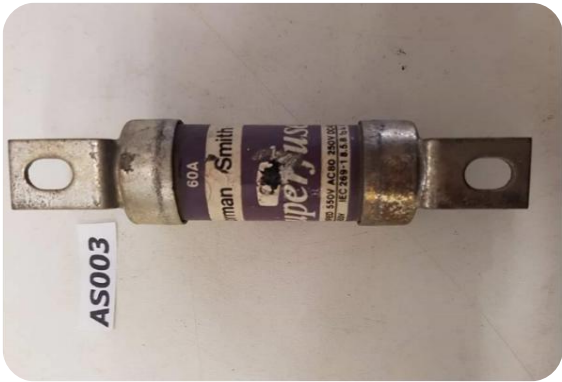
| Manufacturer | Rating | Fuse Body Photographs | Label Markings & Details | Result | Safety Instructions |
|---|---|---|---|---|---|
| Dorman | 60 | <br>176207-001-AS003 | Super fuse, BAO60A, 60A, AC80, 25VDC40, IEC 269-1 8.5.8, Asta certified 2000,000A 55DV, Class Q1, BS88 1967 | <br>Asbestos found | <b>In-Service Fuses:</b><br> If fuse is damaged, cease work and make safe. Contact the Hazmat Hotline - 02 9394 6961.<br> If the fuse is intact, remove the fuse taking care not to damage in accordance with SWMS - AUS008 Removal of Friable Asbestos Containing LV HRC Fuses.<br><b>Stored and Quarantined Fuses:</b><br> Must be disposed of in accordance with SWMS - AUS008 Removal of Friable Asbestos Containing LV HRC Fuses. |

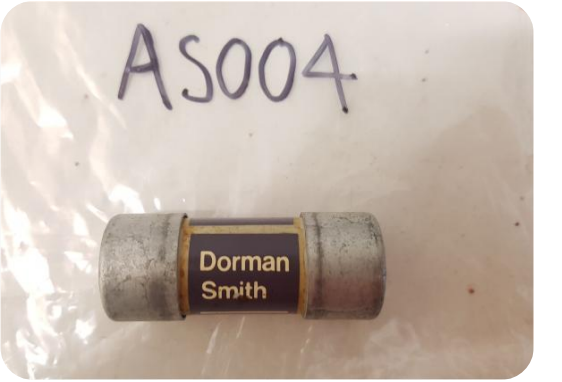
| Manufacturer | Rating | Fuse Body Photographs | Label Markings & Details | Result | Safety Instructions |
|---|---|---|---|---|---|
| Dorman | 60 | <br>182621-001-004 | RHC60A, 60A, asta certified, BS.1361 1971 | <br>Asbestos found | <b>In-Service Fuses:</b><br> If fuse is damaged, cease work and make safe. Contact the Hazmat Hotline - 02 9394 6961.<br> If the fuse is intact, remove the fuse taking care not to damage in accordance with SWMS - AUS008 Removal of Friable Asbestos Containing LV HRC Fuses.<br><b>Stored and Quarantined Fuses:</b><br> Must be disposed of in accordance with SWMS - AUS008 Removal of Friable Asbestos Containing LV HRC Fuses. |

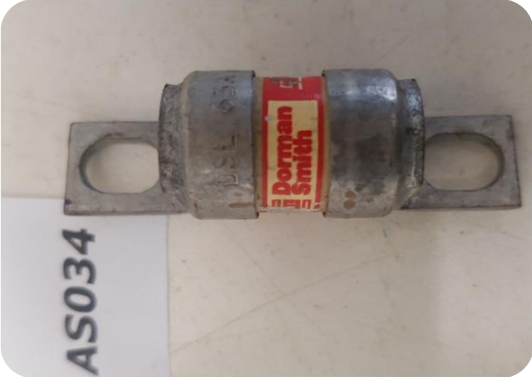
| Manufacturer | Rating | Fuse Body Photographs | Label Markings & Details | Result | Safety Instructions |
|---|---|---|---|---|---|
| Dorman | 63 | <p>174102-001-AS034</p> | DSL63A, 63A, BS88-4: 1976 | <p>No Asbestos found, exercise caution and follow safety instructions</p> | <p>Where no manufacturer or date information can be confirmed and/or the fuse was manufactured prior to 2003, the <b>fuses should be presumed to contain asbestos and disposed</b> of in accordance with SWMS - AUS008 - Removal of Friable Asbestos Containing LV HRC Fuses.</p> |

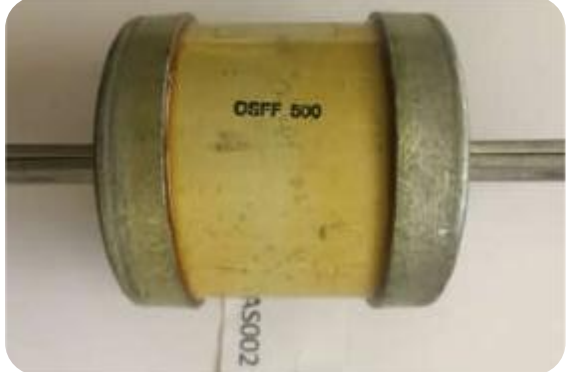
| Manufacturer | Rating | Fuse Body Photographs | Label Markings & Details | Result | Safety Instructions |
|---|---|---|---|---|---|
| Dorman | 500 | <p>PO33786.002-AS002</p> | OSFF 500, 500A, | <p>No Asbestos found, exercise caution and follow safety instructions</p> | <p>Where no manufacturer or date information can be confirmed and/or the fuse was manufactured prior to 2003, the <b>fuses should be presumed to contain asbestos and disposed</b> of in accordance with SWMS - AUS008 - Removal of Friable Asbestos Containing LV HRC Fuses.</p> |

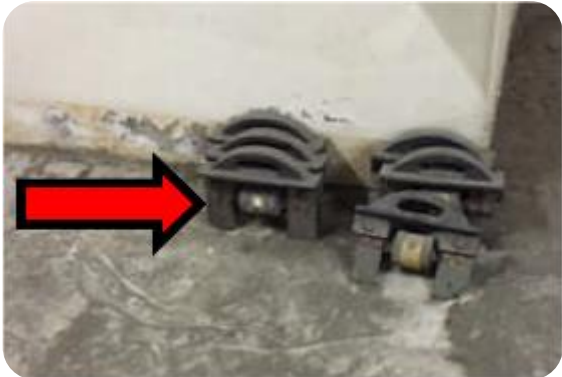
| Manufacturer | Rating | Fuse Body Photographs | Label Markings & Details | Result | Safety Instructions |
|---|---|---|---|---|---|
| Dorman | 800 | <p>181698-001-001</p> | SGF800 | <p>Asbestos found</p> | <p><b>In-Service Fuses:</b></p> <ul style="list-style-type: none"> <li> If fuse is damaged, cease work and make safe. Contact the Hazmat Hotline - 02 9394 6961.</li> <li> If the fuse is intact, remove the fuse taking care not to damage in accordance with SWMS - AUS008 Removal of Friable Asbestos Containing LV HRC Fuses.</li> </ul> <p><b>Stored and Quarantined Fuses:</b></p> <ul style="list-style-type: none"> <li> Must be disposed of in accordance with SWMS - AUS008 Removal of Friable Asbestos Containing LV HRC Fuses.</li> </ul> |
