## Network Standard

Document No : NW000-S0161

NS211 ANNEXURE G – LV HRC FUSE ASBESTOS PRODUCT GUIDE

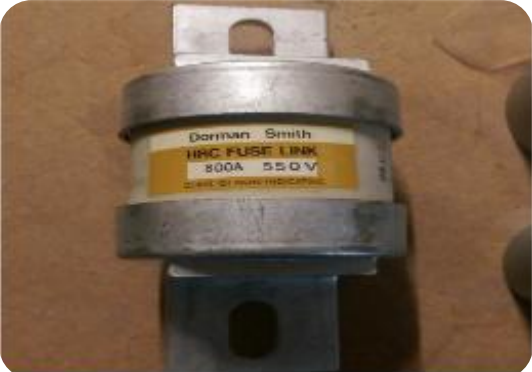
| Manufacturer | Rating | Fuse Body Photographs | Label Markings & Details | Result | Safety Instructions |
|---|---|---|---|---|---|
| Dorman | 800 | | 800A, 550V, Class Q1, Non-indicating<br>(Offset tag - Network Protector Fuse) | <br>Asbestos found | <b>In-Service Fuses:</b><br> If fuse is damaged, cease work and make safe. Contact the Hazmat Hotline - 02 9394 6961.<br> If the fuse is intact, remove the fuse taking care not to damage in accordance with SWMS - AUS008 Removal of Friable Asbestos Containing LV HRC Fuses.<br><b>Stored and Quarantined Fuses:</b><br> Must be disposed of in accordance with SWMS - AUS008 Removal of Friable Asbestos Containing LV HRC Fuses. |

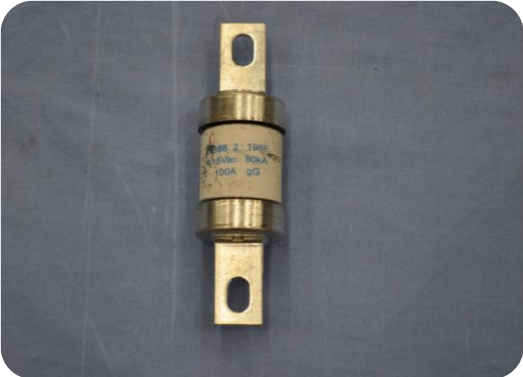
| Manufacturer | Rating | Fuse Body Photographs | Label Markings & Details | Result | Safety Instructions |
|---|---|---|---|---|---|
| Dorman Smith | 100 | | DS OSDD | <br>Current Stock Item No. 85217 | May be used as normal.<br> When disposing of LV HRC Fuses treat all fuses as asbestos waste. |

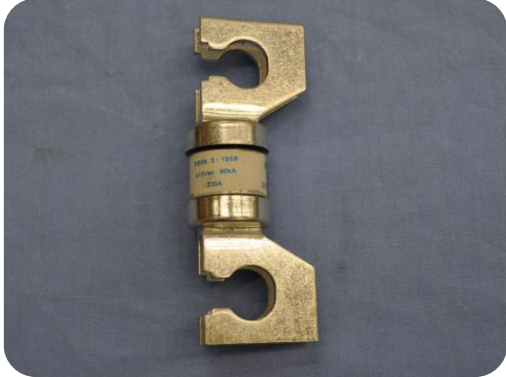
| Manufacturer | Rating | Fuse Body Photographs | Label Markings & Details | Result | Safety Instructions |
|---|---|---|---|---|---|
| Dorman Smith | 200 | | DS OJSDS, | <br>Current Stock Item No. 85688 | May be used as normal.<br> When disposing of LV HRC Fuses treat all fuses as asbestos waste. |

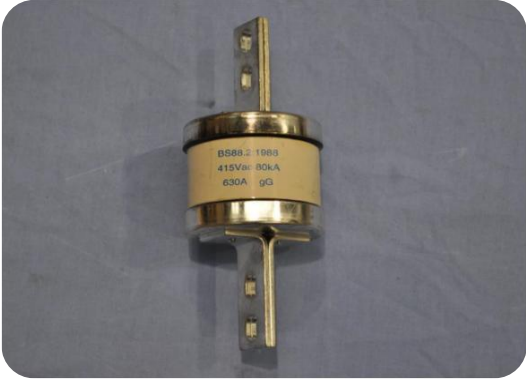
| Manufacturer | Rating | Fuse Body Photographs | Label Markings & Details | Result | Safety Instructions |
|---|---|---|---|---|---|
| Dorman Smith | 630 | | DS SGF, Siemens 3NW1-351/S | <br>Current Stock Item<br>No. 85597 | ✓ May be used as normal.<br>✓ When disposing of LV HRC Fuses treat all fuses as asbestos waste. |

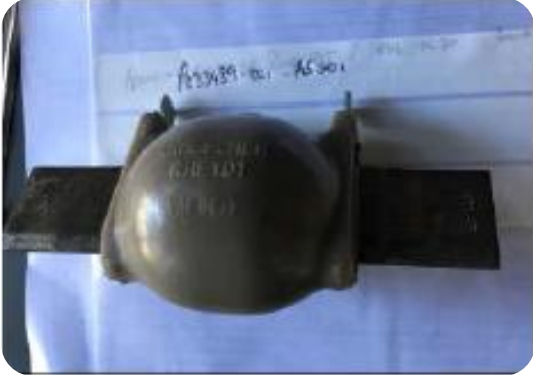
| Manufacturer | Rating | Fuse Body Photographs | Label Markings & Details | Result | Safety Instructions |
|---|---|---|---|---|---|
| Driescher Rheydt | 400 | <br>167851-1 | VDE 0630 – 400A | <br>No Asbestos found,<br>exercise caution and follow safety instructions | Where no manufacturer or date information can be confirmed and/or the fuse was manufactured prior to 2003, the <b>fuses should be presumed to contain asbestos and disposed</b> of in accordance with SWMS - AUS008 - Removal of Friable Asbestos Containing LV HRC Fuses. |

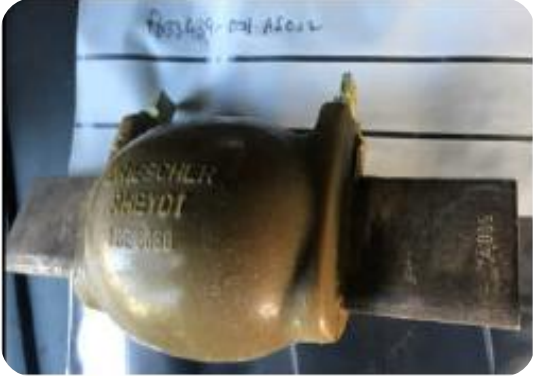
| Manufacturer | Rating | Fuse Body Photographs | Label Markings & Details | Result | Safety Instructions |
|---|---|---|---|---|---|
| Driescher Rheydt | 400 | <br>167851-2 | VDE 0660 - 400AT 500V | <br>No Asbestos found,<br>exercise caution and follow safety instructions | Where no manufacturer or date information can be confirmed and/or the fuse was manufactured prior to 2003, the <b>fuses should be presumed to contain asbestos and disposed</b> of in accordance with SWMS - AUS008 - Removal of Friable Asbestos Containing LV HRC Fuses. |

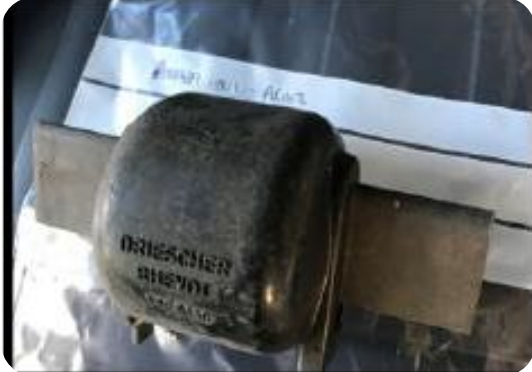
| Manufacturer | Rating | Fuse Body Photographs | Label Markings & Details | Result | Safety Instructions |
|---|---|---|---|---|---|
| Driescher Rheydt | 425 | | VDE 0660 – 500V | <br>No Asbestos found, exercise caution and follow safety instructions | <br>Where no manufacturer or date information can be confirmed and/or the fuse was manufactured prior to 2003, the <b>fuses should be presumed to contain asbestos and disposed</b> of in accordance with SWMS - AUS008 - Removal of Friable Asbestos Containing LV HRC Fuses. |

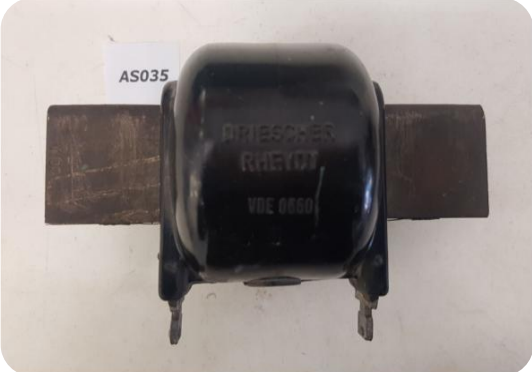
| Manufacturer | Rating | Fuse Body Photographs | Label Markings & Details | Result | Safety Instructions |
|---|---|---|---|---|---|
| Driescher Rheydt | 425 | | VSE0660, 425AT, 425A | <br>No Asbestos found, exercise caution and follow safety instructions | <br>Where no manufacturer or date information can be confirmed and/or the fuse was manufactured prior to 2003, the <b>fuses should be presumed to contain asbestos and disposed</b> of in accordance with SWMS - AUS008 - Removal of Friable Asbestos Containing LV HRC Fuses. |

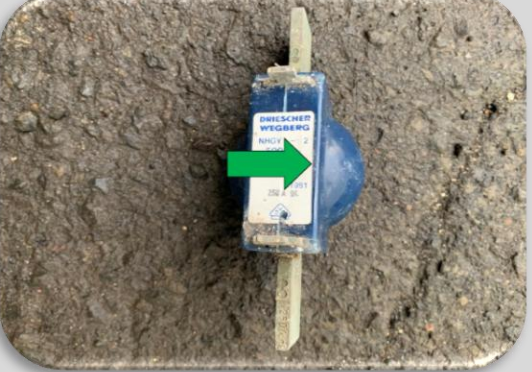
| Manufacturer | Rating | Fuse Body Photographs | Label Markings & Details | Result | Safety Instructions |
|---|---|---|---|---|---|
| Driescher Wegberg | 2 | | NHGY-2 500V 120kA, 1981 | <br>No Asbestos found | ✓ May be used as normal.<br>✓ When disposing of LV HRC Fuses treat all fuses as asbestos waste. |

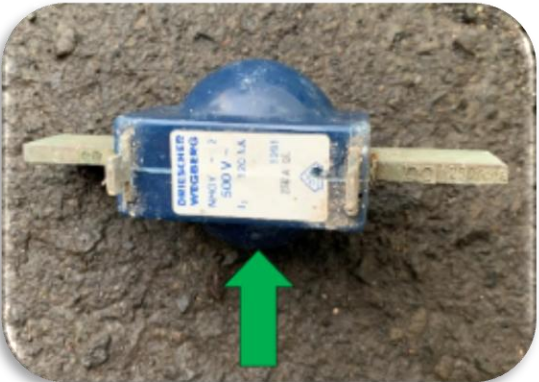
| Manufacturer | Rating | Fuse Body Photographs | Label Markings & Details | Result | Safety Instructions |
|---|---|---|---|---|---|
| Driescher Wegberg | 120 | <br>754-SYDEN202874-003 | NHGY-2 500V 120kA 1981 | <br>No Asbestos found | May be used as normal.<br> When disposing of LV HRC Fuses treat all fuses as asbestos waste. |

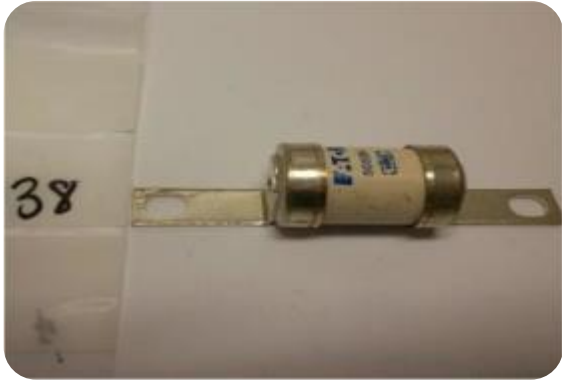
| Manufacturer | Rating | Fuse Body Photographs | Label Markings & Details | Result | Safety Instructions |
|---|---|---|---|---|---|
| Eaton | 50 | <br>54287-002-038 | 50SB4, HRC Asta 20 cert, 415 V ac, 80kA, gG | <br>Current Stock Item | May be used as normal.<br> When disposing of LV HRC Fuses treat all fuses as asbestos waste. |

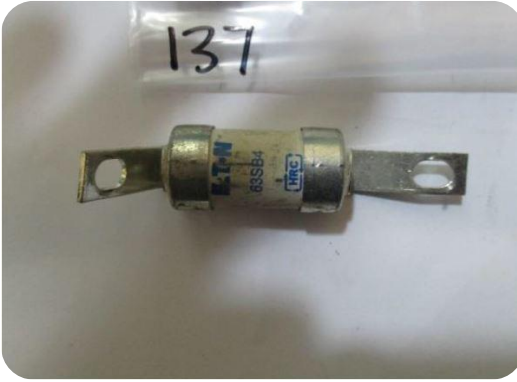
| Manufacturer | Rating | Fuse Body Photographs | Label Markings & Details | Result | Safety Instructions |
|---|---|---|---|---|---|
| Eaton | 63 | <br>54087-001-137 | 63SB4 | <br>No Asbestos found, exercise caution and follow safety instructions | Where no manufacturer or date information can be confirmed and/or the fuse was manufactured prior to 2003, the <b>fuses should be presumed to contain asbestos and disposed</b> of in accordance with SWMS - AUS008 - Removal of Friable Asbestos Containing LV HRC Fuses. |

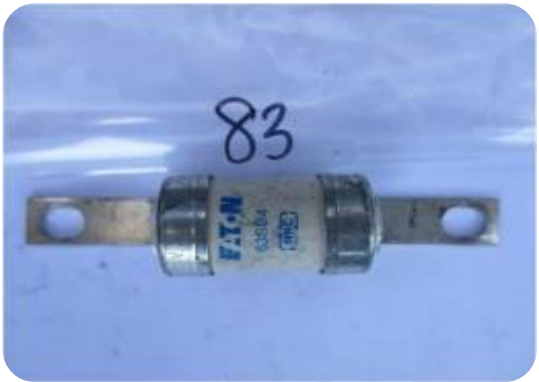
| Manufacturer | Rating | Fuse Body Photographs | Label Markings & Details | Result | Safety Instructions |
|---|---|---|---|---|---|
| Eaton | 63 | <br>54287-001-083 | 63SB4, 63A GG | ✓<br>Current<br>Stock Item | ✓ May be used as normal.<br>✓ When disposing of LV HRC Fuses treat all fuses as asbestos waste. |

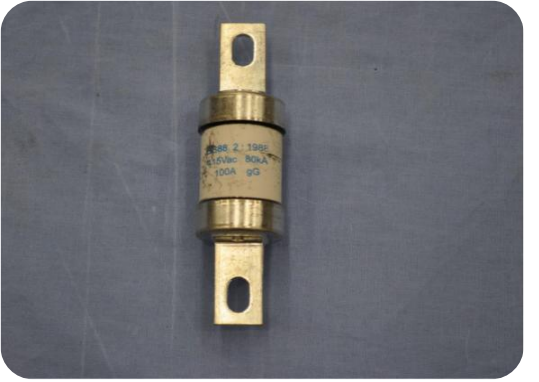
| Manufacturer | Rating | Fuse Body Photographs | Label Markings & Details | Result | Safety Instructions |
|---|---|---|---|---|---|
| Eaton | 100 | <br>54287-002-003 | EATON AA100SF5SWP | ✓<br>Current<br>Stock Item<br>No. 85217 | ✓ May be used as normal.<br>✓ When disposing of LV HRC Fuses treat all fuses as asbestos waste. |

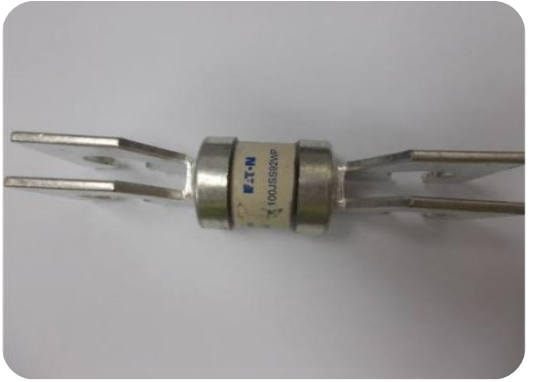
| Manufacturer | Rating | Fuse Body Photographs | Label Markings & Details | Result | Safety Instructions |
|---|---|---|---|---|---|
| Eaton | 100 | <br>54287-002-003 | 100JSS92WP, Asta 20 cert,<br>HRC, 415V, 80kA | ⚠<br>No<br>Asbestos<br>found,<br>exercise<br>caution and<br>follow<br>safety<br>instructions | ⚠ Where no manufacturer or date information can be confirmed and/or the fuse was manufactured prior to 2003, the <b>fuses should be presumed to contain asbestos and disposed</b> of in accordance with SWMS - AUS008 - Removal of Friable Asbestos Containing LV HRC Fuses. |

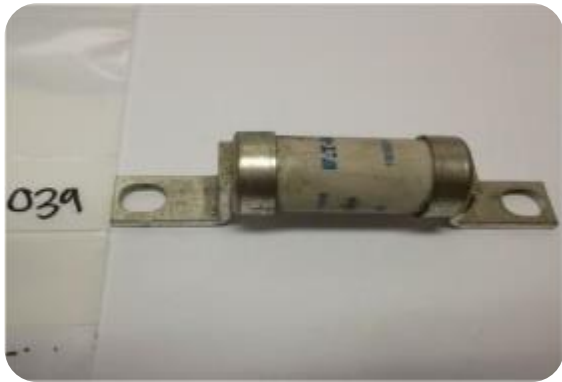
| Manufacturer | Rating | Fuse Body Photographs | Label Markings & Details | Result | Safety Instructions |
|---|---|---|---|---|---|
| Eaton | 100 | | 100SD5, HRC Asta 20 cert, 415 V ac, 80kA, gG | <br>Current Stock Item | ✓ May be used as normal.<br>✓ When disposing of LV HRC Fuses treat all fuses as asbestos waste. |

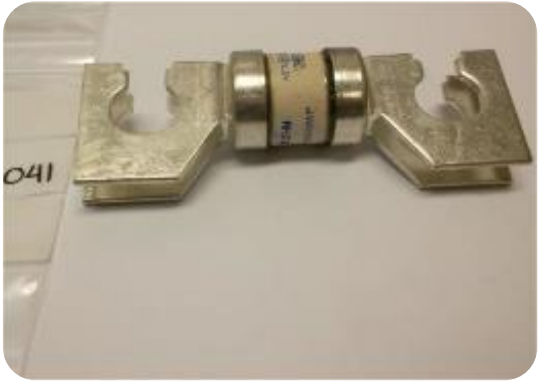
| Manufacturer | Rating | Fuse Body Photographs | Label Markings & Details | Result | Safety Instructions |
|---|---|---|---|---|---|
| Eaton | 100 | | 100JSS92WP, Asta 20 cert, HRC, 415V, 80kA | <br>Current Stock Item | ✓ May be used as normal.<br>✓ When disposing of LV HRC Fuses treat all fuses as asbestos waste. |

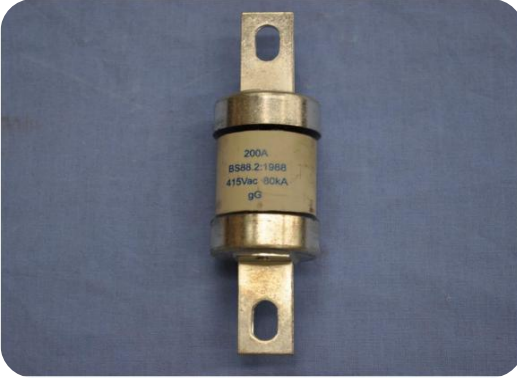
| Manufacturer | Rating | Fuse Body Photographs | Label Markings & Details | Result | Safety Instructions |
|---|---|---|---|---|---|
| Eaton | 200 | | EATON AA200SF6SWP | <br>Current Stock Item<br>No. 85423 | ✓ May be used as normal.<br>✓ When disposing of LV HRC Fuses treat all fuses as asbestos waste. |

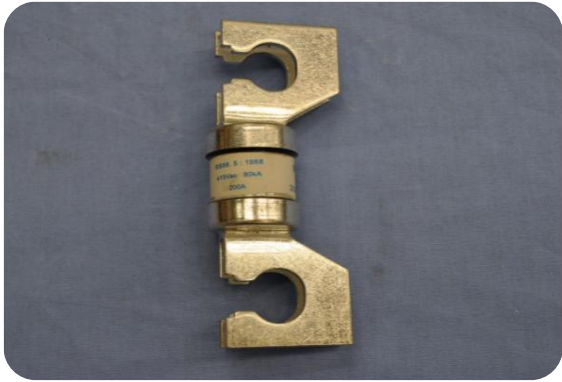
| Manufacturer | Rating | Fuse Body Photographs | Label Markings & Details | Result | Safety Instructions |
|---|---|---|---|---|---|
| Eaton | 200 | <br>EATON AA200JSS92WP | EATON AA200JSS92WP | ✓<br>Current<br>Stock Item<br>No. 85688 | ✓ May be used as normal.<br>✓ When disposing of LV HRC Fuses treat all fuses as asbestos waste. |

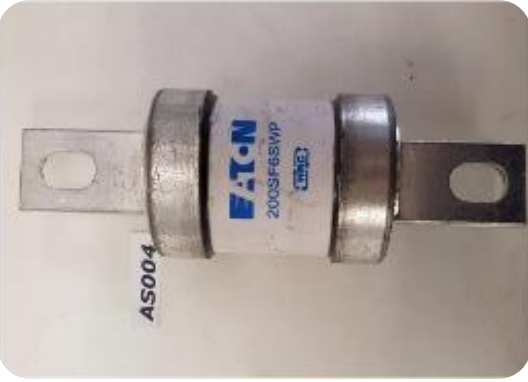
| Manufacturer | Rating | Fuse Body Photographs | Label Markings & Details | Result | Safety Instructions |
|---|---|---|---|---|---|
| Eaton | 200 | <br>AS004<br>176207-001-AS004 | 200SF6SWP, 200A,<br>BS88.2:1988, 80kA, gG | ✓<br>Current<br>Stock Item | ✓ May be used as normal.<br>✓ When disposing of LV HRC Fuses treat all fuses as asbestos waste. |

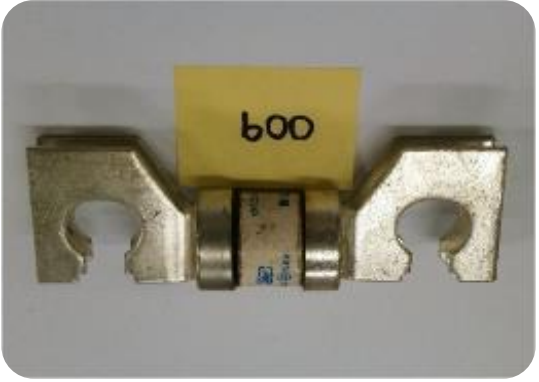
| Manufacturer | Rating | Fuse Body Photographs | Label Markings & Details | Result | Safety Instructions |
|---|---|---|---|---|---|
| Eaton | 200 | <br>55738-001-009 | 400JSS92 WP 200A | ✓<br>Current<br>Stock Item | ✓ May be used as normal.<br>✓ When disposing of LV HRC Fuses treat all fuses as asbestos waste. |

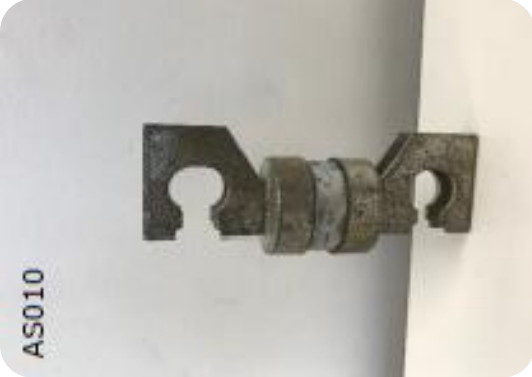
| Manufacturer | Rating | Fuse Body Photographs | Label Markings & Details | Result | Safety Instructions |
|---|---|---|---|---|---|
| Eaton | 250 | <p>AS010</p> | <p>EATON - HRC, 250JSS92WP - BS88-5: 1988, 415V AC 80kA, 250A, ASTA certified - 415V - no country - no date</p> <p>PO33786.002-AS012</p> | <p>✓</p> <p>Current Stock Item</p> | <p>✓ May be used as normal.</p> <p>✓ When disposing of LV HRC Fuses treat all fuses as asbestos waste.</p> |

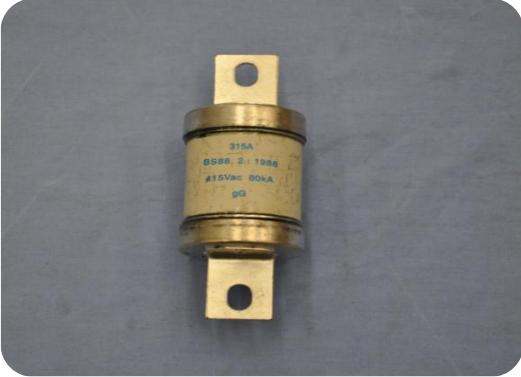
| Manufacturer | Rating | Fuse Body Photographs | Label Markings & Details | Result | Safety Instructions |
|---|---|---|---|---|---|
| Eaton | 300 | <p>EATON AA315SF7SWP</p> | <p>EATON AA315SF7SWP</p> | <p>✓</p> <p>Current Stock Item No. 85506</p> | <p>✓ May be used as normal.</p> <p>✓ When disposing of LV HRC Fuses treat all fuses as asbestos waste.</p> |

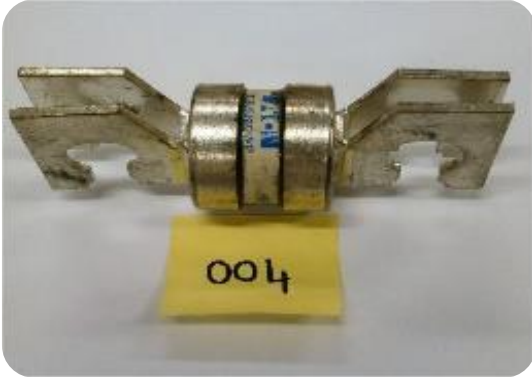
| Manufacturer | Rating | Fuse Body Photographs | Label Markings & Details | Result | Safety Instructions |
|---|---|---|---|---|---|
| Eaton | 315 | <p>004</p> | <p>315JSS92WP, Asta 20 Cert, 415V ac, 80kA</p> <p>55738-001-004</p> | <p>✓</p> <p>Current Stock Item</p> | <p>✓ May be used as normal.</p> <p>✓ When disposing of LV HRC Fuses treat all fuses as asbestos waste.</p> |

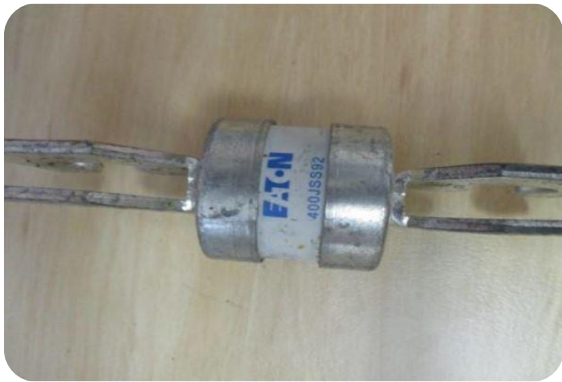
| Manufacturer | Rating | Fuse Body Photographs | Label Markings & Details | Result | Safety Instructions |
|---|---|---|---|---|---|
| Eaton | 400 | <br>54087-001-021 | 400JSS92 WP 400A | ⚠ | |

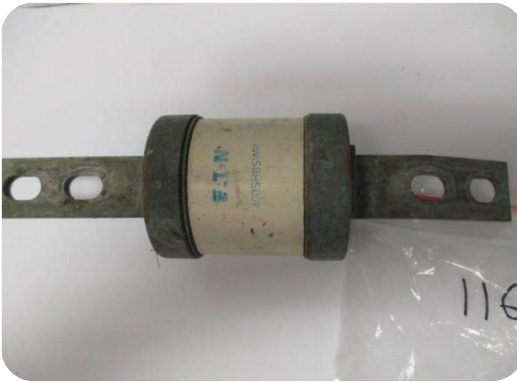
| Manufacturer | Rating | Fuse Body Photographs | Label Markings & Details | Result | Safety Instructions |
|---|---|---|---|---|---|
| EATON | 400 | <br>54087-001-116 | 400SH8SWP 400A GG | ⚠ | |

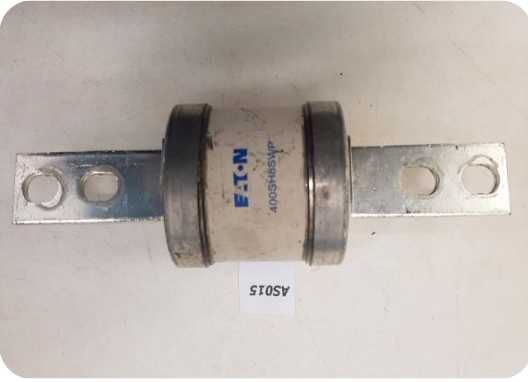
| Manufacturer | Rating | Fuse Body Photographs | Label Markings & Details | Result | Safety Instructions |
|---|---|---|---|---|---|
| Eaton | 400 | <br>174102-001-AS015 | 400SH8SWP, type gG, 400A,<br>BS88.2:1988, 80kA | ✓<br>Current<br>Stock Item | <ul style="list-style-type: none"> <li>✓ May be used as normal.</li> <li>✓ When disposing of LV HRC Fuses treat all fuses as asbestos waste.</li> </ul> |

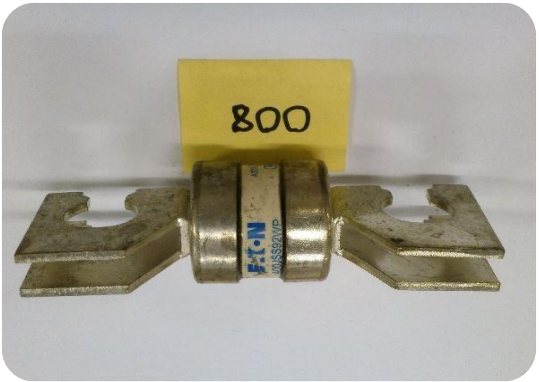
| Manufacturer | Rating | Fuse Body Photographs | Label Markings & Details | Result | Safety Instructions |
|---|---|---|---|---|---|
| Eaton | 400 | | 400JSS92 WP 400A<br>55738-001-008 | <br>No Asbestos found, exercise caution and follow safety instructions | Where no manufacturer or date information can be confirmed and/or the fuse was manufactured prior to 2003, the <b>fuses should be presumed to contain asbestos and disposed</b> of in accordance with SWMS - AUS008 - Removal of Friable Asbestos Containing LV HRC Fuses. |

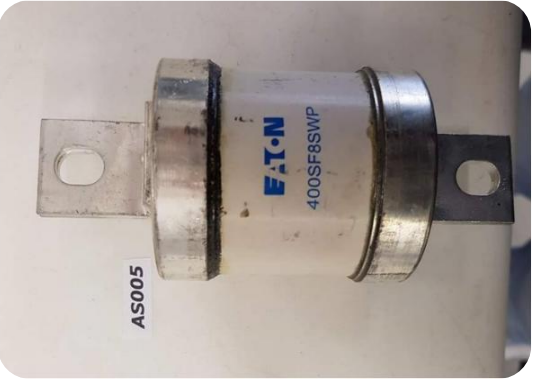
| Manufacturer | Rating | Fuse Body Photographs | Label Markings & Details | Result | Safety Instructions |
|---|---|---|---|---|---|
| Eaton | 400 | | 400SFSWP, 400A, BS88.2:1988, 80kA, gG<br>176207-001-AS005 | <br>Current Stock Item | <ul style="list-style-type: none"> <li>✓ May be used as normal.</li> <li>✓ When disposing of LV HRC Fuses treat all fuses as asbestos waste.</li> </ul> |

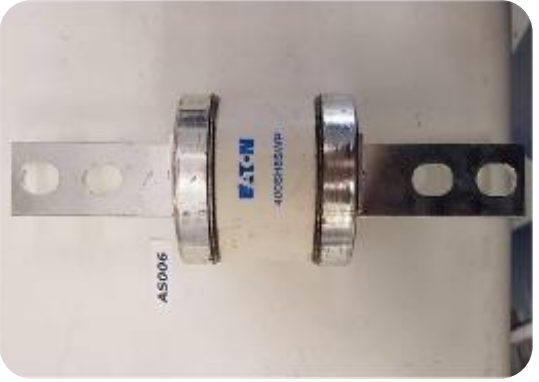
| Manufacturer | Rating | Fuse Body Photographs | Label Markings & Details | Result | Safety Instructions |
|---|---|---|---|---|---|
| Eaton | 400 | | 400SH8SWP, 400A, BS88.2:1988, 80kA, gG<br>176207-001-AS006 | <br>Current Stock Item | <ul style="list-style-type: none"> <li>✓ May be used as normal.</li> <li>✓ When disposing of LV HRC Fuses treat all fuses as asbestos waste.</li> </ul> |

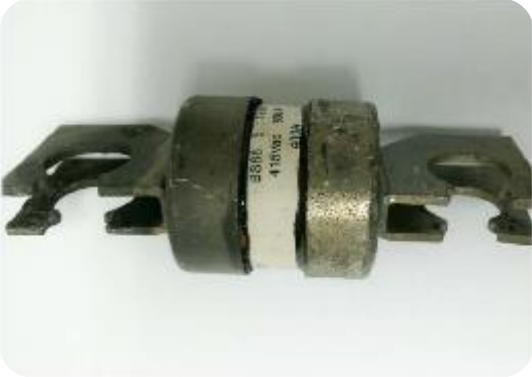
| Manufacturer | Rating | Fuse Body Photographs | Label Markings & Details | Result | Safety Instructions |
|---|---|---|---|---|---|
| Eaton | 400 | | 400JSS82WP, ASTA 20 Cert,<br>415V ac, 80kA | ✓<br>Current<br>Stock Item | ✓ May be used as normal.<br>✓ When disposing of LV HRC Fuses treat all fuses as<br>asbestos waste. |

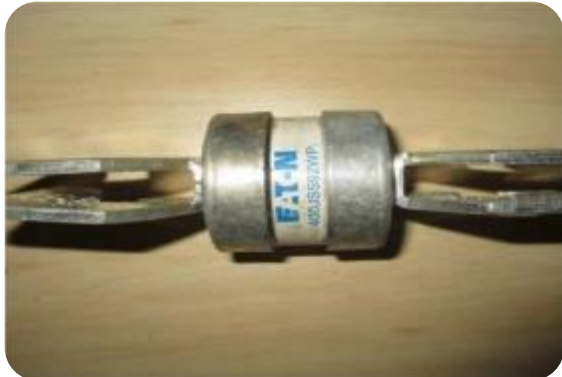
| Manufacturer | Rating | Fuse Body Photographs | Label Markings & Details | Result | Safety Instructions |
|---|---|---|---|---|---|
| Eaton | 400 | | 400JSS92 WP 400A | ✓<br>Current<br>Stock Item | ✓ May be used as normal.<br>✓ When disposing of LV HRC Fuses treat all fuses as<br>asbestos waste. |

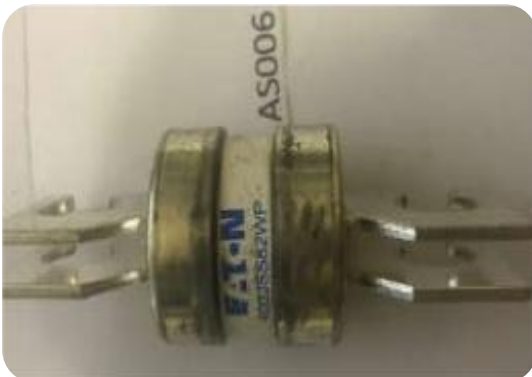
| Manufacturer | Rating | Fuse Body Photographs | Label Markings & Details | Result | Safety Instructions |
|---|---|---|---|---|---|
| Eaton | 400 | | 400JSS82WP, ASTA 20 CERT,<br>BS88. 5 : 1988, 415Vac 80kA,<br>400A | ✓<br>Current<br>Stock Item | ✓ May be used as normal.<br>✓ When disposing of LV HRC Fuses treat all fuses as<br>asbestos waste. |

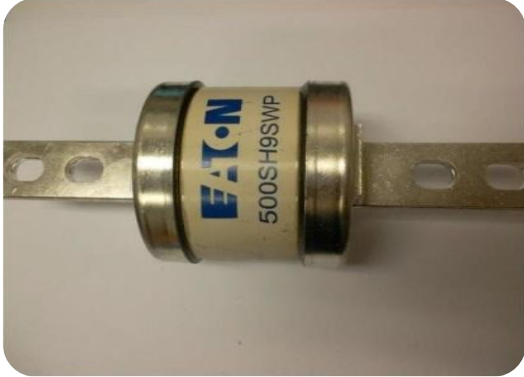
| Manufacturer | Rating | Fuse Body Photographs | Label Markings & Details | Result | Safety Instructions |
|---|---|---|---|---|---|
| Eaton | 500 | | 500SH9SWP, HRC, 415V ac, 80kA, gG<br><small>54287-002-076</small> | <br>No Asbestos found, exercise caution and follow safety instructions | <br>Where no manufacturer or date information can be confirmed and/or the fuse was manufactured prior to 2003, the <b>fuses should be presumed to contain asbestos and disposed</b> of in accordance with SWMS - AUS008 - Removal of Friable Asbestos Containing LV HRC Fuses. |

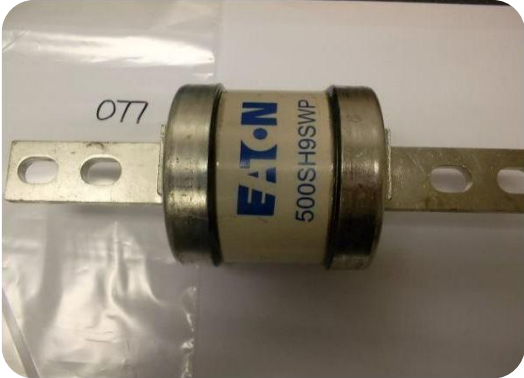
| Manufacturer | Rating | Fuse Body Photographs | Label Markings & Details | Result | Safety Instructions |
|---|---|---|---|---|---|
| Eaton | 500 | | 500SH9SWP, HRC, 415V ac, 80kA, gG<br><small>54287-002-077</small> | <br>No Asbestos found, exercise caution and follow safety instructions | <br>Where no manufacturer or date information can be confirmed and/or the fuse was manufactured prior to 2003, the <b>fuses should be presumed to contain asbestos and disposed</b> of in accordance with SWMS - AUS008 - Removal of Friable Asbestos Containing LV HRC Fuses. |

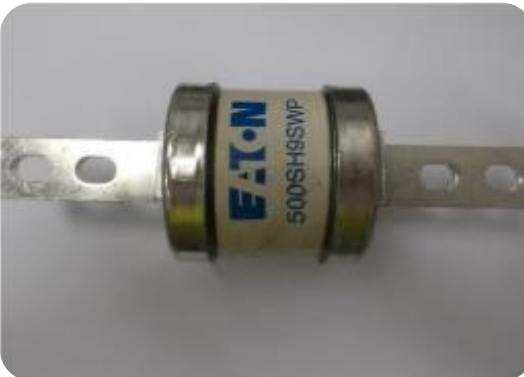
| Manufacturer | Rating | Fuse Body Photographs | Label Markings & Details | Result | Safety Instructions |
|---|---|---|---|---|---|
| Eaton | 500 | | 500SH9SWP, HRC, 415V ac, 80kA, gG<br><small>54287-002-010</small> | <br>Current Stock Item | <ul style="list-style-type: none"> <li>✓ May be used as normal.</li> <li>✓ When disposing of LV HRC Fuses treat all fuses as asbestos waste.</li> </ul> |

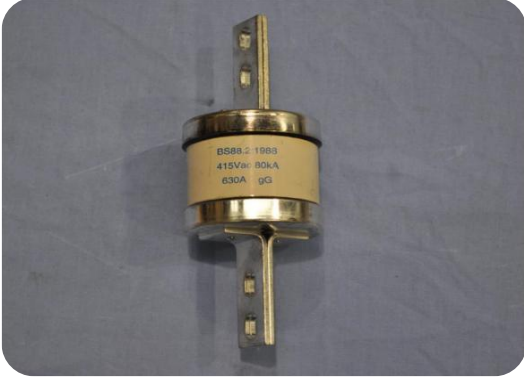
| Manufacturer | Rating | Fuse Body Photographs | Label Markings & Details | Result | Safety Instructions |
|---|---|---|---|---|---|
| Eaton | 630 | | EATON AA630SH9SWP | <br>Current Stock Item<br>No. 85597 | ✓ May be used as normal.<br>✓ When disposing of LV HRC Fuses treat all fuses as asbestos waste. |

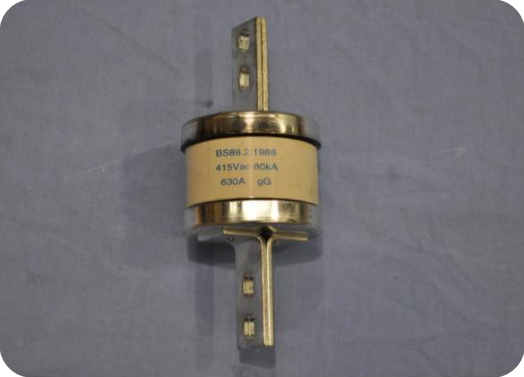
| Manufacturer | Rating | Fuse Body Photographs | Label Markings & Details | Result | Safety Instructions |
|---|---|---|---|---|---|
| Eaton | 630 | | EATON AA630SY9S | <br>Current Stock Item<br>No. 85589 | ✓ May be used as normal.<br>✓ When disposing of LV HRC Fuses treat all fuses as asbestos waste. |

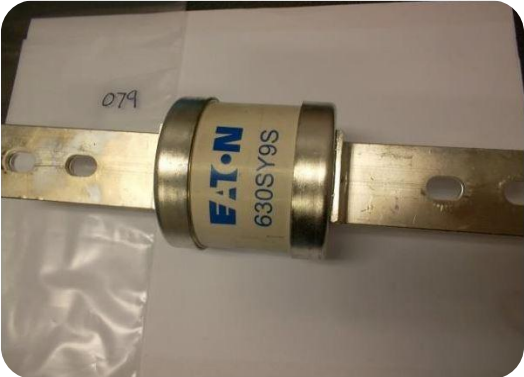
| Manufacturer | Rating | Fuse Body Photographs | Label Markings & Details | Result | Safety Instructions |
|---|---|---|---|---|---|
| Eaton | 630 | | 630SY9S, HRC, 415 V ac, 80kA, gG | | |

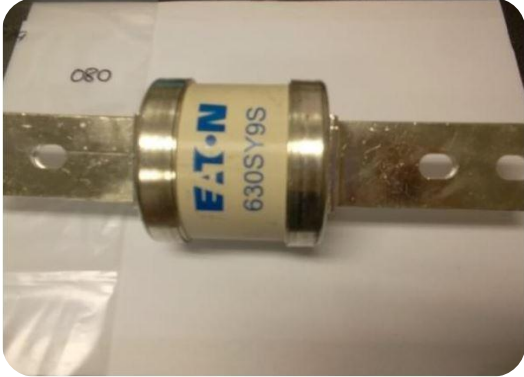
| Manufacturer | Rating | Fuse Body Photographs | Label Markings & Details | Result | Safety Instructions |
|---|---|---|---|---|---|
| Eaton | 630 | | 630SY9S, HRC, 415 V ac, 80kA, gG<br>54287-002-080 | ⚠ | |

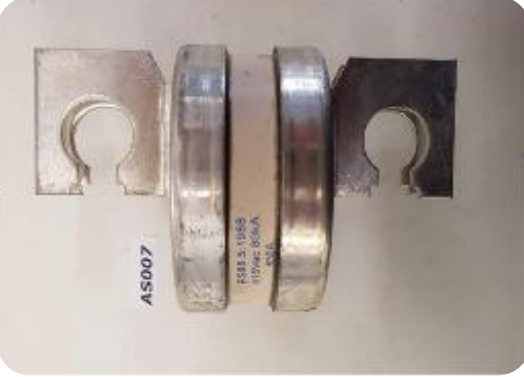
| Manufacturer | Rating | Fuse Body Photographs | Label Markings & Details | Result | Safety Instructions |
|---|---|---|---|---|---|
| Eaton | 630 | | 630JSS92WP, 630A, BS88.5:1988, 80kA, gG<br>176207-001-AS007 | ✓<br>Current Stock Item | <ul style="list-style-type: none"> <li>✓ May be used as normal.</li> <li>✓ When disposing of LV HRC Fuses treat all fuses as asbestos waste.</li> </ul> |

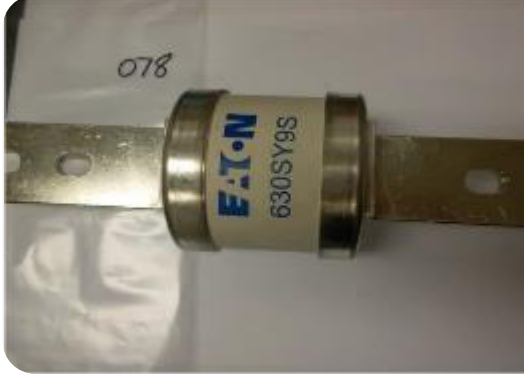
| Manufacturer | Rating | Fuse Body Photographs | Label Markings & Details | Result | Safety Instructions |
|---|---|---|---|---|---|
| Eaton | 630 | | 630SY9S, HRC, 415 V ac, 80kA, gG<br>54287-002-078 | ⚠ | |

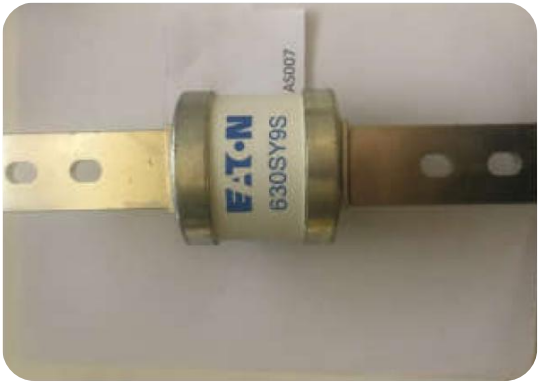
| Manufacturer | Rating | Fuse Body Photographs | Label Markings & Details | Result | Safety Instructions |
|---|---|---|---|---|---|
| Eaton | 630 | <br>PO33786.002-AS007 | 630SY9S, BS88.2:1988, 415Vac<br>80kA, 630A Gg, 630A HRC | ✓<br>Current<br>Stock Item | ✓ May be used as normal.<br>✓ When disposing of LV HRC Fuses treat all fuses as asbestos waste. |

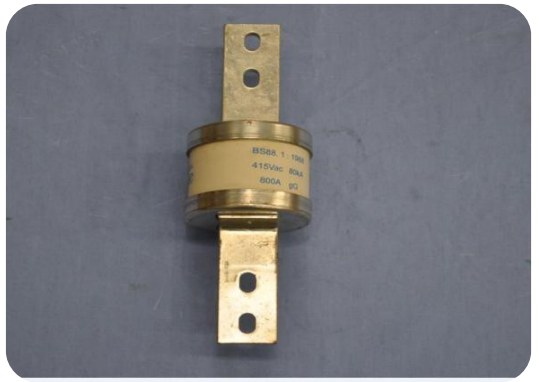
| Manufacturer | Rating | Fuse Body Photographs | Label Markings & Details | Result | Safety Instructions |
|---|---|---|---|---|---|
| Eaton | 800 | | EATON AA800SY10S | ✓<br>Current<br>Stock Item<br>No. 85613 | ✓ May be used as normal.<br>✓ When disposing of LV HRC Fuses treat all fuses as asbestos waste. |

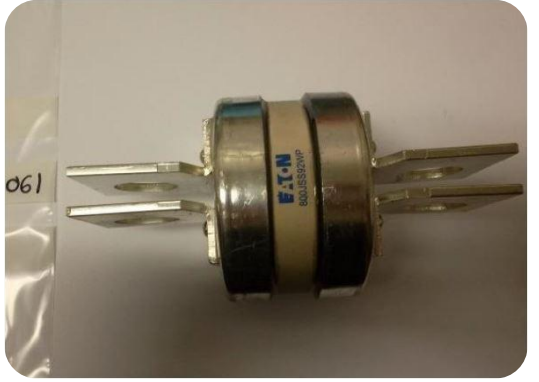
| Manufacturer | Rating | Fuse Body Photographs | Label Markings & Details | Result | Safety Instructions |
|---|---|---|---|---|---|
| Eaton | 800 | <br>54287-002-061 | 800JSS92WP | ⚠<br>No<br>Asbestos<br>found,<br>exercise<br>caution and<br>follow<br>safety<br>instructions | ⚠ Where no manufacturer or date information can be confirmed and/or the fuse was manufactured prior to 2003, the <b>fuses should be presumed to contain asbestos and disposed</b> of in accordance with SWMS - AUS008 - Removal of Friable Asbestos Containing LV HRC Fuses. |

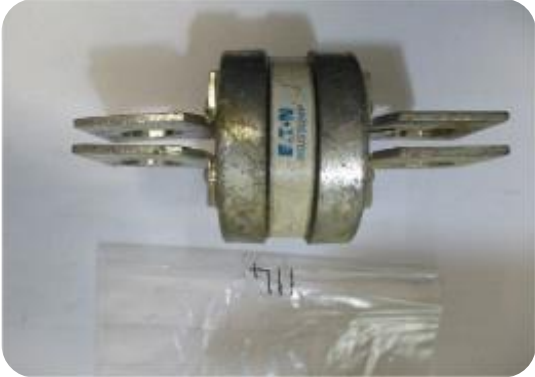
| Manufacturer | Rating | Fuse Body Photographs | Label Markings & Details | Result | Safety Instructions |
|---|---|---|---|---|---|
| Eaton | 800 | | 800JSS92WP | <br>Current Stock Item | ✓ May be used as normal.<br>✓ When disposing of LV HRC Fuses treat all fuses as asbestos waste. |

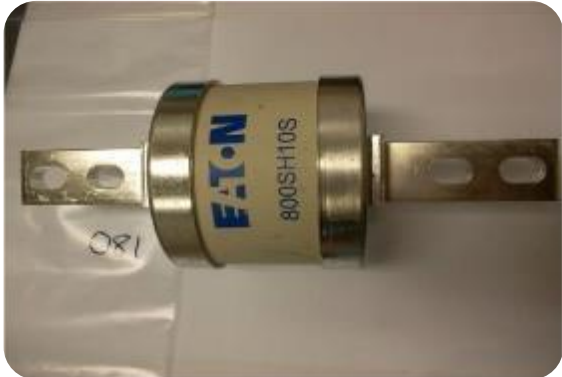
| Manufacturer | Rating | Fuse Body Photographs | Label Markings & Details | Result | Safety Instructions |
|---|---|---|---|---|---|
| Eaton | 800 | | 800SH10S | <br>Current Stock Item | ✓ May be used as normal.<br>✓ When disposing of LV HRC Fuses treat all fuses as asbestos waste. |

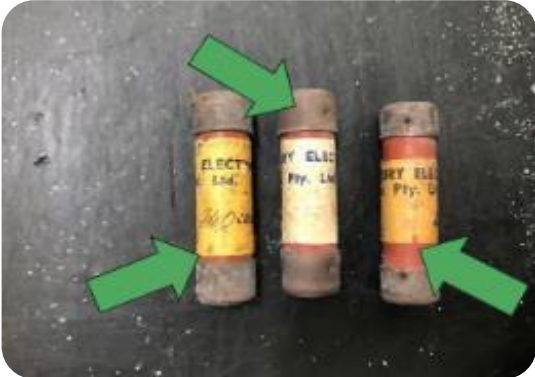
| Manufacturer | Rating | Fuse Body Photographs | Label Markings & Details | Result | Safety Instructions |
|---|---|---|---|---|---|
| Electric Pty. Ltd. | 0 | | Electric Pty. Ltd. 240 Volt | <br>No Asbestos found, exercise caution and follow safety instructions | Where no manufacturer or date information can be confirmed and/or the fuse was manufactured prior to 2003, the <b>fuses should be presumed to contain asbestos and disposed</b> of in accordance with SWMS - AUS008 - Removal of Friable Asbestos Containing LV HRC Fuses. |

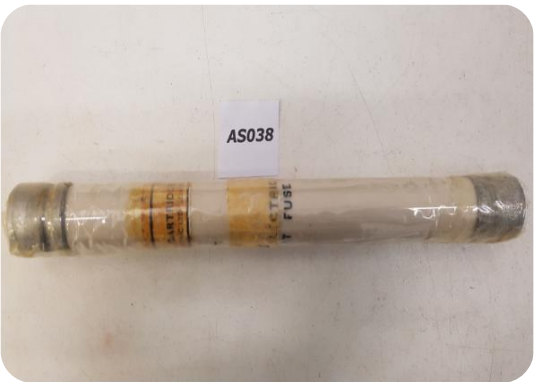
| Manufacturer | Rating | Fuse Body Photographs | Label Markings & Details | Result | Safety Instructions |
|---|---|---|---|---|---|
| EMP | 2 | | N.17, 1.5A, cartridge fuse | <br>No Asbestos found, exercise caution and follow safety instructions | Where no manufacturer or date information can be confirmed and/or the fuse was manufactured prior to 2003, the <b>fuses should be presumed to contain asbestos and disposed</b> of in accordance with SWMS - AUS008 - Removal of Friable Asbestos Containing LV HRC Fuses. |

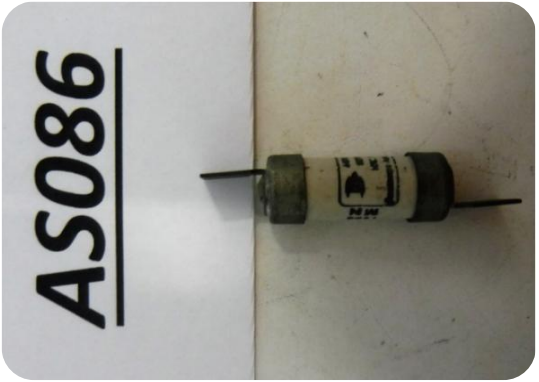
| Manufacturer | Rating | Fuse Body Photographs | Label Markings & Details | Result | Safety Instructions |
|---|---|---|---|---|---|
| EMP | 10 | | MN, 10A, AC5, B.S 88, QFF | <br>Asbestos found | <b>In-Service Fuses:</b><br> If fuse is damaged, cease work and make safe. Contact the Hazmat Hotline - 02 9394 6961.<br> If the fuse is intact, remove the fuse taking care not to damage in accordance with SWMS - AUS008 Removal of Friable Asbestos Containing LV HRC Fuses.<br><b>Stored and Quarantined Fuses:</b><br> Must be disposed of in accordance with SWMS - AUS008 Removal of Friable Asbestos Containing LV HRC Fuses. |

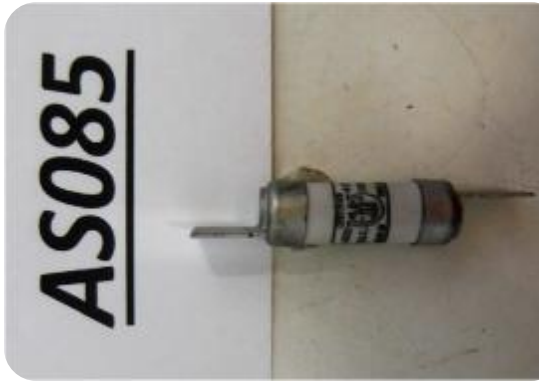
| Manufacturer | Rating | Fuse Body Photographs | Label Markings & Details | Result | Safety Instructions |
|---|---|---|---|---|---|
| EMP | 20 | | 968MN, 20A, AC 5, B.S. 88, QFF | <br>No Asbestos found, exercise caution and follow safety instructions | Where no manufacturer or date information can be confirmed and/or the fuse was manufactured prior to 2003, the <b>fuses should be presumed to contain asbestos and disposed</b> of in accordance with SWMS - AUS008 - Removal of Friable Asbestos Containing LV HRC Fuses. |

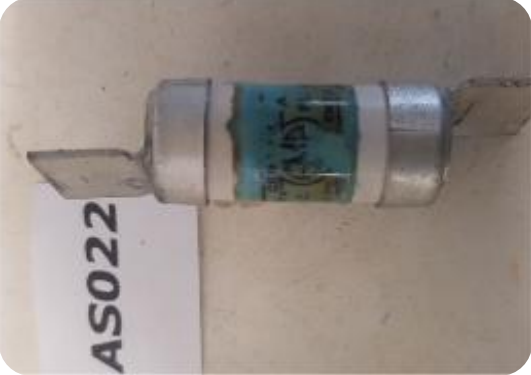
| Manufacturer | Rating | Fuse Body Photographs | Label Markings & Details | Result | Safety Instructions |
|---|---|---|---|---|---|
| EMP | 20 | <br>174102-001-AS022 | MN, 20A, AC5, BS88 | <br>No Asbestos found, exercise caution and follow safety instructions | Where no manufacturer or date information can be confirmed and/or the fuse was manufactured prior to 2003, the <b>fuses should be presumed to contain asbestos and disposed</b> of in accordance with SWMS - AUS008 - Removal of Friable Asbestos Containing LV HRC Fuses. |

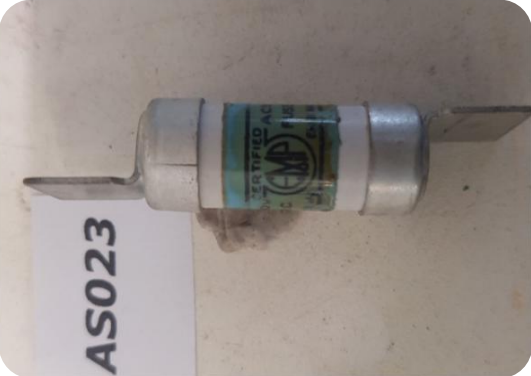
| Manufacturer | Rating | Fuse Body Photographs | Label Markings & Details | Result | Safety Instructions |
|---|---|---|---|---|---|
| EMP | 20 | <br>174102-001-AS023 | MN, 20A, AC5, BS88 | <br>No Asbestos found, exercise caution and follow safety instructions | Where no manufacturer or date information can be confirmed and/or the fuse was manufactured prior to 2003, the <b>fuses should be presumed to contain asbestos and disposed</b> of in accordance with SWMS - AUS008 - Removal of Friable Asbestos Containing LV HRC Fuses. |

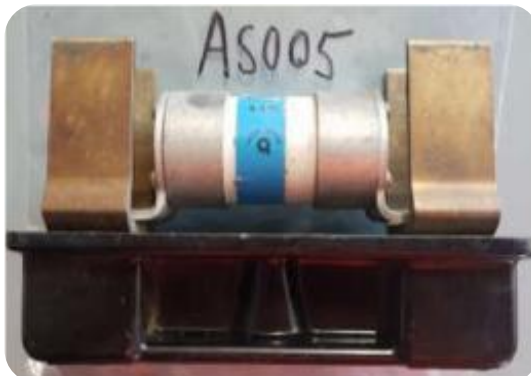
| Manufacturer | Rating | Fuse Body Photographs | Label Markings & Details | Result | Safety Instructions |
|---|---|---|---|---|---|
| EMP | 80 | <br>P033768.003 - AS005 | TYPE ENAA, 80A, AC5,HRC FUSE, BS88, FUSING FACTOR Q | <br>Asbestos found | <b>In-Service Fuses:</b> <ul style="list-style-type: none"> <li> If fuse is damaged, cease work and make safe. Contact the Hazmat Hotline - 02 9394 6961.</li> <li> If the fuse is intact, remove the fuse taking care not to damage in accordance with SWMS - AUS008 Removal of Friable Asbestos Containing LV HRC Fuses.</li> </ul> <b>Stored and Quarantined Fuses:</b> <ul style="list-style-type: none"> <li> Must be disposed of in accordance with SWMS - AUS008 Removal of Friable Asbestos Containing LV HRC Fuses.</li> </ul> |

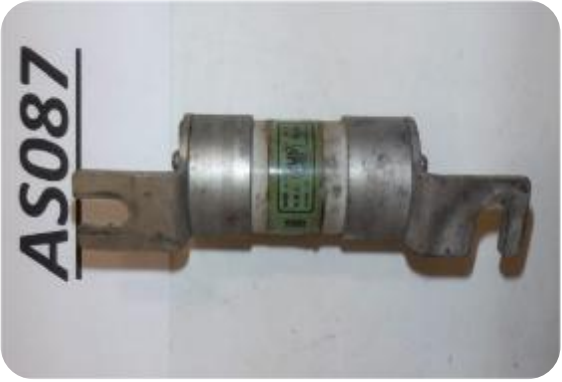
| Manufacturer | Rating | Fuse Body Photographs | Label Markings & Details | Result | Safety Instructions |
|---|---|---|---|---|---|
| EMP | 100 | | ENAA, 100A, AC5, B.S 88, Fusing Factor Q | <br>Asbestos found | <b>In-Service Fuses:</b><br> If fuse is damaged, cease work and make safe. Contact the Hazmat Hotline - 02 9394 6961.<br> If the fuse is intact, remove the fuse taking care not to damage in accordance with SWMS - AUS008 Removal of Friable Asbestos Containing LV HRC Fuses.<br><b>Stored and Quarantined Fuses:</b><br> Must be disposed of in accordance with SWMS - AUS008 Removal of Friable Asbestos Containing LV HRC Fuses. |

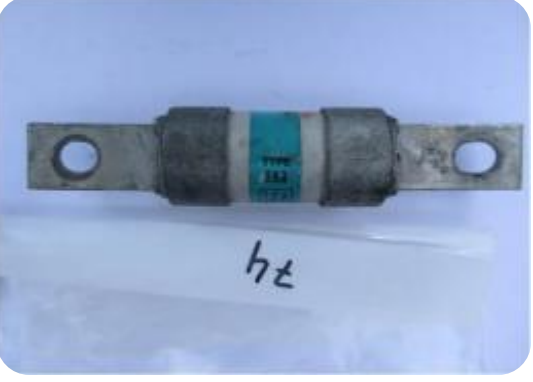
| Manufacturer | Rating | Fuse Body Photographs | Label Markings & Details | Result | Safety Instructions |
|---|---|---|---|---|---|
| EMP | 100 | | AC5 100A BS88 Q | <br>Asbestos found | <b>In-Service Fuses:</b><br> If fuse is damaged, cease work and make safe. Contact the Hazmat Hotline - 02 9394 6961.<br> If the fuse is intact, remove the fuse taking care not to damage in accordance with SWMS - AUS008 Removal of Friable Asbestos Containing LV HRC Fuses.<br><b>Stored and Quarantined Fuses:</b><br> Must be disposed of in accordance with SWMS - AUS008 Removal of Friable Asbestos Containing LV HRC Fuses. |

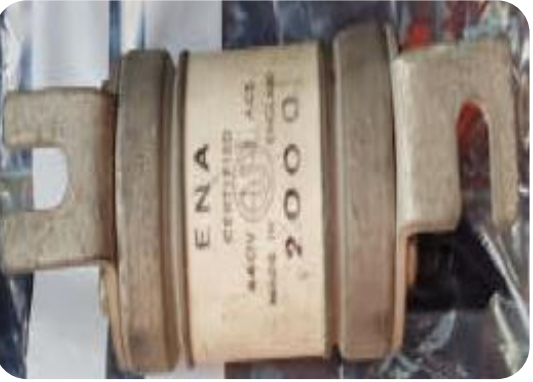
| Manufacturer | Rating | Fuse Body Photographs | Label Markings & Details | Result | Safety Instructions |
|---|---|---|---|---|---|
| EMP | 200 | | ENA 2000, AC5, Fusing Q factor | <br>Asbestos found | <b>In-Service Fuses:</b><br> If fuse is damaged, cease work and make safe. Contact the Hazmat Hotline - 02 9394 6961.<br> If the fuse is intact, remove the fuse taking care not to damage in accordance with SWMS - AUS008 Removal of Friable Asbestos Containing LV HRC Fuses.<br><b>Stored and Quarantined Fuses:</b><br> Must be disposed of in accordance with SWMS - AUS008 Removal of Friable Asbestos Containing LV HRC Fuses. |

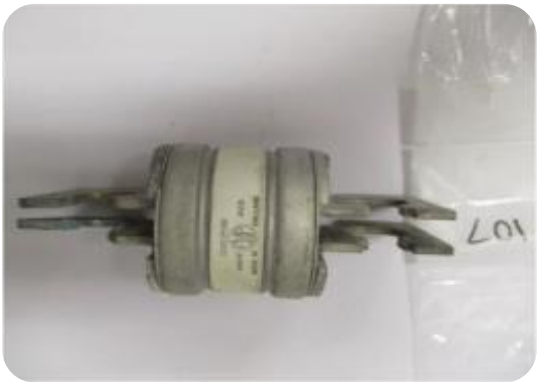
| Manufacturer | Rating | Fuse Body Photographs | Label Markings & Details | Result | Safety Instructions |
|---|---|---|---|---|---|
| EMP | 250 | | AC5 3S/EJB | <br>Asbestos found | <b>In-Service Fuses:</b><br> If fuse is damaged, cease work and make safe. Contact the Hazmat Hotline - 02 9394 6961.<br> If the fuse is intact, remove the fuse taking care not to damage in accordance with SWMS - AUS008 Removal of Friable Asbestos Containing LV HRC Fuses.<br><b>Stored and Quarantined Fuses:</b><br> Must be disposed of in accordance with SWMS - AUS008 Removal of Friable Asbestos Containing LV HRC Fuses. |

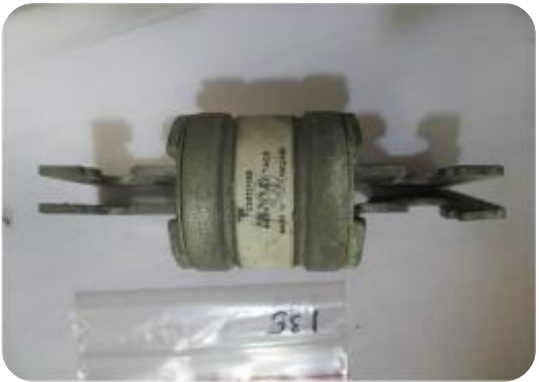
| Manufacturer | Rating | Fuse Body Photographs | Label Markings & Details | Result | Safety Instructions |
|---|---|---|---|---|---|
| EMP | 300 | | 3S/EJB | <br>Asbestos found | <b>In-Service Fuses:</b><br> If fuse is damaged, cease work and make safe. Contact the Hazmat Hotline - 02 9394 6961.<br> If the fuse is intact, remove the fuse taking care not to damage in accordance with SWMS - AUS008 Removal of Friable Asbestos Containing LV HRC Fuses.<br><b>Stored and Quarantined Fuses:</b><br> Must be disposed of in accordance with SWMS - AUS008 Removal of Friable Asbestos Containing LV HRC Fuses. |

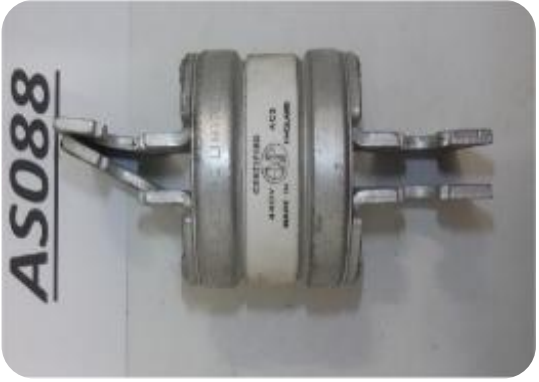
| Manufacturer | Rating | Fuse Body Photographs | Label Markings & Details | Result | Safety Instructions |
|---|---|---|---|---|---|
| EMP | 400 | | 3SVEE, 400A, AC5, Q | <br>Asbestos found | <b>In-Service Fuses:</b><br> If fuse is damaged, cease work and make safe. Contact the Hazmat Hotline - 02 9394 6961.<br> If the fuse is intact, remove the fuse taking care not to damage in accordance with SWMS - AUS008 Removal of Friable Asbestos Containing LV HRC Fuses.<br><b>Stored and Quarantined Fuses:</b><br> Must be disposed of in accordance with SWMS - AUS008 Removal of Friable Asbestos Containing LV HRC Fuses. |

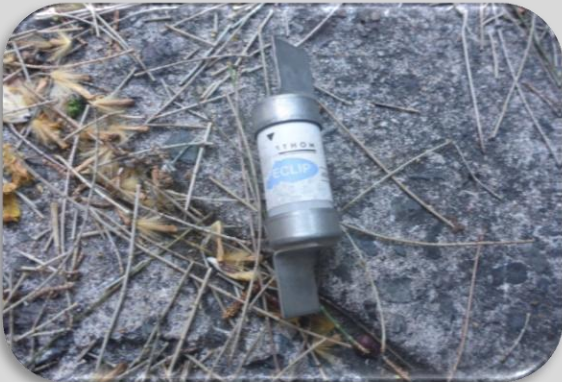
| Manufacturer | Rating | Fuse Body Photographs | Label Markings & Details | Result | Safety Instructions |
|---|---|---|---|---|---|
| EMP Electrical London | 2 | <br>2101006/AS001 | 11kV 2 Amp | <br>Asbestos found | <b>In-Service Fuses:</b><br> If fuse is damaged, cease work and make safe. Contact the Hazmat Hotline - 02 9394 6961.<br> If the fuse is intact, remove the fuse taking care not to damage in accordance with SWMS - AUS008 Removal of Friable Asbestos Containing LV HRC Fuses.<br><b>Stored and Quarantined Fuses:</b><br> Must be disposed of in accordance with SWMS - AUS008 Removal of Friable Asbestos Containing LV HRC Fuses. |

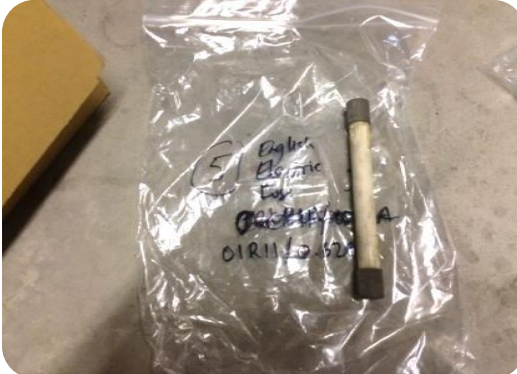
| Manufacturer | Rating | Fuse Body Photographs | Label Markings & Details | Result | Safety Instructions |
|---|---|---|---|---|---|
| English Electric | 0.62 | <br>50753-002-005 | 01R11/ 0.62A | <br>No Asbestos found, exercise caution and follow safety instructions | Where no manufacturer or date information can be confirmed and/or the fuse was manufactured prior to 2003, the <b>fuses should be presumed to contain asbestos and disposed</b> of in accordance with SWMS - AUS008 - Removal of Friable Asbestos Containing LV HRC Fuses. |

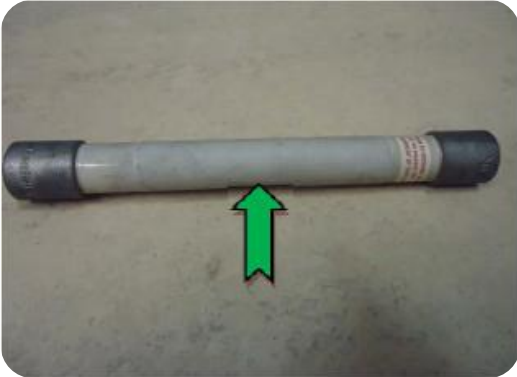
| Manufacturer | Rating | Fuse Body Photographs | Label Markings & Details | Result | Safety Instructions |
|---|---|---|---|---|---|
| English Electric | 0.62 | <br>51378-001-24 | EE OIR 11/0.62A | <br>No Asbestos found, exercise caution and follow safety instructions | <br>Where no manufacturer or date information can be confirmed and/or the fuse was manufactured prior to 2003, the <b>fuses should be presumed to contain asbestos and disposed</b> of in accordance with SWMS - AUS008 - Removal of Friable Asbestos Containing LV HRC Fuses. |

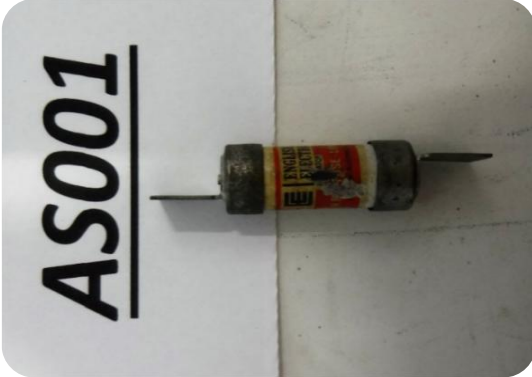
| Manufacturer | Rating | Fuse Body Photographs | Label Markings & Details | Result | Safety Instructions |
|---|---|---|---|---|---|
| English Electric | 2 | <br>168215-1 | NS2, 2A, B.S. 88, AC80, Class Q | <br>Asbestos found | <b>In-Service Fuses:</b><br> If fuse is damaged, cease work and make safe. Contact the Hazmat Hotline - 02 9394 6961.<br> If the fuse is intact, remove the fuse taking care not to damage in accordance with SWMS - AUS008 Removal of Friable Asbestos Containing LV HRC Fuses.<br><b>Stored and Quarantined Fuses:</b><br> Must be disposed of in accordance with SWMS - AUS008 Removal of Friable Asbestos Containing LV HRC Fuses. |

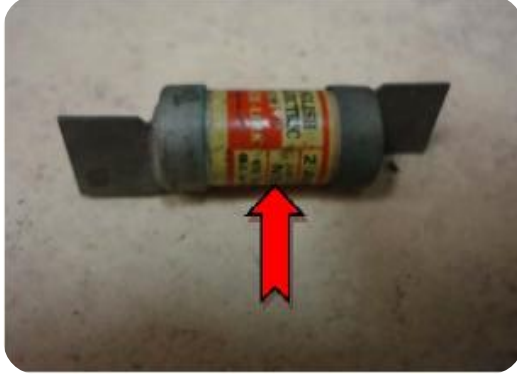
| Manufacturer | Rating | Fuse Body Photographs | Label Markings & Details | Result | Safety Instructions |
|---|---|---|---|---|---|
| English Electric | 2 | <br>5138-001-021 | | <br>Asbestos found | <b>In-Service Fuses:</b><br> If fuse is damaged, cease work and make safe. Contact the Hazmat Hotline - 02 9394 6961.<br> If the fuse is intact, remove the fuse taking care not to damage in accordance with SWMS - AUS008 Removal of Friable Asbestos Containing LV HRC Fuses.<br><b>Stored and Quarantined Fuses:</b><br> Must be disposed of in accordance with SWMS - AUS008 Removal of Friable Asbestos Containing LV HRC Fuses. |

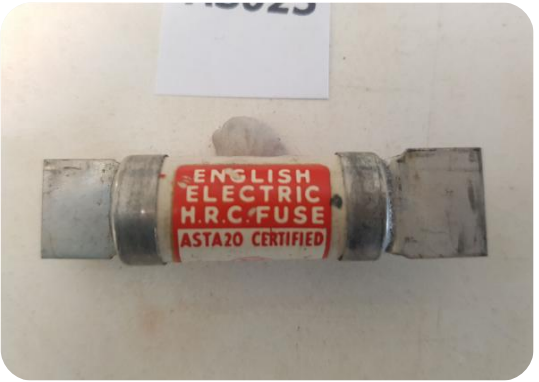
| Manufacturer | Rating | Fuse Body Photographs | Label Markings & Details | Result | Safety Instructions |
|---|---|---|---|---|---|
| English Electric | 4 | | NS4, 4A, BS88, AC5 | <br>Asbestos found | <b>In-Service Fuses:</b><br> If fuse is damaged, cease work and make safe. Contact the Hazmat Hotline - 02 9394 6961.<br> If the fuse is intact, remove the fuse taking care not to damage in accordance with SWMS - AUS008 Removal of Friable Asbestos Containing LV HRC Fuses.<br><b>Stored and Quarantined Fuses:</b><br> Must be disposed of in accordance with SWMS - AUS008 Removal of Friable Asbestos Containing LV HRC Fuses. |

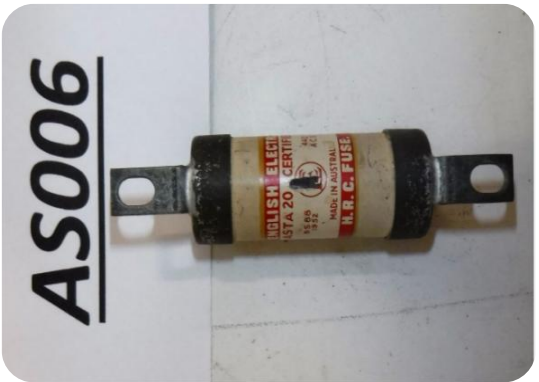
| Manufacturer | Rating | Fuse Body Photographs | Label Markings & Details | Result | Safety Instructions |
|---|---|---|---|---|---|
| English Electric | 10 | | TIA10, 10A, B.S.88, AC5 | <br>Asbestos found | <b>In-Service Fuses:</b><br> If fuse is damaged, cease work and make safe. Contact the Hazmat Hotline - 02 9394 6961.<br> If the fuse is intact, remove the fuse taking care not to damage in accordance with SWMS - AUS008 Removal of Friable Asbestos Containing LV HRC Fuses.<br><b>Stored and Quarantined Fuses:</b><br> Must be disposed of in accordance with SWMS - AUS008 Removal of Friable Asbestos Containing LV HRC Fuses. |

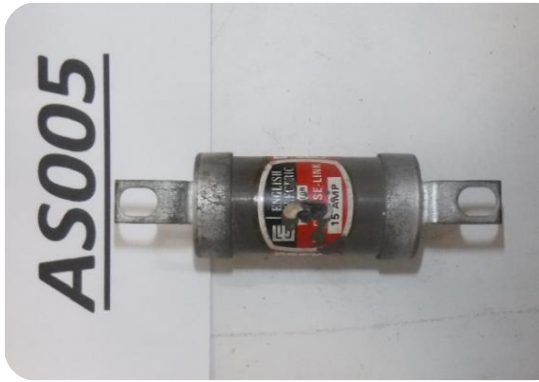
| Manufacturer | Rating | Fuse Body Photographs | Label Markings & Details | Result | Safety Instructions |
|---|---|---|---|---|---|
| English Electric | 15 | | TIA15, 15A, B.S.88, AC 80, Class Q1 | <br>Asbestos found | <b>In-Service Fuses:</b><br> If fuse is damaged, cease work and make safe. Contact the Hazmat Hotline - 02 9394 6961.<br> If the fuse is intact, remove the fuse taking care not to damage in accordance with SWMS - AUS008 Removal of Friable Asbestos Containing LV HRC Fuses.<br><b>Stored and Quarantined Fuses:</b><br> Must be disposed of in accordance with SWMS - AUS008 Removal of Friable Asbestos Containing LV HRC Fuses. |
