## Network Standard

Document No : NW000-S0161

NS211 ANNEXURE G – LV HRC FUSE ASBESTOS PRODUCT GUIDE

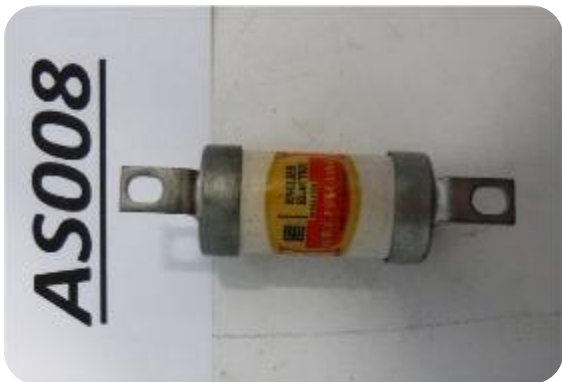
| Manufacturer | Rating | Fuse Body Photographs | Label Markings & Details | Result | Safety Instructions |
|---|---|---|---|---|---|
| English Electric | 15 | | TIA15, 15A, B.S.88, AC 80, Class Q1 | <br>Asbestos found | <b>In-Service Fuses:</b><br> If fuse is damaged, cease work and make safe. Contact the Hazmat Hotline - 02 9394 6961.<br> If the fuse is intact, remove the fuse taking care not to damage in accordance with SWMS - AUS008 Removal of Friable Asbestos Containing LV HRC Fuses.<br><b>Stored and Quarantined Fuses:</b><br> Must be disposed of in accordance with SWMS - AUS008 Removal of Friable Asbestos Containing LV HRC Fuses. |

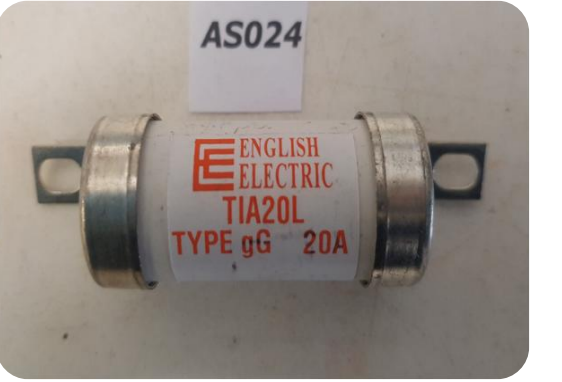
| Manufacturer | Rating | Fuse Body Photographs | Label Markings & Details | Result | Safety Instructions |
|---|---|---|---|---|---|
| English Electric | 20 | | TIA20L, type gG, 20A, BS88:2:1988, 80kA, AS2005.21.2 | <br>No Asbestos found, exercise caution and follow safety instructions | Where no manufacturer or date information can be confirmed and/or the fuse was manufactured prior to 2003, the <b>fuses should be presumed to contain asbestos and disposed</b> of in accordance with SWMS - AUS008 - Removal of Friable Asbestos Containing LV HRC Fuses. |

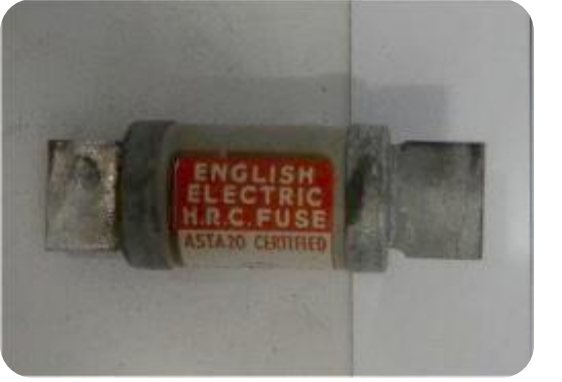
| Manufacturer | Rating | Fuse Body Photographs | Label Markings & Details | Result | Safety Instructions |
|---|---|---|---|---|---|
| English Electric | 20 | | NS20, 20A, B.S.88, AC5 | <br>Asbestos found | <b>In-Service Fuses:</b><br> If fuse is damaged, cease work and make safe. Contact the Hazmat Hotline - 02 9394 6961.<br> If the fuse is intact, remove the fuse taking care not to damage in accordance with SWMS - AUS008 Removal of Friable Asbestos Containing LV HRC Fuses.<br><b>Stored and Quarantined Fuses:</b><br> Must be disposed of in accordance with SWMS - AUS008 Removal of Friable Asbestos Containing LV HRC Fuses. |

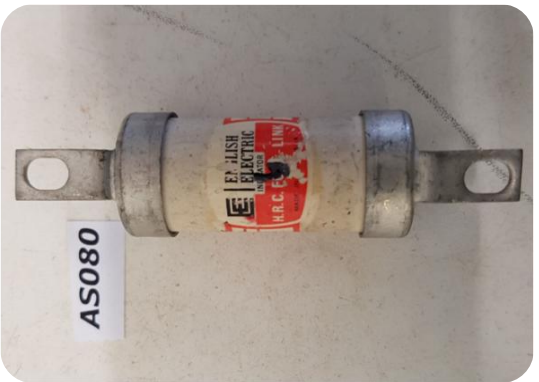
| Manufacturer | Rating | Fuse Body Photographs | Label Markings & Details | Result | Safety Instructions |
|---|---|---|---|---|---|
| English Electric | 20 | <p>AS080</p> <p>174783-001-AS080</p> | TIA 20, 20A, Indicator, AC80, BS88:1967, Class Q1, Asta 20 certified | <br>Asbestos found | <b>In-Service Fuses:</b><br> If fuse is damaged, cease work and make safe. Contact the Hazmat Hotline - 02 9394 6961.<br> If the fuse is intact, remove the fuse taking care not to damage in accordance with SWMS - AUS008 Removal of Friable Asbestos Containing LV HRC Fuses.<br><b>Stored and Quarantined Fuses:</b><br> Must be disposed of in accordance with SWMS - AUS008 Removal of Friable Asbestos Containing LV HRC Fuses. |

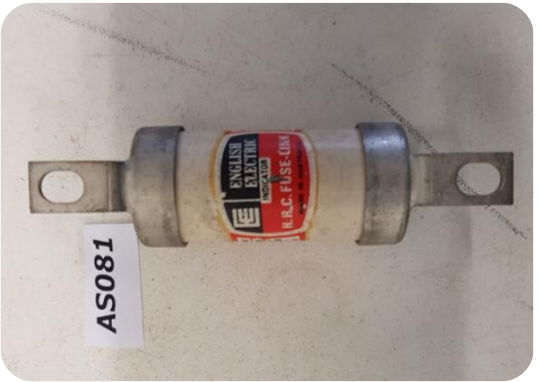
| Manufacturer | Rating | Fuse Body Photographs | Label Markings & Details | Result | Safety Instructions |
|---|---|---|---|---|---|
| English Electric | 20 | <p>AS081</p> <p>174783-001-AS081</p> | TIA 20, 20A, Indicator, AC80, BS88:1967, Class Q1, Asta 20 certified | <br>Asbestos found | <b>In-Service Fuses:</b><br> If fuse is damaged, cease work and make safe. Contact the Hazmat Hotline - 02 9394 6961.<br> If the fuse is intact, remove the fuse taking care not to damage in accordance with SWMS - AUS008 Removal of Friable Asbestos Containing LV HRC Fuses.<br><b>Stored and Quarantined Fuses:</b><br> Must be disposed of in accordance with SWMS - AUS008 Removal of Friable Asbestos Containing LV HRC Fuses. |

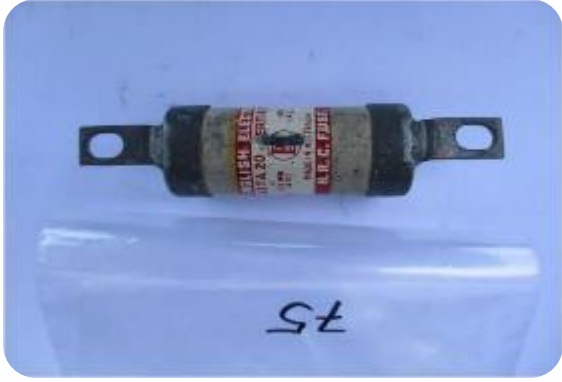
| Manufacturer | Rating | Fuse Body Photographs | Label Markings & Details | Result | Safety Instructions |
|---|---|---|---|---|---|
| English Electric | 25 | <p>AS4287</p> <p>54287-001-075</p> | TIA25 25A | <br>Asbestos found | <b>In-Service Fuses:</b><br> If fuse is damaged, cease work and make safe. Contact the Hazmat Hotline - 02 9394 6961.<br> If the fuse is intact, remove the fuse taking care not to damage in accordance with SWMS - AUS008 Removal of Friable Asbestos Containing LV HRC Fuses.<br><b>Stored and Quarantined Fuses:</b><br> Must be disposed of in accordance with SWMS - AUS008 Removal of Friable Asbestos Containing LV HRC Fuses. |

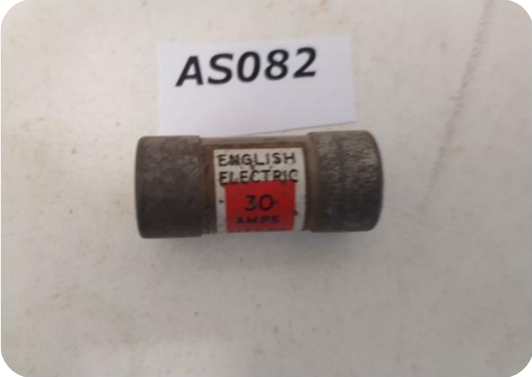
| Manufacturer | Rating | Fuse Body Photographs | Label Markings & Details | Result | Safety Instructions |
|---|---|---|---|---|---|
| English Electric | 30 | <br>174783-001-AS082 | D3030, 30A, Asta certified, BS1361 | <br>Asbestos found | <b>In-Service Fuses:</b><br> If fuse is damaged, cease work and make safe. Contact the Hazmat Hotline - 02 9394 6961.<br> If the fuse is intact, remove the fuse taking care not to damage in accordance with SWMS - AUS008 Removal of Friable Asbestos Containing LV HRC Fuses.<br><b>Stored and Quarantined Fuses:</b><br> Must be disposed of in accordance with SWMS - AUS008 Removal of Friable Asbestos Containing LV HRC Fuses. |

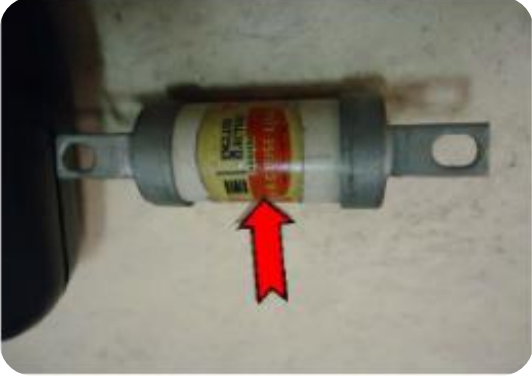
| Manufacturer | Rating | Fuse Body Photographs | Label Markings & Details | Result | Safety Instructions |
|---|---|---|---|---|---|
| English Electric | 30 | <br>51378-001-22 | | <br>Asbestos found | <b>In-Service Fuses:</b><br> If fuse is damaged, cease work and make safe. Contact the Hazmat Hotline - 02 9394 6961.<br> If the fuse is intact, remove the fuse taking care not to damage in accordance with SWMS - AUS008 Removal of Friable Asbestos Containing LV HRC Fuses.<br><b>Stored and Quarantined Fuses:</b><br> Must be disposed of in accordance with SWMS - AUS008 Removal of Friable Asbestos Containing LV HRC Fuses. |

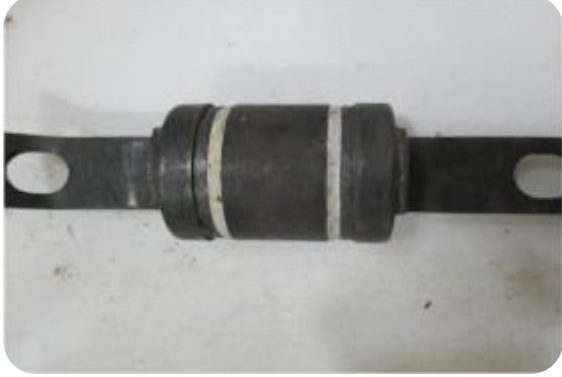
| Manufacturer | Rating | Fuse Body Photographs | Label Markings & Details | Result | Safety Instructions |
|---|---|---|---|---|---|
| English Electric | 30 | <br>54287-001-030 | 232TK 30A | <br>Asbestos found | <b>In-Service Fuses:</b><br> If fuse is damaged, cease work and make safe. Contact the Hazmat Hotline - 02 9394 6961.<br> If the fuse is intact, remove the fuse taking care not to damage in accordance with SWMS - AUS008 Removal of Friable Asbestos Containing LV HRC Fuses.<br><b>Stored and Quarantined Fuses:</b><br> Must be disposed of in accordance with SWMS - AUS008 Removal of Friable Asbestos Containing LV HRC Fuses. |

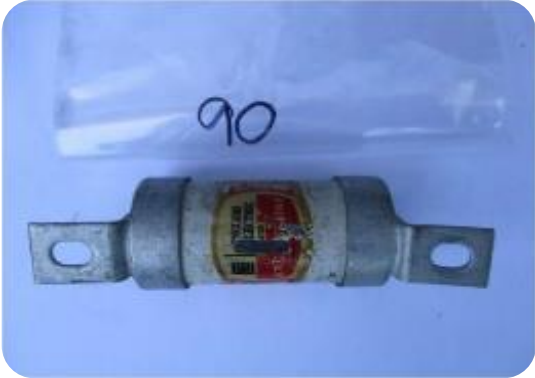
| Manufacturer | Rating | Fuse Body Photographs | Label Markings & Details | Result | Safety Instructions |
|---|---|---|---|---|---|
| English Electric | 35 | | TIS35<br>54287-001-090 | <br>No Asbestos found, exercise caution and follow safety instructions | <br>Where no manufacturer or date information can be confirmed and/or the fuse was manufactured prior to 2003, the <b>fuses should be presumed to contain asbestos and disposed</b> of in accordance with SWMS - AUS008 - Removal of Friable Asbestos Containing LV HRC Fuses. |

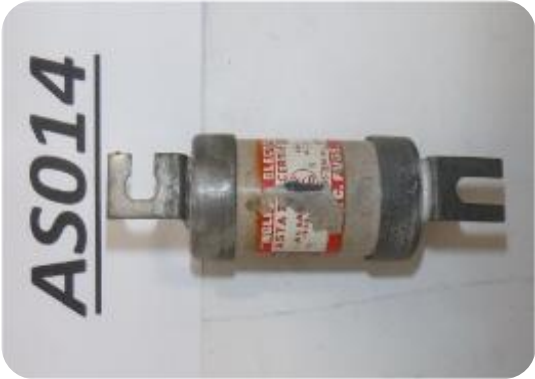
| Manufacturer | Rating | Fuse Body Photographs | Label Markings & Details | Result | Safety Instructions |
|---|---|---|---|---|---|
| English Electric | 35 | | TIS35, 35A, B.S.88, AC4<br>168215-14 | <br>Asbestos found | <b>In-Service Fuses:</b><br> If fuse is damaged, cease work and make safe. Contact the Hazmat Hotline - 02 9394 6961.<br> If the fuse is intact, remove the fuse taking care not to damage in accordance with SWMS - AUS008 Removal of Friable Asbestos Containing LV HRC Fuses.<br><b>Stored and Quarantined Fuses:</b><br> Must be disposed of in accordance with SWMS - AUS008 Removal of Friable Asbestos Containing LV HRC Fuses. |

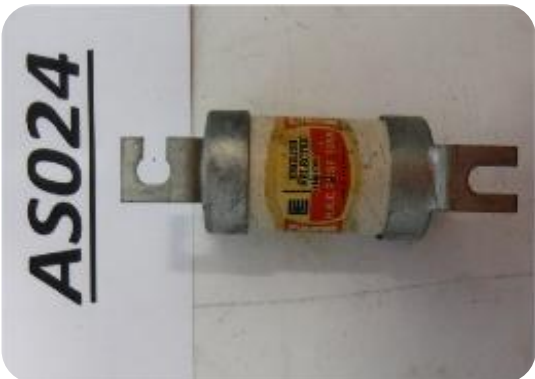
| Manufacturer | Rating | Fuse Body Photographs | Label Markings & Details | Result | Safety Instructions |
|---|---|---|---|---|---|
| English Electric | 35 | | TIS35, 35A, B.S.88, AC80, Class Q1<br>168215-24 | <br>Asbestos found | <b>In-Service Fuses:</b><br> If fuse is damaged, cease work and make safe. Contact the Hazmat Hotline - 02 9394 6961.<br> If the fuse is intact, remove the fuse taking care not to damage in accordance with SWMS - AUS008 Removal of Friable Asbestos Containing LV HRC Fuses.<br><b>Stored and Quarantined Fuses:</b><br> Must be disposed of in accordance with SWMS - AUS008 Removal of Friable Asbestos Containing LV HRC Fuses. |

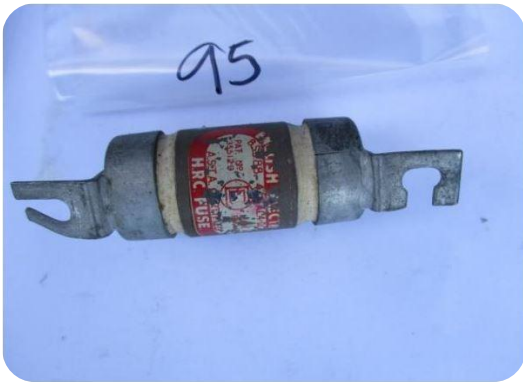
| Manufacturer | Rating | Fuse Body Photographs | Label Markings & Details | Result | Safety Instructions |
|---|---|---|---|---|---|
| English Electric | 35 | | TIS35A<br><small>54287-001-095</small> | <br>Asbestos found | <b>In-Service Fuses:</b><br>☒ If fuse is damaged, cease work and make safe. Contact the Hazmat Hotline - 02 9394 6961.<br>☒ If the fuse is intact, remove the fuse taking care not to damage in accordance with SWMS - AUS008 Removal of Friable Asbestos Containing LV HRC Fuses.<br><b>Stored and Quarantined Fuses:</b><br>☒ Must be disposed of in accordance with SWMS - AUS008 Removal of Friable Asbestos Containing LV HRC Fuses. |

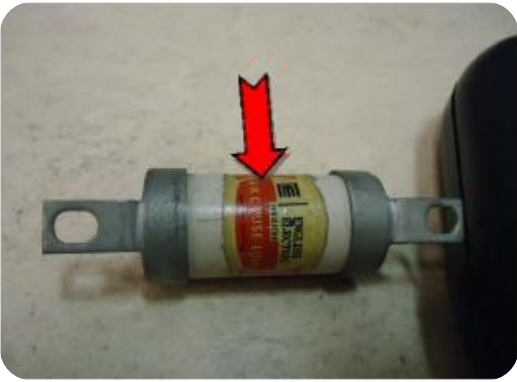
| Manufacturer | Rating | Fuse Body Photographs | Label Markings & Details | Result | Safety Instructions |
|---|---|---|---|---|---|
| English Electric | 35 | | <small>51378-001-23</small> | <br>Asbestos found | <b>In-Service Fuses:</b><br>☒ If fuse is damaged, cease work and make safe. Contact the Hazmat Hotline - 02 9394 6961.<br>☒ If the fuse is intact, remove the fuse taking care not to damage in accordance with SWMS - AUS008 Removal of Friable Asbestos Containing LV HRC Fuses.<br><b>Stored and Quarantined Fuses:</b><br>☒ Must be disposed of in accordance with SWMS - AUS008 Removal of Friable Asbestos Containing LV HRC Fuses. |

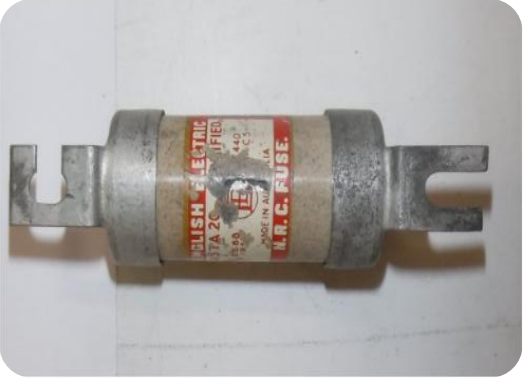
| Manufacturer | Rating | Fuse Body Photographs | Label Markings & Details | Result | Safety Instructions |
|---|---|---|---|---|---|
| English Electric | 35 | | TIS35, 35 A, B.S.88, AC5<br><small>168215-2</small> | <br>Asbestos found | <b>In-Service Fuses:</b><br>☒ If fuse is damaged, cease work and make safe. Contact the Hazmat Hotline - 02 9394 6961.<br>☒ If the fuse is intact, remove the fuse taking care not to damage in accordance with SWMS - AUS008 Removal of Friable Asbestos Containing LV HRC Fuses.<br><b>Stored and Quarantined Fuses:</b><br>☒ Must be disposed of in accordance with SWMS - AUS008 Removal of Friable Asbestos Containing LV HRC Fuses. |

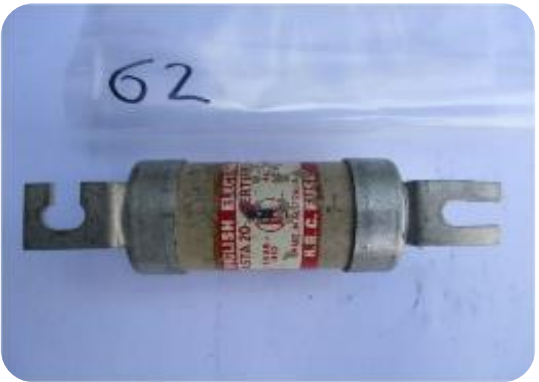
| Manufacturer | Rating | Fuse Body Photographs | Label Markings & Details | Result | Safety Instructions |
|---|---|---|---|---|---|
| English Electric | 35 | | 440 | <br>Asbestos found | <b>In-Service Fuses:</b><br> If fuse is damaged, cease work and make safe. Contact the Hazmat Hotline - 02 9394 6961.<br> If the fuse is intact, remove the fuse taking care not to damage in accordance with SWMS - AUS008 Removal of Friable Asbestos Containing LV HRC Fuses.<br><b>Stored and Quarantined Fuses:</b><br> Must be disposed of in accordance with SWMS - AUS008 Removal of Friable Asbestos Containing LV HRC Fuses. |

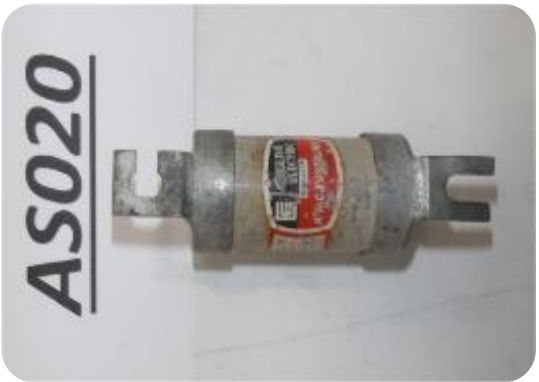
| Manufacturer | Rating | Fuse Body Photographs | Label Markings & Details | Result | Safety Instructions |
|---|---|---|---|---|---|
| English Electric | 40 | | TIS40, 40A, B.S.88, AC80, Class Q1 | <br>Asbestos found | <b>In-Service Fuses:</b><br> If fuse is damaged, cease work and make safe. Contact the Hazmat Hotline - 02 9394 6961.<br> If the fuse is intact, remove the fuse taking care not to damage in accordance with SWMS - AUS008 Removal of Friable Asbestos Containing LV HRC Fuses.<br><b>Stored and Quarantined Fuses:</b><br> Must be disposed of in accordance with SWMS - AUS008 Removal of Friable Asbestos Containing LV HRC Fuses. |

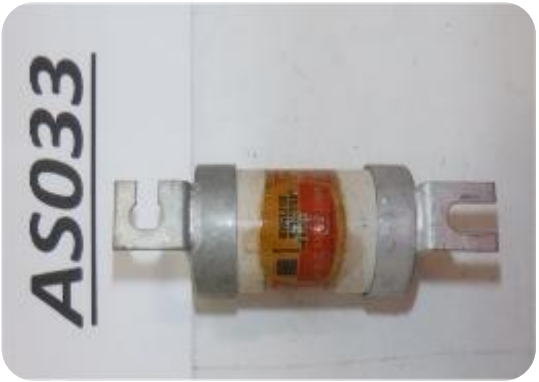
| Manufacturer | Rating | Fuse Body Photographs | Label Markings & Details | Result | Safety Instructions |
|---|---|---|---|---|---|
| English Electric | 40 | | TIS40, 40A, B.S.88, AC80, Class Q1 | <br>Asbestos found | <b>In-Service Fuses:</b><br> If fuse is damaged, cease work and make safe. Contact the Hazmat Hotline - 02 9394 6961.<br> If the fuse is intact, remove the fuse taking care not to damage in accordance with SWMS - AUS008 Removal of Friable Asbestos Containing LV HRC Fuses.<br><b>Stored and Quarantined Fuses:</b><br> Must be disposed of in accordance with SWMS - AUS008 Removal of Friable Asbestos Containing LV HRC Fuses. |

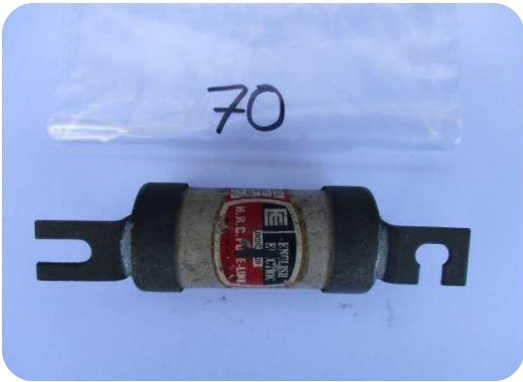
| Manufacturer | Rating | Fuse Body Photographs | Label Markings & Details | Result | Safety Instructions |
|---|---|---|---|---|---|
| English Electric | 40 | | TIS40<br>54287-001-070 | <br>Asbestos found | <b>In-Service Fuses:</b><br>☒ If fuse is damaged, cease work and make safe. Contact the Hazmat Hotline - 02 9394 6961.<br>☒ If the fuse is intact, remove the fuse taking care not to damage in accordance with SWMS - AUS008 Removal of Friable Asbestos Containing LV HRC Fuses.<br><b>Stored and Quarantined Fuses:</b><br>☒ Must be disposed of in accordance with SWMS - AUS008 Removal of Friable Asbestos Containing LV HRC Fuses. |

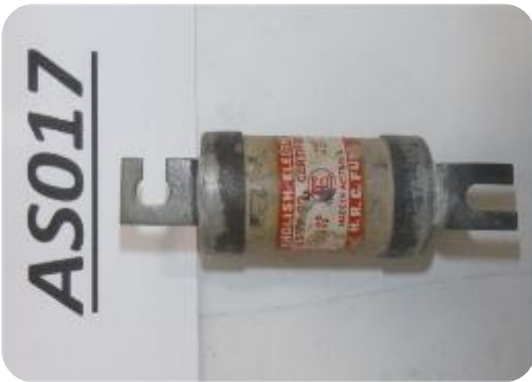
| Manufacturer | Rating | Fuse Body Photographs | Label Markings & Details | Result | Safety Instructions |
|---|---|---|---|---|---|
| English Electric | 50 | | TIS50, 50A, B.S.88, AC5<br>168215-17 | <br>Asbestos found | <b>In-Service Fuses:</b><br>☒ If fuse is damaged, cease work and make safe. Contact the Hazmat Hotline - 02 9394 6961.<br>☒ If the fuse is intact, remove the fuse taking care not to damage in accordance with SWMS - AUS008 Removal of Friable Asbestos Containing LV HRC Fuses.<br><b>Stored and Quarantined Fuses:</b><br>☒ Must be disposed of in accordance with SWMS - AUS008 Removal of Friable Asbestos Containing LV HRC Fuses. |

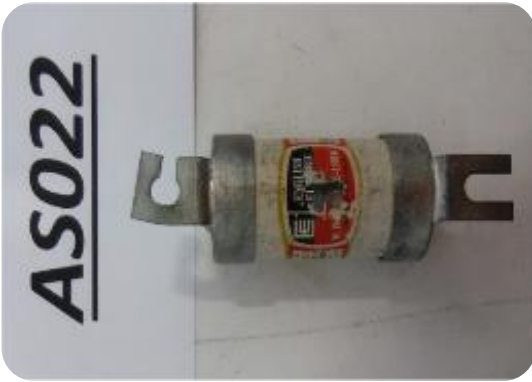
| Manufacturer | Rating | Fuse Body Photographs | Label Markings & Details | Result | Safety Instructions |
|---|---|---|---|---|---|
| English Electric | 50 | | TIS50, 50A, B.S.88, AC80, Class Q1<br>168215-22 | <br>Asbestos found | <b>In-Service Fuses:</b><br>☒ If fuse is damaged, cease work and make safe. Contact the Hazmat Hotline - 02 9394 6961.<br>☒ If the fuse is intact, remove the fuse taking care not to damage in accordance with SWMS - AUS008 Removal of Friable Asbestos Containing LV HRC Fuses.<br><b>Stored and Quarantined Fuses:</b><br>☒ Must be disposed of in accordance with SWMS - AUS008 Removal of Friable Asbestos Containing LV HRC Fuses. |

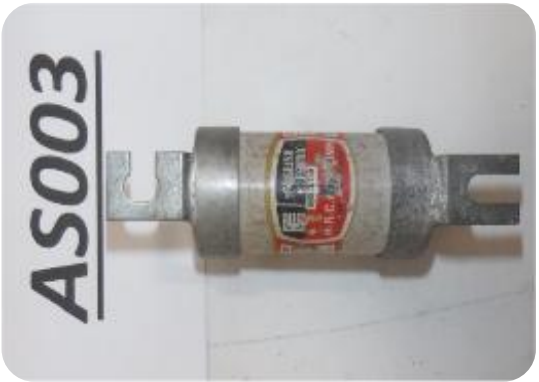
| Manufacturer | Rating | Fuse Body Photographs | Label Markings & Details | Result | Safety Instructions |
|---|---|---|---|---|---|
| English Electric | 50 | | TIS50, 50A, B.S.88, AC80, CLASS Q | <br>Asbestos found | <b>In-Service Fuses:</b><br> If fuse is damaged, cease work and make safe. Contact the Hazmat Hotline - 02 9394 6961.<br> If the fuse is intact, remove the fuse taking care not to damage in accordance with SWMS - AUS008 Removal of Friable Asbestos Containing LV HRC Fuses.<br><b>Stored and Quarantined Fuses:</b><br> Must be disposed of in accordance with SWMS - AUS008 Removal of Friable Asbestos Containing LV HRC Fuses. |

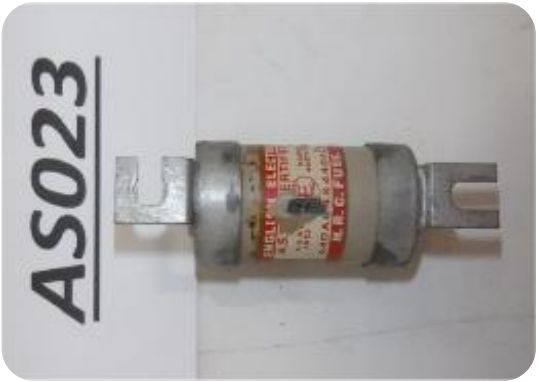
| Manufacturer | Rating | Fuse Body Photographs | Label Markings & Details | Result | Safety Instructions |
|---|---|---|---|---|---|
| English Electric | 60 | | TIS60, 60A, B.S.88, AC4 & AC5 | <br>Asbestos found | <b>In-Service Fuses:</b><br> If fuse is damaged, cease work and make safe. Contact the Hazmat Hotline - 02 9394 6961.<br> If the fuse is intact, remove the fuse taking care not to damage in accordance with SWMS - AUS008 Removal of Friable Asbestos Containing LV HRC Fuses.<br><b>Stored and Quarantined Fuses:</b><br> Must be disposed of in accordance with SWMS - AUS008 Removal of Friable Asbestos Containing LV HRC Fuses. |

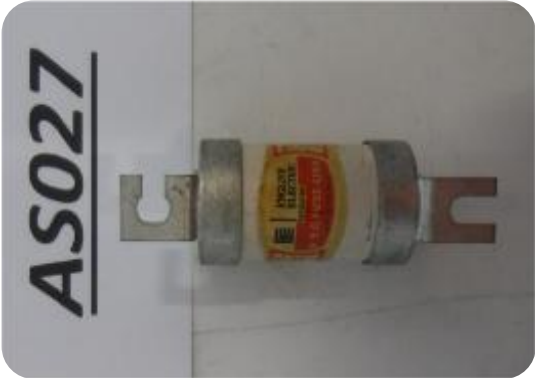
| Manufacturer | Rating | Fuse Body Photographs | Label Markings & Details | Result | Safety Instructions |
|---|---|---|---|---|---|
| English Electric | 60 | | TIS60, 60A, B.S.88, AC80, Class Q1<br>168215-27 | <br>Asbestos found | <b>In-Service Fuses:</b><br> If fuse is damaged, cease work and make safe. Contact the Hazmat Hotline - 02 9394 6961.<br> If the fuse is intact, remove the fuse taking care not to damage in accordance with SWMS - AUS008 Removal of Friable Asbestos Containing LV HRC Fuses.<br><b>Stored and Quarantined Fuses:</b><br> Must be disposed of in accordance with SWMS - AUS008 Removal of Friable Asbestos Containing LV HRC Fuses. |

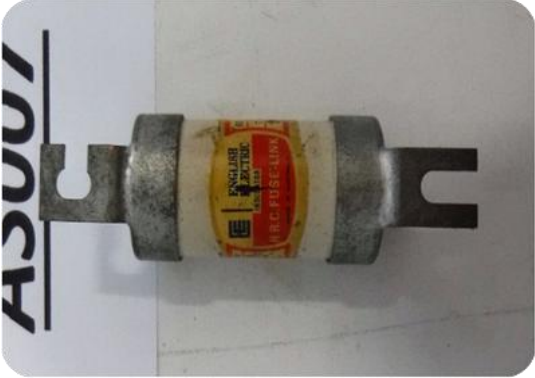
| Manufacturer | Rating | Fuse Body Photographs | Label Markings & Details | Result | Safety Instructions |
|---|---|---|---|---|---|
| English Electric | 60 | | TIS60, 60A, B.S.88, AC80, Class Q1<br>168215-7 | <br>Asbestos found | <b>In-Service Fuses:</b><br> If fuse is damaged, cease work and make safe. Contact the Hazmat Hotline - 02 9394 6961.<br> If the fuse is intact, remove the fuse taking care not to damage in accordance with SWMS - AUS008 Removal of Friable Asbestos Containing LV HRC Fuses.<br><b>Stored and Quarantined Fuses:</b><br> Must be disposed of in accordance with SWMS - AUS008 Removal of Friable Asbestos Containing LV HRC Fuses. |

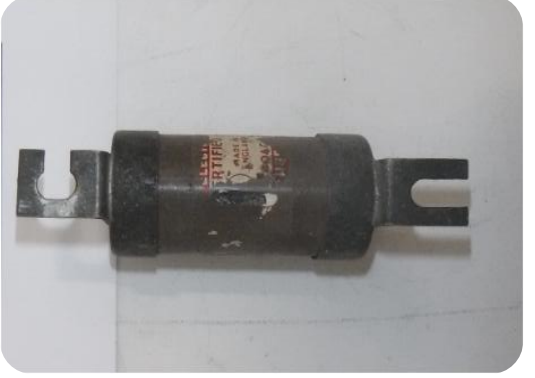
| Manufacturer | Rating | Fuse Body Photographs | Label Markings & Details | Result | Safety Instructions |
|---|---|---|---|---|---|
| English Electric | 60 | | TIS60, 60A<br>168215-11 | <br>Asbestos found | <b>In-Service Fuses:</b><br> If fuse is damaged, cease work and make safe. Contact the Hazmat Hotline - 02 9394 6961.<br> If the fuse is intact, remove the fuse taking care not to damage in accordance with SWMS - AUS008 Removal of Friable Asbestos Containing LV HRC Fuses.<br><b>Stored and Quarantined Fuses:</b><br> Must be disposed of in accordance with SWMS - AUS008 Removal of Friable Asbestos Containing LV HRC Fuses. |

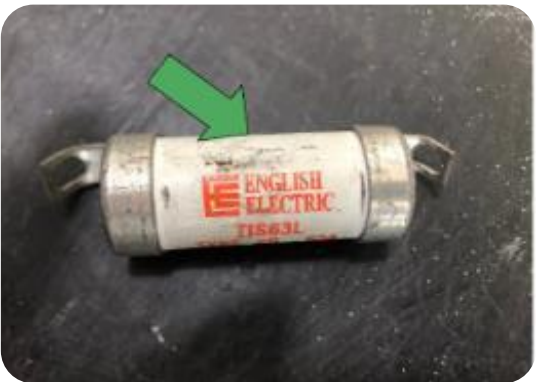
| Manufacturer | Rating | Fuse Body Photographs | Label Markings & Details | Result | Safety Instructions |
|---|---|---|---|---|---|
| English Electric | 63 | | English Electric TIS63L/TYPE gG 63A<br>754-SYDEN202874-AS18 | <br>No Asbestos found, exercise caution and follow safety instructions | Where no manufacturer or date information can be confirmed and/or the fuse was manufactured prior to 2003, the <b>fuses should be presumed to contain asbestos and disposed</b> of in accordance with SWMS - AUS008 - Removal of Friable Asbestos Containing LV HRC Fuses. |

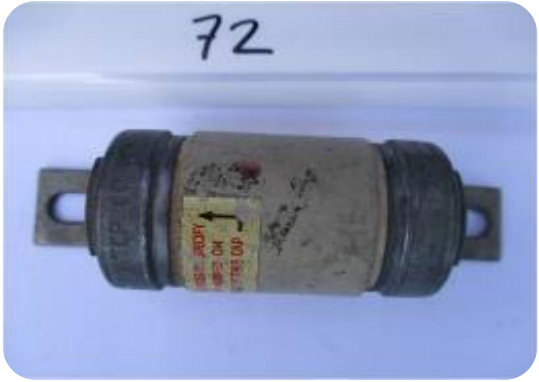
| Manufacturer | Rating | Fuse Body Photographs | Label Markings & Details | Result | Safety Instructions |
|---|---|---|---|---|---|
| English Electric | 80 | | TCP 80A<br>54287-001-072 | <br>Asbestos found | <b>In-Service Fuses:</b><br> If fuse is damaged, cease work and make safe. Contact the Hazmat Hotline - 02 9394 6961.<br> If the fuse is intact, remove the fuse taking care not to damage in accordance with SWMS - AUS008 Removal of Friable Asbestos Containing LV HRC Fuses.<br><b>Stored and Quarantined Fuses:</b><br> Must be disposed of in accordance with SWMS - AUS008 Removal of Friable Asbestos Containing LV HRC Fuses. |

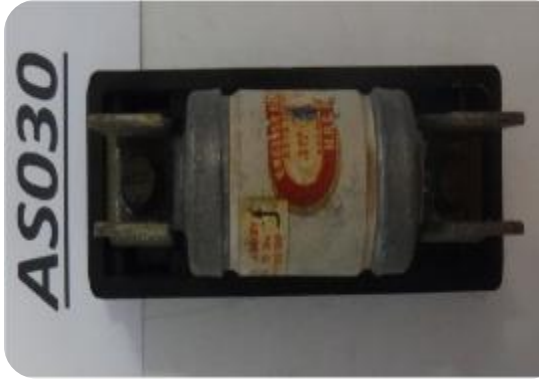
| Manufacturer | Rating | Fuse Body Photographs | Label Markings & Details | Result | Safety Instructions |
|---|---|---|---|---|---|
| English Electric | 100 | | 581C, 100A, B.S.88, AC4 & AC6<br>168215-30 | <br>Asbestos found | <b>In-Service Fuses:</b><br> If fuse is damaged, cease work and make safe. Contact the Hazmat Hotline - 02 9394 6961.<br> If the fuse is intact, remove the fuse taking care not to damage in accordance with SWMS - AUS008 Removal of Friable Asbestos Containing LV HRC Fuses.<br><b>Stored and Quarantined Fuses:</b><br> Must be disposed of in accordance with SWMS - AUS008 Removal of Friable Asbestos Containing LV HRC Fuses. |

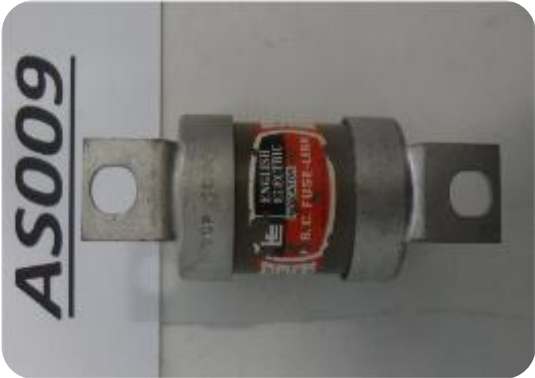
| Manufacturer | Rating | Fuse Body Photographs | Label Markings & Details | Result | Safety Instructions |
|---|---|---|---|---|---|
| English Electric | 100 | | TCP, 100A, B.S.88, AC80, Class Q1 | <br>Asbestos found | <b>In-Service Fuses:</b><br> If fuse is damaged, cease work and make safe. Contact the Hazmat Hotline - 02 9394 6961.<br> If the fuse is intact, remove the fuse taking care not to damage in accordance with SWMS - AUS008 Removal of Friable Asbestos Containing LV HRC Fuses.<br><b>Stored and Quarantined Fuses:</b><br> Must be disposed of in accordance with SWMS - AUS008 Removal of Friable Asbestos Containing LV HRC Fuses. |

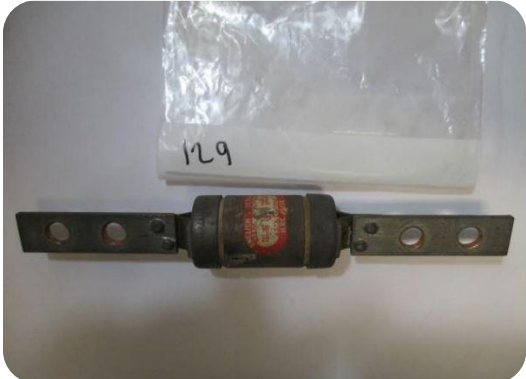
| Manufacturer | Rating | Fuse Body Photographs | Label Markings & Details | Result | Safety Instructions |
|---|---|---|---|---|---|
| English Electric | 100 | | 5 8 TC 100A | <br>Asbestos found | <b>In-Service Fuses:</b><br> If fuse is damaged, cease work and make safe. Contact the Hazmat Hotline - 02 9394 6961.<br> If the fuse is intact, remove the fuse taking care not to damage in accordance with SWMS - AUS008 Removal of Friable Asbestos Containing LV HRC Fuses.<br><b>Stored and Quarantined Fuses:</b><br> Must be disposed of in accordance with SWMS - AUS008 Removal of Friable Asbestos Containing LV HRC Fuses. |

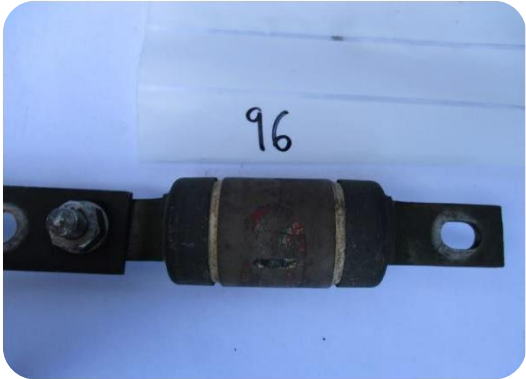
| Manufacturer | Rating | Fuse Body Photographs | Label Markings & Details | Result | Safety Instructions |
|---|---|---|---|---|---|
| English Electric | 100 | | TC100A | <br>Asbestos found | <b>In-Service Fuses:</b><br> If fuse is damaged, cease work and make safe. Contact the Hazmat Hotline - 02 9394 6961.<br> If the fuse is intact, remove the fuse taking care not to damage in accordance with SWMS - AUS008 Removal of Friable Asbestos Containing LV HRC Fuses.<br><b>Stored and Quarantined Fuses:</b><br> Must be disposed of in accordance with SWMS - AUS008 Removal of Friable Asbestos Containing LV HRC Fuses. |

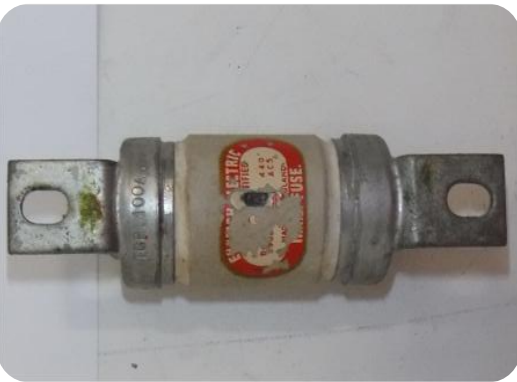
| Manufacturer | Rating | Fuse Body Photographs | Label Markings & Details | Result | Safety Instructions |
|---|---|---|---|---|---|
| English Electric | 100 | | TCP, 100A, AC5, PAT.355129 | <br>Asbestos found | <b>In-Service Fuses:</b><br>☒ If fuse is damaged, cease work and make safe. Contact the Hazmat Hotline - 02 9394 6961.<br>☒ If the fuse is intact, remove the fuse taking care not to damage in accordance with SWMS - AUS008 Removal of Friable Asbestos Containing LV HRC Fuses.<br><b>Stored and Quarantined Fuses:</b><br>☒ Must be disposed of in accordance with SWMS - AUS008 Removal of Friable Asbestos Containing LV HRC Fuses. |

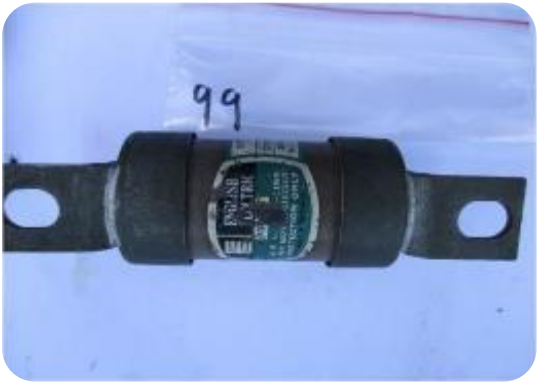
| Manufacturer | Rating | Fuse Body Photographs | Label Markings & Details | Result | Safety Instructions |
|---|---|---|---|---|---|
| English Electric | 100 | | TCP100M150 | <br>Asbestos found | <b>In-Service Fuses:</b><br>☒ If fuse is damaged, cease work and make safe. Contact the Hazmat Hotline - 02 9394 6961.<br>☒ If the fuse is intact, remove the fuse taking care not to damage in accordance with SWMS - AUS008 Removal of Friable Asbestos Containing LV HRC Fuses.<br><b>Stored and Quarantined Fuses:</b><br>☒ Must be disposed of in accordance with SWMS - AUS008 Removal of Friable Asbestos Containing LV HRC Fuses. |

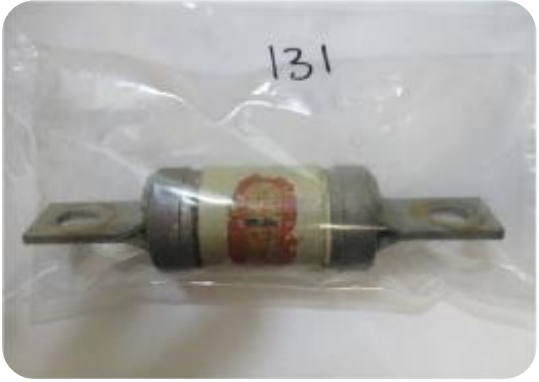
| Manufacturer | Rating | Fuse Body Photographs | Label Markings & Details | Result | Safety Instructions |
|---|---|---|---|---|---|
| English Electric | 100 | | TC 100A | <br>Asbestos found | <b>In-Service Fuses:</b><br>☒ If fuse is damaged, cease work and make safe. Contact the Hazmat Hotline - 02 9394 6961.<br>☒ If the fuse is intact, remove the fuse taking care not to damage in accordance with SWMS - AUS008 Removal of Friable Asbestos Containing LV HRC Fuses.<br><b>Stored and Quarantined Fuses:</b><br>☒ Must be disposed of in accordance with SWMS - AUS008 Removal of Friable Asbestos Containing LV HRC Fuses. |

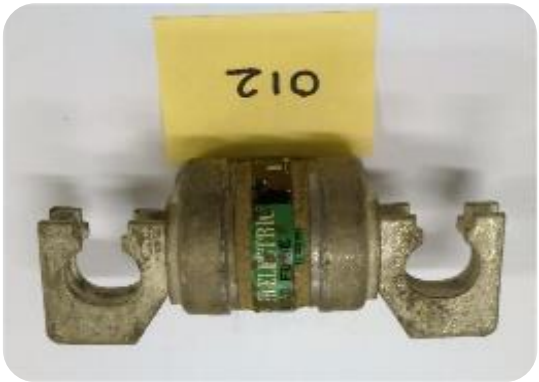
| Manufacturer | Rating | Fuse Body Photographs | Label Markings & Details | Result | Safety Instructions |
|---|---|---|---|---|---|
| English Electric | 100 | | HRC Fuse, 440AC Class Q1, 95TY,<br><small>55738-001-012</small> | <br>Asbestos found | <b>In-Service Fuses:</b><br> If fuse is damaged, cease work and make safe. Contact the Hazmat Hotline - 02 9394 6961.<br> If the fuse is intact, remove the fuse taking care not to damage in accordance with SWMS - AUS008 Removal of Friable Asbestos Containing LV HRC Fuses.<br><b>Stored and Quarantined Fuses:</b><br> Must be disposed of in accordance with SWMS - AUS008 Removal of Friable Asbestos Containing LV HRC Fuses. |

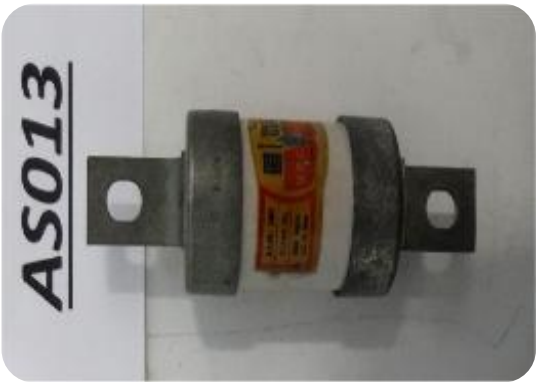
| Manufacturer | Rating | Fuse Body Photographs | Label Markings & Details | Result | Safety Instructions |
|---|---|---|---|---|---|
| English Electric | 150 | | TF, 150A, B.S.88, AC80, Class Q1<br><small>168215-13</small> | <br>Asbestos found | <b>In-Service Fuses:</b><br> If fuse is damaged, cease work and make safe. Contact the Hazmat Hotline - 02 9394 6961.<br> If the fuse is intact, remove the fuse taking care not to damage in accordance with SWMS - AUS008 Removal of Friable Asbestos Containing LV HRC Fuses.<br><b>Stored and Quarantined Fuses:</b><br> Must be disposed of in accordance with SWMS - AUS008 Removal of Friable Asbestos Containing LV HRC Fuses. |

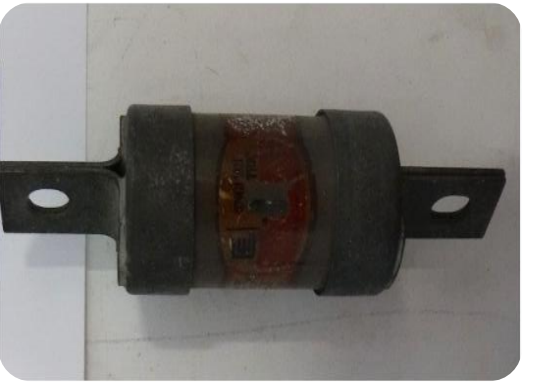
| Manufacturer | Rating | Fuse Body Photographs | Label Markings & Details | Result | Safety Instructions |
|---|---|---|---|---|---|
| English Electric | 150 | | TF, 150A, B.S.88, AC80, Class Q1<br><small>168215-21</small> | <br>Asbestos found | <b>In-Service Fuses:</b><br> If fuse is damaged, cease work and make safe. Contact the Hazmat Hotline - 02 9394 6961.<br> If the fuse is intact, remove the fuse taking care not to damage in accordance with SWMS - AUS008 Removal of Friable Asbestos Containing LV HRC Fuses.<br><b>Stored and Quarantined Fuses:</b><br> Must be disposed of in accordance with SWMS - AUS008 Removal of Friable Asbestos Containing LV HRC Fuses. |

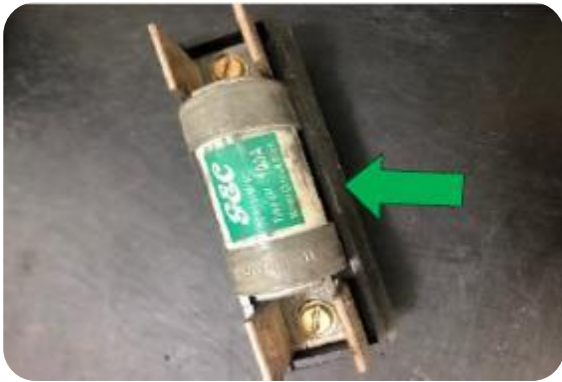
| Manufacturer | Rating | Fuse Body Photographs | Label Markings & Details | Result | Safety Instructions |
|---|---|---|---|---|---|
| English Electric | 160 | | English Electric TCP 100M 160A<br><small>754-SYDEN202874-AS05 and AS06</small> | <br>No Asbestos found, exercise caution and follow safety instructions | Where no manufacturer or date information can be confirmed and/or the fuse was manufactured prior to 2003, the <b>fuses should be presumed to contain asbestos and disposed</b> of in accordance with SWMS - AUS008 - Removal of Friable Asbestos Containing LV HRC Fuses. |

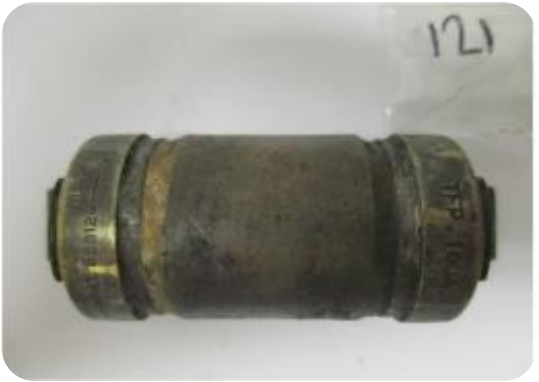
| Manufacturer | Rating | Fuse Body Photographs | Label Markings & Details | Result | Safety Instructions |
|---|---|---|---|---|---|
| English Electric | 160 | | TFP.160A<br><small>54287-001-121</small> | <br>Asbestos found | <b>In-Service Fuses:</b><br> If fuse is damaged, cease work and make safe. Contact the Hazmat Hotline - 02 9394 6961.<br> If the fuse is intact, remove the fuse taking care not to damage in accordance with SWMS - AUS008 Removal of Friable Asbestos Containing LV HRC Fuses.<br><b>Stored and Quarantined Fuses:</b><br> Must be disposed of in accordance with SWMS - AUS008 Removal of Friable Asbestos Containing LV HRC Fuses. |

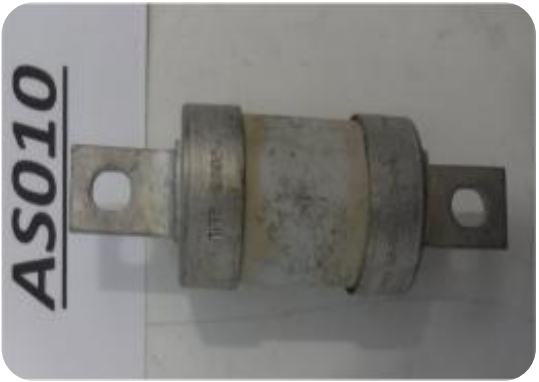
| Manufacturer | Rating | Fuse Body Photographs | Label Markings & Details | Result | Safety Instructions |
|---|---|---|---|---|---|
| English Electric | 200 | | OTF, 200A<br><small>168215-10</small> | <br>Asbestos found | <b>In-Service Fuses:</b><br> If fuse is damaged, cease work and make safe. Contact the Hazmat Hotline - 02 9394 6961.<br> If the fuse is intact, remove the fuse taking care not to damage in accordance with SWMS - AUS008 Removal of Friable Asbestos Containing LV HRC Fuses.<br><b>Stored and Quarantined Fuses:</b><br> Must be disposed of in accordance with SWMS - AUS008 Removal of Friable Asbestos Containing LV HRC Fuses. |

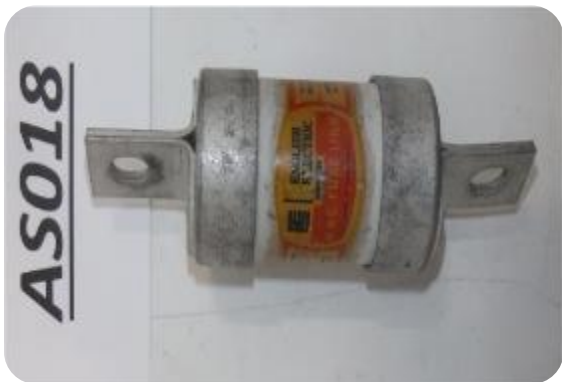
| Manufacturer | Rating | Fuse Body Photographs | Label Markings & Details | Result | Safety Instructions |
|---|---|---|---|---|---|
| English Electric | 200 | | TF, 200A, B.S.88, AC80, Class Q1 | <br>Asbestos found | <b>In-Service Fuses:</b><br> If fuse is damaged, cease work and make safe. Contact the Hazmat Hotline - 02 9394 6961.<br> If the fuse is intact, remove the fuse taking care not to damage in accordance with SWMS - AUS008 Removal of Friable Asbestos Containing LV HRC Fuses.<br><b>Stored and Quarantined Fuses:</b><br> Must be disposed of in accordance with SWMS - AUS008 Removal of Friable Asbestos Containing LV HRC Fuses. |

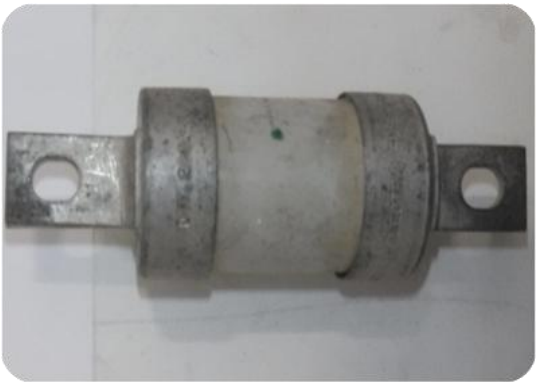
| Manufacturer | Rating | Fuse Body Photographs | Label Markings & Details | Result | Safety Instructions |
|---|---|---|---|---|---|
| English Electric | 200 | | OTF, 200A | <br>Asbestos found | <b>In-Service Fuses:</b><br> If fuse is damaged, cease work and make safe. Contact the Hazmat Hotline - 02 9394 6961.<br> If the fuse is intact, remove the fuse taking care not to damage in accordance with SWMS - AUS008 Removal of Friable Asbestos Containing LV HRC Fuses.<br><b>Stored and Quarantined Fuses:</b><br> Must be disposed of in accordance with SWMS - AUS008 Removal of Friable Asbestos Containing LV HRC Fuses. |

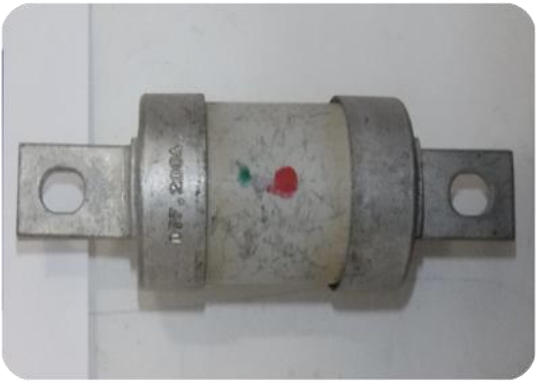
| Manufacturer | Rating | Fuse Body Photographs | Label Markings & Details | Result | Safety Instructions |
|---|---|---|---|---|---|
| English Electric | 200 | | OTF, 200A | <br>Asbestos found | <b>In-Service Fuses:</b><br> If fuse is damaged, cease work and make safe. Contact the Hazmat Hotline - 02 9394 6961.<br> If the fuse is intact, remove the fuse taking care not to damage in accordance with SWMS - AUS008 Removal of Friable Asbestos Containing LV HRC Fuses.<br><b>Stored and Quarantined Fuses:</b><br> Must be disposed of in accordance with SWMS - AUS008 Removal of Friable Asbestos Containing LV HRC Fuses. |

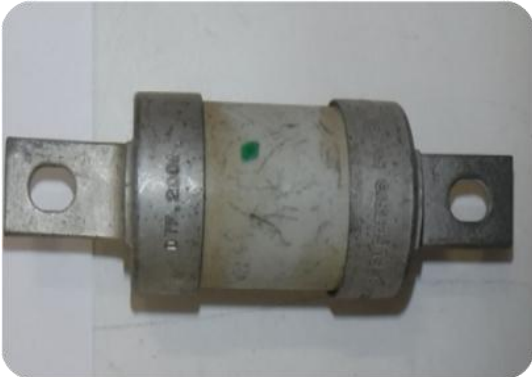
| Manufacturer | Rating | Fuse Body Photographs | Label Markings & Details | Result | Safety Instructions |
|---|---|---|---|---|---|
| English Electric | 200 | <br>168215-16 | OTF, 200A | <br>Asbestos found | <b>In-Service Fuses:</b><br>⊗ If fuse is damaged, cease work and make safe. Contact the Hazmat Hotline - 02 9394 6961.<br>⊗ If the fuse is intact, remove the fuse taking care not to damage in accordance with SWMS - AUS008 Removal of Friable Asbestos Containing LV HRC Fuses.<br><b>Stored and Quarantined Fuses:</b><br>⊗ Must be disposed of in accordance with SWMS - AUS008 Removal of Friable Asbestos Containing LV HRC Fuses. |

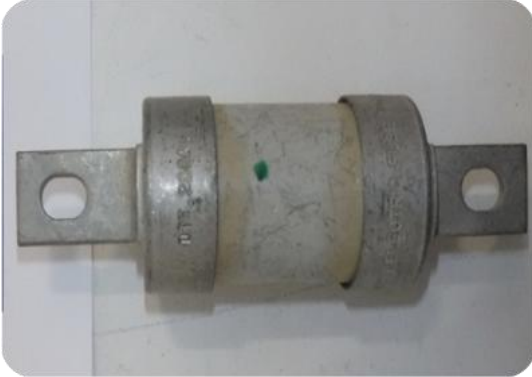
| Manufacturer | Rating | Fuse Body Photographs | Label Markings & Details | Result | Safety Instructions |
|---|---|---|---|---|---|
| English Electric | 200 | <br>168215-19 | OTF, 200A | <br>Asbestos found | <b>In-Service Fuses:</b><br>⊗ If fuse is damaged, cease work and make safe. Contact the Hazmat Hotline - 02 9394 6961.<br>⊗ If the fuse is intact, remove the fuse taking care not to damage in accordance with SWMS - AUS008 Removal of Friable Asbestos Containing LV HRC Fuses.<br><b>Stored and Quarantined Fuses:</b><br>⊗ Must be disposed of in accordance with SWMS - AUS008 Removal of Friable Asbestos Containing LV HRC Fuses. |

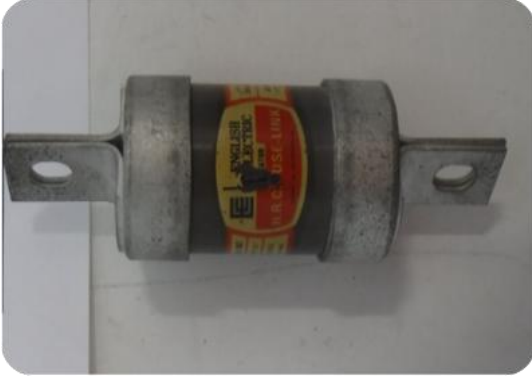
| Manufacturer | Rating | Fuse Body Photographs | Label Markings & Details | Result | Safety Instructions |
|---|---|---|---|---|---|
| English Electric | 200 | <br>168215-25 | TF, 200A, B.S.88, AC80, Class Q1 | <br>Asbestos found | <b>In-Service Fuses:</b><br>⊗ If fuse is damaged, cease work and make safe. Contact the Hazmat Hotline - 02 9394 6961.<br>⊗ If the fuse is intact, remove the fuse taking care not to damage in accordance with SWMS - AUS008 Removal of Friable Asbestos Containing LV HRC Fuses.<br><b>Stored and Quarantined Fuses:</b><br>⊗ Must be disposed of in accordance with SWMS - AUS008 Removal of Friable Asbestos Containing LV HRC Fuses. |

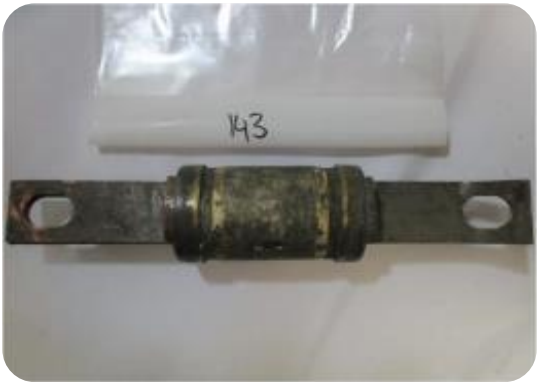
| Manufacturer | Rating | Fuse Body Photographs | Label Markings & Details | Result | Safety Instructions |
|---|---|---|---|---|---|
| English Electric | 200 | | 231TF | <br>Asbestos found | <b>In-Service Fuses:</b><br> If fuse is damaged, cease work and make safe. Contact the Hazmat Hotline - 02 9394 6961.<br> If the fuse is intact, remove the fuse taking care not to damage in accordance with SWMS - AUS008 Removal of Friable Asbestos Containing LV HRC Fuses.<br><b>Stored and Quarantined Fuses:</b><br> Must be disposed of in accordance with SWMS - AUS008 Removal of Friable Asbestos Containing LV HRC Fuses. |

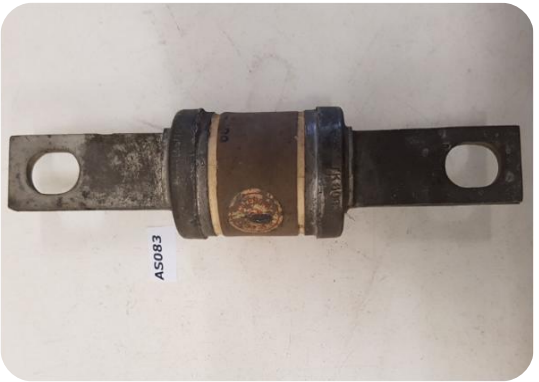
| Manufacturer | Rating | Fuse Body Photographs | Label Markings & Details | Result | Safety Instructions |
|---|---|---|---|---|---|
| English Electric | 300 | | 238TK 355129, 300A | <br>Asbestos found | <b>In-Service Fuses:</b><br> If fuse is damaged, cease work and make safe. Contact the Hazmat Hotline - 02 9394 6961.<br> If the fuse is intact, remove the fuse taking care not to damage in accordance with SWMS - AUS008 Removal of Friable Asbestos Containing LV HRC Fuses.<br><b>Stored and Quarantined Fuses:</b><br> Must be disposed of in accordance with SWMS - AUS008 Removal of Friable Asbestos Containing LV HRC Fuses. |

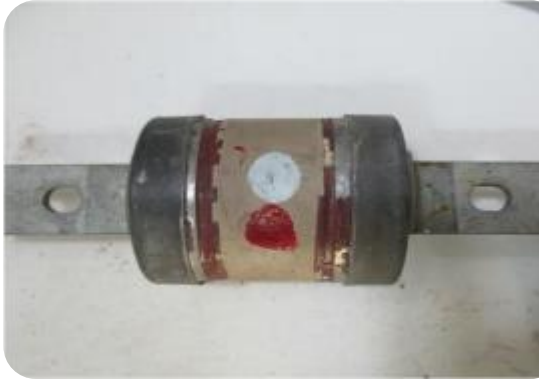
| Manufacturer | Rating | Fuse Body Photographs | Label Markings & Details | Result | Safety Instructions |
|---|---|---|---|---|---|
| English Electric | 350 | | OTM.350A | <br>Asbestos found | <b>In-Service Fuses:</b><br> If fuse is damaged, cease work and make safe. Contact the Hazmat Hotline - 02 9394 6961.<br> If the fuse is intact, remove the fuse taking care not to damage in accordance with SWMS - AUS008 Removal of Friable Asbestos Containing LV HRC Fuses.<br><b>Stored and Quarantined Fuses:</b><br> Must be disposed of in accordance with SWMS - AUS008 Removal of Friable Asbestos Containing LV HRC Fuses. |

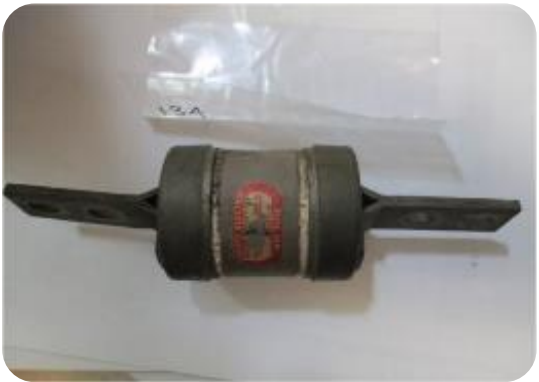
| Manufacturer | Rating | Fuse Body Photographs | Label Markings & Details | Result | Safety Instructions |
|---|---|---|---|---|---|
| English Electric | 350 | | R5 TM350A | <br>Asbestos found | <b>In-Service Fuses:</b><br> If fuse is damaged, cease work and make safe. Contact the Hazmat Hotline - 02 9394 6961.<br> If the fuse is intact, remove the fuse taking care not to damage in accordance with SWMS - AUS008 Removal of Friable Asbestos Containing LV HRC Fuses.<br><b>Stored and Quarantined Fuses:</b><br> Must be disposed of in accordance with SWMS - AUS008 Removal of Friable Asbestos Containing LV HRC Fuses. |

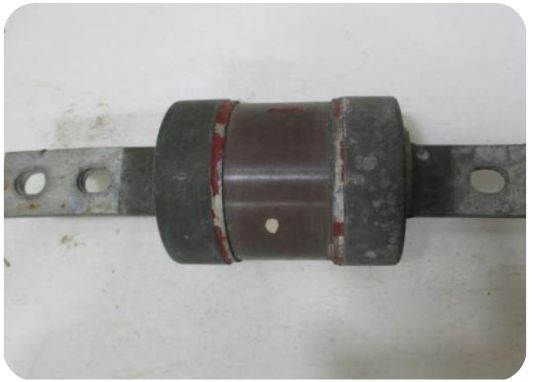
| Manufacturer | Rating | Fuse Body Photographs | Label Markings & Details | Result | Safety Instructions |
|---|---|---|---|---|---|
| English Electric | 400 | | SCC OTM 400A | <br>Asbestos found | <b>In-Service Fuses:</b><br> If fuse is damaged, cease work and make safe. Contact the Hazmat Hotline - 02 9394 6961.<br> If the fuse is intact, remove the fuse taking care not to damage in accordance with SWMS - AUS008 Removal of Friable Asbestos Containing LV HRC Fuses.<br><b>Stored and Quarantined Fuses:</b><br> Must be disposed of in accordance with SWMS - AUS008 Removal of Friable Asbestos Containing LV HRC Fuses. |

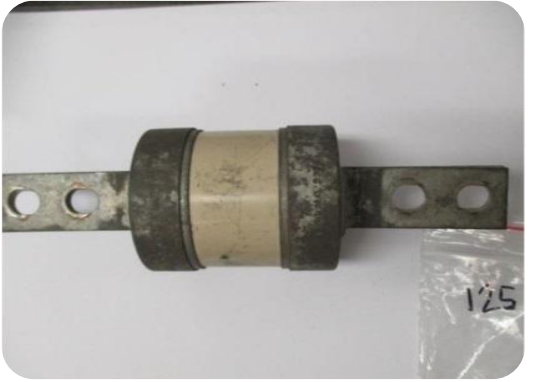
| Manufacturer | Rating | Fuse Body Photographs | Label Markings & Details | Result | Safety Instructions |
|---|---|---|---|---|---|
| English Electric | 400 | | SCC OTM 400A | <br>Asbestos found | <b>In-Service Fuses:</b><br> If fuse is damaged, cease work and make safe. Contact the Hazmat Hotline - 02 9394 6961.<br> If the fuse is intact, remove the fuse taking care not to damage in accordance with SWMS - AUS008 Removal of Friable Asbestos Containing LV HRC Fuses.<br><b>Stored and Quarantined Fuses:</b><br> Must be disposed of in accordance with SWMS - AUS008 Removal of Friable Asbestos Containing LV HRC Fuses. |

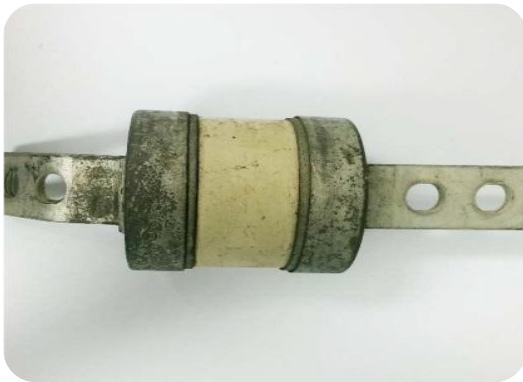
| Manufacturer | Rating | Fuse Body Photographs | Label Markings & Details | Result | Safety Instructions |
|---|---|---|---|---|---|
| English Electric | 400 | <br>54093-001-002 | SCC OTM, 400A | <br>Asbestos found | <b>In-Service Fuses:</b><br>⊗ If fuse is damaged, cease work and make safe. Contact the Hazmat Hotline - 02 9394 6961.<br>⊗ If the fuse is intact, remove the fuse taking care not to damage in accordance with SWMS - AUS008 Removal of Friable Asbestos Containing LV HRC Fuses.<br><b>Stored and Quarantined Fuses:</b><br>⊗ Must be disposed of in accordance with SWMS - AUS008 Removal of Friable Asbestos Containing LV HRC Fuses. |

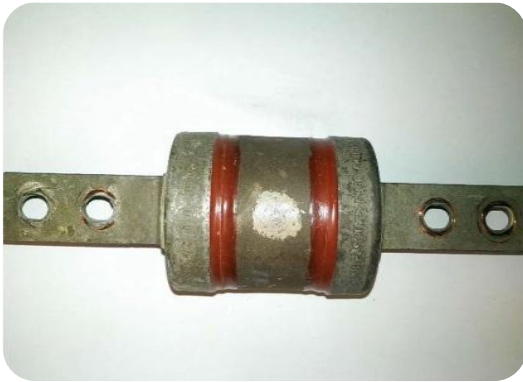
| Manufacturer | Rating | Fuse Body Photographs | Label Markings & Details | Result | Safety Instructions |
|---|---|---|---|---|---|
| English Electric | 400 | <br>54093-001-009 | SCC OTM, patented | <br>Asbestos found | <b>In-Service Fuses:</b><br>⊗ If fuse is damaged, cease work and make safe. Contact the Hazmat Hotline - 02 9394 6961.<br>⊗ If the fuse is intact, remove the fuse taking care not to damage in accordance with SWMS - AUS008 Removal of Friable Asbestos Containing LV HRC Fuses.<br><b>Stored and Quarantined Fuses:</b><br>⊗ Must be disposed of in accordance with SWMS - AUS008 Removal of Friable Asbestos Containing LV HRC Fuses. |

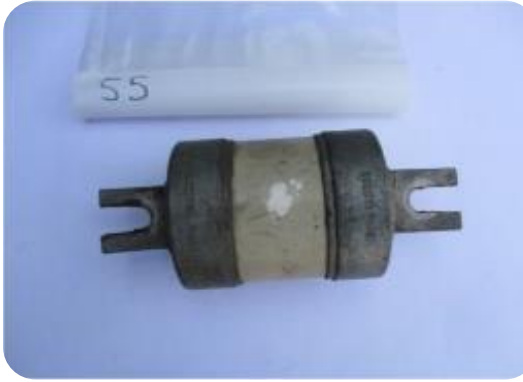
| Manufacturer | Rating | Fuse Body Photographs | Label Markings & Details | Result | Safety Instructions |
|---|---|---|---|---|---|
| English Electric | 400 | <br>54287-001-055 | SCC OTM F 400A | <br>Asbestos found | <b>In-Service Fuses:</b><br>⊗ If fuse is damaged, cease work and make safe. Contact the Hazmat Hotline - 02 9394 6961.<br>⊗ If the fuse is intact, remove the fuse taking care not to damage in accordance with SWMS - AUS008 Removal of Friable Asbestos Containing LV HRC Fuses.<br><b>Stored and Quarantined Fuses:</b><br>⊗ Must be disposed of in accordance with SWMS - AUS008 Removal of Friable Asbestos Containing LV HRC Fuses. |

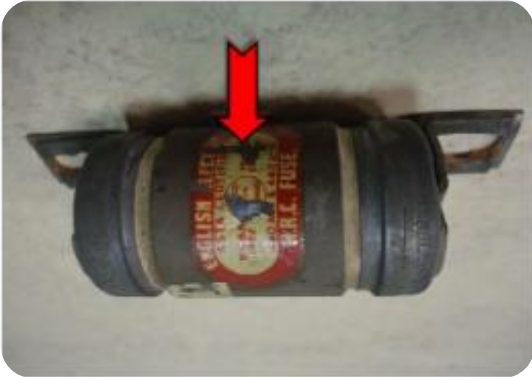
| Manufacturer | Rating | Fuse Body Photographs | Label Markings & Details | Result | Safety Instructions |
|---|---|---|---|---|---|
| English Electric | 440 | <br>51378-001-25 | | <br>Asbestos found | <b>In-Service Fuses:</b><br> If fuse is damaged, cease work and make safe. Contact the Hazmat Hotline - 02 9394 6961.<br> If the fuse is intact, remove the fuse taking care not to damage in accordance with SWMS - AUS008 Removal of Friable Asbestos Containing LV HRC Fuses.<br><b>Stored and Quarantined Fuses:</b><br> Must be disposed of in accordance with SWMS - AUS008 Removal of Friable Asbestos Containing LV HRC Fuses. |
