## Network Standard

Document No : NW000-S0161

NS211 ANNEXURE G – LV HRC FUSE ASBESTOS PRODUCT GUIDE

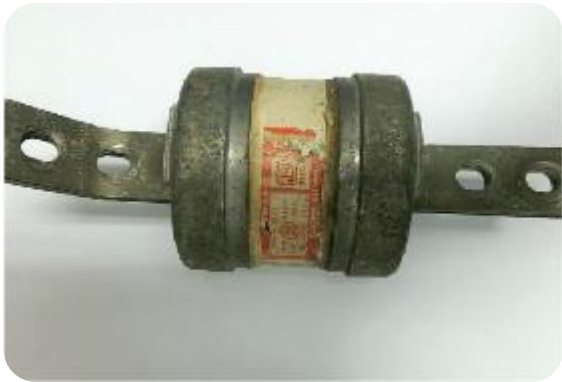
| Manufacturer | Rating | Fuse Body Photographs | Label Markings & Details | Result | Safety Instructions |
|---|---|---|---|---|---|
| English Electric | 500 | | ISI Cert, 440V, 46ka Made in India, TMM.500A, EE patient no. 355129 | <br>Asbestos found | <b>In-Service Fuses:</b><br> If fuse is damaged, cease work and make safe. Contact the Hazmat Hotline - 02 9394 6961.<br> If the fuse is intact, remove the fuse taking care not to damage in accordance with SWMS - AUS008 Removal of Friable Asbestos Containing LV HRC Fuses.<br><b>Stored and Quarantined Fuses:</b><br> Must be disposed of in accordance with SWMS - AUS008 Removal of Friable Asbestos Containing LV HRC Fuses. |

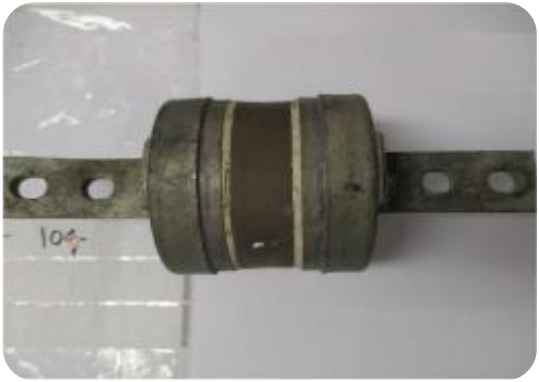
| Manufacturer | Rating | Fuse Body Photographs | Label Markings & Details | Result | Safety Instructions |
|---|---|---|---|---|---|
| English Electric | 500 | | TTM 500A | <br>Asbestos found | <b>In-Service Fuses:</b><br> If fuse is damaged, cease work and make safe. Contact the Hazmat Hotline - 02 9394 6961.<br> If the fuse is intact, remove the fuse taking care not to damage in accordance with SWMS - AUS008 Removal of Friable Asbestos Containing LV HRC Fuses.<br><b>Stored and Quarantined Fuses:</b><br> Must be disposed of in accordance with SWMS - AUS008 Removal of Friable Asbestos Containing LV HRC Fuses. |

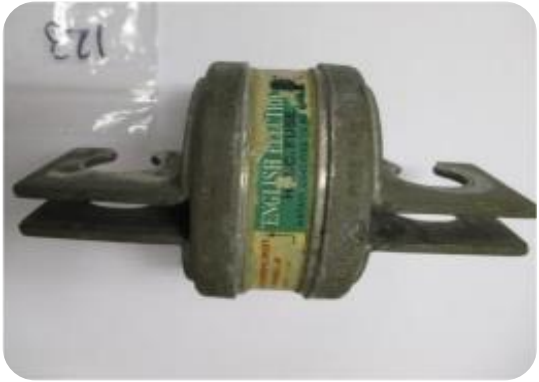
| Manufacturer | Rating | Fuse Body Photographs | Label Markings & Details | Result | Safety Instructions |
|---|---|---|---|---|---|
| English Electric | 500 | | 387TW500A | <br>Asbestos found | <b>In-Service Fuses:</b><br> If fuse is damaged, cease work and make safe. Contact the Hazmat Hotline - 02 9394 6961.<br> If the fuse is intact, remove the fuse taking care not to damage in accordance with SWMS - AUS008 Removal of Friable Asbestos Containing LV HRC Fuses.<br><b>Stored and Quarantined Fuses:</b><br> Must be disposed of in accordance with SWMS - AUS008 Removal of Friable Asbestos Containing LV HRC Fuses. |

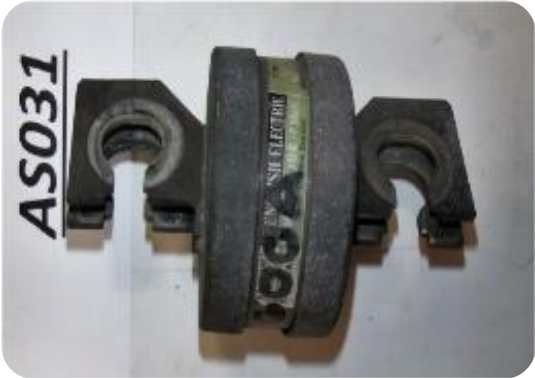
| Manufacturer | Rating | Fuse Body Photographs | Label Markings & Details | Result | Safety Instructions |
|---|---|---|---|---|---|
| English Electric | 600 | | J, 600A, B.S.88<br>168215-31 | <br>Asbestos found | <b>In-Service Fuses:</b><br> If fuse is damaged, cease work and make safe. Contact the Hazmat Hotline - 02 9394 6961.<br> If the fuse is intact, remove the fuse taking care not to damage in accordance with SWMS - AUS008 Removal of Friable Asbestos Containing LV HRC Fuses.<br><b>Stored and Quarantined Fuses:</b><br> Must be disposed of in accordance with SWMS - AUS008 Removal of Friable Asbestos Containing LV HRC Fuses. |

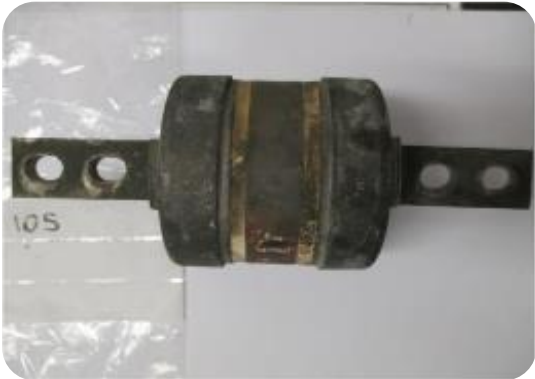
| Manufacturer | Rating | Fuse Body Photographs | Label Markings & Details | Result | Safety Instructions |
|---|---|---|---|---|---|
| English Electric | 600 | | TLM 600A<br>54287-001-105 | <br>Asbestos found | <b>In-Service Fuses:</b><br> If fuse is damaged, cease work and make safe. Contact the Hazmat Hotline - 02 9394 6961.<br> If the fuse is intact, remove the fuse taking care not to damage in accordance with SWMS - AUS008 Removal of Friable Asbestos Containing LV HRC Fuses.<br><b>Stored and Quarantined Fuses:</b><br> Must be disposed of in accordance with SWMS - AUS008 Removal of Friable Asbestos Containing LV HRC Fuses. |

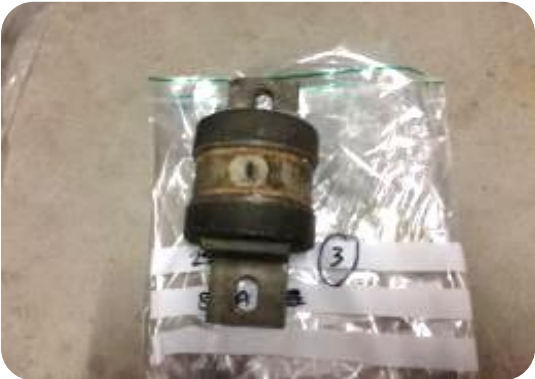
| Manufacturer | Rating | Fuse Body Photographs | Label Markings & Details | Result | Safety Instructions |
|---|---|---|---|---|---|
| English Electric | 800 | | 252TL/ 800A<br>50753-002-003 | <br>Asbestos found | <b>In-Service Fuses:</b><br> If fuse is damaged, cease work and make safe. Contact the Hazmat Hotline - 02 9394 6961.<br> If the fuse is intact, remove the fuse taking care not to damage in accordance with SWMS - AUS008 Removal of Friable Asbestos Containing LV HRC Fuses.<br><b>Stored and Quarantined Fuses:</b><br> Must be disposed of in accordance with SWMS - AUS008 Removal of Friable Asbestos Containing LV HRC Fuses. |

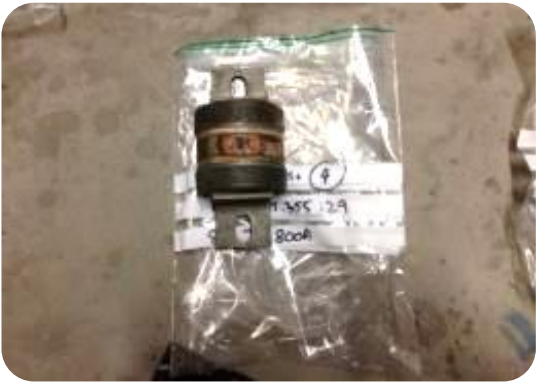
| Manufacturer | Rating | Fuse Body Photographs | Label Markings & Details | Result | Safety Instructions |
|---|---|---|---|---|---|
| English Electric | 800 | | PAT.35512A/ 852 TL 800A<br>(Offset Tag - Network Protector Fuse) | <br>Asbestos found | <b>In-Service Fuses:</b><br> If fuse is damaged, cease work and make safe. Contact the Hazmat Hotline - 02 9394 6961.<br> If the fuse is intact, remove the fuse taking care not to damage in accordance with SWMS - AUS008 Removal of Friable Asbestos Containing LV HRC Fuses.<br><b>Stored and Quarantined Fuses:</b><br> Must be disposed of in accordance with SWMS - AUS008 Removal of Friable Asbestos Containing LV HRC Fuses. |

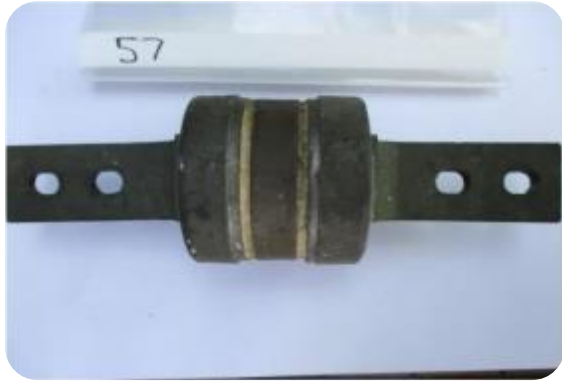
| Manufacturer | Rating | Fuse Body Photographs | Label Markings & Details | Result | Safety Instructions |
|---|---|---|---|---|---|
| English Electric | 800 | | TLT 800A | <br>Asbestos found | <b>In-Service Fuses:</b><br> If fuse is damaged, cease work and make safe. Contact the Hazmat Hotline - 02 9394 6961.<br> If the fuse is intact, remove the fuse taking care not to damage in accordance with SWMS - AUS008 Removal of Friable Asbestos Containing LV HRC Fuses.<br><b>Stored and Quarantined Fuses:</b><br> Must be disposed of in accordance with SWMS - AUS008 Removal of Friable Asbestos Containing LV HRC Fuses. |

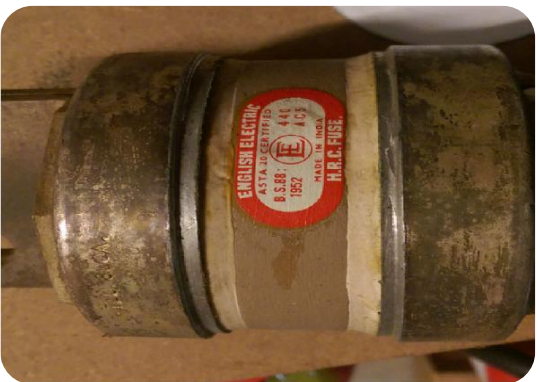
| Manufacturer | Rating | Fuse Body Photographs | Label Markings & Details | Result | Safety Instructions |
|---|---|---|---|---|---|
| English Electric | 800 | | 440 AC5, B.S.88, Asta 20<br>Certified (Made in India)<br>TLU800 | <br>Asbestos found | <b>In-Service Fuses:</b><br> If fuse is damaged, cease work and make safe. Contact the Hazmat Hotline - 02 9394 6961.<br> If the fuse is intact, remove the fuse taking care not to damage in accordance with SWMS - AUS008 Removal of Friable Asbestos Containing LV HRC Fuses.<br><b>Stored and Quarantined Fuses:</b><br> Must be disposed of in accordance with SWMS - AUS008 Removal of Friable Asbestos Containing LV HRC Fuses. |

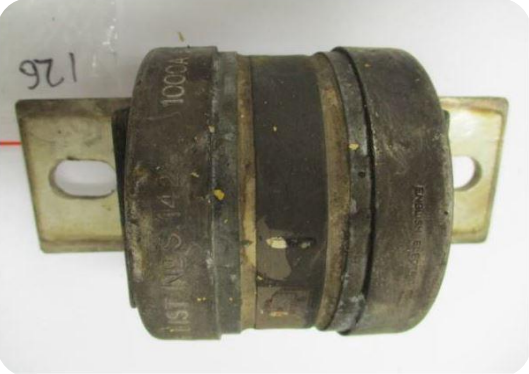
| Manufacturer | Rating | Fuse Body Photographs | Label Markings & Details | Result | Safety Instructions |
|---|---|---|---|---|---|
| English Electric | 1000 | | LIST NO S1428<br>(Offset Tag - Network Protector Tag) | <br>Asbestos found | <b>In-Service Fuses:</b><br>☒ If fuse is damaged, cease work and make safe. Contact the Hazmat Hotline - 02 9394 6961.<br>☒ If the fuse is intact, remove the fuse taking care not to damage in accordance with SWMS - AUS008 Removal of Friable Asbestos Containing LV HRC Fuses.<br><b>Stored and Quarantined Fuses:</b><br>☒ Must be disposed of in accordance with SWMS - AUS008 Removal of Friable Asbestos Containing LV HRC Fuses. |

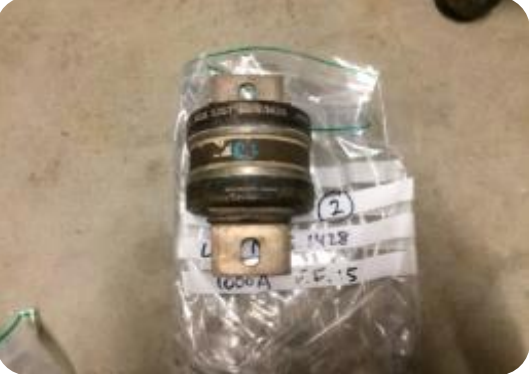
| Manufacturer | Rating | Fuse Body Photographs | Label Markings & Details | Result | Safety Instructions |
|---|---|---|---|---|---|
| English Electric | 1000 | | AC5 List No. S.1428 /1000A<br>F.F.15 /440V AC5<br>(Offset Tag - Network Protector Tag) | <br>Asbestos found | <b>In-Service Fuses:</b><br>☒ If fuse is damaged, cease work and make safe. Contact the Hazmat Hotline - 02 9394 6961.<br>☒ If the fuse is intact, remove the fuse taking care not to damage in accordance with SWMS - AUS008 Removal of Friable Asbestos Containing LV HRC Fuses.<br><b>Stored and Quarantined Fuses:</b><br>☒ Must be disposed of in accordance with SWMS - AUS008 Removal of Friable Asbestos Containing LV HRC Fuses. |

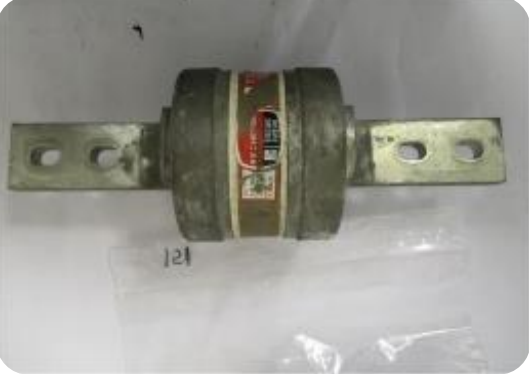
| Manufacturer | Rating | Fuse Body Photographs | Label Markings & Details | Result | Safety Instructions |
|---|---|---|---|---|---|
| English Electric | 1000 | | CAT 550 AC80 TX1000A | <br>Asbestos found | <b>In-Service Fuses:</b><br>☒ If fuse is damaged, cease work and make safe. Contact the Hazmat Hotline - 02 9394 6961.<br>☒ If the fuse is intact, remove the fuse taking care not to damage in accordance with SWMS - AUS008 Removal of Friable Asbestos Containing LV HRC Fuses.<br><b>Stored and Quarantined Fuses:</b><br>☒ Must be disposed of in accordance with SWMS - AUS008 Removal of Friable Asbestos Containing LV HRC Fuses. |

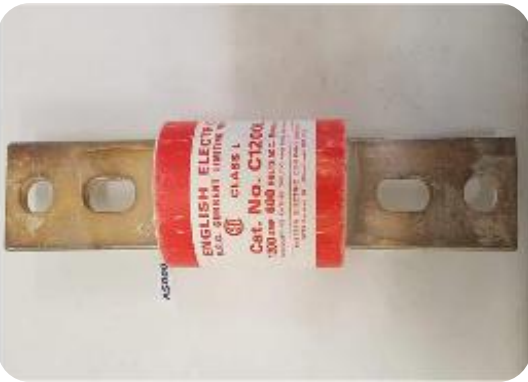
| Manufacturer | Rating | Fuse Body Photographs | Label Markings & Details | Result | Safety Instructions |
|---|---|---|---|---|---|
| English Electric | 1200 | | C1200L, 1200A, HRC current limiting, 50/60 cycle, Class L | <br>No Asbestos found, exercise caution and follow safety instructions | Where no manufacturer or date information can be confirmed and/or the fuse was manufactured prior to 2003, the <b>fuses should be presumed to contain asbestos and disposed</b> of in accordance with SWMS - AUS008 - Removal of Friable Asbestos Containing LV HRC Fuses. |

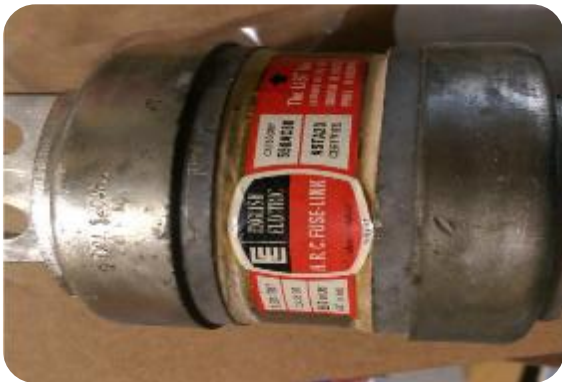
| Manufacturer | Rating | Fuse Body Photographs | Label Markings & Details | Result | Safety Instructions |
|---|---|---|---|---|---|
| English Electric | 1200 | | 550V, Class Q1, Cat 550AC80, Asta20 Certified TXU1200 | <br>No Asbestos found, exercise caution and follow safety instructions | Where no manufacturer or date information can be confirmed and/or the fuse was manufactured prior to 2003, the <b>fuses should be presumed to contain asbestos and disposed</b> of in accordance with SWMS - AUS008 - Removal of Friable Asbestos Containing LV HRC Fuses. |

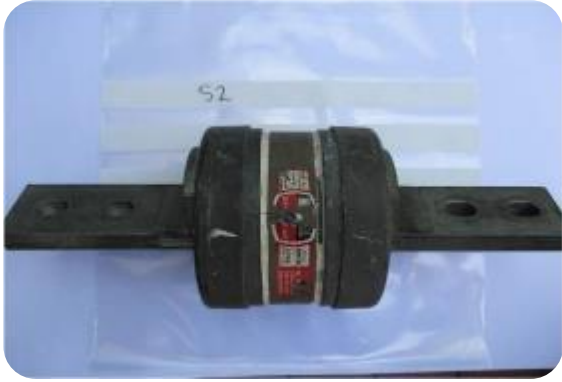
| Manufacturer | Rating | Fuse Body Photographs | Label Markings & Details | Result | Safety Instructions |
|---|---|---|---|---|---|
| English Electric | 1200 | | 550AC80 TX1200A | <br>Asbestos found | <b>In-Service Fuses:</b> <ul style="list-style-type: none"> <li> If fuse is damaged, cease work and make safe. Contact the Hazmat Hotline - 02 9394 6961.</li> <li> If the fuse is intact, remove the fuse taking care not to damage in accordance with SWMS - AUS008 Removal of Friable Asbestos Containing LV HRC Fuses.</li> </ul> <b>Stored and Quarantined Fuses:</b> <ul style="list-style-type: none"> <li> Must be disposed of in accordance with SWMS - AUS008 Removal of Friable Asbestos Containing LV HRC Fuses.</li> </ul> |

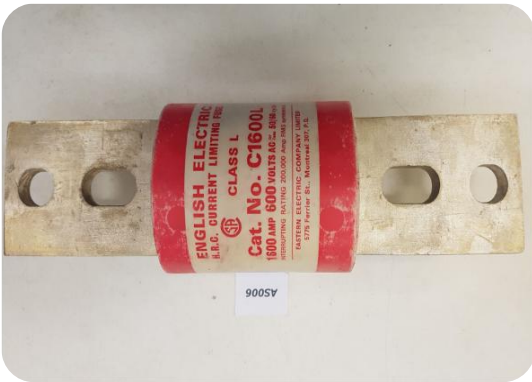
| Manufacturer | Rating | Fuse Body Photographs | Label Markings & Details | Result | Safety Instructions |
|---|---|---|---|---|---|
| English Electric | 1600 | <br>AS006 | C1600L, current limiting fuse, 1600A, Class L, 50/60 cycle<br><br>174102-001-AS006 | <br><br>No Asbestos found, exercise caution and follow safety instructions | <br>Where no manufacturer or date information can be confirmed and/or the fuse was manufactured prior to 2003, the <b>fuses should be presumed to contain asbestos and disposed</b> of in accordance with SWMS - AUS008 - Removal of Friable Asbestos Containing LV HRC Fuses. |

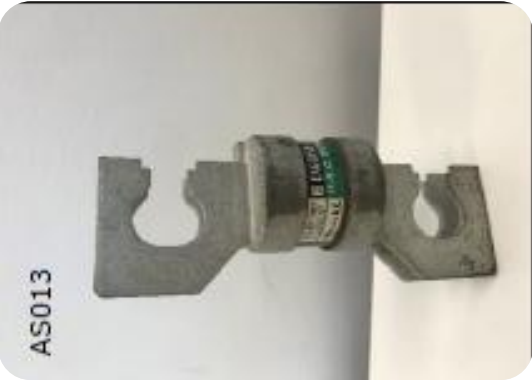
| Manufacturer | Rating | Fuse Body Photographs | Label Markings & Details | Result | Safety Instructions |
|---|---|---|---|---|---|
| English Electric | | <br>AS013 | English Electric - HRC Fuse Link - Type J, Class Q1, BS88: 1967, 415V AC, Category: 415AC46, ASTA certified - 415V - England - no date -<br><br>P033786.002-AS012 | <br><br>Asbestos found | <b>In-Service Fuses:</b><br> If fuse is damaged, cease work and make safe. Contact the Hazmat Hotline - 02 9394 6961.<br> If the fuse is intact, remove the fuse taking care not to damage in accordance with SWMS - AUS008 Removal of Friable Asbestos Containing LV HRC Fuses.<br><b>Stored and Quarantined Fuses:</b><br> Must be disposed of in accordance with SWMS - AUS008 Removal of Friable Asbestos Containing LV HRC Fuses. |

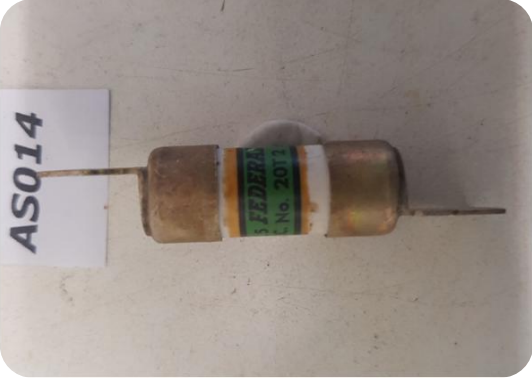
| Manufacturer | Rating | Fuse Body Photographs | Label Markings & Details | Result | Safety Instructions |
|---|---|---|---|---|---|
| Federal | 2 | <br>AS014 | 20T2, 2A, AC5<br><br>174102-001-AS014 | <br><br>No Asbestos found, exercise caution and follow safety instructions | <br>Where no manufacturer or date information can be confirmed and/or the fuse was manufactured prior to 2003, the <b>fuses should be presumed to contain asbestos and disposed</b> of in accordance with SWMS - AUS008 - Removal of Friable Asbestos Containing LV HRC Fuses. |

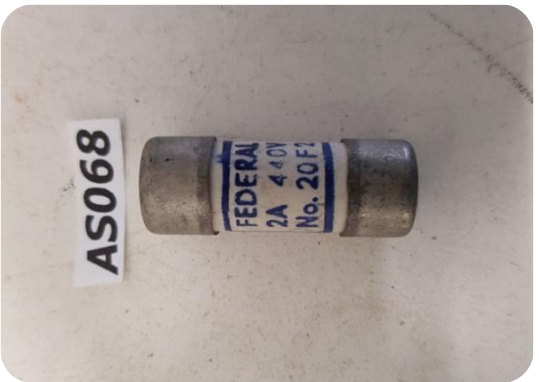
| Manufacturer | Rating | Fuse Body Photographs | Label Markings & Details | Result | Safety Instructions |
|---|---|---|---|---|---|
| Federal | 2 | <br>174783-001-AS068 | 20F2, 2A, AC5, BS88, S.A.A.0135 | <br>No Asbestos found, exercise caution and follow safety instructions | Where no manufacturer or date information can be confirmed and/or the fuse was manufactured prior to 2003, the <b>fuses should be presumed to contain asbestos and disposed</b> of in accordance with SWMS - AUS008 - Removal of Friable Asbestos Containing LV HRC Fuses. |

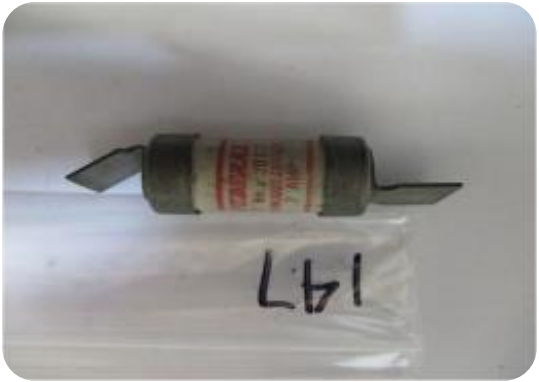
| Manufacturer | Rating | Fuse Body Photographs | Label Markings & Details | Result | Safety Instructions |
|---|---|---|---|---|---|
| Federal | 2 | <br>54287-001-147 | CAT NO 20C2 | <br>Asbestos found | <b>In-Service Fuses:</b><br> If fuse is damaged, cease work and make safe. Contact the Hazmat Hotline - 02 9394 6961.<br> If the fuse is intact, remove the fuse taking care not to damage in accordance with SWMS - AUS008 Removal of Friable Asbestos Containing LV HRC Fuses.<br><b>Stored and Quarantined Fuses:</b><br> Must be disposed of in accordance with SWMS - AUS008 Removal of Friable Asbestos Containing LV HRC Fuses. |

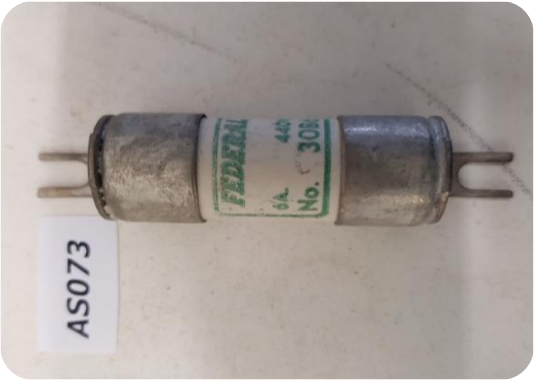
| Manufacturer | Rating | Fuse Body Photographs | Label Markings & Details | Result | Safety Instructions |
|---|---|---|---|---|---|
| Federal | 6 | <br>174783-001-AS073 | 30B6, 6A, AC5, BS88, S.A.A C135 | <br>No Asbestos found, exercise caution and follow safety instructions | Where no manufacturer or date information can be confirmed and/or the fuse was manufactured prior to 2003, the <b>fuses should be presumed to contain asbestos and disposed</b> of in accordance with SWMS - AUS008 - Removal of Friable Asbestos Containing LV HRC Fuses. |

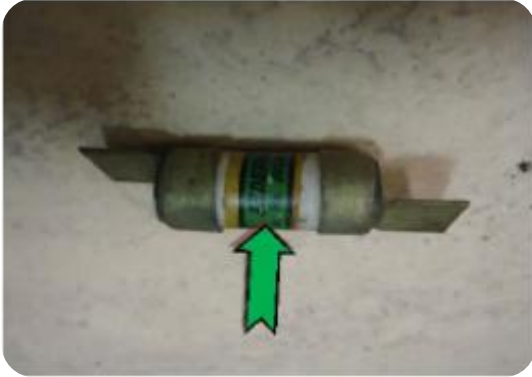
| Manufacturer | Rating | Fuse Body Photographs | Label Markings & Details | Result | Safety Instructions |
|---|---|---|---|---|---|
| Federal | 6 | | 20T 6'6A<br>51378-001-20 | <br>No Asbestos found, exercise caution and follow safety instructions | <br>Where no manufacturer or date information can be confirmed and/or the fuse was manufactured prior to 2003, the <b>fuses should be presumed to contain asbestos and disposed</b> of in accordance with SWMS - AUS008 - Removal of Friable Asbestos Containing LV HRC Fuses. |

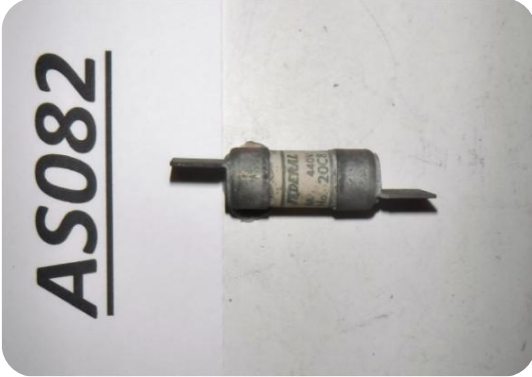
| Manufacturer | Rating | Fuse Body Photographs | Label Markings & Details | Result | Safety Instructions |
|---|---|---|---|---|---|
| Federal | 8 | | 20C8, 8A, AC5, B.S.S88, S.A.A C135<br>168273-82 | <br>No Asbestos found, exercise caution and follow safety instructions | <br>Where no manufacturer or date information can be confirmed and/or the fuse was manufactured prior to 2003, the <b>fuses should be presumed to contain asbestos and disposed</b> of in accordance with SWMS - AUS008 - Removal of Friable Asbestos Containing LV HRC Fuses. |

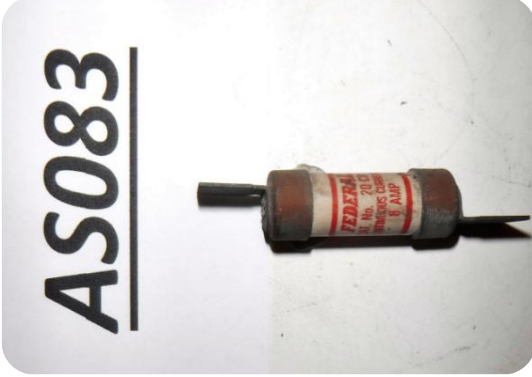
| Manufacturer | Rating | Fuse Body Photographs | Label Markings & Details | Result | Safety Instructions |
|---|---|---|---|---|---|
| Federal | 8 | | 20C8, 8A, AC46, B.S88, AS C135, Class Q1<br>168273-83 | <br>Asbestos found | <b>In-Service Fuses:</b><br> If fuse is damaged, cease work and make safe. Contact the Hazmat Hotline - 02 9394 6961.<br> If the fuse is intact, remove the fuse taking care not to damage in accordance with SWMS - AUS008 Removal of Friable Asbestos Containing LV HRC Fuses.<br><b>Stored and Quarantined Fuses:</b><br> Must be disposed of in accordance with SWMS - AUS008 Removal of Friable Asbestos Containing LV HRC Fuses. |

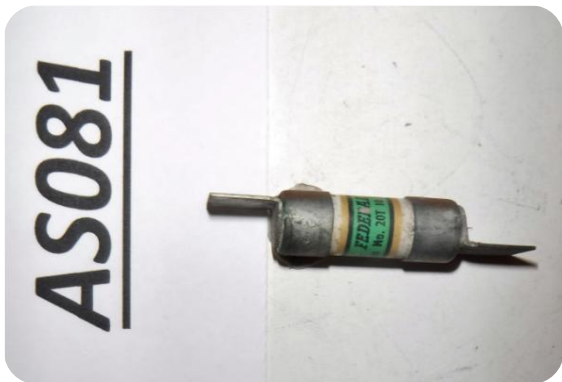
| Manufacturer | Rating | Fuse Body Photographs | Label Markings & Details | Result | Safety Instructions |
|---|---|---|---|---|---|
| Federal | 10 | | 20T10, 10A, AC5, B.S.S88, S.A.A C135 | <br>No Asbestos found, exercise caution and follow safety instructions | <br>Where no manufacturer or date information can be confirmed and/or the fuse was manufactured prior to 2003, the <b>fuses should be presumed to contain asbestos and disposed</b> of in accordance with SWMS - AUS008 - Removal of Friable Asbestos Containing LV HRC Fuses. |

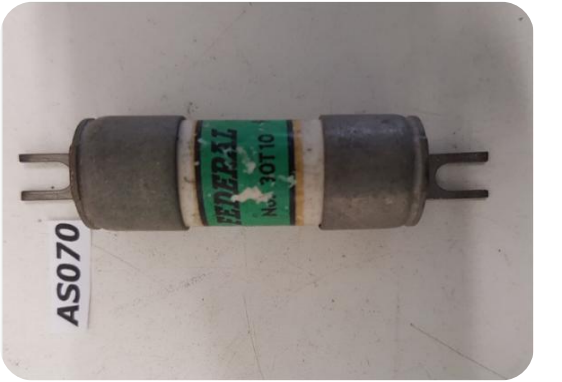
| Manufacturer | Rating | Fuse Body Photographs | Label Markings & Details | Result | Safety Instructions |
|---|---|---|---|---|---|
| Federal | 10 | | 30T10, 10A, AC5 | <br>No Asbestos found, exercise caution and follow safety instructions | <br>Where no manufacturer or date information can be confirmed and/or the fuse was manufactured prior to 2003, the <b>fuses should be presumed to contain asbestos and disposed</b> of in accordance with SWMS - AUS008 - Removal of Friable Asbestos Containing LV HRC Fuses. |

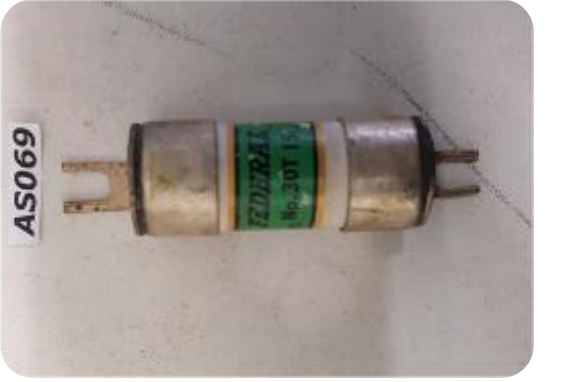
| Manufacturer | Rating | Fuse Body Photographs | Label Markings & Details | Result | Safety Instructions |
|---|---|---|---|---|---|
| Federal | 15 | | 30T15, 15A, BS 88, S.A.A C135 | <br>No Asbestos found, exercise caution and follow safety instructions | <br>Where no manufacturer or date information can be confirmed and/or the fuse was manufactured prior to 2003, the <b>fuses should be presumed to contain asbestos and disposed</b> of in accordance with SWMS - AUS008 - Removal of Friable Asbestos Containing LV HRC Fuses. |

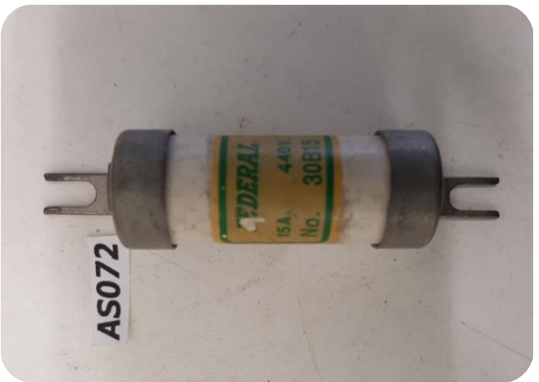
| Manufacturer | Rating | Fuse Body Photographs | Label Markings & Details | Result | Safety Instructions |
|---|---|---|---|---|---|
| Federal | 15 | | 30B15, 15A, BS 88, S.A.A C135, AC 46 | <br>No Asbestos found, exercise caution and follow safety instructions | Where no manufacturer or date information can be confirmed and/or the fuse was manufactured prior to 2003, the <b>fuses should be presumed to contain asbestos and disposed</b> of in accordance with SWMS - AUS008 - Removal of Friable Asbestos Containing LV HRC Fuses. |

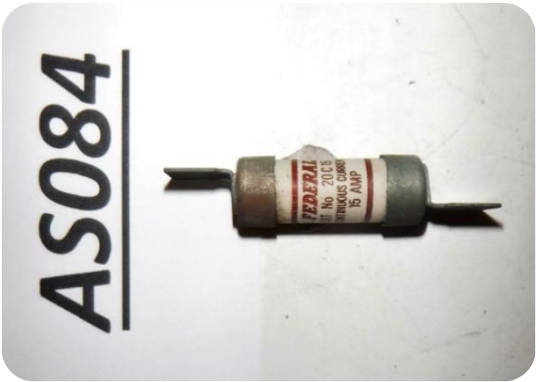
| Manufacturer | Rating | Fuse Body Photographs | Label Markings & Details | Result | Safety Instructions |
|---|---|---|---|---|---|
| Federal | 15 | | 20C15, 15A, AC46, B.S88, AS C135, Class Q1 | <br>Asbestos found | <b>In-Service Fuses:</b><br> If fuse is damaged, cease work and make safe. Contact the Hazmat Hotline - 02 9394 6961.<br> If the fuse is intact, remove the fuse taking care not to damage in accordance with SWMS - AUS008 Removal of Friable Asbestos Containing LV HRC Fuses.<br><b>Stored and Quarantined Fuses:</b><br> Must be disposed of in accordance with SWMS - AUS008 Removal of Friable Asbestos Containing LV HRC Fuses. |

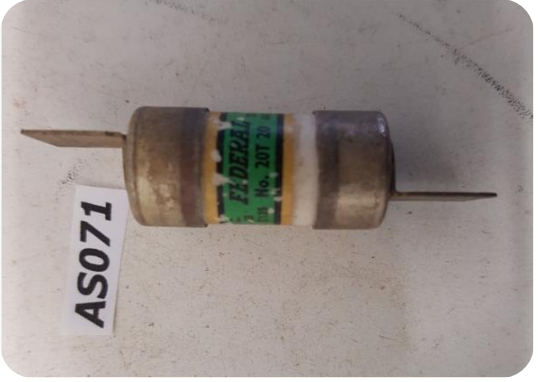
| Manufacturer | Rating | Fuse Body Photographs | Label Markings & Details | Result | Safety Instructions |
|---|---|---|---|---|---|
| Federal | 20 | | 20T20, 20A, AC5, BS88, S.A.A C135 | <br>No Asbestos found, exercise caution and follow safety instructions | Where no manufacturer or date information can be confirmed and/or the fuse was manufactured prior to 2003, the <b>fuses should be presumed to contain asbestos and disposed</b> of in accordance with SWMS - AUS008 - Removal of Friable Asbestos Containing LV HRC Fuses. |

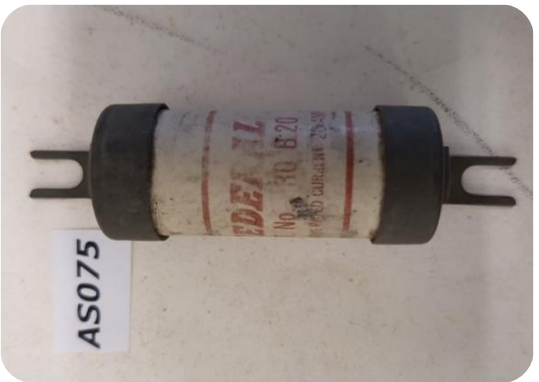
| Manufacturer | Rating | Fuse Body Photographs | Label Markings & Details | Result | Safety Instructions |
|---|---|---|---|---|---|
| Federal | 20 | | 30B20, 20A, AC46, Class Q1, BS 88-195, AS - C135<br>174783-001-AS075 | <br>Asbestos found | <b>In-Service Fuses:</b><br> If fuse is damaged, cease work and make safe. Contact the Hazmat Hotline - 02 9394 6961.<br> If the fuse is intact, remove the fuse taking care not to damage in accordance with SWMS - AUS008 Removal of Friable Asbestos Containing LV HRC Fuses.<br><b>Stored and Quarantined Fuses:</b><br> Must be disposed of in accordance with SWMS - AUS008 Removal of Friable Asbestos Containing LV HRC Fuses. |

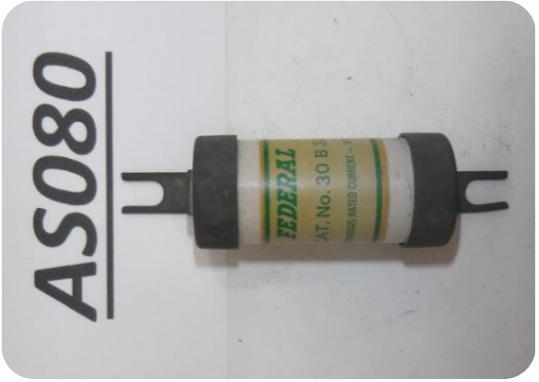
| Manufacturer | Rating | Fuse Body Photographs | Label Markings & Details | Result | Safety Instructions |
|---|---|---|---|---|---|
| Federal | 30 | | 30B30, 30A, AC46, B.S.S88, AS-C135<br>168273-80 | <br>Asbestos found | <b>In-Service Fuses:</b><br> If fuse is damaged, cease work and make safe. Contact the Hazmat Hotline - 02 9394 6961.<br> If the fuse is intact, remove the fuse taking care not to damage in accordance with SWMS - AUS008 Removal of Friable Asbestos Containing LV HRC Fuses.<br><b>Stored and Quarantined Fuses:</b><br> Must be disposed of in accordance with SWMS - AUS008 Removal of Friable Asbestos Containing LV HRC Fuses. |

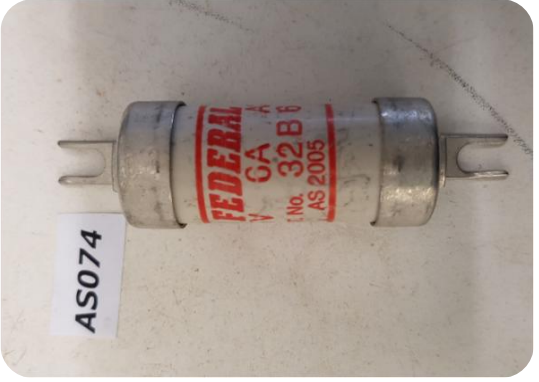
| Manufacturer | Rating | Fuse Body Photographs | Label Markings & Details | Result | Safety Instructions |
|---|---|---|---|---|---|
| Federal | 32 | | 32 B 5, 32A, CA A2, AS 2005<br>174783-001-AS074 | <br>No Asbestos found, exercise caution and follow safety instructions | Where no manufacturer or date information can be confirmed and/or the fuse was manufactured prior to 2003, the <b>fuses should be presumed to contain asbestos and disposed</b> of in accordance with SWMS - AUS008 - Removal of Friable Asbestos Containing LV HRC Fuses. |

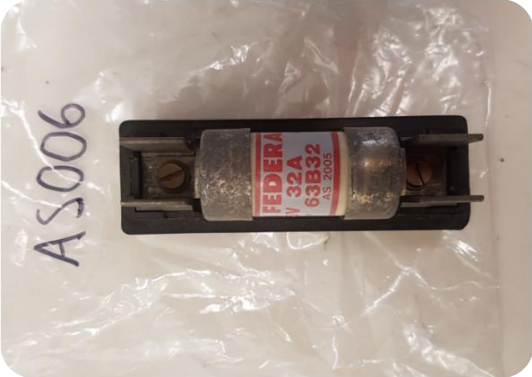
| Manufacturer | Rating | Fuse Body Photographs | Label Markings & Details | Result | Safety Instructions |
|---|---|---|---|---|---|
| Federal | 32 | | 63B32, 32A, A3, AS2005 | <br>No Asbestos found, exercise caution and follow safety instructions | <br>Where no manufacturer or date information can be confirmed and/or the fuse was manufactured prior to 2003, the <b>fuses should be presumed to contain asbestos and disposed</b> of in accordance with SWMS - AUS008 - Removal of Friable Asbestos Containing LV HRC Fuses. |

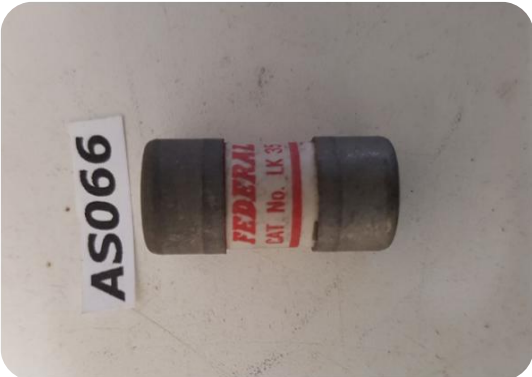
| Manufacturer | Rating | Fuse Body Photographs | Label Markings & Details | Result | Safety Instructions |
|---|---|---|---|---|---|
| Federal | 35 | | LK35, 35A, AC4 | <br>No Asbestos found, exercise caution and follow safety instructions | <br>Where no manufacturer or date information can be confirmed and/or the fuse was manufactured prior to 2003, the <b>fuses should be presumed to contain asbestos and disposed</b> of in accordance with SWMS - AUS008 - Removal of Friable Asbestos Containing LV HRC Fuses. |

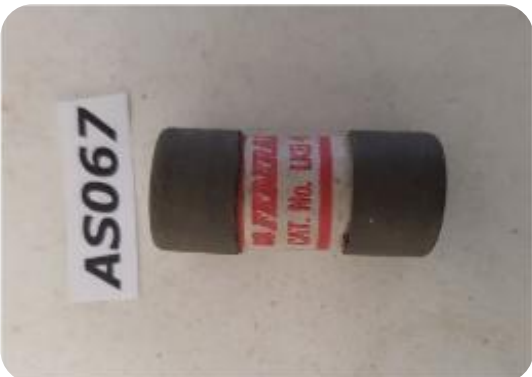
| Manufacturer | Rating | Fuse Body Photographs | Label Markings & Details | Result | Safety Instructions |
|---|---|---|---|---|---|
| Federal | 45 | | LKB 45, 45A, AC4 | <br>No Asbestos found, exercise caution and follow safety instructions | <br>Where no manufacturer or date information can be confirmed and/or the fuse was manufactured prior to 2003, the <b>fuses should be presumed to contain asbestos and disposed</b> of in accordance with SWMS - AUS008 - Removal of Friable Asbestos Containing LV HRC Fuses. |

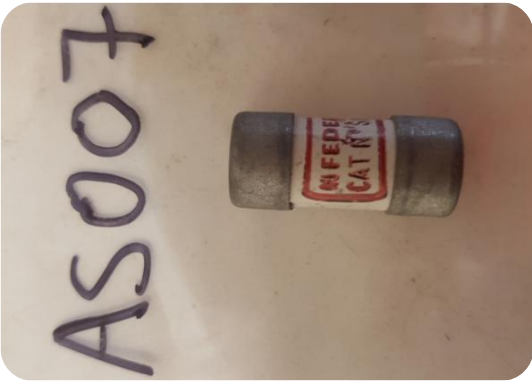
| Manufacturer | Rating | Fuse Body Photographs | Label Markings & Details | Result | Safety Instructions |
|---|---|---|---|---|---|
| Federal | 45 | <br>182621-001-007 | SK-45, 45A, AC2 | <br>No Asbestos found, exercise caution and follow safety instructions | <br>Where no manufacturer or date information can be confirmed and/or the fuse was manufactured prior to 2003, the <b>fuses should be presumed to contain asbestos and disposed</b> of in accordance with SWMS - AUS008 - Removal of Friable Asbestos Containing LV HRC Fuses. |

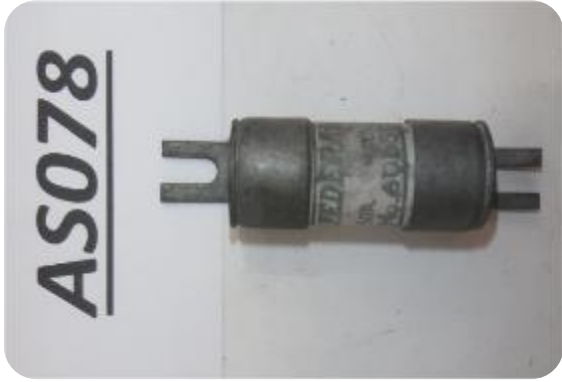
| Manufacturer | Rating | Fuse Body Photographs | Label Markings & Details | Result | Safety Instructions |
|---|---|---|---|---|---|
| Federal | 50 | <br>168273-78 | 60B50, 50A, AC 5, B.S.S88, S.A.A C135 | <br>No Asbestos found, exercise caution and follow safety instructions | <br>Where no manufacturer or date information can be confirmed and/or the fuse was manufactured prior to 2003, the <b>fuses should be presumed to contain asbestos and disposed</b> of in accordance with SWMS - AUS008 - Removal of Friable Asbestos Containing LV HRC Fuses. |

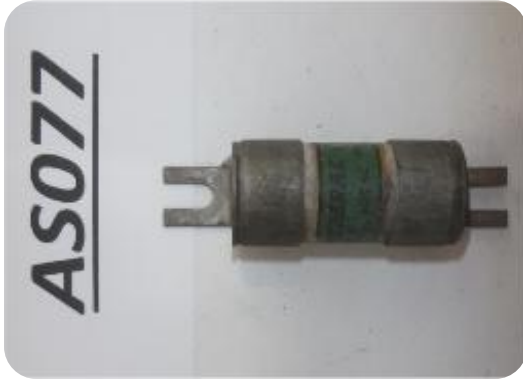
| Manufacturer | Rating | Fuse Body Photographs | Label Markings & Details | Result | Safety Instructions |
|---|---|---|---|---|---|
| Federal | 60 | <br>168273-77 | 60T60, 60A, AC5 | <br>No Asbestos found, exercise caution and follow safety instructions | <br>Where no manufacturer or date information can be confirmed and/or the fuse was manufactured prior to 2003, the <b>fuses should be presumed to contain asbestos and disposed</b> of in accordance with SWMS - AUS008 - Removal of Friable Asbestos Containing LV HRC Fuses. |

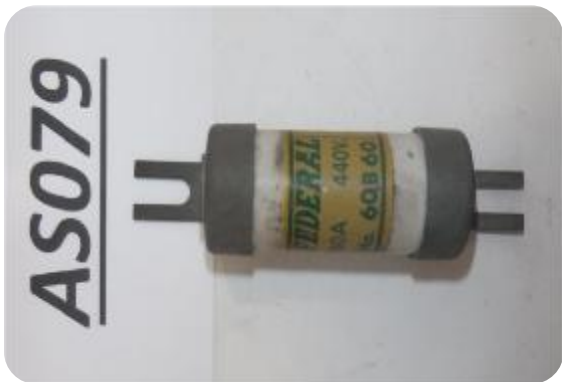
| Manufacturer | Rating | Fuse Body Photographs | Label Markings & Details | Result | Safety Instructions |
|---|---|---|---|---|---|
| Federal | 60 | <br>168273-79 | 60B60, 60A, AC46, B.S.S88,<br>S.A.A C135 | <br>Asbestos<br>found | <b>In-Service Fuses:</b><br> If fuse is damaged, cease work and make safe.<br>Contact the Hazmat Hotline - 02 9394 6961.<br> If the fuse is intact, remove the fuse taking care not to<br>damage in accordance with SWMS - AUS008 Removal of<br>Friable Asbestos Containing LV HRC Fuses.<br><b>Stored and Quarantined Fuses:</b><br> Must be disposed of in accordance with SWMS - AUS008<br>Removal of Friable Asbestos Containing LV HRC Fuses. |

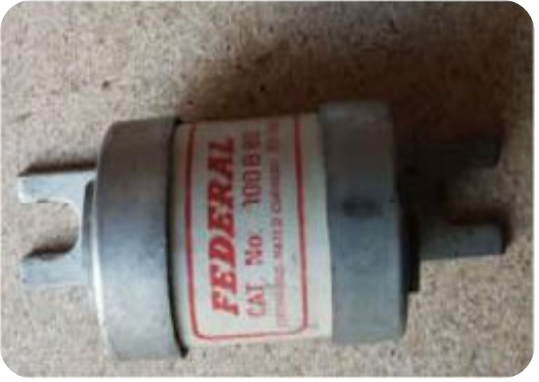
| Manufacturer | Rating | Fuse Body Photographs | Label Markings & Details | Result | Safety Instructions |
|---|---|---|---|---|---|
| Federal | 80 | <br>P033768.003-AS015 | CAT.No.100 B 80, CONTINUOUS<br>RATED CURRENT 80 AMP,<br>H.R.C, 440V-AC43, CLASS 01,<br>BS.88-1967, AS-C135 | <br>Asbestos<br>found | <b>In-Service Fuses:</b><br> If fuse is damaged, cease work and make safe.<br>Contact the Hazmat Hotline - 02 9394 6961.<br> If the fuse is intact, remove the fuse taking care not to<br>damage in accordance with SWMS - AUS008 Removal of<br>Friable Asbestos Containing LV HRC Fuses.<br><b>Stored and Quarantined Fuses:</b><br> Must be disposed of in accordance with SWMS - AUS008<br>Removal of Friable Asbestos Containing LV HRC Fuses. |

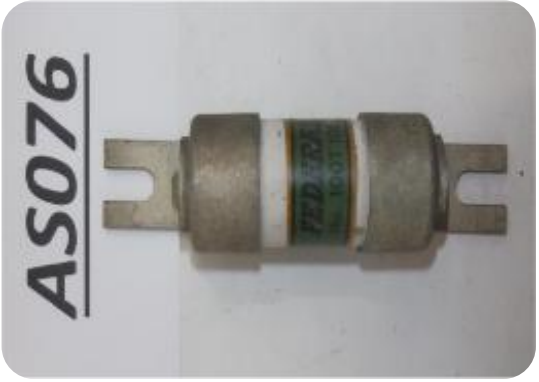
| Manufacturer | Rating | Fuse Body Photographs | Label Markings & Details | Result | Safety Instructions |
|---|---|---|---|---|---|
| Federal | 100 | <br>168273-76 | 100T100, 100A, AC5 | <br>No Asbestos<br>found,<br>exercise<br>caution and<br>follow safety<br>instructions | Where no manufacturer or date information can be<br>confirmed and/or the fuse was manufactured prior to 2003,<br>the <b>fuses should be presumed to contain asbestos and<br/>disposed</b> of in accordance with SWMS - AUS008 - Removal<br>of Friable Asbestos Containing LV HRC Fuses. |

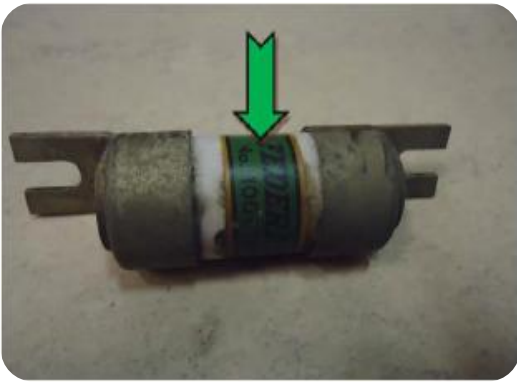
| Manufacturer | Rating | Fuse Body Photographs | Label Markings & Details | Result | Safety Instructions |
|---|---|---|---|---|---|
| Federal | 100 | | 100+100 100A<br>51378-001-24 | <br>No Asbestos found, exercise caution and follow safety instructions | Where no manufacturer or date information can be confirmed and/or the fuse was manufactured prior to 2003, the <b>fuses should be presumed to contain asbestos and disposed</b> of in accordance with SWMS - AUS008 - Removal of Friable Asbestos Containing LV HRC Fuses. |

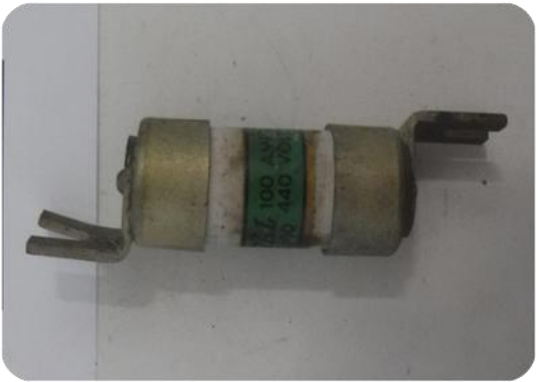
| Manufacturer | Rating | Fuse Body Photographs | Label Markings & Details | Result | Safety Instructions |
|---|---|---|---|---|---|
| Federal | 100 | | 100T100, 100A, AC5<br>168273-75 | <br>No Asbestos found, exercise caution and follow safety instructions | Where no manufacturer or date information can be confirmed and/or the fuse was manufactured prior to 2003, the <b>fuses should be presumed to contain asbestos and disposed</b> of in accordance with SWMS - AUS008 - Removal of Friable Asbestos Containing LV HRC Fuses. |

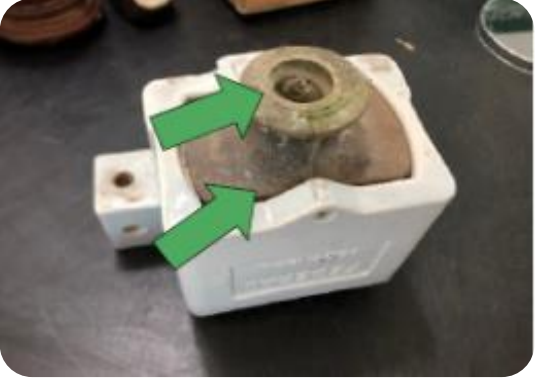
| Manufacturer | Rating | Fuse Body Photographs | Label Markings & Details | Result | Safety Instructions |
|---|---|---|---|---|---|
| Federal | 100 | | Federal 500V 100A<br>754-SYDEN202874-AS01 and AS02 | <br>No Asbestos found, exercise caution and follow safety instructions | Where no manufacturer or date information can be confirmed and/or the fuse was manufactured prior to 2003, the <b>fuses should be presumed to contain asbestos and disposed</b> of in accordance with SWMS - AUS008 - Removal of Friable Asbestos Containing LV HRC Fuses. |

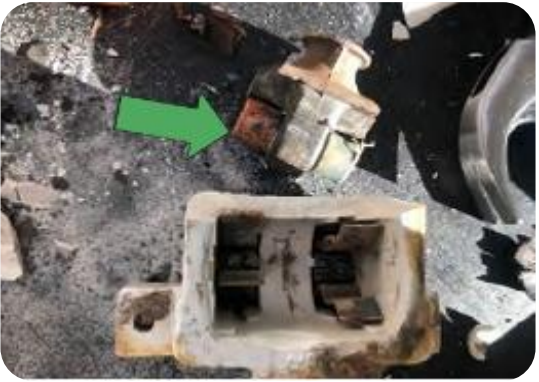
| Manufacturer | Rating | Fuse Body Photographs | Label Markings & Details | Result | Safety Instructions |
|---|---|---|---|---|---|
| Federal | 100 | | 500V. 100A<br>754-SYDEN202874-AS16 | <br>No Asbestos found, exercise caution and follow safety instructions | Where no manufacturer or date information can be confirmed and/or the fuse was manufactured prior to 2003, the <b>fuses should be presumed to contain asbestos and disposed</b> of in accordance with SWMS - AUS008 - Removal of Friable Asbestos Containing LV HRC Fuses. |

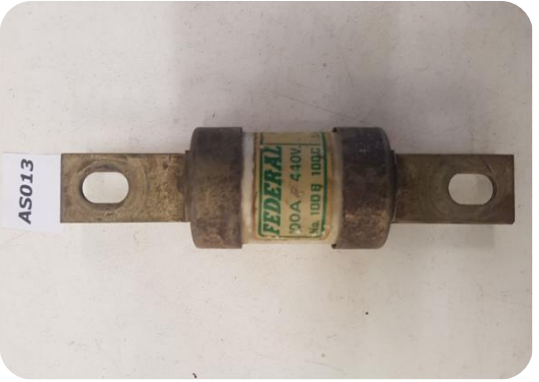
| Manufacturer | Rating | Fuse Body Photographs | Label Markings & Details | Result | Safety Instructions |
|---|---|---|---|---|---|
| Federal | 100 | | 100B 100V, 100A, HRC AC46, BS88, S.A.A C135<br>174102-001-AS013 | <br>Asbestos found | <b>In-Service Fuses:</b><br> If fuse is damaged, cease work and make safe. Contact the Hazmat Hotline - 02 9394 6961.<br> If the fuse is intact, remove the fuse taking care not to damage in accordance with SWMS - AUS008 Removal of Friable Asbestos Containing LV HRC Fuses.<br><b>Stored and Quarantined Fuses:</b><br> Must be disposed of in accordance with SWMS - AUS008 Removal of Friable Asbestos Containing LV HRC Fuses. |

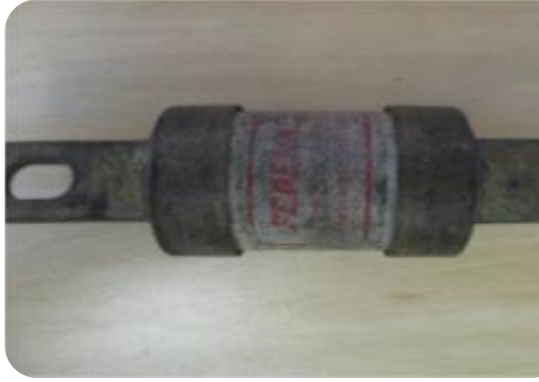
| Manufacturer | Rating | Fuse Body Photographs | Label Markings & Details | Result | Safety Instructions |
|---|---|---|---|---|---|
| Federal | 100 | | 100Amp<br>54287-001-014 | <br>Asbestos found | <b>In-Service Fuses:</b><br> If fuse is damaged, cease work and make safe. Contact the Hazmat Hotline - 02 9394 6961.<br> If the fuse is intact, remove the fuse taking care not to damage in accordance with SWMS - AUS008 Removal of Friable Asbestos Containing LV HRC Fuses.<br><b>Stored and Quarantined Fuses:</b><br> Must be disposed of in accordance with SWMS - AUS008 Removal of Friable Asbestos Containing LV HRC Fuses. |

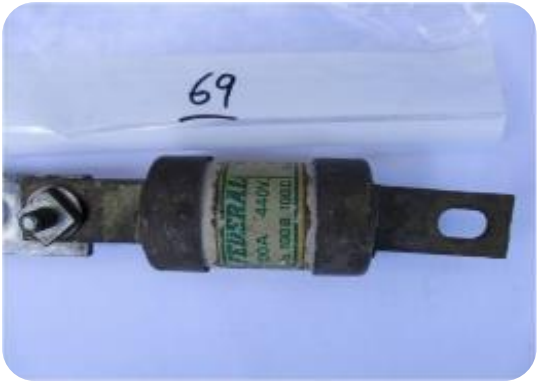
| Manufacturer | Rating | Fuse Body Photographs | Label Markings & Details | Result | Safety Instructions |
|---|---|---|---|---|---|
| Federal | 100 | | 100B 100C HRC AC46<br>54287-001-069 | <br>Asbestos found | <b>In-Service Fuses:</b><br> If fuse is damaged, cease work and make safe. Contact the Hazmat Hotline - 02 9394 6961.<br> If the fuse is intact, remove the fuse taking care not to damage in accordance with SWMS - AUS008 Removal of Friable Asbestos Containing LV HRC Fuses.<br><b>Stored and Quarantined Fuses:</b><br> Must be disposed of in accordance with SWMS - AUS008 Removal of Friable Asbestos Containing LV HRC Fuses. |

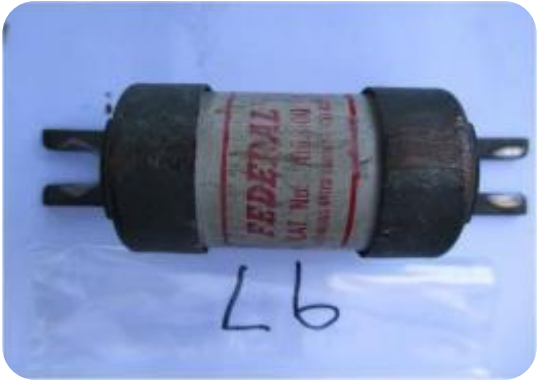
| Manufacturer | Rating | Fuse Body Photographs | Label Markings & Details | Result | Safety Instructions |
|---|---|---|---|---|---|
| Federal | 100 | | 100B100<br>54287-001-097 | <br>Asbestos found | <b>In-Service Fuses:</b><br> If fuse is damaged, cease work and make safe. Contact the Hazmat Hotline - 02 9394 6961.<br> If the fuse is intact, remove the fuse taking care not to damage in accordance with SWMS - AUS008 Removal of Friable Asbestos Containing LV HRC Fuses.<br><b>Stored and Quarantined Fuses:</b><br> Must be disposed of in accordance with SWMS - AUS008 Removal of Friable Asbestos Containing LV HRC Fuses. |

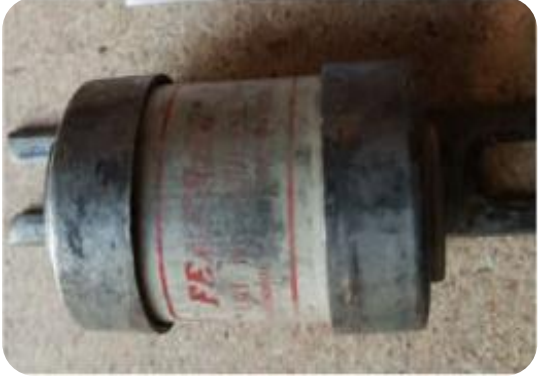
| Manufacturer | Rating | Fuse Body Photographs | Label Markings & Details | Result | Safety Instructions |
|---|---|---|---|---|---|
| Federal | 100 | | CAT.No.100 B 100,<br>CONTINUOUS RATED CURRENT<br>100 AMP, H.R.C, 440V-AC46,<br>CLASS 01, BS.88.1957, AS-C13?<br>P033768.003-AS019 | <br>Asbestos found | <b>In-Service Fuses:</b><br> If fuse is damaged, cease work and make safe. Contact the Hazmat Hotline - 02 9394 6961.<br> If the fuse is intact, remove the fuse taking care not to damage in accordance with SWMS - AUS008 Removal of Friable Asbestos Containing LV HRC Fuses.<br><b>Stored and Quarantined Fuses:</b><br> Must be disposed of in accordance with SWMS - AUS008 Removal of Friable Asbestos Containing LV HRC Fuses. |

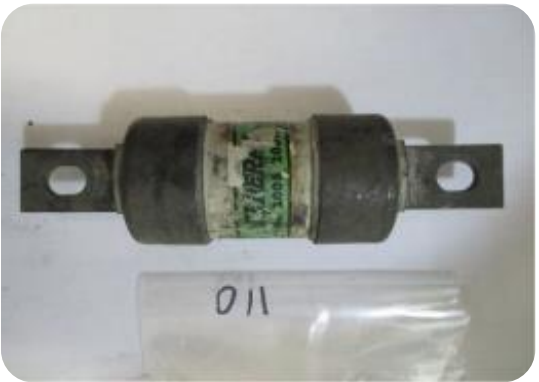
| Manufacturer | Rating | Fuse Body Photographs | Label Markings & Details | Result | Safety Instructions |
|---|---|---|---|---|---|
| Federal | 200 | | No 200B | <br>Asbestos found | <b>In-Service Fuses:</b><br> If fuse is damaged, cease work and make safe. Contact the Hazmat Hotline - 02 9394 6961.<br> If the fuse is intact, remove the fuse taking care not to damage in accordance with SWMS - AUS008 Removal of Friable Asbestos Containing LV HRC Fuses.<br><b>Stored and Quarantined Fuses:</b><br> Must be disposed of in accordance with SWMS - AUS008 Removal of Friable Asbestos Containing LV HRC Fuses. |

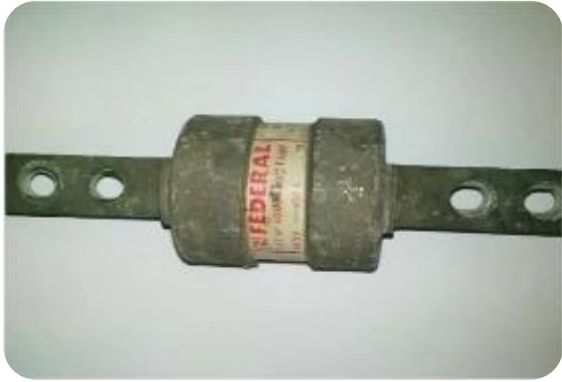
| Manufacturer | Rating | Fuse Body Photographs | Label Markings & Details | Result | Safety Instructions |
|---|---|---|---|---|---|
| Federal | 400 | | Cat. No. 40413 400C FAWP<br>400V-400A-01 | <br>No Asbestos found,<br>exercise caution and follow safety instructions | Where no manufacturer or date information can be confirmed and/or the fuse was manufactured prior to 2003, the <b>fuses should be presumed to contain asbestos and disposed</b> of in accordance with SWMS - AUS008 - Removal of Friable Asbestos Containing LV HRC Fuses. |

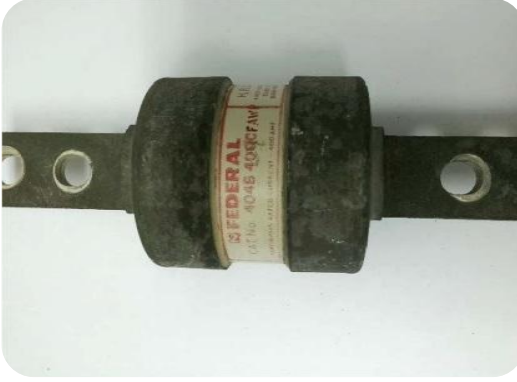
| Manufacturer | Rating | Fuse Body Photographs | Label Markings & Details | Result | Safety Instructions |
|---|---|---|---|---|---|
| Federal | 400 | | Cat. No. 40413 400C FAWP<br>440V-400A-01 | <br>No Asbestos found,<br>exercise caution and follow safety instructions | Where no manufacturer or date information can be confirmed and/or the fuse was manufactured prior to 2003, the <b>fuses should be presumed to contain asbestos and disposed</b> of in accordance with SWMS - AUS008 - Removal of Friable Asbestos Containing LV HRC Fuses. |

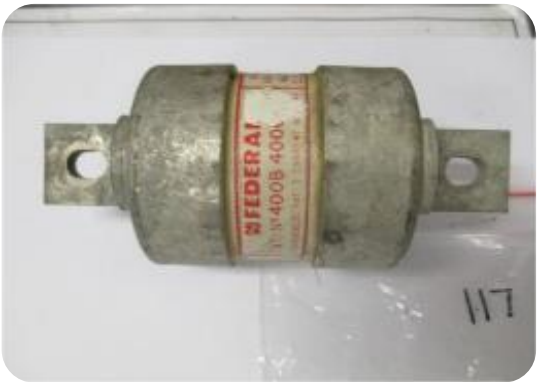
| Manufacturer | Rating | Fuse Body Photographs | Label Markings & Details | Result | Safety Instructions |
|---|---|---|---|---|---|
| Federal | 400 | | CAT No 400B | <br>No Asbestos found, exercise caution and follow safety instructions | Where no manufacturer or date information can be confirmed and/or the fuse was manufactured prior to 2003, the <b>fuses should be presumed to contain asbestos and disposed</b> of in accordance with SWMS - AUS008 - Removal of Friable Asbestos Containing LV HRC Fuses. |

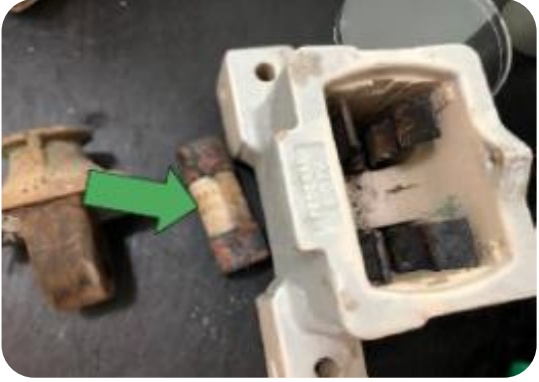
| Manufacturer | Rating | Fuse Body Photographs | Label Markings & Details | Result | Safety Instructions |
|---|---|---|---|---|---|
| Federal | | | Federal 601 FV | <br>No Asbestos found, exercise caution and follow safety instructions | Where no manufacturer or date information can be confirmed and/or the fuse was manufactured prior to 2003, the <b>fuses should be presumed to contain asbestos and disposed</b> of in accordance with SWMS - AUS008 - Removal of Friable Asbestos Containing LV HRC Fuses. |

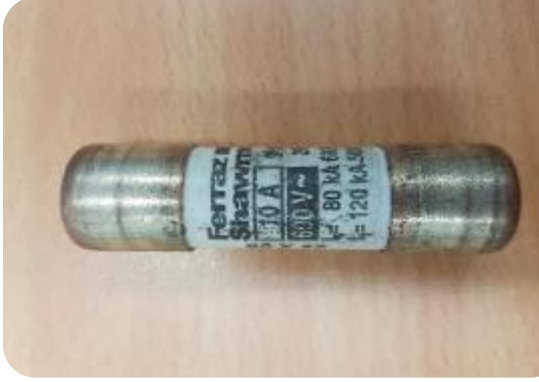
| Manufacturer | Rating | Fuse Body Photographs | Label Markings & Details | Result | Safety Instructions |
|---|---|---|---|---|---|
| Ferraz Shawmut | 10 | | T200761, 22x58, 10A, 690V~, I1=80kA 690V~, I1=120kA 500V~, IEC269-2-1, NFC63210 | <br>No Asbestos found, exercise caution and follow safety instructions | Where no manufacturer or date information can be confirmed and/or the fuse was manufactured prior to 2003, the <b>fuses should be presumed to contain asbestos and disposed</b> of in accordance with SWMS - AUS008 - Removal of Friable Asbestos Containing LV HRC Fuses. |

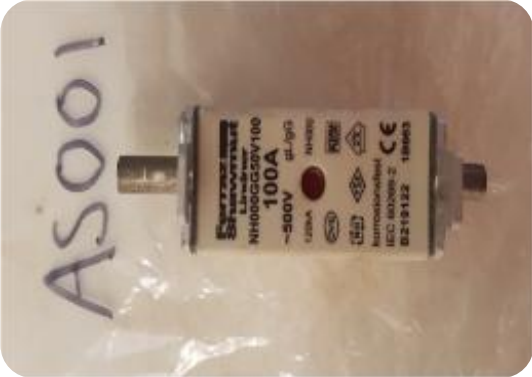
| Manufacturer | Rating | Fuse Body Photographs | Label Markings & Details | Result | Safety Instructions |
|---|---|---|---|---|---|
| Ferraz Shawmut | 100 | | Linder, NH000GG50V100, W05Y10GP, 100A, gL/gG, 120kA, NH000, korrosionsfest, IEC60269-2, B219122, 1B663 | <br>No Asbestos found, exercise caution and follow safety instructions | <br>Where no manufacturer or date information can be confirmed and/or the fuse was manufactured prior to 2003, the <b>fuses should be presumed to contain asbestos and disposed</b> of in accordance with SWMS - AUS008 - Removal of Friable Asbestos Containing LV HRC Fuses. |

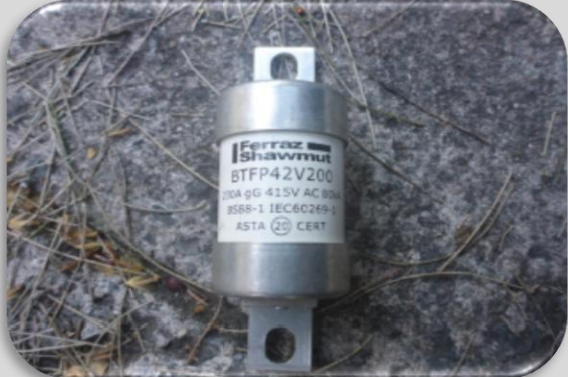
| Manufacturer | Rating | Fuse Body Photographs | Label Markings & Details | Result | Safety Instructions |
|---|---|---|---|---|---|
| Ferraz Shawmut | 200 | | BTFP42V200 415V 200 Amp AC 80kA | <br>No Asbestos found, exercise caution and follow safety instructions | <br>Where no manufacturer or date information can be confirmed and/or the fuse was manufactured prior to 2003, the <b>fuses should be presumed to contain asbestos and disposed</b> of in accordance with SWMS - AUS008 - Removal of Friable Asbestos Containing LV HRC Fuses. |
