## Network Standard

Document No : NW000-S0161

NS211 ANNEXURE G – LV HRC FUSE ASBESTOS PRODUCT GUIDE

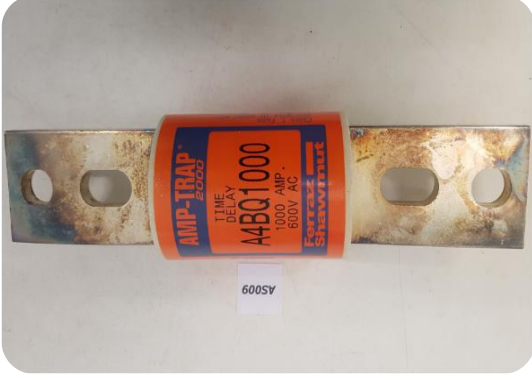
| Manufacturer | Rating | Fuse Body Photographs | Label Markings & Details | Result | Safety Instructions |
|---|---|---|---|---|---|
| Ferraz Shawmut | 1000 | | Amp-Trap 2000, Time Delay, 1000A, 600V AC, Class L Fuse, A4BQ1000, FP07-37, 200000A IR 500V DC 198L, current limiting 300000 IR 600V AC, | <br>No Asbestos found, exercise caution and follow safety instructions | <br>Where no manufacturer or date information can be confirmed and/or the fuse was manufactured prior to 2003, the <b>fuses should be presumed to contain asbestos and disposed</b> of in accordance with SWMS - AUS008 - Removal of Friable Asbestos Containing LV HRC Fuses. |

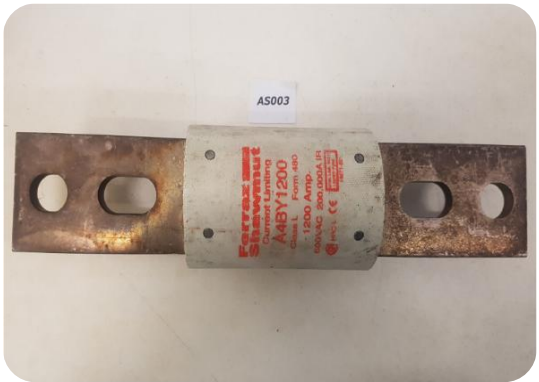
| Manufacturer | Rating | Fuse Body Photographs | Label Markings & Details | Result | Safety Instructions |
|---|---|---|---|---|---|
| Ferraz Shawmut | 1200 | | A4BY1200, 1200A, Class L, form 480, 200,000A IR | <br>No Asbestos found, exercise caution and follow safety instructions | Where no manufacturer or date information can be confirmed and/or the fuse was manufactured prior to 2003, the <b>fuses should be presumed to contain asbestos and disposed</b> of in accordance with SWMS - AUS008 - Removal of Friable Asbestos Containing LV HRC Fuses. |

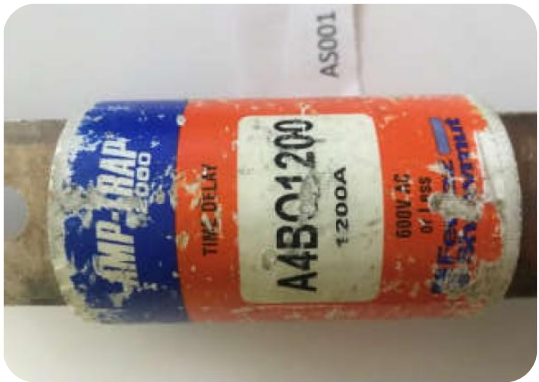
| Manufacturer | Rating | Fuse Body Photographs | Label Markings & Details | Result | Safety Instructions |
|---|---|---|---|---|---|
| Ferraz Shawmut | 1200 | | AMP-TRAP 2000, A4BO1200, 1200A, 600V AC or Less, Time Delay, Class L Fuse, 200,000A IR 600V AC, 100,000A IR 500V DC, Current Limiting, 300,000A IR 600V AC | <br>No Asbestos found, exercise caution and follow safety instructions | Where no manufacturer or date information can be confirmed and/or the fuse was manufactured prior to 2003, the <b>fuses should be presumed to contain asbestos and disposed</b> of in accordance with SWMS - AUS008 - Removal of Friable Asbestos Containing LV HRC Fuses. |

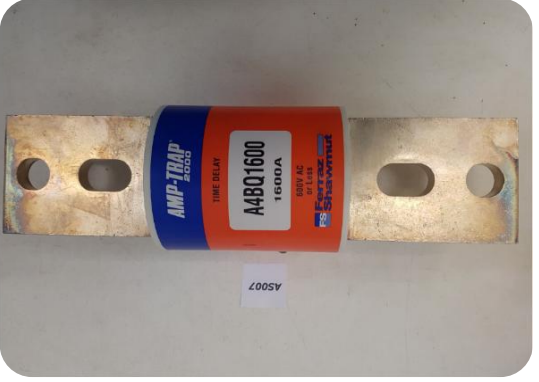
| Manufacturer | Rating | Fuse Body Photographs | Label Markings & Details | Result | Safety Instructions |
|---|---|---|---|---|---|
| Ferraz Shawmut | 1600 | | Amp-Trap 2000, Time Delay A4BQ1600, FP34-31, 1600A, Class L, 200000A IR 600V AC, 10000A IR 500V DC, current limiting, 300000A IR 600V AC | <br>No Asbestos found, exercise caution and follow safety instructions | Where no manufacturer or date information can be confirmed and/or the fuse was manufactured prior to 2003, the <b>fuses should be presumed to contain asbestos and disposed</b> of in accordance with SWMS - AUS008 - Removal of Friable Asbestos Containing LV HRC Fuses. |

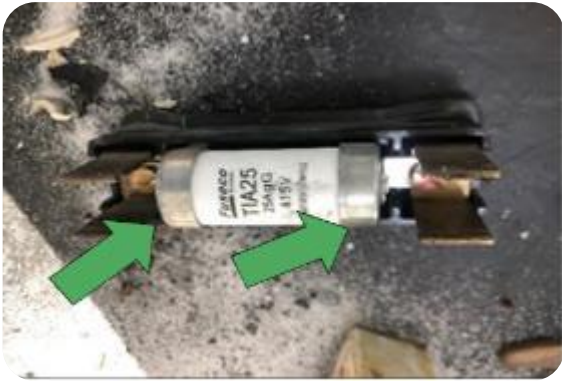
| Manufacturer | Rating | Fuse Body Photographs | Label Markings & Details | Result | Safety Instructions |
|---|---|---|---|---|---|
| Fuseco Rizner | 25 | | TIA25 / 25AgG/415C | <br>No Asbestos found,<br>exercise caution and follow safety instructions | Where no manufacturer or date information can be confirmed and/or the fuse was manufactured prior to 2003, the <b>fuses should be presumed to contain asbestos and disposed</b> of in accordance with SWMS - AUS008 - Removal of Friable Asbestos Containing LV HRC Fuses. |

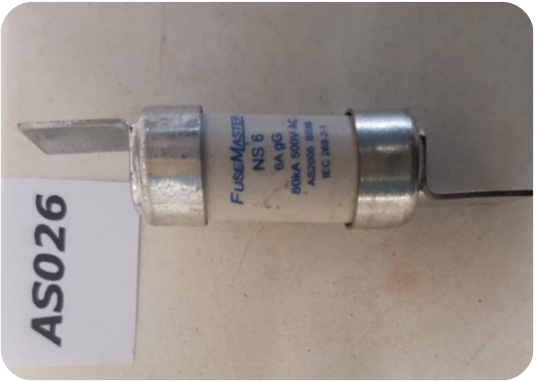
| Manufacturer | Rating | Fuse Body Photographs | Label Markings & Details | Result | Safety Instructions |
|---|---|---|---|---|---|
| FuseMaster | 6 | | NS6, gG, 6A, 80kA, AS2005, BS88, IEC269-2-1 | <br>Current Stock Item | <ul style="list-style-type: none"> <li>✓ Manufacturers declaration that fuses do not contain asbestos.</li> <li>✓ May be used and disposed of as normal.</li> <li>✓ When disposing of LV HRC Fuses treat all fuses as asbestos waste.</li> </ul> |

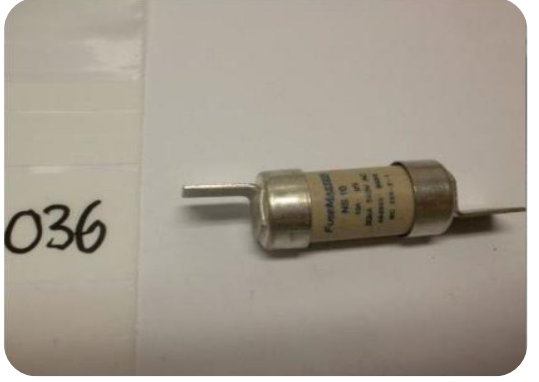
| Manufacturer | Rating | Fuse Body Photographs | Label Markings & Details | Result | Safety Instructions |
|---|---|---|---|---|---|
| Fusemaster | 10 | | NS10, gG, 80kA, AC | <br>No Asbestos found | <ul style="list-style-type: none"> <li>✓ May be used as normal.</li> <li>✓ When disposing of LV HRC Fuses treat all fuses as asbestos waste.</li> </ul> |

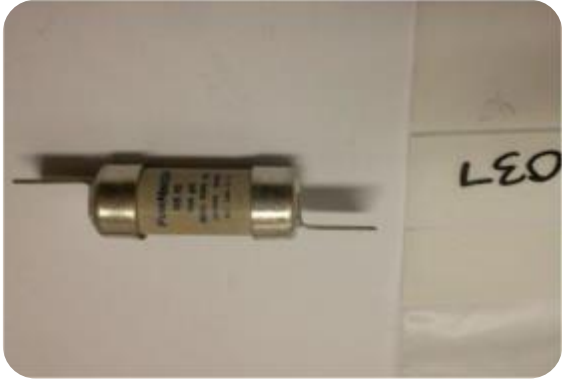
| Manufacturer | Rating | Fuse Body Photographs | Label Markings & Details | Result | Safety Instructions |
|---|---|---|---|---|---|
| FuseMaster | 10 | <br>54287-002-037 | NS10, gG, 80kA, 500V ac, | ✓<br>Current<br>Stock Item | ✓ Manufacturers declaration that fuses do not contain asbestos.<br>✓ May be used and disposed of as normal.<br>✓ When disposing of LV HRC Fuses treat all fuses as asbestos waste. |

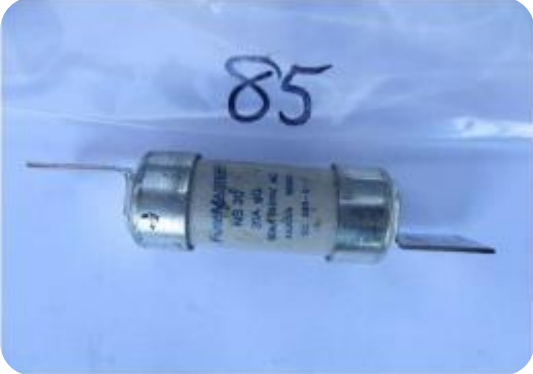
| Manufacturer | Rating | Fuse Body Photographs | Label Markings & Details | Result | Safety Instructions |
|---|---|---|---|---|---|
| FuseMaster | 20 | <br>54287-001-085 | NS20 20A GG | ✓<br>Current<br>Stock Item | ✓ Manufacturers declaration that fuses do not contain asbestos.<br>✓ May be used and disposed of as normal.<br>✓ When disposing of LV HRC Fuses treat all fuses as asbestos waste. |

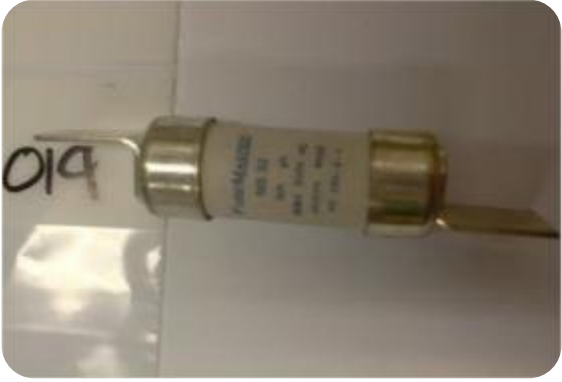
| Manufacturer | Rating | Fuse Body Photographs | Label Markings & Details | Result | Safety Instructions |
|---|---|---|---|---|---|
| FuseMaster | 32 | <br>54287-002-019 | NS32, gG, 80kA, 50V ac, | ✓<br>Current<br>Stock Item | ✓ Manufacturers declaration that fuses do not contain asbestos.<br>✓ May be used and disposed of as normal.<br>✓ When disposing of LV HRC Fuses treat all fuses as asbestos waste. |

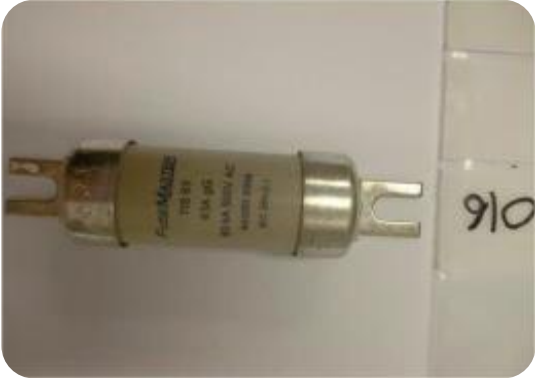
| Manufacturer | Rating | Fuse Body Photographs | Label Markings & Details | Result | Safety Instructions |
|---|---|---|---|---|---|
| Fusemaster | 63 | | TIS63, 63A gG, 80kA, 500 V ac, 150521 | <br>Current Stock Item | ✓ Manufacturers declaration that fuses do not contain asbestos.<br>✓ May be used and disposed of as normal.<br>✓ When disposing of LV HRC Fuses treat all fuses as asbestos waste. |

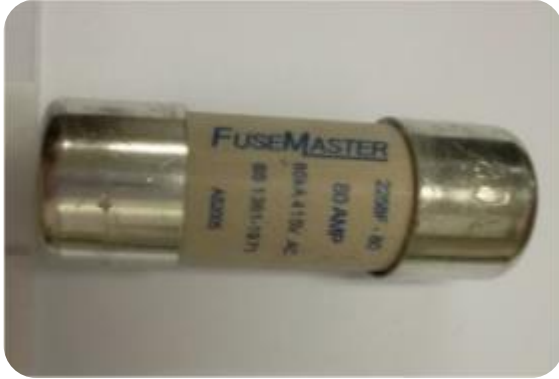
| Manufacturer | Rating | Fuse Body Photographs | Label Markings & Details | Result | Safety Instructions |
|---|---|---|---|---|---|
| Fusemaster | 80 | | 2258F-80, 80A, 80kA, 415V ac, 150425 | <br>Current Stock Item | ✓ Manufacturers declaration that fuses do not contain asbestos.<br>✓ May be used and disposed of as normal.<br>✓ When disposing of LV HRC Fuses treat all fuses as asbestos waste. |

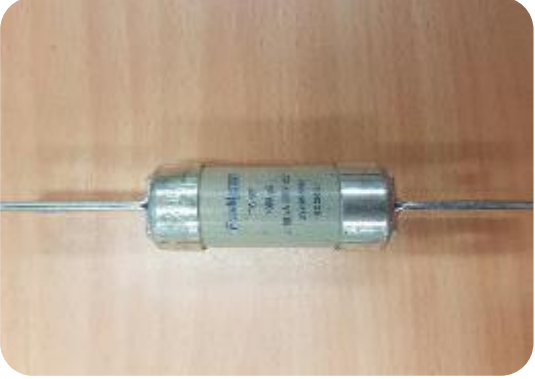
| Manufacturer | Rating | Fuse Body Photographs | Label Markings & Details | Result | Safety Instructions |
|---|---|---|---|---|---|
| FuseMaster | 100 | | TC100, 100 A gG, 80 kA 500V AC, AS2005 BS88, IEC 269-2-1 | <br>Current Stock Item | ✓ Manufacturers declaration that fuses do not contain asbestos.<br>✓ May be used and disposed of as normal.<br>✓ When disposing of LV HRC Fuses treat all fuses as asbestos waste. |

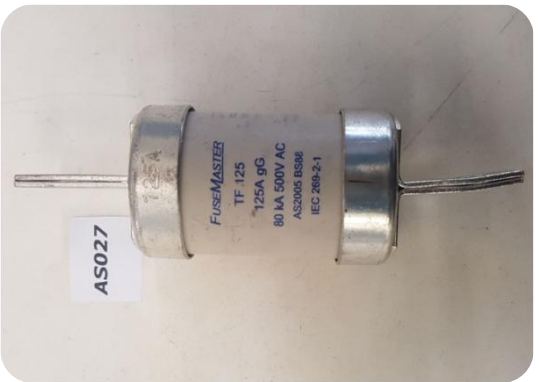
| Manufacturer | Rating | Fuse Body Photographs | Label Markings & Details | Result | Safety Instructions |
|---|---|---|---|---|---|
| FuseMaster | 125 | | TF125, gG, 125A, 80kA, AS2005, BS88, IEC 269-2-1 | <br>Current Stock Item | ✓ Manufacturers declaration that fuses do not contain asbestos.<br>✓ May be used and disposed of as normal.<br>✓ When disposing of LV HRC Fuses treat all fuses as asbestos waste. |

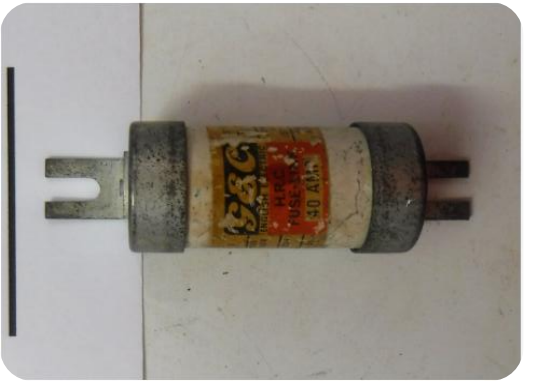
| Manufacturer | Rating | Fuse Body Photographs | Label Markings & Details | Result | Safety Instructions |
|---|---|---|---|---|---|
| G&C | 40 | | TIS40, 40A, B.S.88-2, Complies with IEC 269-2, AC80, 250V40, Class Q1 | <br>No Asbestos found, exercise caution and follow safety instructions | Where no manufacturer or date information can be confirmed and/or the fuse was manufactured prior to 2003, the <b>fuses should be presumed to contain asbestos and disposed</b> of in accordance with SWMS - AUS008 - Removal of Friable Asbestos Containing LV HRC Fuses. |

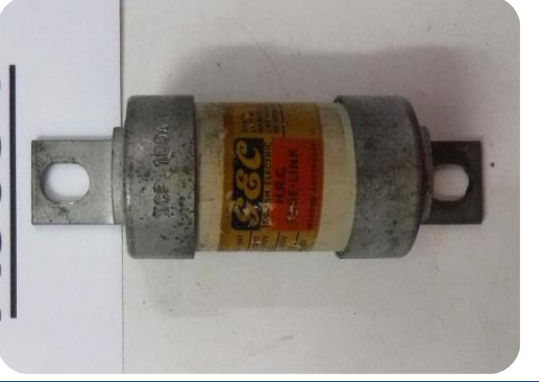
| Manufacturer | Rating | Fuse Body Photographs | Label Markings & Details | Result | Safety Instructions |
|---|---|---|---|---|---|
| G&C | 100 | | TCP, 100A, B.S. 88, 80A, 250DC40, Class Q1 | <br>Asbestos found | <b>In-Service Fuses:</b><br>⊗ If fuse is damaged, cease work and make safe. Contact the Hazmat Hotline - 02 9394 6961.<br>⊗ If the fuse is intact, remove the fuse taking care not to damage in accordance with SWMS - AUS008 Removal of Friable Asbestos Containing LV HRC Fuses.<br><b>Stored and Quarantined Fuses:</b><br>⊗ Must be disposed of in accordance with SWMS - AUS008 Removal of Friable Asbestos Containing LV HRC Fuses. |

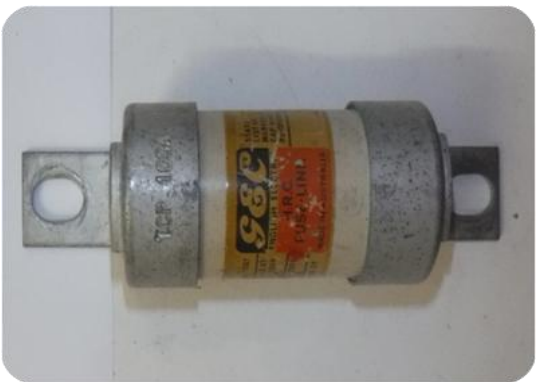
| Manufacturer | Rating | Fuse Body Photographs | Label Markings & Details | Result | Safety Instructions |
|---|---|---|---|---|---|
| G&C | 100 | | TCP, 100A, B.S. 88, 80A, 250DC40, Class Q1 | <br>Asbestos found | <b>In-Service Fuses:</b><br>⊗ If fuse is damaged, cease work and make safe. Contact the Hazmat Hotline - 02 9394 6961.<br>⊗ If the fuse is intact, remove the fuse taking care not to damage in accordance with SWMS - AUS008 Removal of Friable Asbestos Containing LV HRC Fuses.<br><b>Stored and Quarantined Fuses:</b><br>⊗ Must be disposed of in accordance with SWMS - AUS008 Removal of Friable Asbestos Containing LV HRC Fuses. |

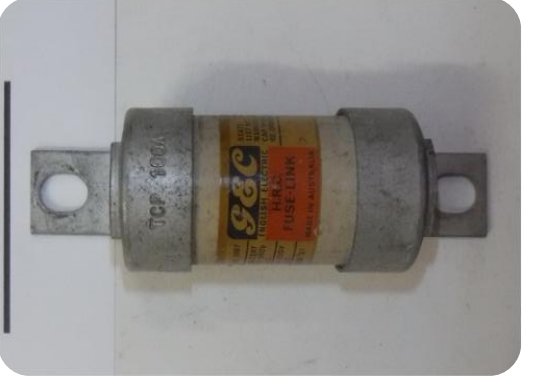
| Manufacturer | Rating | Fuse Body Photographs | Label Markings & Details | Result | Safety Instructions |
|---|---|---|---|---|---|
| G&C | 100 | | TCP, 100A, B.S. 88, 80A, 250DC40, Class Q1 | <br>Asbestos found | <b>In-Service Fuses:</b><br>⊗ If fuse is damaged, cease work and make safe. Contact the Hazmat Hotline - 02 9394 6961.<br>⊗ If the fuse is intact, remove the fuse taking care not to damage in accordance with SWMS - AUS008 Removal of Friable Asbestos Containing LV HRC Fuses.<br><b>Stored and Quarantined Fuses:</b><br>⊗ Must be disposed of in accordance with SWMS - AUS008 Removal of Friable Asbestos Containing LV HRC Fuses. |

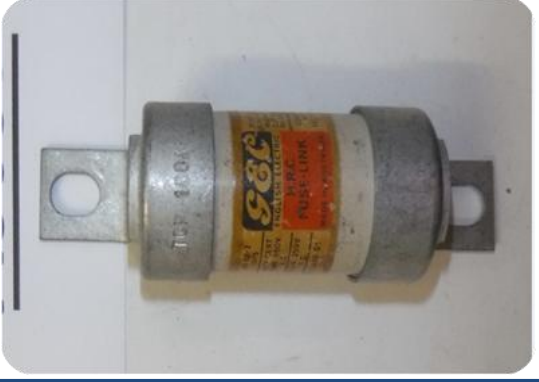
| Manufacturer | Rating | Fuse Body Photographs | Label Markings & Details | Result | Safety Instructions |
|---|---|---|---|---|---|
| G&C | 100 | | TCP, 100A, B.S. 88, 80A, 250DC40, Class Q1 | <br>Asbestos found | <b>In-Service Fuses:</b><br>⊗ If fuse is damaged, cease work and make safe. Contact the Hazmat Hotline - 02 9394 6961.<br>⊗ If the fuse is intact, remove the fuse taking care not to damage in accordance with SWMS - AUS008 Removal of Friable Asbestos Containing LV HRC Fuses.<br><b>Stored and Quarantined Fuses:</b><br>⊗ Must be disposed of in accordance with SWMS - AUS008 Removal of Friable Asbestos Containing LV HRC Fuses. |

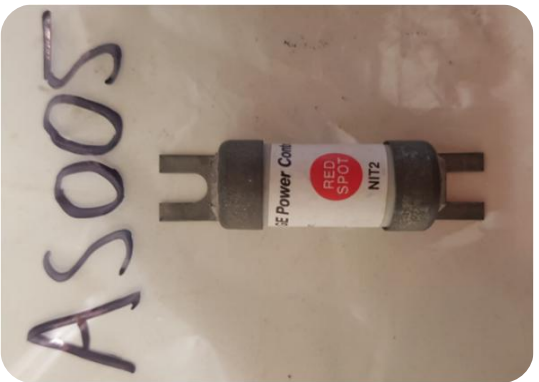
| Manufacturer | Rating | Fuse Body Photographs | Label Markings & Details | Result | Safety Instructions |
|---|---|---|---|---|---|
| GE Power Controls | 2 | | Red spot, NIT2, 2A, 80kA, 40kA 250V DC, type gG, asta 20 cert, BS88-2 1988, IEC269-2-1 | <br>No Asbestos found, exercise caution and follow safety instructions | Where no manufacturer or date information can be confirmed and/or the fuse was manufactured prior to 2003, the <b>fuses should be presumed to contain asbestos and disposed</b> of in accordance with SWMS - AUS008 - Removal of Friable Asbestos Containing LV HRC Fuses. |

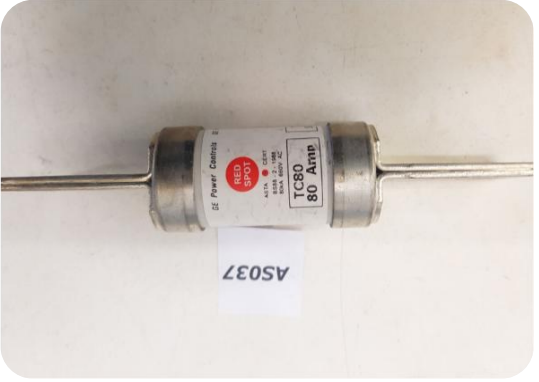
| Manufacturer | Rating | Fuse Body Photographs | Label Markings & Details | Result | Safety Instructions |
|---|---|---|---|---|---|
| GE Power Controls | 80 | | TC80, type gG, 80A, BS99-2-1988, 80kA, 40kA 350V DC, IEC 269-2-1 | <br>No Asbestos found, exercise caution and follow safety instructions | Where no manufacturer or date information can be confirmed and/or the fuse was manufactured prior to 2003, the <b>fuses should be presumed to contain asbestos and disposed</b> of in accordance with SWMS - AUS008 - Removal of Friable Asbestos Containing LV HRC Fuses. |

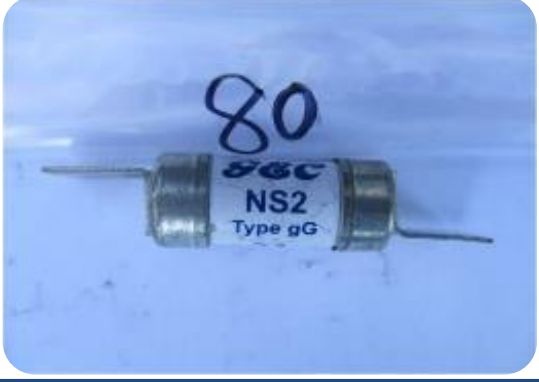
| Manufacturer | Rating | Fuse Body Photographs | Label Markings & Details | Result | Safety Instructions |
|---|---|---|---|---|---|
| GEC | 2 | | NS2 GG | <br>No Asbestos found, exercise caution and follow safety instructions | Where no manufacturer or date information can be confirmed and/or the fuse was manufactured prior to 2003, the <b>fuses should be presumed to contain asbestos and disposed</b> of in accordance with SWMS - AUS008 - Removal of Friable Asbestos Containing LV HRC Fuses. |

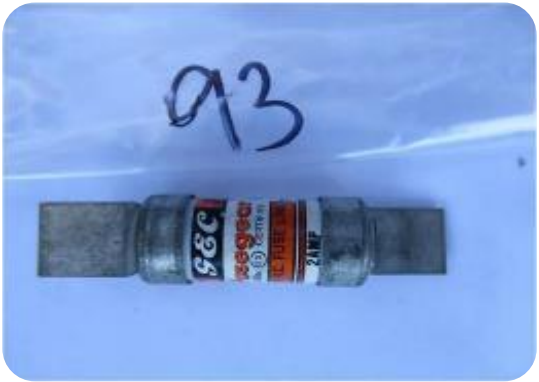
| Manufacturer | Rating | Fuse Body Photographs | Label Markings & Details | Result | Safety Instructions |
|---|---|---|---|---|---|
| GEC | 2 | | NS2 | <br>No Asbestos found, exercise caution and follow safety instructions | Where no manufacturer or date information can be confirmed and/or the fuse was manufactured prior to 2003, the <b>fuses should be presumed to contain asbestos and disposed</b> of in accordance with SWMS - AUS008 - Removal of Friable Asbestos Containing LV HRC Fuses. |

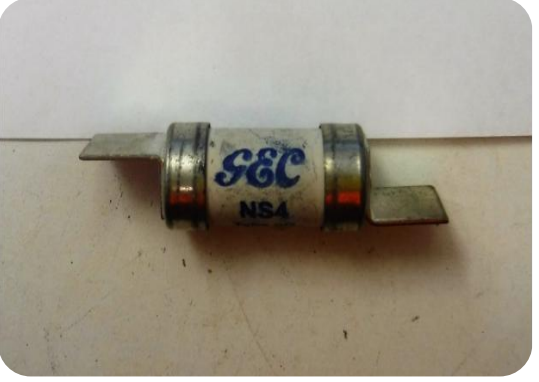
| Manufacturer | Rating | Fuse Body Photographs | Label Markings & Details | Result | Safety Instructions |
|---|---|---|---|---|---|
| GEC | 4 | | NS4, 4A, B.S.88:6, 80A, AS2005.29, type gG | <br>No Asbestos found | ✓ May be used as normal.<br>✓ When disposing of LV HRC Fuses treat all fuses as asbestos waste. |

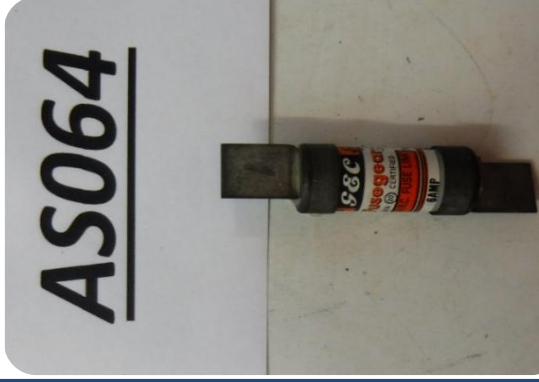
| Manufacturer | Rating | Fuse Body Photographs | Label Markings & Details | Result | Safety Instructions |
|---|---|---|---|---|---|
| GEC | 6 | | NS6, 6A, BS88-1, 80A, Complies with AS 2005-1, Class Q1, Pat no. 2061639 | <br>No Asbestos found, exercise caution and follow safety instructions | Where no manufacturer or date information can be confirmed and/or the fuse was manufactured prior to 2003, the <b>fuses should be presumed to contain asbestos and disposed</b> of in accordance with SWMS - AUS008 - Removal of Friable Asbestos Containing LV HRC Fuses. |

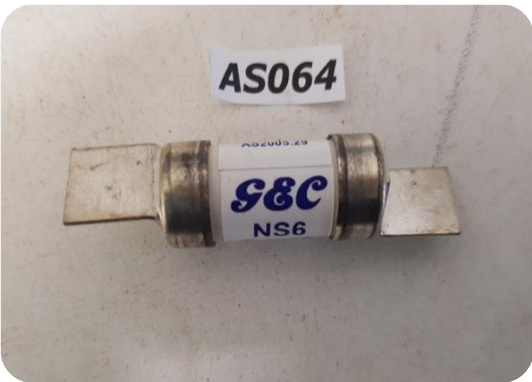
| Manufacturer | Rating | Fuse Body Photographs | Label Markings & Details | Result | Safety Instructions |
|---|---|---|---|---|---|
| GEC | 6 | | NS6, gG, 6A, Asta 20 cert,<br>BS88:6:1988, 80kA, AS2005.29,<br>gG<br>174783-001-AS064 | <br>No Asbestos found,<br>exercise caution and follow safety instructions | Where no manufacturer or date information can be confirmed and/or the fuse was manufactured prior to 2003, the <b>fuses should be presumed to contain asbestos and disposed</b> of in accordance with SWMS - AUS008 - Removal of Friable Asbestos Containing LV HRC Fuses. |

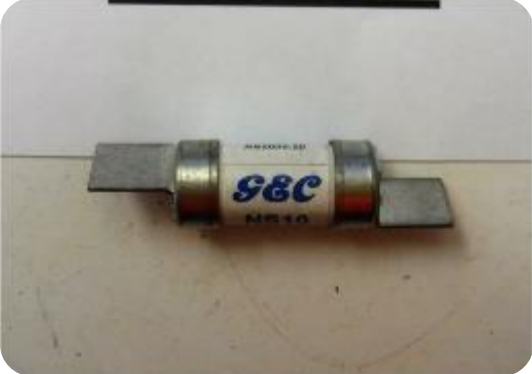
| Manufacturer | Rating | Fuse Body Photographs | Label Markings & Details | Result | Safety Instructions |
|---|---|---|---|---|---|
| GEC | 10 | | NS10, 10A, B.S.88:6, 80A,<br>AS2005.29, type gG<br>168273-62 | <br>Current Stock Item | ✓ May be used as normal.<br>✓ When disposing of LV HRC Fuses treat all fuses as asbestos waste. |

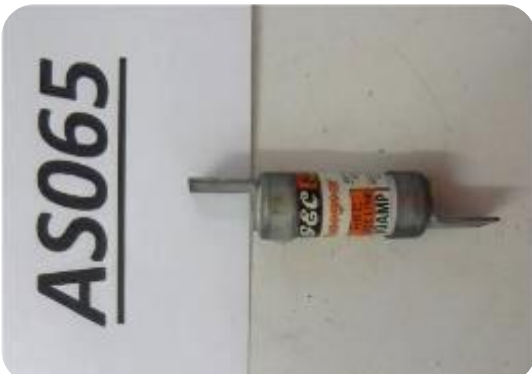
| Manufacturer | Rating | Fuse Body Photographs | Label Markings & Details | Result | Safety Instructions |
|---|---|---|---|---|---|
| GEC | 10 | | NS10, 10A, BS88-1, 80A,<br>Complies with AS 2005-1, Class Q1, Pat no. 2061639<br>168273-65 | <br>No Asbestos found,<br>exercise caution and follow safety instructions | Where no manufacturer or date information can be confirmed and/or the fuse was manufactured prior to 2003, the <b>fuses should be presumed to contain asbestos and disposed</b> of in accordance with SWMS - AUS008 - Removal of Friable Asbestos Containing LV HRC Fuses. |

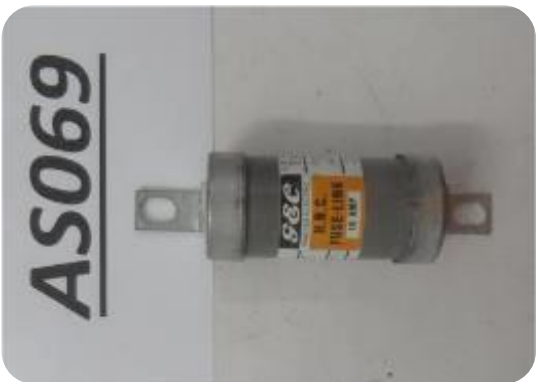
| Manufacturer | Rating | Fuse Body Photographs | Label Markings & Details | Result | Safety Instructions |
|---|---|---|---|---|---|
| GEC | 10 | <p>AS069</p> <p>168273-69</p> | TIA 10, 10A, B.S.88-2, Complies with IEC 269-2, AC80, 250DC40, Class Q1 | <p>No Asbestos found, exercise caution and follow safety instructions</p> | <p>Where no manufacturer or date information can be confirmed and/or the fuse was manufactured prior to 2003, the <b>fuses should be presumed to contain asbestos and disposed</b> of in accordance with SWMS - AUS008 - Removal of Friable Asbestos Containing LV HRC Fuses.</p> |

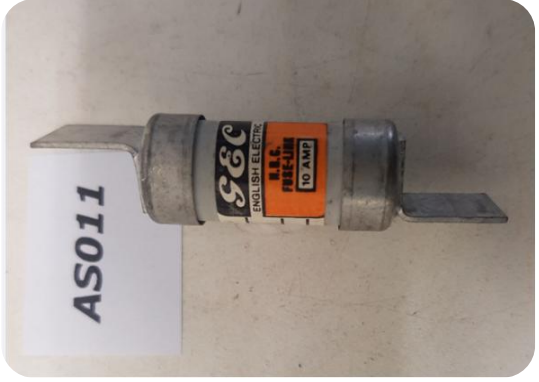
| Manufacturer | Rating | Fuse Body Photographs | Label Markings & Details | Result | Safety Instructions |
|---|---|---|---|---|---|
| GEC | 10 | <p>AS011</p> <p>174102-001-AS011</p> | NS10, 10A, BS 88-2 1975, Asta cert 80kA 415V AC, 40kA 250V DC, Class Q1, complies with IEC 269-2 | <p>No Asbestos found, exercise caution and follow safety instructions</p> | <p>Where no manufacturer or date information can be confirmed and/or the fuse was manufactured prior to 2003, the <b>fuses should be presumed to contain asbestos and disposed</b> of in accordance with SWMS - AUS008 - Removal of Friable Asbestos Containing LV HRC Fuses.</p> |

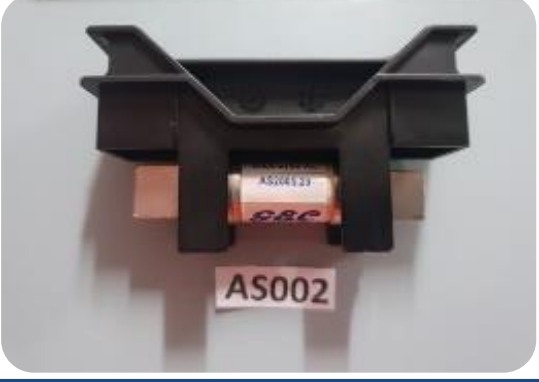
| Manufacturer | Rating | Fuse Body Photographs | Label Markings & Details | Result | Safety Instructions |
|---|---|---|---|---|---|
| GEC | 10 | <p>AS002</p> <p>P033786.002-AS012</p> | NS10, Type gG, 10A, Asta20 cert, BS88:6:1988, 80kA, AS2005.29 | <p>No Asbestos found, exercise caution and follow safety instructions</p> | <p>Where no manufacturer or date information can be confirmed and/or the fuse was manufactured prior to 2003, the <b>fuses should be presumed to contain asbestos and disposed</b> of in accordance with SWMS - AUS008 - Removal of Friable Asbestos Containing LV HRC Fuses.</p> |

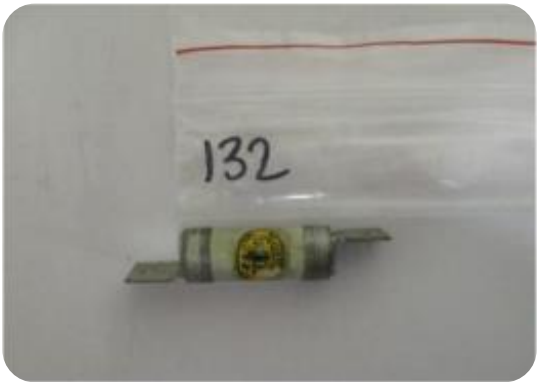
| Manufacturer | Rating | Fuse Body Photographs | Label Markings & Details | Result | Safety Instructions |
|---|---|---|---|---|---|
| GEC | 10 | | Y10PF<br>54287-001-132 | <br>Asbestos found | <b>In-Service Fuses:</b><br> If fuse is damaged, cease work and make safe. Contact the Hazmat Hotline - 02 9394 6961.<br> If the fuse is intact, remove the fuse taking care not to damage in accordance with SWMS - AUS008 Removal of Friable Asbestos Containing LV HRC Fuses.<br><b>Stored and Quarantined Fuses:</b><br> Must be disposed of in accordance with SWMS - AUS008 Removal of Friable Asbestos Containing LV HRC Fuses. |

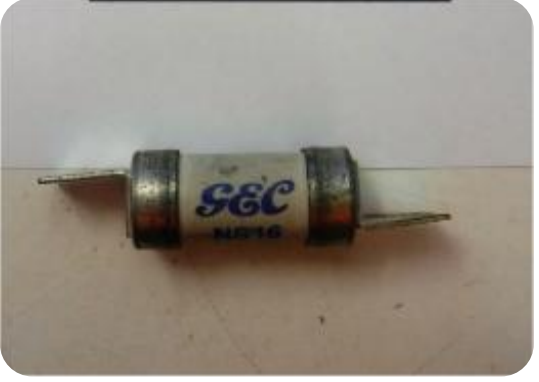
| Manufacturer | Rating | Fuse Body Photographs | Label Markings & Details | Result | Safety Instructions |
|---|---|---|---|---|---|
| GEC | 16 | | NS16, 16A, B.S.88:6, 80A, AS2005.29, type gG<br>168273-63 | <br>Current Stock Item | May be used as normal.<br> When disposing of LV HRC Fuses treat all fuses as asbestos waste. |

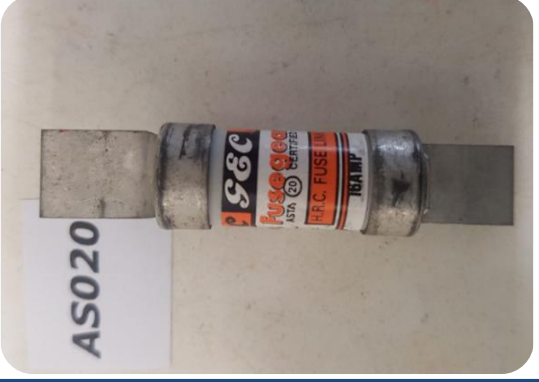
| Manufacturer | Rating | Fuse Body Photographs | Label Markings & Details | Result | Safety Instructions |
|---|---|---|---|---|---|
| GEC | 16 | | NS16, 2061639, 16A, Class Q1, BS88-1 1975 , 80kA, AS2005-1<br>174102-001-AS020 | <br>No Asbestos found, exercise caution and follow safety instructions | Where no manufacturer or date information can be confirmed and/or the fuse was manufactured prior to 2003, the <b>fuses should be presumed to contain asbestos and disposed</b> of in accordance with SWMS - AUS008 - Removal of Friable Asbestos Containing LV HRC Fuses. |

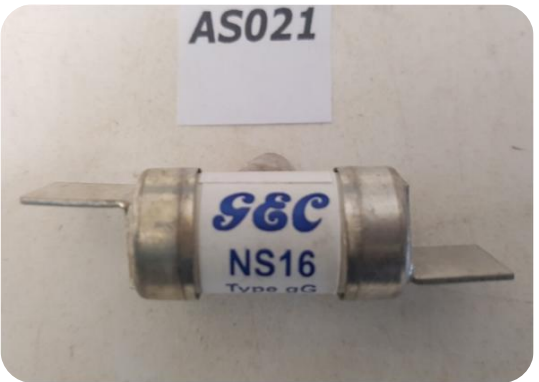
| Manufacturer | Rating | Fuse Body Photographs | Label Markings & Details | Result | Safety Instructions |
|---|---|---|---|---|---|
| GEC | 16 | | NS16, type gG, 16A,<br>BS88:6:1988, 80kA, AS2005.29 | <br>No Asbestos found,<br>exercise caution and follow safety instructions | Where no manufacturer or date information can be confirmed and/or the fuse was manufactured prior to 2003, the <b>fuses should be presumed to contain asbestos and disposed</b> of in accordance with SWMS - AUS008 - Removal of Friable Asbestos Containing LV HRC Fuses. |

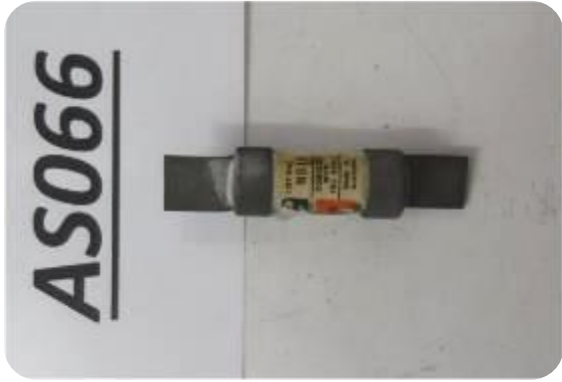
| Manufacturer | Rating | Fuse Body Photographs | Label Markings & Details | Result | Safety Instructions |
|---|---|---|---|---|---|
| GEC | 16 | | NS16, 16A, Complies with IEC 269-2 (label torn) | <br>Asbestos found | <b>In-Service Fuses:</b><br> If fuse is damaged, cease work and make safe. Contact the Hazmat Hotline - 02 9394 6961.<br> If the fuse is intact, remove the fuse taking care not to damage in accordance with SWMS - AUS008 Removal of Friable Asbestos Containing LV HRC Fuses.<br><b>Stored and Quarantined Fuses:</b><br> Must be disposed of in accordance with SWMS - AUS008 Removal of Friable Asbestos Containing LV HRC Fuses. |

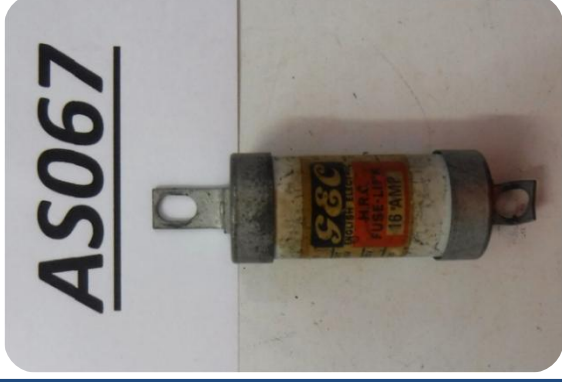
| Manufacturer | Rating | Fuse Body Photographs | Label Markings & Details | Result | Safety Instructions |
|---|---|---|---|---|---|
| GEC | 16 | | TIA 16, 16A, B.S.88-2, Complies with IEC 269-2, AC80, 250DC40, Class Q1 | <br>Asbestos found | <b>In-Service Fuses:</b><br> If fuse is damaged, cease work and make safe. Contact the Hazmat Hotline - 02 9394 6961.<br> If the fuse is intact, remove the fuse taking care not to damage in accordance with SWMS - AUS008 Removal of Friable Asbestos Containing LV HRC Fuses.<br><b>Stored and Quarantined Fuses:</b><br> Must be disposed of in accordance with SWMS - AUS008 Removal of Friable Asbestos Containing LV HRC Fuses. |

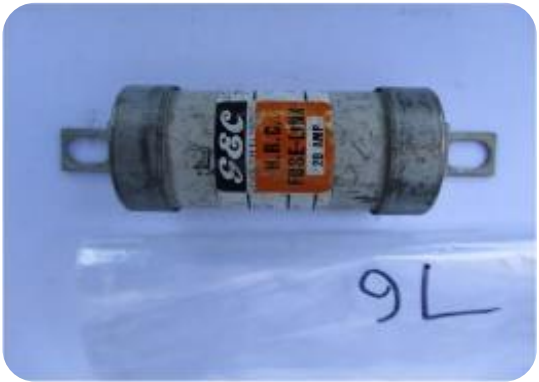
| Manufacturer | Rating | Fuse Body Photographs | Label Markings & Details | Result | Safety Instructions |
|---|---|---|---|---|---|
| GEC | 20 | | TIA20 | <br>No Asbestos found, exercise caution and follow safety instructions | Where no manufacturer or date information can be confirmed and/or the fuse was manufactured prior to 2003, the <b>fuses should be presumed to contain asbestos and disposed</b> of in accordance with SWMS - AUS008 - Removal of Friable Asbestos Containing LV HRC Fuses. |

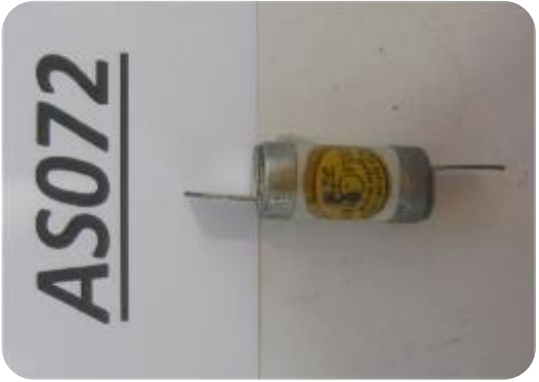
| Manufacturer | Rating | Fuse Body Photographs | Label Markings & Details | Result | Safety Instructions |
|---|---|---|---|---|---|
| GEC | 20 | | Y20QF, 20A, B.S.88, AC5 | <br>Asbestos found | <b>In-Service Fuses:</b><br> If fuse is damaged, cease work and make safe. Contact the Hazmat Hotline - 02 9394 6961.<br> If the fuse is intact, remove the fuse taking care not to damage in accordance with SWMS - AUS008 Removal of Friable Asbestos Containing LV HRC Fuses.<br><b>Stored and Quarantined Fuses:</b><br> Must be disposed of in accordance with SWMS - AUS008 Removal of Friable Asbestos Containing LV HRC Fuses. |

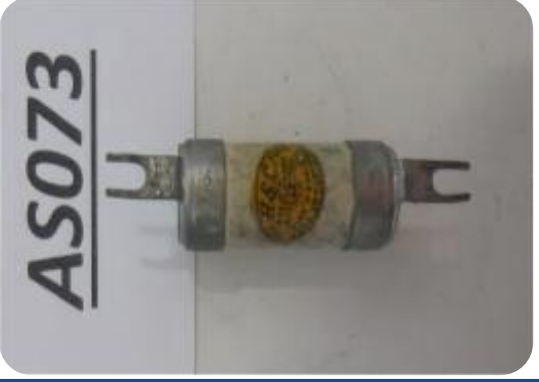
| Manufacturer | Rating | Fuse Body Photographs | Label Markings & Details | Result | Safety Instructions |
|---|---|---|---|---|---|
| GEC | 30 | | Y30RA, 30A, B.S.88, AC5, 460DC4, | <br>Asbestos found | <b>In-Service Fuses:</b><br> If fuse is damaged, cease work and make safe. Contact the Hazmat Hotline - 02 9394 6961.<br> If the fuse is intact, remove the fuse taking care not to damage in accordance with SWMS - AUS008 Removal of Friable Asbestos Containing LV HRC Fuses.<br><b>Stored and Quarantined Fuses:</b><br> Must be disposed of in accordance with SWMS - AUS008 Removal of Friable Asbestos Containing LV HRC Fuses. |

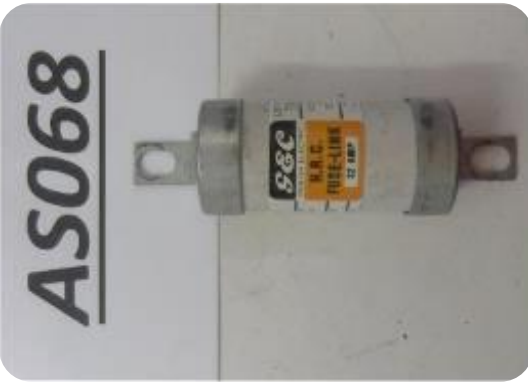
| Manufacturer | Rating | Fuse Body Photographs | Label Markings & Details | Result | Safety Instructions |
|---|---|---|---|---|---|
| GEC | 32 | | TIA 32, 32A, B.S.88-2, Complies with IEC 269-2, AC80, 250DC40, Class Q1 | <br>No Asbestos found, exercise caution and follow safety instructions | Where no manufacturer or date information can be confirmed and/or the fuse was manufactured prior to 2003, the <b>fuses should be presumed to contain asbestos and disposed</b> of in accordance with SWMS - AUS008 - Removal of Friable Asbestos Containing LV HRC Fuses. |

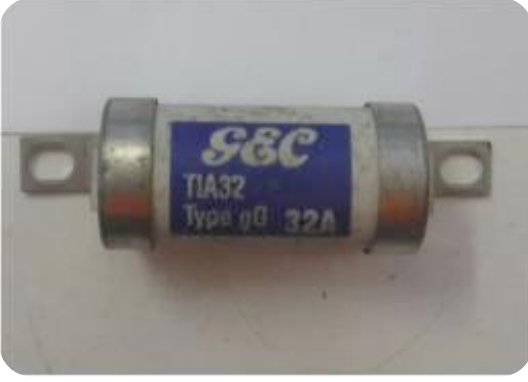
| Manufacturer | Rating | Fuse Body Photographs | Label Markings & Details | Result | Safety Instructions |
|---|---|---|---|---|---|
| GEC | 32 | | TIA 32, 32A, B.S.88:2, 80A, 460DC40, AS2005:21.2, type gG | <br>No Asbestos found, exercise caution and follow safety instructions | Where no manufacturer or date information can be confirmed and/or the fuse was manufactured prior to 2003, the <b>fuses should be presumed to contain asbestos and disposed</b> of in accordance with SWMS - AUS008 - Removal of Friable Asbestos Containing LV HRC Fuses. |

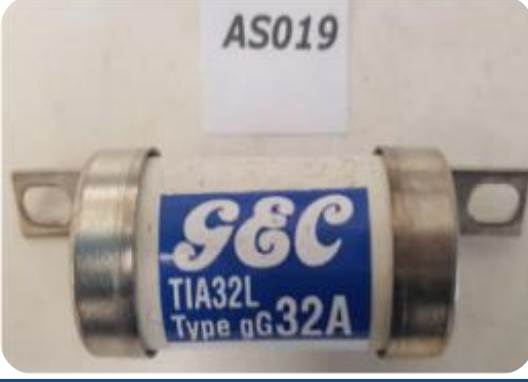
| Manufacturer | Rating | Fuse Body Photographs | Label Markings & Details | Result | Safety Instructions |
|---|---|---|---|---|---|
| GEC | 32 | | TIA32L, type gG, 32A, BS88:2:1988, 80kA, AS2005.21.2 | <br>No Asbestos found, exercise caution and follow safety instructions | Where no manufacturer or date information can be confirmed and/or the fuse was manufactured prior to 2003, the <b>fuses should be presumed to contain asbestos and disposed</b> of in accordance with SWMS - AUS008 - Removal of Friable Asbestos Containing LV HRC Fuses. |

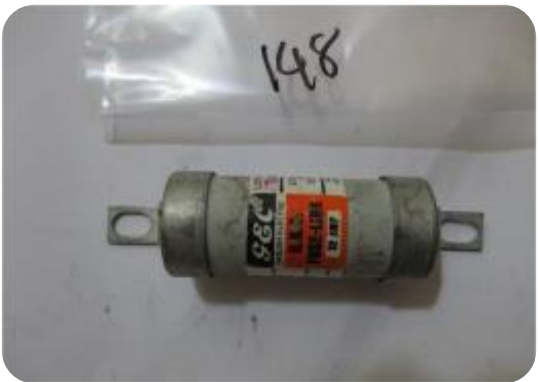
| Manufacturer | Rating | Fuse Body Photographs | Label Markings & Details | Result | Safety Instructions |
|---|---|---|---|---|---|
| GEC | 32 | | English Electric TIA 32 | <br>No Asbestos found, exercise caution and follow safety instructions | Where no manufacturer or date information can be confirmed and/or the fuse was manufactured prior to 2003, the <b>fuses should be presumed to contain asbestos and disposed</b> of in accordance with SWMS - AUS008 - Removal of Friable Asbestos Containing LV HRC Fuses. |

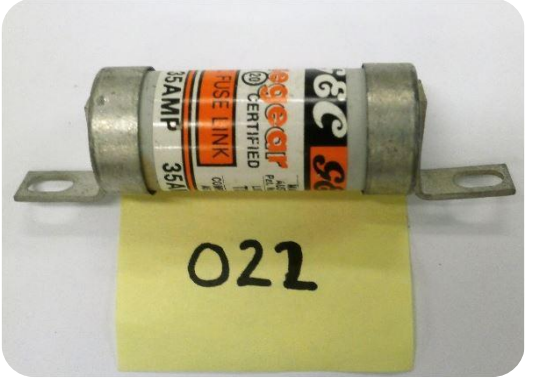
| Manufacturer | Rating | Fuse Body Photographs | Label Markings & Details | Result | Safety Instructions |
|---|---|---|---|---|---|
| GEC | 35 | | Fusegear, Asta 20 Cert, HRC Fuse link, Class Q1, | <br>No Asbestos found, exercise caution and follow safety instructions | Where no manufacturer or date information can be confirmed and/or the fuse was manufactured prior to 2003, the <b>fuses should be presumed to contain asbestos and disposed</b> of in accordance with SWMS - AUS008 - Removal of Friable Asbestos Containing LV HRC Fuses. |

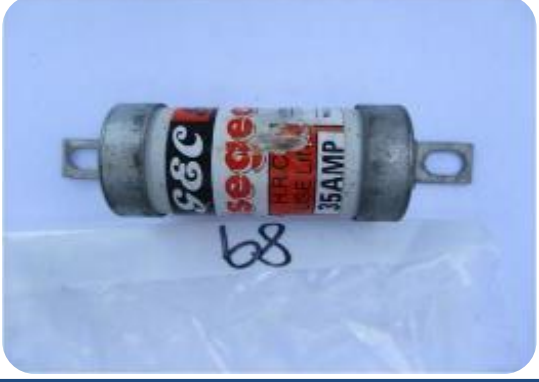
| Manufacturer | Rating | Fuse Body Photographs | Label Markings & Details | Result | Safety Instructions |
|---|---|---|---|---|---|
| GEC | 35 | | TIS35 | <br>No Asbestos found, exercise caution and follow safety instructions | Where no manufacturer or date information can be confirmed and/or the fuse was manufactured prior to 2003, the <b>fuses should be presumed to contain asbestos and disposed</b> of in accordance with SWMS - AUS008 - Removal of Friable Asbestos Containing LV HRC Fuses. |

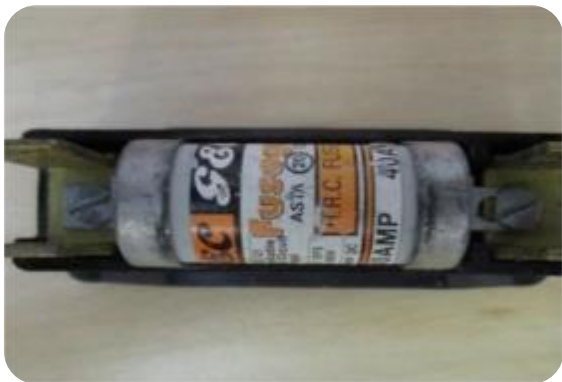
| Manufacturer | Rating | Fuse Body Photographs | Label Markings & Details | Result | Safety Instructions |
|---|---|---|---|---|---|
| GEC | 40 | | BS88.2 80kA 2061689 | <br>No Asbestos found,<br>exercise caution and follow safety instructions | Where no manufacturer or date information can be confirmed and/or the fuse was manufactured prior to 2003, the <b>fuses should be presumed to contain asbestos and disposed</b> of in accordance with SWMS - AUS008 - Removal of Friable Asbestos Containing LV HRC Fuses. |

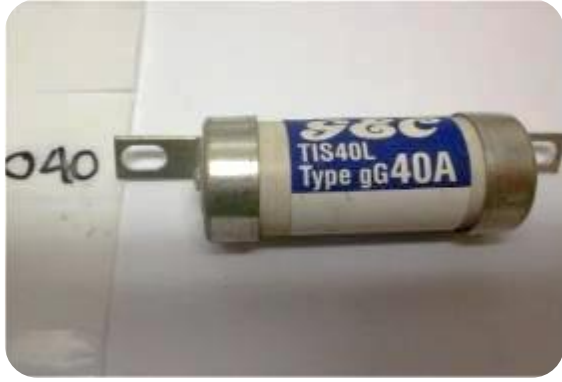
| Manufacturer | Rating | Fuse Body Photographs | Label Markings & Details | Result | Safety Instructions |
|---|---|---|---|---|---|
| GEC | 40 | | TIS40L, gG, Asta 20 cert, 415 V ac, 80kA, | <br>No Asbestos found,<br>exercise caution and follow safety instructions | Where no manufacturer or date information can be confirmed and/or the fuse was manufactured prior to 2003, the <b>fuses should be presumed to contain asbestos and disposed</b> of in accordance with SWMS - AUS008 - Removal of Friable Asbestos Containing LV HRC Fuses. |

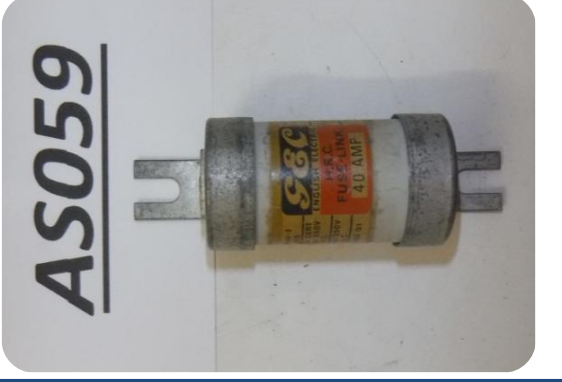
| Manufacturer | Rating | Fuse Body Photographs | Label Markings & Details | Result | Safety Instructions |
|---|---|---|---|---|---|
| GEC | 40 | | TIS40, 40A, B.S.88-2, Complies with IEC 269-2, AC80, 250V40, Class Q1 | <br>Asbestos found | <b>In-Service Fuses:</b> <ul style="list-style-type: none"> <li> If fuse is damaged, cease work and make safe. Contact the Hazmat Hotline - 02 9394 6961.</li> <li> If the fuse is intact, remove the fuse taking care not to damage in accordance with SWMS - AUS008 Removal of Friable Asbestos Containing LV HRC Fuses.</li> </ul> <b>Stored and Quarantined Fuses:</b> <ul style="list-style-type: none"> <li> Must be disposed of in accordance with SWMS - AUS008 Removal of Friable Asbestos Containing LV HRC Fuses.</li> </ul> |

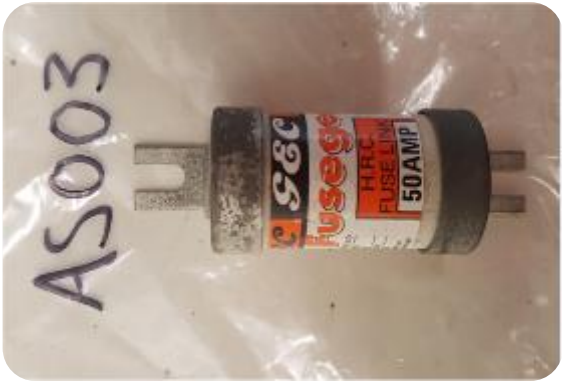
| Manufacturer | Rating | Fuse Body Photographs | Label Markings & Details | Result | Safety Instructions |
|---|---|---|---|---|---|
| GEC | 50 | | fusegear TIS50, 50A, 2061639, complies with AS 2005-2, ASTA Certified, BS88-2 1975, 80kA, 460V DC, Class Q1 | <br>No Asbestos found, exercise caution and follow safety instructions | Where no manufacturer or date information can be confirmed and/or the fuse was manufactured prior to 2003, the <b>fuses should be presumed to contain asbestos and disposed</b> of in accordance with SWMS - AUS008 - Removal of Friable Asbestos Containing LV HRC Fuses. |

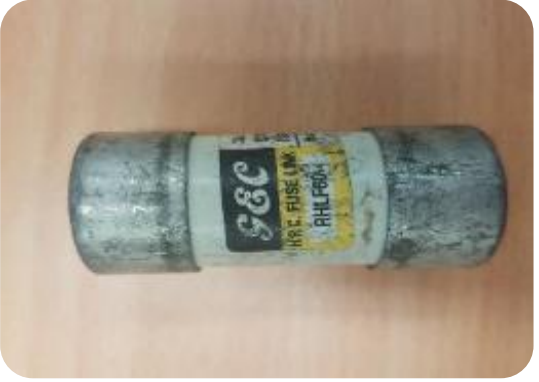
| Manufacturer | Rating | Fuse Body Photographs | Label Markings & Details | Result | Safety Instructions |
|---|---|---|---|---|---|
| GEC | 60 | | RHLF60, 33kA, 415V A.C., BS1371-1971, BS88-1-1975, made in England, 148 | <br>No Asbestos found, exercise caution and follow safety instructions | Where no manufacturer or date information can be confirmed and/or the fuse was manufactured prior to 2003, the <b>fuses should be presumed to contain asbestos and disposed</b> of in accordance with SWMS - AUS008 - Removal of Friable Asbestos Containing LV HRC Fuses. |

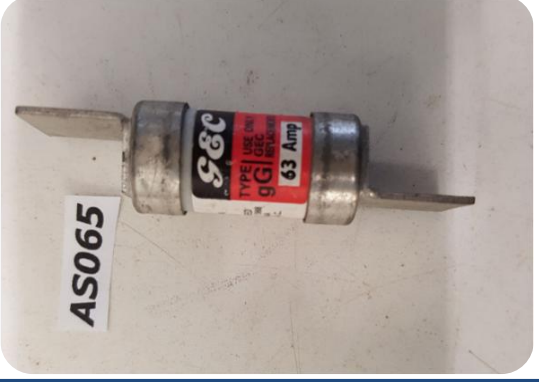
| Manufacturer | Rating | Fuse Body Photographs | Label Markings & Details | Result | Safety Instructions |
|---|---|---|---|---|---|
| GEC | 63 | | ES63, 63A, Asta 20 cert, BS88: 6: 1988, 80kA, IEC 269-1 | <br>No Asbestos found, exercise caution and follow safety instructions | Where no manufacturer or date information can be confirmed and/or the fuse was manufactured prior to 2003, the <b>fuses should be presumed to contain asbestos and disposed</b> of in accordance with SWMS - AUS008 - Removal of Friable Asbestos Containing LV HRC Fuses. |

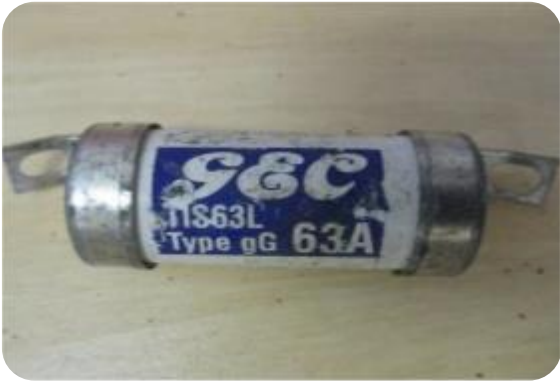
| Manufacturer | Rating | Fuse Body Photographs | Label Markings & Details | Result | Safety Instructions |
|---|---|---|---|---|---|
| GEC | 63 | 54287-001-005 | TIS63L Type gG 63A | <br>No Asbestos found, exercise caution and follow safety instructions | <br>Where no manufacturer or date information can be confirmed and/or the fuse was manufactured prior to 2003, the <b>fuses should be presumed to contain asbestos and disposed</b> of in accordance with SWMS - AUS008 - Removal of Friable Asbestos Containing LV HRC Fuses. |

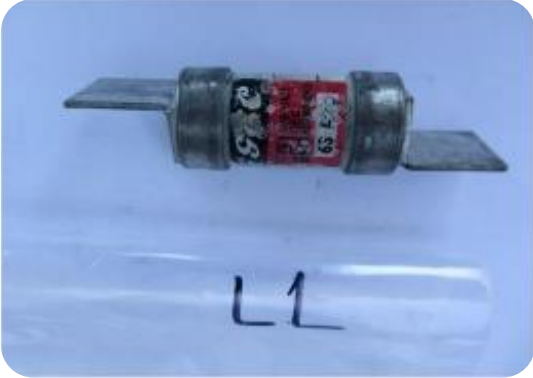
| Manufacturer | Rating | Fuse Body Photographs | Label Markings & Details | Result | Safety Instructions |
|---|---|---|---|---|---|
| GEC | 63 | 54287-001-077 | | <br>No Asbestos found, exercise caution and follow safety instructions | <br>Where no manufacturer or date information can be confirmed and/or the fuse was manufactured prior to 2003, the <b>fuses should be presumed to contain asbestos and disposed</b> of in accordance with SWMS - AUS008 - Removal of Friable Asbestos Containing LV HRC Fuses. |

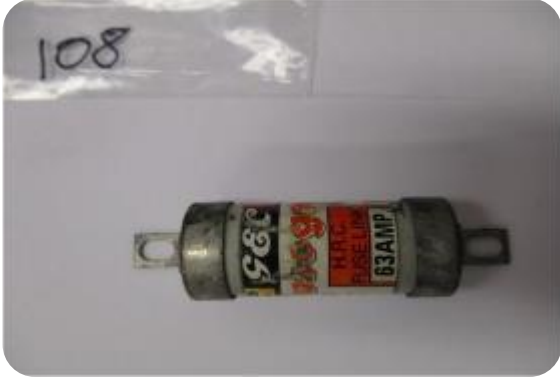
| Manufacturer | Rating | Fuse Body Photographs | Label Markings & Details | Result | Safety Instructions |
|---|---|---|---|---|---|
| GEC | 63 | 54287-001-108 | List Numb TIS63 | <br>No Asbestos found, exercise caution and follow safety instructions | <br>Where no manufacturer or date information can be confirmed and/or the fuse was manufactured prior to 2003, the <b>fuses should be presumed to contain asbestos and disposed</b> of in accordance with SWMS - AUS008 - Removal of Friable Asbestos Containing LV HRC Fuses. |

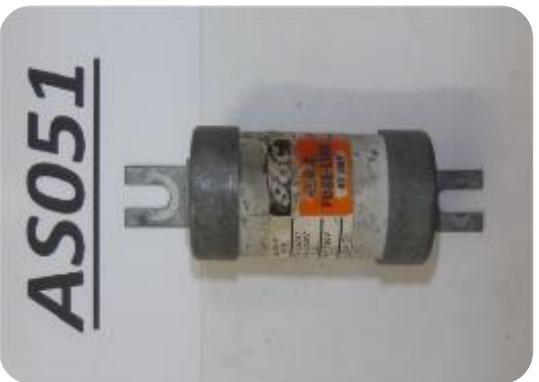
| Manufacturer | Rating | Fuse Body Photographs | Label Markings & Details | Result | Safety Instructions |
|---|---|---|---|---|---|
| GEC | 63 | <br>168273-51 | TIS63, 63A, B.S.88-2, Complies with IEC 269-2, AC80, 250V40, Class Q1 | <br>Asbestos found | <b>In-Service Fuses:</b><br> If fuse is damaged, cease work and make safe. Contact the Hazmat Hotline - 02 9394 6961.<br> If the fuse is intact, remove the fuse taking care not to damage in accordance with SWMS - AUS008 Removal of Friable Asbestos Containing LV HRC Fuses.<br><b>Stored and Quarantined Fuses:</b><br> Must be disposed of in accordance with SWMS - AUS008 Removal of Friable Asbestos Containing LV HRC Fuses. |

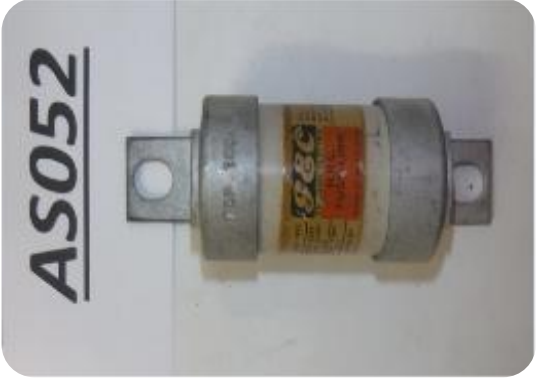
| Manufacturer | Rating | Fuse Body Photographs | Label Markings & Details | Result | Safety Instructions |
|---|---|---|---|---|---|
| GEC | 80 | <br>168273-52 | TCP, 100A, B.S. 88, 80A, 250DC40, Class Q1 | <br>Asbestos found | <b>In-Service Fuses:</b><br> If fuse is damaged, cease work and make safe. Contact the Hazmat Hotline - 02 9394 6961.<br> If the fuse is intact, remove the fuse taking care not to damage in accordance with SWMS - AUS008 Removal of Friable Asbestos Containing LV HRC Fuses.<br><b>Stored and Quarantined Fuses:</b><br> Must be disposed of in accordance with SWMS - AUS008 Removal of Friable Asbestos Containing LV HRC Fuses. |

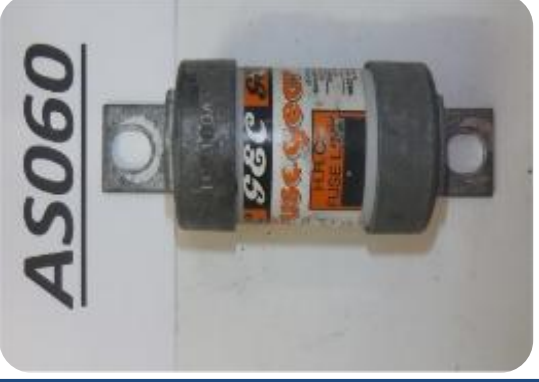
| Manufacturer | Rating | Fuse Body Photographs | Label Markings & Details | Result | Safety Instructions |
|---|---|---|---|---|---|
| GEC | 100 | <br>168273-60 | TCP, 100A, B.S.88-2, Complies with AS2005-2, AC80, 460DC40, Class Q1, Pat no. 2061639 | <br>No Asbestos found | May be used as normal.<br> When disposing of LV HRC Fuses treat all fuses as asbestos waste. |

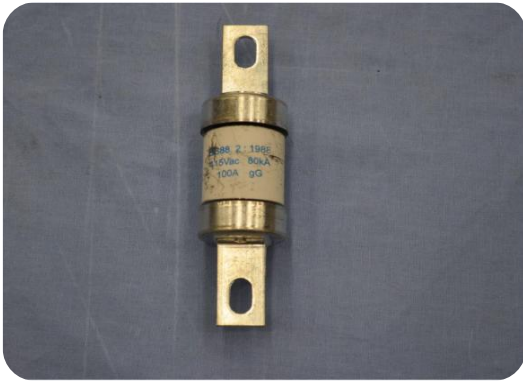
| Manufacturer | Rating | Fuse Body Photographs | Label Markings & Details | Result | Safety Instructions |
|---|---|---|---|---|---|
| GEC | 100 | | GEC OTC | <br>Current Stock Item<br>No. 85217 | ✓ May be used as normal.<br>✓ When disposing of LV HRC Fuses treat all fuses as asbestos waste. |

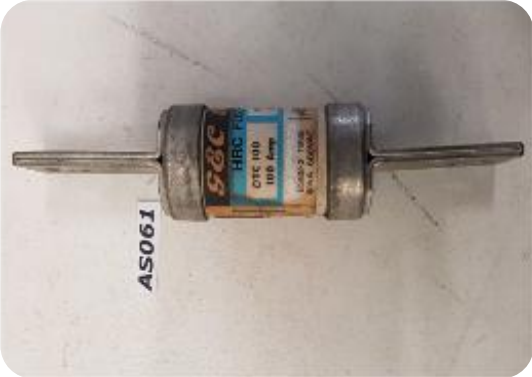
| Manufacturer | Rating | Fuse Body Photographs | Label Markings & Details | Result | Safety Instructions |
|---|---|---|---|---|---|
| GEC | 100 | <div>AS061</div> <div>174783-001-AS061</div> | OTC 100, 2061639, 100A, 80kA,<br>BS88-2: 1988, 40kA350VDC,<br>IEC269-2-1, gG | <br>No Asbestos found,<br>exercise caution and follow safety instructions | Where no manufacturer or date information can be confirmed and/or the fuse was manufactured prior to 2003, the <b>fuses should be presumed to contain asbestos and disposed</b> of in accordance with SWMS - AUS008 - Removal of Friable Asbestos Containing LV HRC Fuses. |

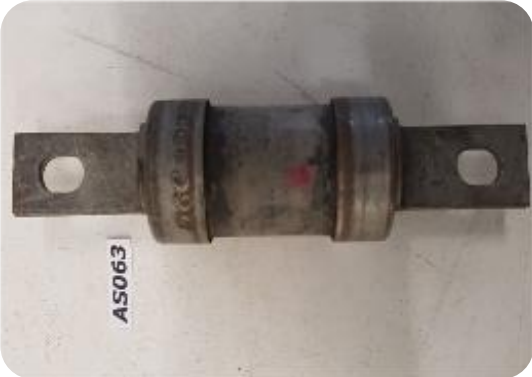
| Manufacturer | Rating | Fuse Body Photographs | Label Markings & Details | Result | Safety Instructions |
|---|---|---|---|---|---|
| GEC | 100 | <div>AS063</div> <div>174783-001-AS063</div> | OTC100, 100A | <br>No Asbestos found,<br>exercise caution and follow safety instructions | Where no manufacturer or date information can be confirmed and/or the fuse was manufactured prior to 2003, the <b>fuses should be presumed to contain asbestos and disposed</b> of in accordance with SWMS - AUS008 - Removal of Friable Asbestos Containing LV HRC Fuses. |

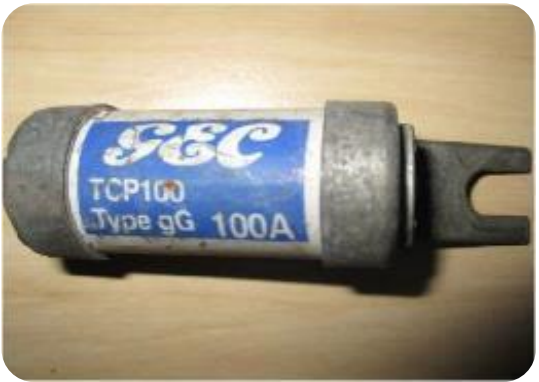
| Manufacturer | Rating | Fuse Body Photographs | Label Markings & Details | Result | Safety Instructions |
|---|---|---|---|---|---|
| GEC | 100 | | TCP100 Type gG | <br>No Asbestos found, exercise caution and follow safety instructions | Where no manufacturer or date information can be confirmed and/or the fuse was manufactured prior to 2003, the <b>fuses should be presumed to contain asbestos and disposed</b> of in accordance with SWMS - AUS008 - Removal of Friable Asbestos Containing LV HRC Fuses. |
