## Network Standard

Document No : NW000-S0161

NS211 ANNEXURE G – LV HRC FUSE ASBESTOS PRODUCT GUIDE

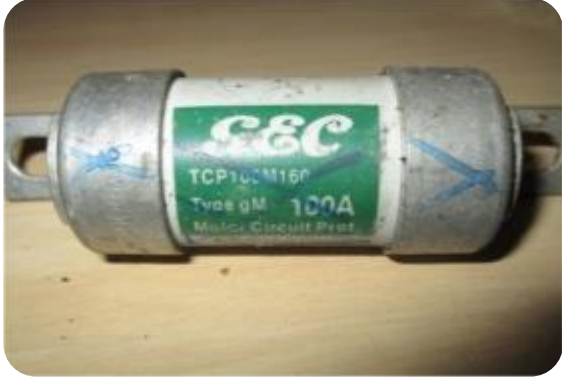
| Manufacturer | Rating | Fuse Body Photographs | Label Markings & Details | Result | Safety Instructions |
|---|---|---|---|---|---|
| GEC | 100 | | TCP 100M160 type gG 100A | <br>No Asbestos found, exercise caution and follow safety instructions | Where no manufacturer or date information can be confirmed and/or the fuse was manufactured prior to 2003, the <b>fuses should be presumed to contain asbestos and disposed</b> of in accordance with SWMS - AUS008 - Removal of Friable Asbestos Containing LV HRC Fuses. |

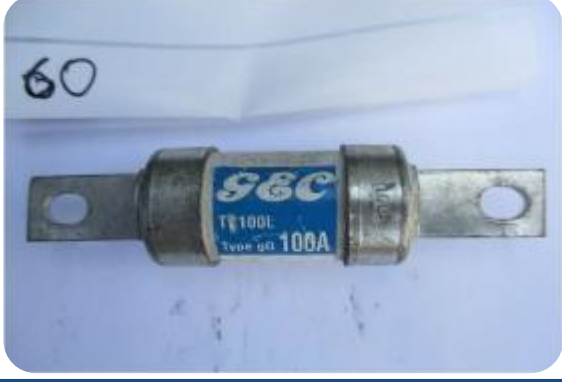
| Manufacturer | Rating | Fuse Body Photographs | Label Markings & Details | Result | Safety Instructions |
|---|---|---|---|---|---|
| GEC | 100 | | TC100L | <br>No Asbestos found, exercise caution and follow safety instructions | Where no manufacturer or date information can be confirmed and/or the fuse was manufactured prior to 2003, the <b>fuses should be presumed to contain asbestos and disposed</b> of in accordance with SWMS - AUS008 - Removal of Friable Asbestos Containing LV HRC Fuses. |

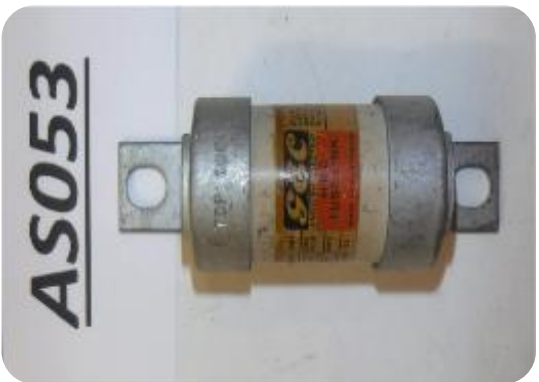
| Manufacturer | Rating | Fuse Body Photographs | Label Markings & Details | Result | Safety Instructions |
|---|---|---|---|---|---|
| GEC | 100 | | TCP, 100A, B.S. 88, 80A, 250DC40, Class Q1 | <br>Asbestos found | <b>In-Service Fuses:</b><br> If fuse is damaged, cease work and make safe. Contact the Hazmat Hotline - 02 9394 6961.<br> If the fuse is intact, remove the fuse taking care not to damage in accordance with SWMS - AUS008 Removal of Friable Asbestos Containing LV HRC Fuses.<br><b>Stored and Quarantined Fuses:</b><br> Must be disposed of in accordance with SWMS - AUS008 Removal of Friable Asbestos Containing LV HRC Fuses. |

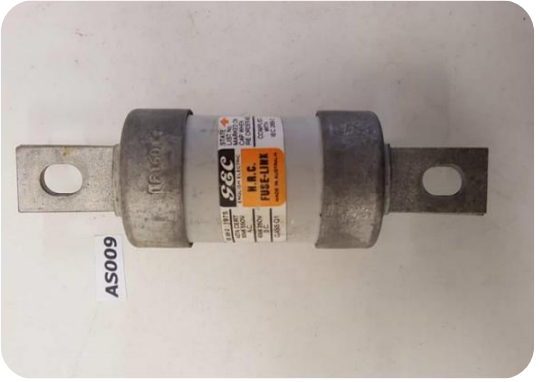
| Manufacturer | Rating | Fuse Body Photographs | Label Markings & Details | Result | Safety Instructions |
|---|---|---|---|---|---|
| GEC | 160 | | TF160A*, BS88-2:1975, Asta Cert 80kA, 40kA250V DC, Class Q1. Complies with IEC 269-2 | <br>No Asbestos found, exercise caution and follow safety instructions | Where no manufacturer or date information can be confirmed and/or the fuse was manufactured prior to 2003, the <b>fuses should be presumed to contain asbestos and disposed</b> of in accordance with SWMS - AUS008 - Removal of Friable Asbestos Containing LV HRC Fuses. |

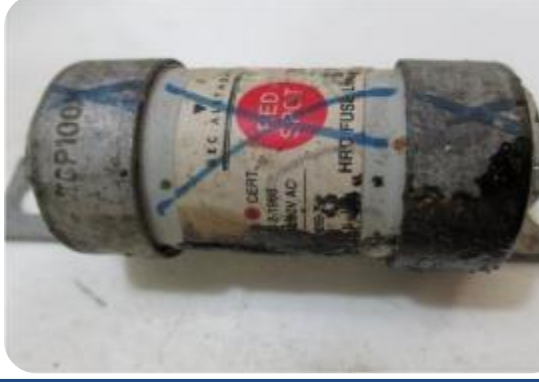
| Manufacturer | Rating | Fuse Body Photographs | Label Markings & Details | Result | Safety Instructions |
|---|---|---|---|---|---|
| GEC | 160 | | Alstom Red Spot 40kA 25V TCP100M160A | <br>No Asbestos found, exercise caution and follow safety instructions | Where no manufacturer or date information can be confirmed and/or the fuse was manufactured prior to 2003, the <b>fuses should be presumed to contain asbestos and disposed</b> of in accordance with SWMS - AUS008 - Removal of Friable Asbestos Containing LV HRC Fuses. |

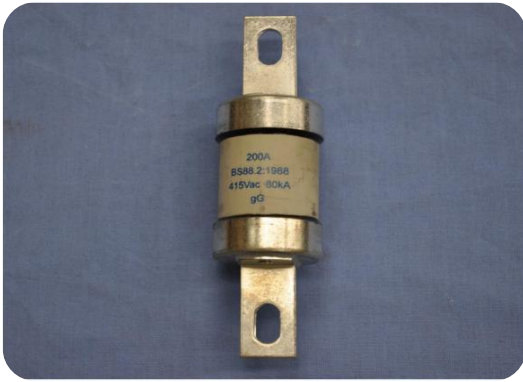
| Manufacturer | Rating | Fuse Body Photographs | Label Markings & Details | Result | Safety Instructions |
|---|---|---|---|---|---|
| GEC | 200 | | GEC OTF | <br>Current Stock Item No. 85423 | ✓ May be used as normal.<br>✓ When disposing of LV HRC Fuses treat all fuses as asbestos waste. |

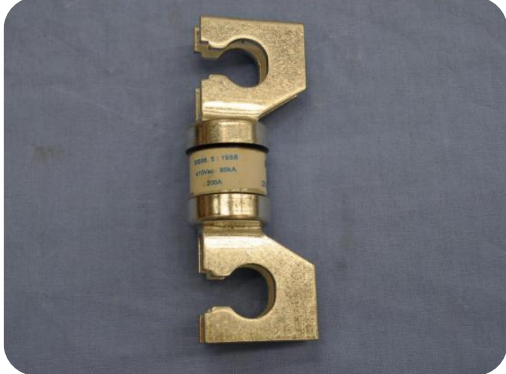
| Manufacturer | Rating | Fuse Body Photographs | Label Markings & Details | Result | Safety Instructions |
|---|---|---|---|---|---|
| GEC | 200 | | GEC 0835 TJ 200, | <br>Current Stock Item No. 85688 | ✓ May be used as normal.<br>✓ When disposing of LV HRC Fuses treat all fuses as asbestos waste. |

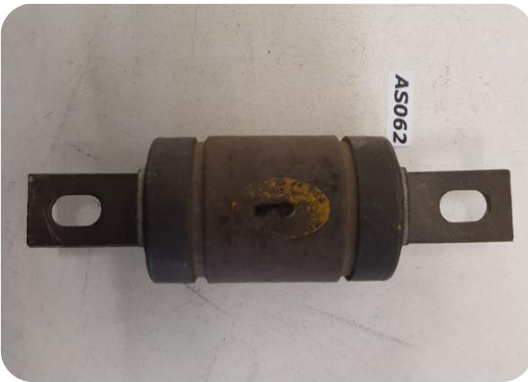
| Manufacturer | Rating | Fuse Body Photographs | Label Markings & Details | Result | Safety Instructions |
|---|---|---|---|---|---|
| GEC | 200 | <div style="position: absolute; left: 475px; top: 830px; transform: rotate(-90deg);">174783-001-AS062</div> | Y200VB, 200A | <br>Asbestos found | <b>In-Service Fuses:</b><br>✗ If fuse is damaged, cease work and make safe. Contact the Hazmat Hotline - 02 9394 6961.<br>✗ If the fuse is intact, remove the fuse taking care not to damage in accordance with SWMS - AUS008 Removal of Friable Asbestos Containing LV HRC Fuses.<br><b>Stored and Quarantined Fuses:</b><br>✗ Must be disposed of in accordance with SWMS - AUS008 Removal of Friable Asbestos Containing LV HRC Fuses. |

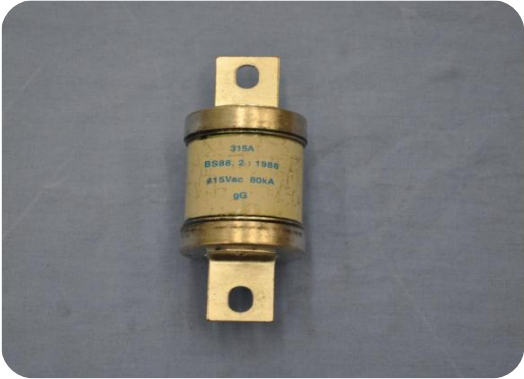
| Manufacturer | Rating | Fuse Body Photographs | Label Markings & Details | Result | Safety Instructions |
|---|---|---|---|---|---|
| GEC | 300 | | GEC OTKF, DS OSED | <br>Current Stock Item<br>No. 85506 | May be used as normal.<br> When disposing of LV HRC Fuses treat all fuses as asbestos waste. |

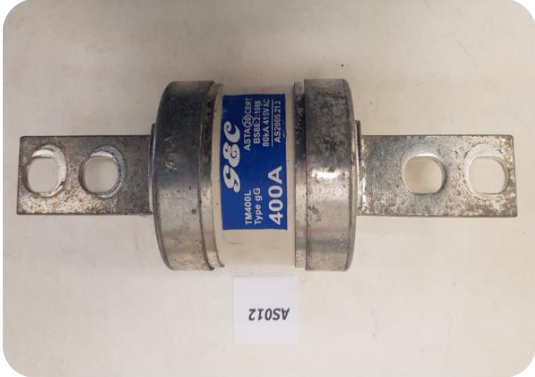
| Manufacturer | Rating | Fuse Body Photographs | Label Markings & Details | Result | Safety Instructions |
|---|---|---|---|---|---|
| GEC | 400 | | TM400L, Type gG, 400A,<br>BS88:2:1988, 80kA,<br>AS2005.21.2<br>174102-001-AS012 | <br>No Asbestos found, exercise caution and follow safety instructions | Where no manufacturer or date information can be confirmed and/or the fuse was manufactured prior to 2003, the <b>fuses should be presumed to contain asbestos and disposed</b> of in accordance with SWMS - AUS008 - Removal of Friable Asbestos Containing LV HRC Fuses. |

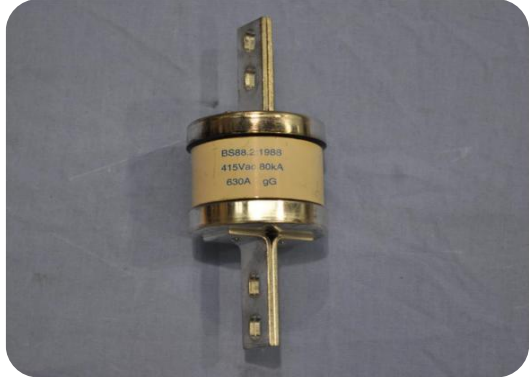
| Manufacturer | Rating | Fuse Body Photographs | Label Markings & Details | Result | Safety Instructions |
|---|---|---|---|---|---|
| GEC | 630 | | GEC TLT | <br>Current Stock Item<br>No. 85589 | May be used as normal.<br> When disposing of LV HRC Fuses treat all fuses as asbestos waste. |

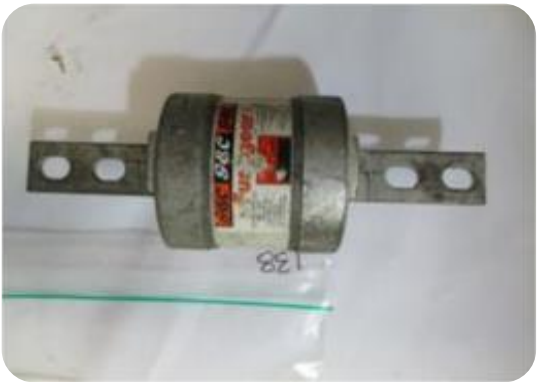
| Manufacturer | Rating | Fuse Body Photographs | Label Markings & Details | Result | Safety Instructions |
|---|---|---|---|---|---|
| GEC | 630 | | TTM630A<br>54287-001-138 | <br>No Asbestos found,<br>exercise caution and follow safety instructions | Where no manufacturer or date information can be confirmed and/or the fuse was manufactured prior to 2003, the <b>fuses should be presumed to contain asbestos and disposed</b> of in accordance with SWMS - AUS008 - Removal of Friable Asbestos Containing LV HRC Fuses. |

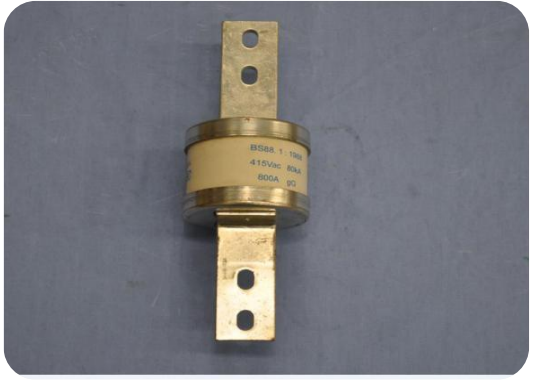
| Manufacturer | Rating | Fuse Body Photographs | Label Markings & Details | Result | Safety Instructions |
|---|---|---|---|---|---|
| GEC | 800 | | GEC TLT, DS SGG,<br>168273-70 | <br>Current Stock Item No. 85613 | May be used as normal.<br> When disposing of LV HRC Fuses treat all fuses as asbestos waste. |

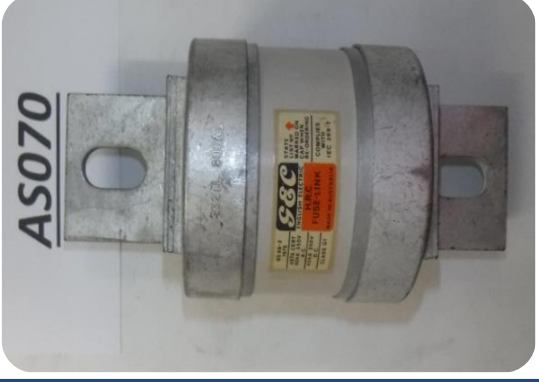
| Manufacturer | Rating | Fuse Body Photographs | Label Markings & Details | Result | Safety Instructions |
|---|---|---|---|---|---|
| GEC | 800 | | 252TL, 800A, B.S.88-2,<br>Complies with IEC 269-2, AC80,<br>250DC40, Class Q1<br>168273-70 | <br>Asbestos found | <b>In-Service Fuses:</b><br> If fuse is damaged, cease work and make safe. Contact the Hazmat Hotline - 02 9394 6961.<br> If the fuse is intact, remove the fuse taking care not to damage in accordance with SWMS - AUS008 Removal of Friable Asbestos Containing LV HRC Fuses.<br><b>Stored and Quarantined Fuses:</b><br> Must be disposed of in accordance with SWMS - AUS008 Removal of Friable Asbestos Containing LV HRC Fuses. |

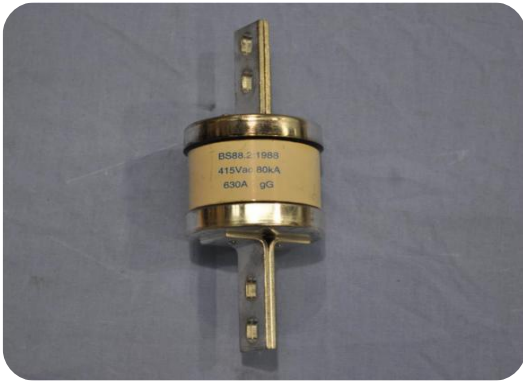
| Manufacturer | Rating | Fuse Body Photographs | Label Markings & Details | Result | Safety Instructions |
|---|---|---|---|---|---|
| GEC | 600 / 630 | | GEC TLM | <br>Current Stock Item<br>No. 85506 | ✓ May be used as normal.<br>✓ When disposing of LV HRC Fuses treat all fuses as asbestos waste. |

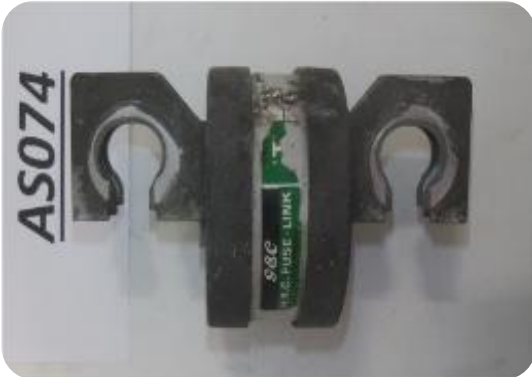
| Manufacturer | Rating | Fuse Body Photographs | Label Markings & Details | Result | Safety Instructions |
|---|---|---|---|---|---|
| GEC | | <br>168273-74 | JS630, no other markings | <br>No Asbestos found, exercise caution and follow safety instructions | Where no manufacturer or date information can be confirmed and/or the fuse was manufactured prior to 2003, the <b>fuses should be presumed to contain asbestos and disposed</b> of in accordance with SWMS - AUS008 - Removal of Friable Asbestos Containing LV HRC Fuses. |

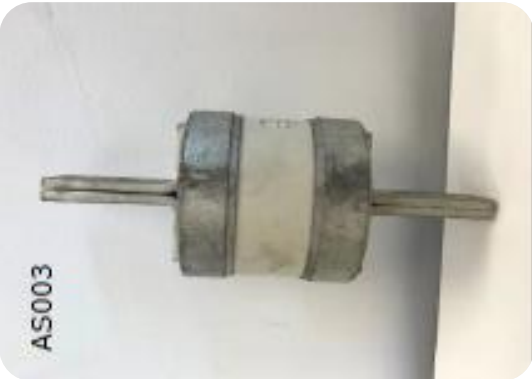
| Manufacturer | Rating | Fuse Body Photographs | Label Markings & Details | Result | Safety Instructions |
|---|---|---|---|---|---|
| GEC | | <br>P033786.002-AS012 | MEM - 250JSS92WP - 250A, BS 88: 5: 1988, AC 80 - 415V - United Kingdom - no date - AS002 | <br>No Asbestos found, exercise caution and follow safety instructions | Where no manufacturer or date information can be confirmed and/or the fuse was manufactured prior to 2003, the <b>fuses should be presumed to contain asbestos and disposed</b> of in accordance with SWMS - AUS008 - Removal of Friable Asbestos Containing LV HRC Fuses. |

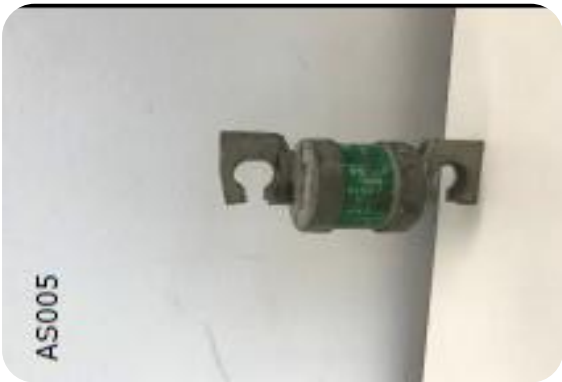
| Manufacturer | Rating | Fuse Body Photographs | Label Markings & Details | Result | Safety Instructions |
|---|---|---|---|---|---|
| GEC | | <p>AS005</p> <p>P033786.002-AS012</p> | GEC - JP400 - BS88-5: 1988, 415V AC, 80kA, ASTA certified - 415V - United Kingdom - no date | <p>No Asbestos found, exercise caution and follow safety instructions</p> | <p>Where no manufacturer or date information can be confirmed and/or the fuse was manufactured prior to 2003, the <b>fuses should be presumed to contain asbestos and disposed</b> of in accordance with SWMS - AUS008 - Removal of Friable Asbestos Containing LV HRC Fuses.</p> |

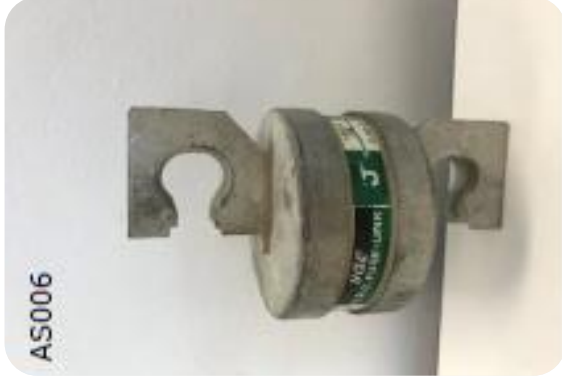
| Manufacturer | Rating | Fuse Body Photographs | Label Markings & Details | Result | Safety Instructions |
|---|---|---|---|---|---|
| GEC | | <p>AS006</p> <p>P033786.002-AS012</p> | GEC - HRC Fuse Link - Type J, Class Q1, BS88-5; 1980, 415V 80kA AC, list no: JS630 - 415V - England - no date | <p>No Asbestos found, exercise caution and follow safety instructions</p> | <p>Where no manufacturer or date information can be confirmed and/or the fuse was manufactured prior to 2003, the <b>fuses should be presumed to contain asbestos and disposed</b> of in accordance with SWMS - AUS008 - Removal of Friable Asbestos Containing LV HRC Fuses.</p> |

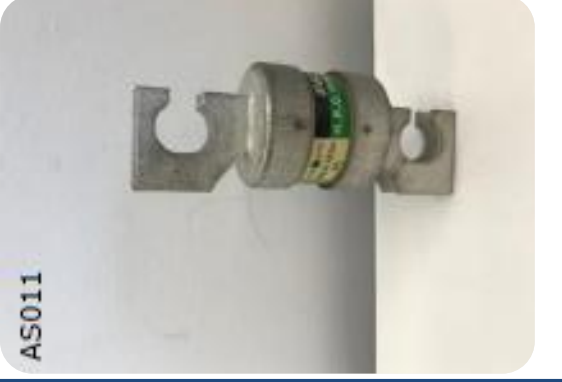
| Manufacturer | Rating | Fuse Body Photographs | Label Markings & Details | Result | Safety Instructions |
|---|---|---|---|---|---|
| GEC | | <p>AS011</p> <p>P033786.002-AS012</p> | GEC - HRC Fuse Link - Type J, Class Q1, BS88-5: 1980, 415V AC 80kA -415V - England - no date | <p>No Asbestos found, exercise caution and follow safety instructions</p> | <p>Where no manufacturer or date information can be confirmed and/or the fuse was manufactured prior to 2003, the <b>fuses should be presumed to contain asbestos and disposed</b> of in accordance with SWMS - AUS008 - Removal of Friable Asbestos Containing LV HRC Fuses.</p> |

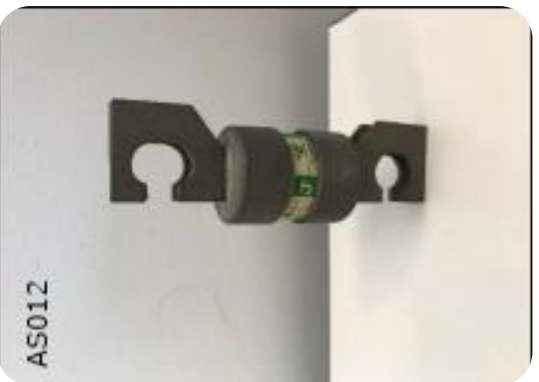
| Manufacturer | Rating | Fuse Body Photographs | Label Markings & Details | Result | Safety Instructions |
|---|---|---|---|---|---|
| GEC | | <p>AS012</p> <p>P033786.002-AS012</p> | GEC - HRC Fuse Link - Type J, Class Q1, BS88-5: 1980, 415V AC 80kA, ASTA certified - 415V - England - no date | <p>No Asbestos found, exercise caution and follow safety instructions</p> | <p>Where no manufacturer or date information can be confirmed and/or the fuse was manufactured prior to 2003, the <b>fuses should be presumed to contain asbestos and disposed</b> of in accordance with SWMS - AUS008 - Removal of Friable Asbestos Containing LV HRC Fuses.</p> |

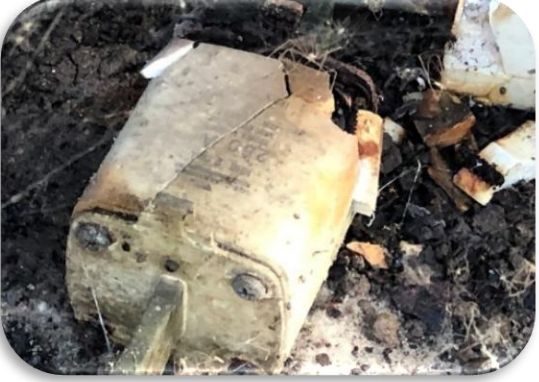
| Manufacturer | Rating | Fuse Body Photographs | Label Markings & Details | Result | Safety Instructions |
|---|---|---|---|---|---|
| GEC Alsthom | 250 | <p>SMPL-MC-210701-01</p> | NHG 2gL, 120kA 500V, DIN 43620, IEC 269-2-1 | <p>No Asbestos found, exercise caution and follow safety instructions</p> | <p>Where no manufacturer or date information can be confirmed and/or the fuse was manufactured prior to 2003, the <b>fuses should be presumed to contain asbestos and disposed</b> of in accordance with SWMS - AUS008 - Removal of Friable Asbestos Containing LV HRC Fuses.</p> |

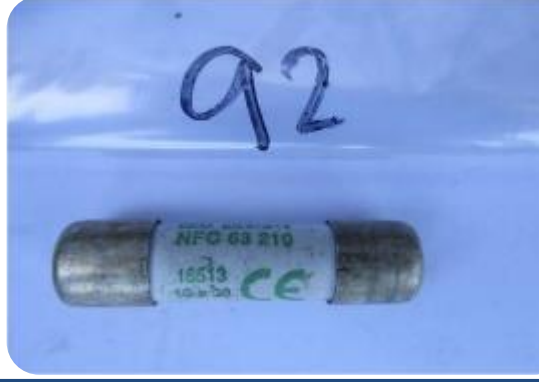
| Manufacturer | Rating | Fuse Body Photographs | Label Markings & Details | Result | Safety Instructions |
|---|---|---|---|---|---|
| Gould | 2 | <p>54287-001-092</p> | NFC 63 210 16513 | <p>No Asbestos found, exercise caution and follow safety instructions</p> | <p>Where no manufacturer or date information can be confirmed and/or the fuse was manufactured prior to 2003, the <b>fuses should be presumed to contain asbestos and disposed</b> of in accordance with SWMS - AUS008 - Removal of Friable Asbestos Containing LV HRC Fuses.</p> |

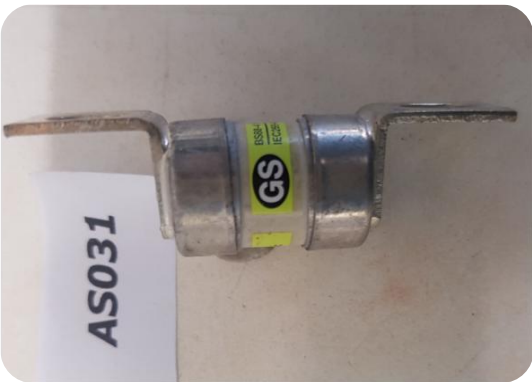
| Manufacturer | Rating | Fuse Body Photographs | Label Markings & Details | Result | Safety Instructions |
|---|---|---|---|---|---|
| GS | 75 | | GSA75, 75A, 100kA, BS88-4 1988, IEC269-4<br>174102-001-AS031 | <br>No Asbestos found, exercise caution and follow safety instructions | <br>Where no manufacturer or date information can be confirmed and/or the fuse was manufactured prior to 2003, the <b>fuses should be presumed to contain asbestos and disposed</b> of in accordance with SWMS - AUS008 - Removal of Friable Asbestos Containing LV HRC Fuses. |

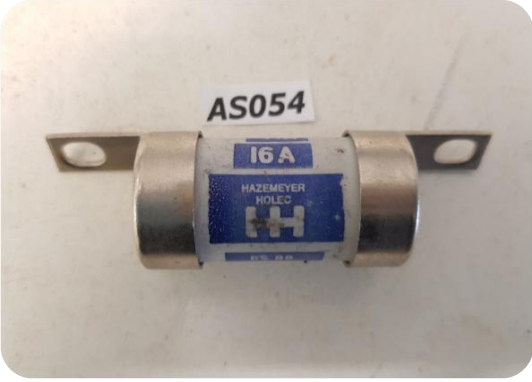
| Manufacturer | Rating | Fuse Body Photographs | Label Markings & Details | Result | Safety Instructions |
|---|---|---|---|---|---|
| Hazemayer Holec | 16 | | TIA, 16A, 80kA, Asta Cert, Q1, BS88 1975<br>174783-001-AS054 | <br>Asbestos found | <b>In-Service Fuses:</b><br> If fuse is damaged, cease work and make safe. Contact the Hazmat Hotline - 02 9394 6961.<br> If the fuse is intact, remove the fuse taking care not to damage in accordance with SWMS - AUS008 Removal of Friable Asbestos Containing LV HRC Fuses.<br><b>Stored and Quarantined Fuses:</b><br> Must be disposed of in accordance with SWMS - AUS008 Removal of Friable Asbestos Containing LV HRC Fuses. |

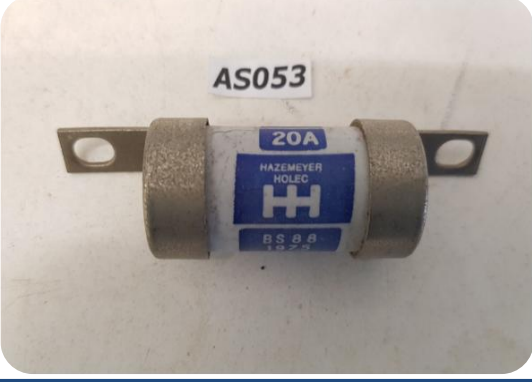
| Manufacturer | Rating | Fuse Body Photographs | Label Markings & Details | Result | Safety Instructions |
|---|---|---|---|---|---|
| Hazemayer Holec | 20 | | TIA, 20A, 80kA, Asta Cert, Q1, BS88 1975<br>174783-001-AS053 | <br>Asbestos found | <b>In-Service Fuses:</b><br> If fuse is damaged, cease work and make safe. Contact the Hazmat Hotline - 02 9394 6961.<br> If the fuse is intact, remove the fuse taking care not to damage in accordance with SWMS - AUS008 Removal of Friable Asbestos Containing LV HRC Fuses.<br><b>Stored and Quarantined Fuses:</b><br> Must be disposed of in accordance with SWMS - AUS008 Removal of Friable Asbestos Containing LV HRC Fuses. |

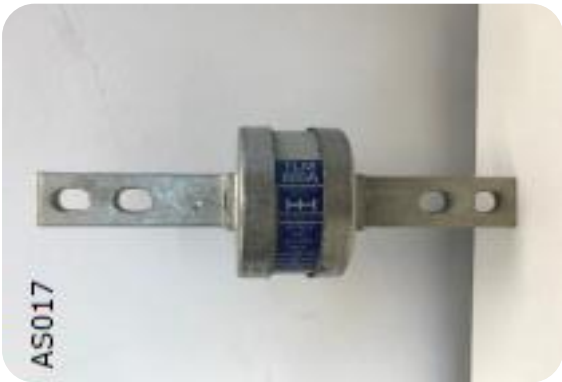
| Manufacturer | Rating | Fuse Body Photographs | Label Markings & Details | Result | Safety Instructions |
|---|---|---|---|---|---|
| Hazemayer Holec | 800 | | Hazemayer Holec - TLM 800A - Q1, BS88-2:1975, 415V AC 80kA, ASTA certified - 415V - United Kingdom - no date | <br>No Asbestos found, exercise caution and follow safety instructions | Where no manufacturer or date information can be confirmed and/or the fuse was manufactured prior to 2003, the <b>fuses should be presumed to contain asbestos and disposed</b> of in accordance with SWMS - AUS008 - Removal of Friable Asbestos Containing LV HRC Fuses. |

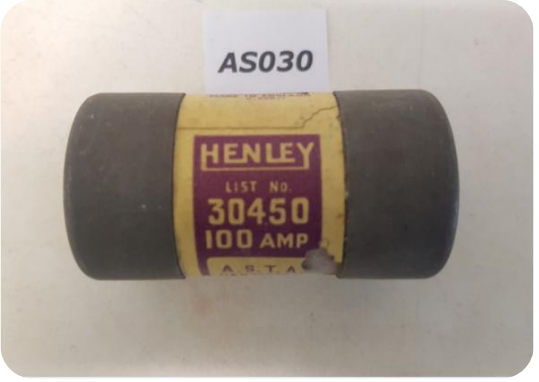
| Manufacturer | Rating | Fuse Body Photographs | Label Markings & Details | Result | Safety Instructions |
|---|---|---|---|---|---|
| Henley | 100 | | 30450, 581269, 100A, AC4, BS88:1952, FF I70 | <br>Asbestos found | <b>In-Service Fuses:</b><br> If fuse is damaged, cease work and make safe. Contact the Hazmat Hotline - 02 9394 6961.<br> If the fuse is intact, remove the fuse taking care not to damage in accordance with SWMS - AUS008 Removal of Friable Asbestos Containing LV HRC Fuses.<br><b>Stored and Quarantined Fuses:</b><br> Must be disposed of in accordance with SWMS - AUS008 Removal of Friable Asbestos Containing LV HRC Fuses. |

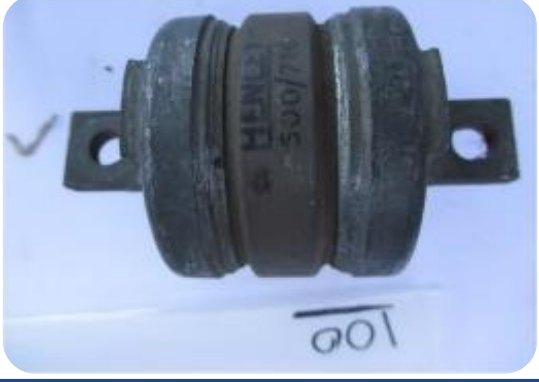
| Manufacturer | Rating | Fuse Body Photographs | Label Markings & Details | Result | Safety Instructions |
|---|---|---|---|---|---|
| Henley | 500 | | 30185 500/710 | <br>Asbestos found | <b>In-Service Fuses:</b><br> If fuse is damaged, cease work and make safe. Contact the Hazmat Hotline - 02 9394 6961.<br> If the fuse is intact, remove the fuse taking care not to damage in accordance with SWMS - AUS008 Removal of Friable Asbestos Containing LV HRC Fuses.<br><b>Stored and Quarantined Fuses:</b><br> Must be disposed of in accordance with SWMS - AUS008 Removal of Friable Asbestos Containing LV HRC Fuses. |

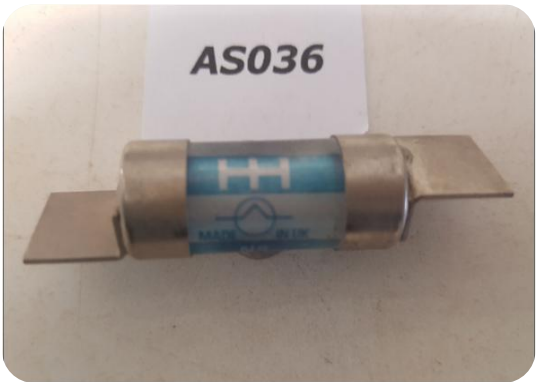
| Manufacturer | Rating | Fuse Body Photographs | Label Markings & Details | Result | Safety Instructions |
|---|---|---|---|---|---|
| HH | 2 | | NS2A, 2A, BS88-1975, AS2005-1,2, 80kA, class Q1<br><br>174102-001-AS036 | <br>No Asbestos found, exercise caution and follow safety instructions | Where no manufacturer or date information can be confirmed and/or the fuse was manufactured prior to 2003, the <b>fuses should be presumed to contain asbestos and disposed</b> of in accordance with SWMS - AUS008 - Removal of Friable Asbestos Containing LV HRC Fuses. |

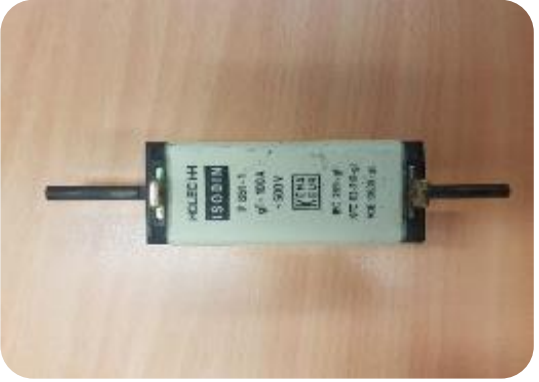
| Manufacturer | Rating | Fuse Body Photographs | Label Markings & Details | Result | Safety Instructions |
|---|---|---|---|---|---|
| Holec Isodin | 100 | | P851-1, gT-100A, ~500V, IEC 269-gl, NFC 63-210-gl, VDE 0636-gL<br><br>OF00053-120718-AS01 | <br>No Asbestos found, exercise caution and follow safety instructions | Where no manufacturer or date information can be confirmed and/or the fuse was manufactured prior to 2003, the <b>fuses should be presumed to contain asbestos and disposed</b> of in accordance with SWMS - AUS008 - Removal of Friable Asbestos Containing LV HRC Fuses. |

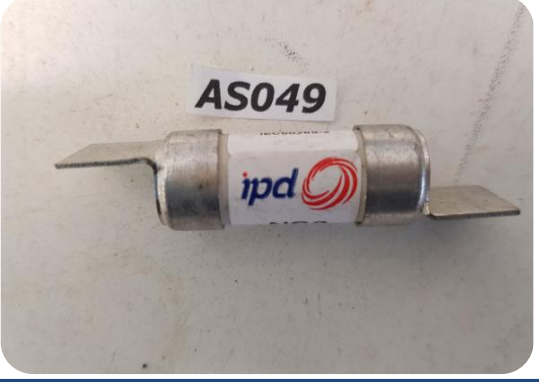
| Manufacturer | Rating | Fuse Body Photographs | Label Markings & Details | Result | Safety Instructions |
|---|---|---|---|---|---|
| IPD | 2 | | NS2, 2A, gG, 80kA, Asta 20 cert, BS88-6, IEC60269-2<br><br>174783-001-AS049 | <br>No Asbestos found, exercise caution and follow safety instructions | Where no manufacturer or date information can be confirmed and/or the fuse was manufactured prior to 2003, the <b>fuses should be presumed to contain asbestos and disposed</b> of in accordance with SWMS - AUS008 - Removal of Friable Asbestos Containing LV HRC Fuses. |

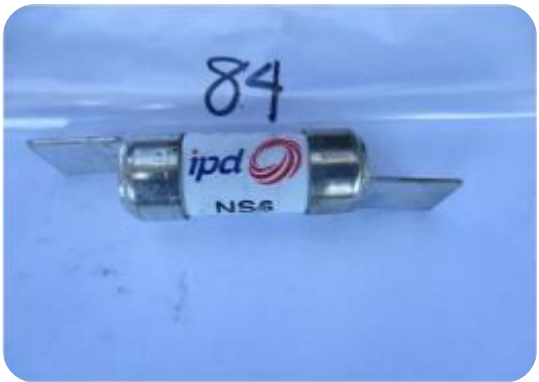
| Manufacturer | Rating | Fuse Body Photographs | Label Markings & Details | Result | Safety Instructions |
|---|---|---|---|---|---|
| IPD | 6 | | NS6 GG ^a | <br>No Asbestos found, exercise caution and follow safety instructions | Where no manufacturer or date information can be confirmed and/or the fuse was manufactured prior to 2003, the <b>fuses should be presumed to contain asbestos and disposed</b> of in accordance with SWMS - AUS008 - Removal of Friable Asbestos Containing LV HRC Fuses. |

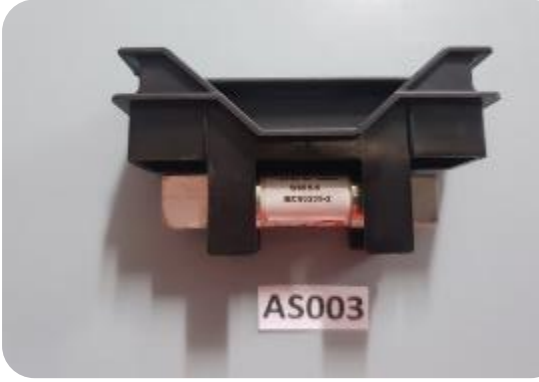
| Manufacturer | Rating | Fuse Body Photographs | Label Markings & Details | Result | Safety Instructions |
|---|---|---|---|---|---|
| IPD | 10 | | NS10, Type gG, 10A, Asta20 cert, BS88-6, AC 80kA, IEC60269-2 | <br>No Asbestos found, exercise caution and follow safety instructions | Where no manufacturer or date information can be confirmed and/or the fuse was manufactured prior to 2003, the <b>fuses should be presumed to contain asbestos and disposed</b> of in accordance with SWMS - AUS008 - Removal of Friable Asbestos Containing LV HRC Fuses. |

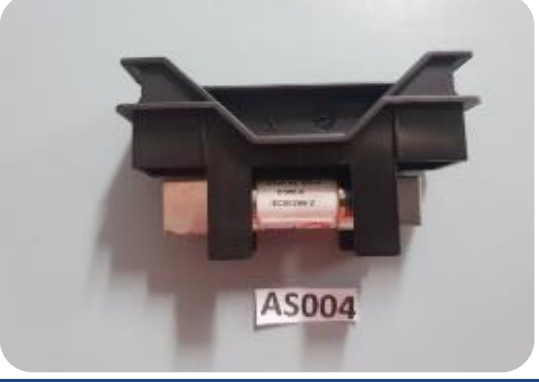
| Manufacturer | Rating | Fuse Body Photographs | Label Markings & Details | Result | Safety Instructions |
|---|---|---|---|---|---|
| IPD | 10 | | NS10, Type gG, 10A, Asta20 cert, BS88-6, AC 80kA, IEC60269-2 | <br>No Asbestos found, exercise caution and follow safety instructions | Where no manufacturer or date information can be confirmed and/or the fuse was manufactured prior to 2003, the <b>fuses should be presumed to contain asbestos and disposed</b> of in accordance with SWMS - AUS008 - Removal of Friable Asbestos Containing LV HRC Fuses. |

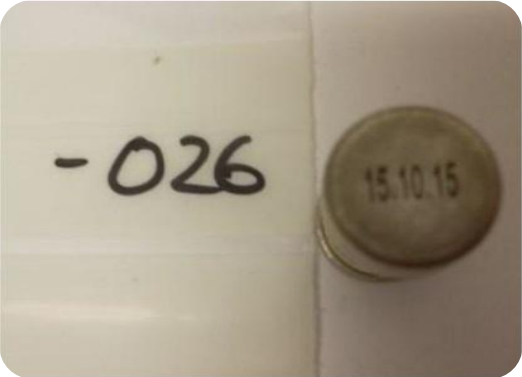
| Manufacturer | Rating | Fuse Body Photographs | Label Markings & Details | Result | Safety Instructions |
|---|---|---|---|---|---|
| IPD | 16 | <br>54287-002-026 | SK16, 20kA/440V ac | <br>No Asbestos found | ✓ May be used as normal.<br>✓ When disposing of LV HRC Fuses treat all fuses as asbestos waste. |

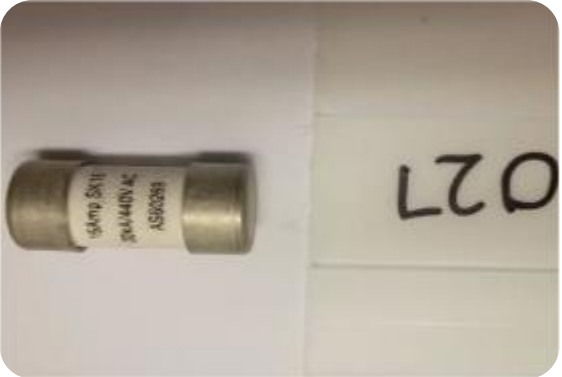
| Manufacturer | Rating | Fuse Body Photographs | Label Markings & Details | Result | Safety Instructions |
|---|---|---|---|---|---|
| IPD | 16 | <br>54287-002-027 | SK16, 20kA/440V ac | <br>No Asbestos found | ✓ May be used as normal.<br>✓ When disposing of LV HRC Fuses treat all fuses as asbestos waste. |

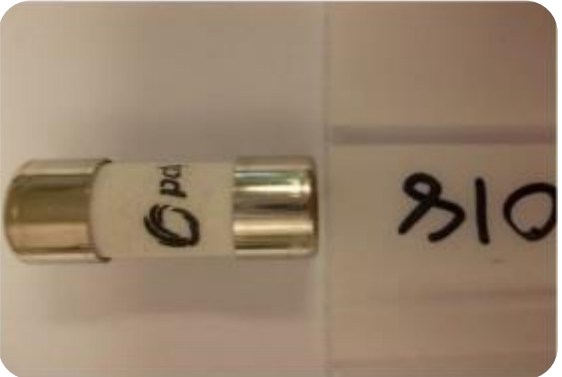
| Manufacturer | Rating | Fuse Body Photographs | Label Markings & Details | Result | Safety Instructions |
|---|---|---|---|---|---|
| IPD | 16 | <br>54287-002-018 | LC16, 6kA/250V ac, | <br>No Asbestos found, exercise caution and follow safety instructions | Where no manufacturer or date information can be confirmed and/or the fuse was manufactured prior to 2003, the <b>fuses should be presumed to contain asbestos and disposed</b> of in accordance with SWMS - AUS008 - Removal of Friable Asbestos Containing LV HRC Fuses. |

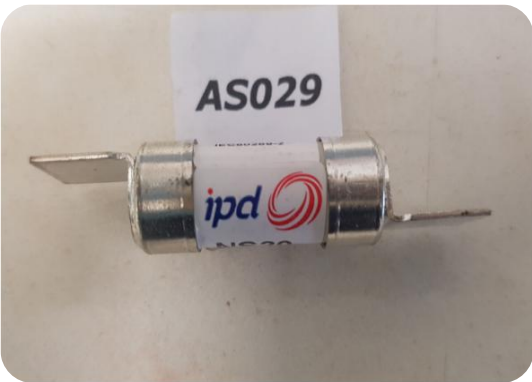
| Manufacturer | Rating | Fuse Body Photographs | Label Markings & Details | Result | Safety Instructions |
|---|---|---|---|---|---|
| IPD | 20 | <p>174102-001-AS029</p> | NS20, gG, 20A, 80kA, BS88-6, IEC60269-2 | <br>No Asbestos found, exercise caution and follow safety instructions | <br>Where no manufacturer or date information can be confirmed and/or the fuse was manufactured prior to 2003, the <b>fuses should be presumed to contain asbestos and disposed</b> of in accordance with SWMS - AUS008 - Removal of Friable Asbestos Containing LV HRC Fuses. |

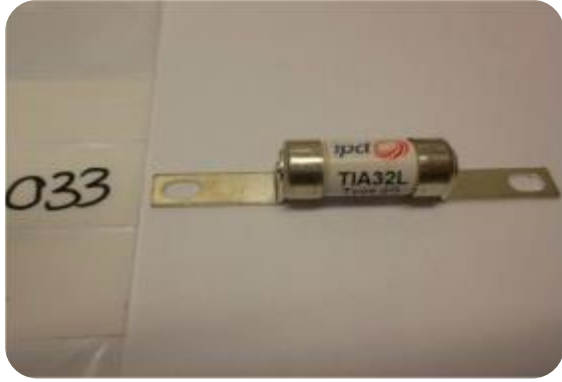
| Manufacturer | Rating | Fuse Body Photographs | Label Markings & Details | Result | Safety Instructions |
|---|---|---|---|---|---|
| IPD | 32 | <p>54287-002-033</p> | TIA32L, gG, Asta 20 cert, 415V ac, 80kA, | <br>No Asbestos found, exercise caution and follow safety instructions | <br>Where no manufacturer or date information can be confirmed and/or the fuse was manufactured prior to 2003, the <b>fuses should be presumed to contain asbestos and disposed</b> of in accordance with SWMS - AUS008 - Removal of Friable Asbestos Containing LV HRC Fuses. |

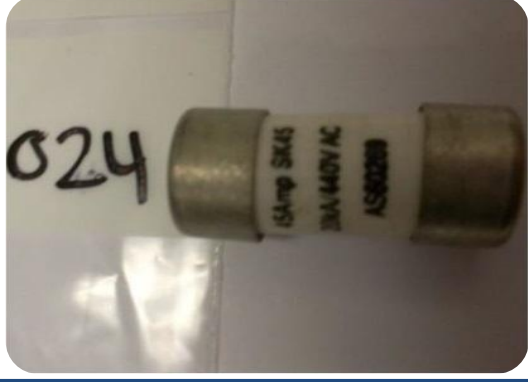
| Manufacturer | Rating | Fuse Body Photographs | Label Markings & Details | Result | Safety Instructions |
|---|---|---|---|---|---|
| IPD | 45 | <p>54287-002-024</p> | SK45, 20kA/440V ac, | <br>No Asbestos found | <br>May be used as normal.<br>When disposing of LV HRC Fuses treat all fuses as asbestos waste. |

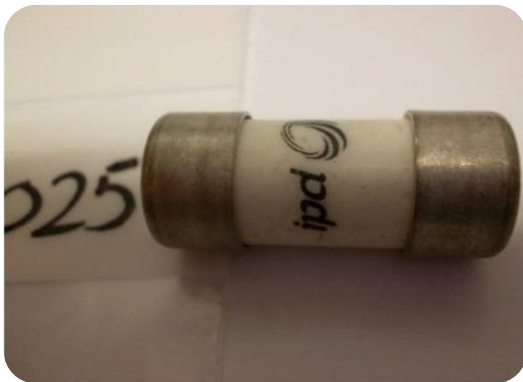
| Manufacturer | Rating | Fuse Body Photographs | Label Markings & Details | Result | Safety Instructions |
|---|---|---|---|---|---|
| IPD | 45 | <br>54287-002-025 | SK45, 20kA/440V ac, | ✓<br>No Asbestos found | ✓ May be used as normal.<br>✓ When disposing of LV HRC Fuses treat all fuses as asbestos waste. |

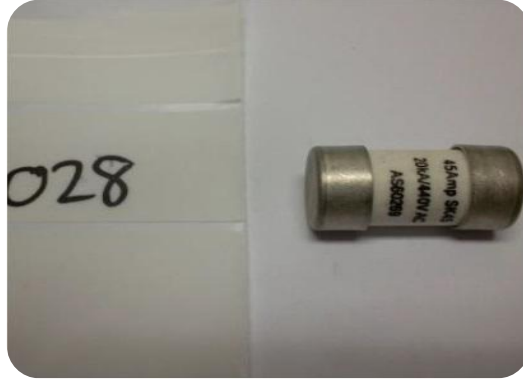
| Manufacturer | Rating | Fuse Body Photographs | Label Markings & Details | Result | Safety Instructions |
|---|---|---|---|---|---|
| IPD | 45 | <br>54287-002-028 | SK45, 20kA/440V ac, | ✓<br>No Asbestos found | ✓ May be used as normal.<br>✓ When disposing of LV HRC Fuses treat all fuses as asbestos waste. |

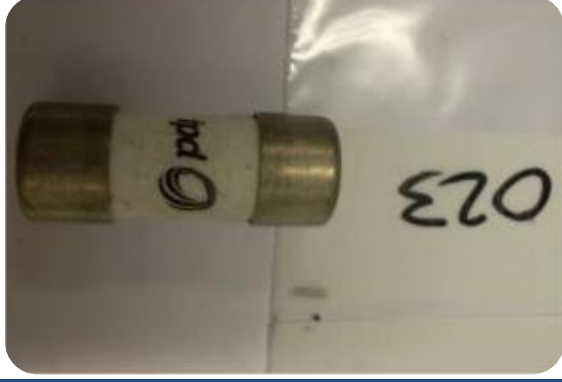
| Manufacturer | Rating | Fuse Body Photographs | Label Markings & Details | Result | Safety Instructions |
|---|---|---|---|---|---|
| IPD | 45 | <br>54287-002-023 | SK45, 20kA/440V ac, | ✓<br>No Asbestos found | ✓ May be used as normal.<br>✓ When disposing of LV HRC Fuses treat all fuses as asbestos waste. |

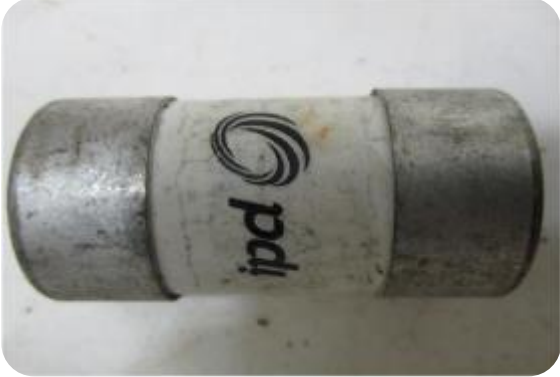
| Manufacturer | Rating | Fuse Body Photographs | Label Markings & Details | Result | Safety Instructions |
|---|---|---|---|---|---|
| IPD | 60 | | 60ARHLF60 | <br>No Asbestos found | ✓ May be used as normal.<br>✓ When disposing of LV HRC Fuses treat all fuses as asbestos waste. |

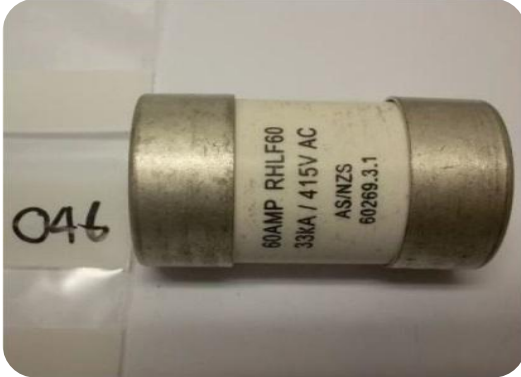
| Manufacturer | Rating | Fuse Body Photographs | Label Markings & Details | Result | Safety Instructions |
|---|---|---|---|---|---|
| IPD | 60 | | RHLF60, 33kA/415V ac, | <br>Asbestos found | <b>In-Service Fuses:</b><br>ⓧ If fuse is damaged, cease work and make safe. Contact the Hazmat Hotline - 02 9394 6961.<br>ⓧ If the fuse is intact, remove the fuse taking care not to damage in accordance with SWMS - AUS008 Removal of Friable Asbestos Containing LV HRC Fuses.<br><b>Stored and Quarantined Fuses:</b><br>ⓧ Must be disposed of in accordance with SWMS - AUS008 Removal of Friable Asbestos Containing LV HRC Fuses. |

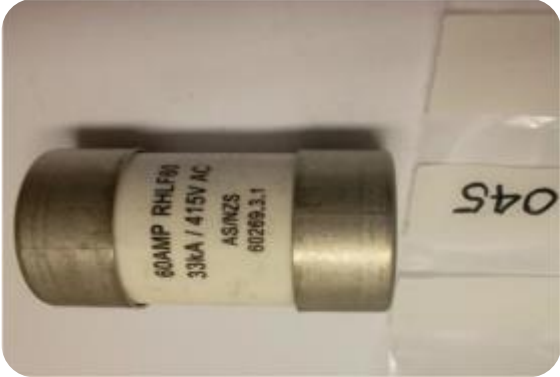
| Manufacturer | Rating | Fuse Body Photographs | Label Markings & Details | Result | Safety Instructions |
|---|---|---|---|---|---|
| IPD | 60 | | RHLF60, 33kA/415V ac, | <br>Asbestos found | <b>In-Service Fuses:</b><br>ⓧ If fuse is damaged, cease work and make safe. Contact the Hazmat Hotline - 02 9394 6961.<br>ⓧ If the fuse is intact, remove the fuse taking care not to damage in accordance with SWMS - AUS008 Removal of Friable Asbestos Containing LV HRC Fuses.<br><b>Stored and Quarantined Fuses:</b><br>ⓧ Must be disposed of in accordance with SWMS - AUS008 Removal of Friable Asbestos Containing LV HRC Fuses. |

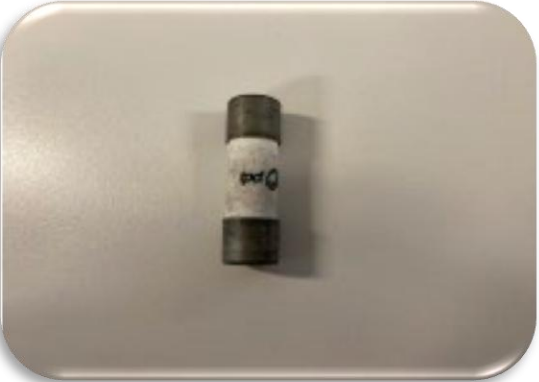
| Manufacturer | Rating | Fuse Body Photographs | Label Markings & Details | Result | Safety Instructions |
|---|---|---|---|---|---|
| IPD | 63 | | ipd 63Amp UK63 | <br>No Asbestos found, exercise caution and follow safety instructions | Where no manufacturer or date information can be confirmed and/or the fuse was manufactured prior to 2003, the <b>fuses should be presumed to contain asbestos and disposed</b> of in accordance with SWMS - AUS008 - Removal of Friable Asbestos Containing LV HRC Fuses. |

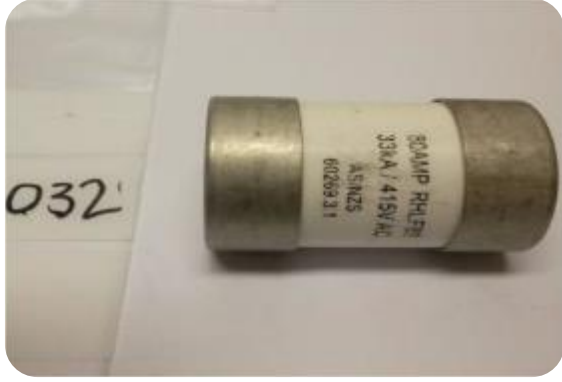
| Manufacturer | Rating | Fuse Body Photographs | Label Markings & Details | Result | Safety Instructions |
|---|---|---|---|---|---|
| IPD | 80 | | RHLF80, 33kA/415V ac, | <br>Asbestos found | <b>In-Service Fuses:</b><br> If fuse is damaged, cease work and make safe. Contact the Hazmat Hotline - 02 9394 6961.<br> If the fuse is intact, remove the fuse taking care not to damage in accordance with SWMS - AUS008 Removal of Friable Asbestos Containing LV HRC Fuses.<br><b>Stored and Quarantined Fuses:</b><br> Must be disposed of in accordance with SWMS - AUS008 Removal of Friable Asbestos Containing LV HRC Fuses. |

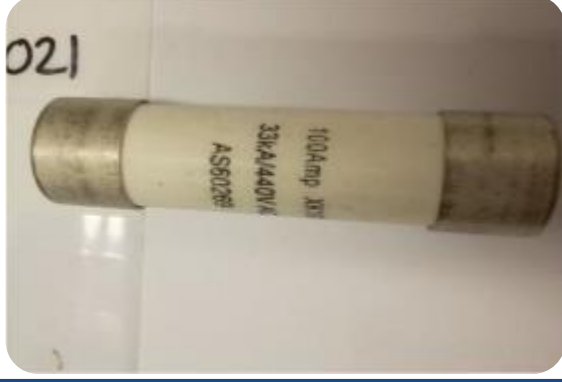
| Manufacturer | Rating | Fuse Body Photographs | Label Markings & Details | Result | Safety Instructions |
|---|---|---|---|---|---|
| IPD | 100 | | XK100, 33kA, a/440V ac, | <br>No Asbestos found | May be used as normal.<br> When disposing of LV HRC Fuses treat all fuses as asbestos waste. |

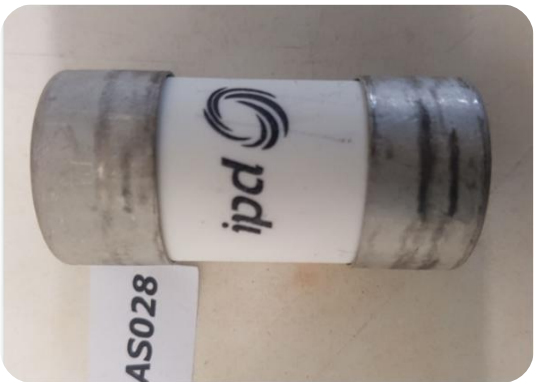
| Manufacturer | Rating | Fuse Body Photographs | Label Markings & Details | Result | Safety Instructions |
|---|---|---|---|---|---|
| IPD | 100 | | RHLF100, 100A, 33kA, AS/NZS 60269.3.1<br>174102-001-AS028 | <br>Asbestos found | <b>In-Service Fuses:</b><br> If fuse is damaged, cease work and make safe. Contact the Hazmat Hotline - 02 9394 6961.<br> If the fuse is intact, remove the fuse taking care not to damage in accordance with SWMS - AUS008 Removal of Friable Asbestos Containing LV HRC Fuses.<br><b>Stored and Quarantined Fuses:</b><br> Must be disposed of in accordance with SWMS - AUS008 Removal of Friable Asbestos Containing LV HRC Fuses. |

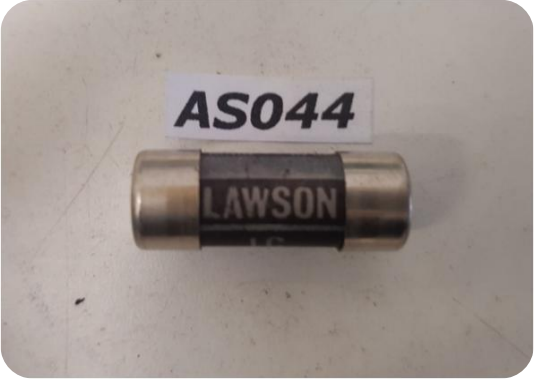
| Manufacturer | Rating | Fuse Body Photographs | Label Markings & Details | Result | Safety Instructions |
|---|---|---|---|---|---|
| Lawson | 10 | | LC, 10A, AC4, BS88,<br>174783-001-AS044 | <br>No Asbestos found, exercise caution and follow safety instructions | Where no manufacturer or date information can be confirmed and/or the fuse was manufactured prior to 2003, the <b>fuses should be presumed to contain asbestos and disposed</b> of in accordance with SWMS - AUS008 - Removal of Friable Asbestos Containing LV HRC Fuses. |

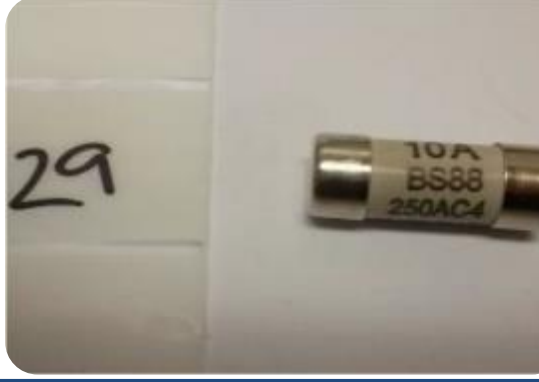
| Manufacturer | Rating | Fuse Body Photographs | Label Markings & Details | Result | Safety Instructions |
|---|---|---|---|---|---|
| Lawson | 10 | | LC, 240V<br>54287-002-029 | <br>No Asbestos found, exercise caution and follow safety instructions | Where no manufacturer or date information can be confirmed and/or the fuse was manufactured prior to 2003, the <b>fuses should be presumed to contain asbestos and disposed</b> of in accordance with SWMS - AUS008 - Removal of Friable Asbestos Containing LV HRC Fuses. |

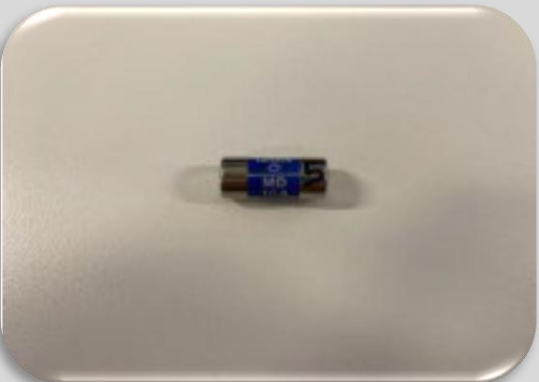
| Manufacturer | Rating | Fuse Body Photographs | Label Markings & Details | Result | Safety Instructions |
|---|---|---|---|---|---|
| Lawson | 10 | <br>221102/AS005 | MD 10A | <br>No Asbestos found, exercise caution and follow safety instructions | Where no manufacturer or date information can be confirmed and/or the fuse was manufactured prior to 2003, the <b>fuses should be presumed to contain asbestos and disposed</b> of in accordance with SWMS - AUS008 - Removal of Friable Asbestos Containing LV HRC Fuses. |

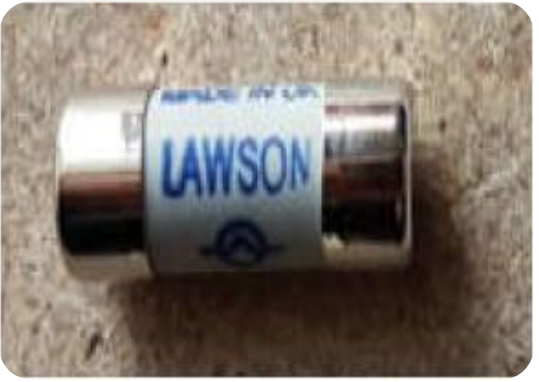
| Manufacturer | Rating | Fuse Body Photographs | Label Markings & Details | Result | Safety Instructions |
|---|---|---|---|---|---|
| Lawson | 15 | <br>P033768.003-AS021 | LC, 15A, BS1361, 240V, MADE IN THE UK | <br>No Asbestos found, exercise caution and follow safety instructions | Where no manufacturer or date information can be confirmed and/or the fuse was manufactured prior to 2003, the <b>fuses should be presumed to contain asbestos and disposed</b> of in accordance with SWMS - AUS008 - Removal of Friable Asbestos Containing LV HRC Fuses. |

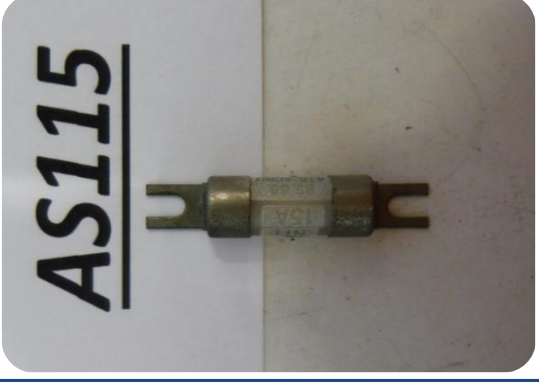
| Manufacturer | Rating | Fuse Body Photographs | Label Markings & Details | Result | Safety Instructions |
|---|---|---|---|---|---|
| Lawson | 15 | <br>168273-115 | NIT, 15A, AC80, B.S 88, Q1 | <br>Asbestos found | <b>In-Service Fuses:</b><br> If fuse is damaged, cease work and make safe. Contact the Hazmat Hotline - 02 9394 6961.<br> If the fuse is intact, remove the fuse taking care not to damage in accordance with SWMS - AUS008 Removal of Friable Asbestos Containing LV HRC Fuses.<br><b>Stored and Quarantined Fuses:</b><br> Must be disposed of in accordance with SWMS - AUS008 Removal of Friable Asbestos Containing LV HRC Fuses. |

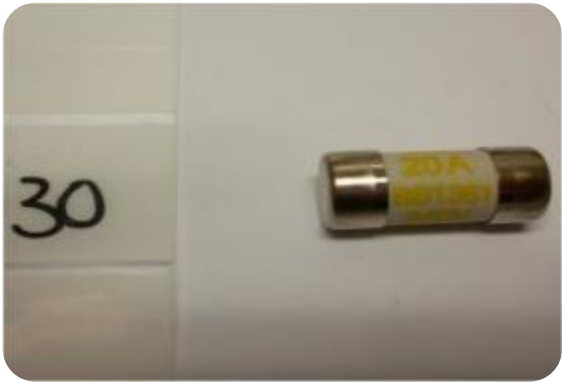
| Manufacturer | Rating | Fuse Body Photographs | Label Markings & Details | Result | Safety Instructions |
|---|---|---|---|---|---|
| Lawson | 20 | | LC, 240V | <br>No Asbestos found, exercise caution and follow safety instructions | <br>Where no manufacturer or date information can be confirmed and/or the fuse was manufactured prior to 2003, the <b>fuses should be presumed to contain asbestos and disposed</b> of in accordance with SWMS - AUS008 - Removal of Friable Asbestos Containing LV HRC Fuses. |

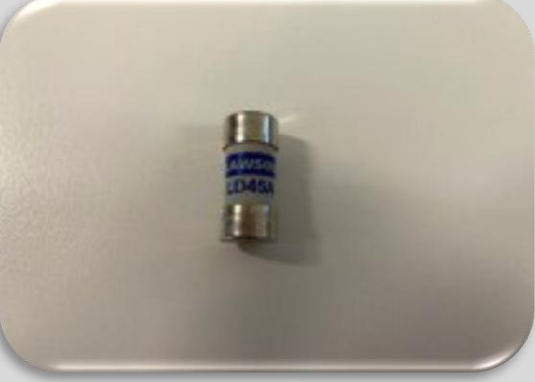
| Manufacturer | Rating | Fuse Body Photographs | Label Markings & Details | Result | Safety Instructions |
|---|---|---|---|---|---|
| Lawson | 45 | | LD45A | <br>No Asbestos found, exercise caution and follow safety instructions | <br>Where no manufacturer or date information can be confirmed and/or the fuse was manufactured prior to 2003, the <b>fuses should be presumed to contain asbestos and disposed</b> of in accordance with SWMS - AUS008 - Removal of Friable Asbestos Containing LV HRC Fuses. |

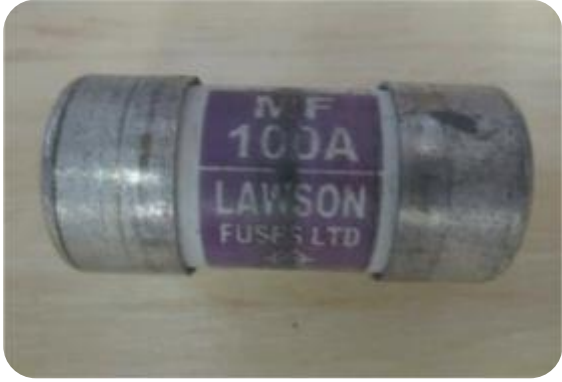
| Manufacturer | Rating | Fuse Body Photographs | Label Markings & Details | Result | Safety Instructions |
|---|---|---|---|---|---|
| Lawson | 100 | | MF 100A B1361 | <br>No Asbestos found, exercise caution and follow safety instructions | <br>Where no manufacturer or date information can be confirmed and/or the fuse was manufactured prior to 2003, the <b>fuses should be presumed to contain asbestos and disposed</b> of in accordance with SWMS - AUS008 - Removal of Friable Asbestos Containing LV HRC Fuses. |

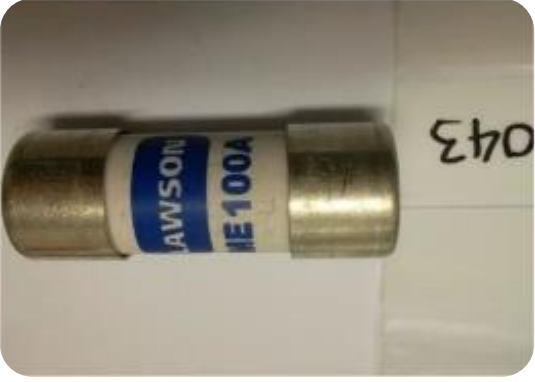
| Manufacturer | Rating | Fuse Body Photographs | Label Markings & Details | Result | Safety Instructions |
|---|---|---|---|---|---|
| Lawson | 100 | | ME100A, 415V, AC, 80kA | <br>No Asbestos found, exercise caution and follow safety instructions | <br>Where no manufacturer or date information can be confirmed and/or the fuse was manufactured prior to 2003, the <b>fuses should be presumed to contain asbestos and disposed</b> of in accordance with SWMS - AUS008 - Removal of Friable Asbestos Containing LV HRC Fuses. |

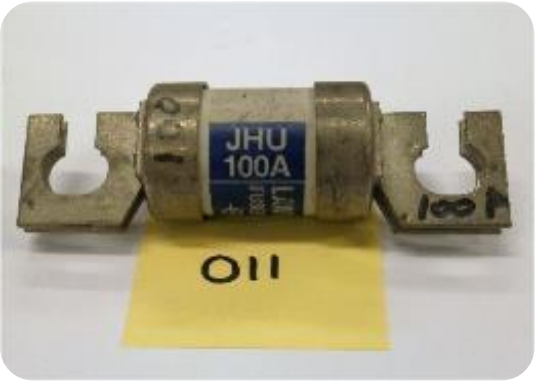
| Manufacturer | Rating | Fuse Body Photographs | Label Markings & Details | Result | Safety Instructions |
|---|---|---|---|---|---|
| Lawson | 100 | | JHU100A, 415V ac, 80kA, Asta 20 Cert | <br>No Asbestos found, exercise caution and follow safety instructions | <br>Where no manufacturer or date information can be confirmed and/or the fuse was manufactured prior to 2003, the <b>fuses should be presumed to contain asbestos and disposed</b> of in accordance with SWMS - AUS008 - Removal of Friable Asbestos Containing LV HRC Fuses. |

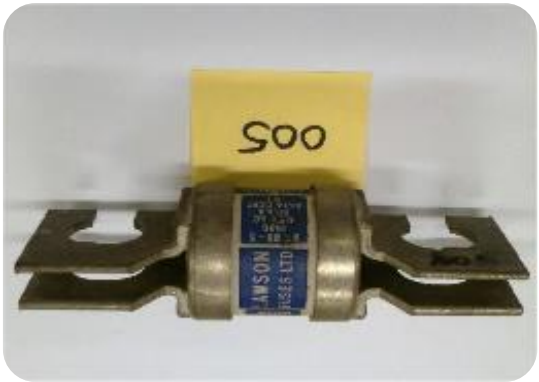
| Manufacturer | Rating | Fuse Body Photographs | Label Markings & Details | Result | Safety Instructions |
|---|---|---|---|---|---|
| Lawson | 100 | | JSU, 100A, 415V ac, 80kA, Q1, Asta Cert<br><small>55738-001-005</small> | <br>Asbestos found | <b>In-Service Fuses:</b><br> If fuse is damaged, cease work and make safe. Contact the Hazmat Hotline - 02 9394 6961.<br> If the fuse is intact, remove the fuse taking care not to damage in accordance with SWMS - AUS008 Removal of Friable Asbestos Containing LV HRC Fuses.<br><b>Stored and Quarantined Fuses:</b><br> Must be disposed of in accordance with SWMS - AUS008 Removal of Friable Asbestos Containing LV HRC Fuses. |

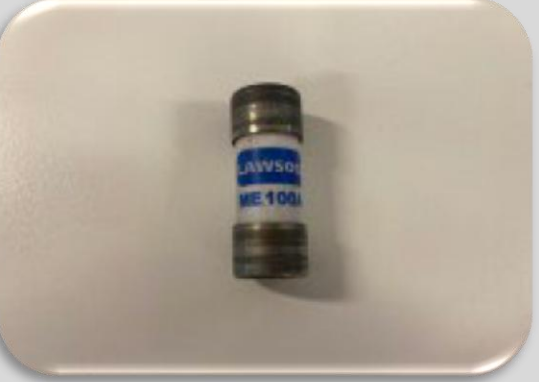
| Manufacturer | Rating | Fuse Body Photographs | Label Markings & Details | Result | Safety Instructions |
|---|---|---|---|---|---|
| Lawson | 100 | | ME100A<br><small>221102/AS003</small> | <br>No Asbestos found, exercise caution and follow safety instructions | Where no manufacturer or date information can be confirmed and/or the fuse was manufactured prior to 2003, the <b>fuses should be presumed to contain asbestos and disposed</b> of in accordance with SWMS - AUS008 - Removal of Friable Asbestos Containing LV HRC Fuses. |
