## Network Standard

Document No : NW000-S0161

NS211 ANNEXURE G – LV HRC FUSE ASBESTOS PRODUCT GUIDE

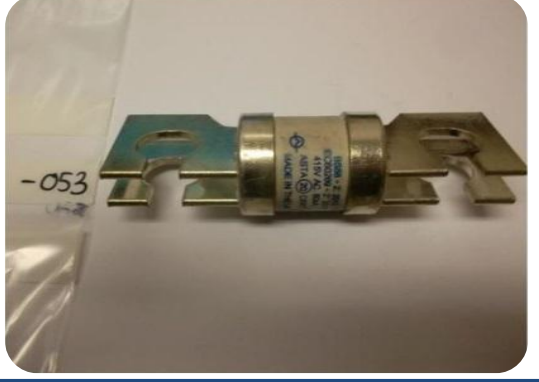
| Manufacturer | Rating | Fuse Body Photographs | Label Markings & Details | Result | Safety Instructions |
|---|---|---|---|---|---|
| Lawson | 200 | | OJSU200A, 415V ac, 80KA, Asta 20 Cert<br><small>54287-002-053</small> | <br>No Asbestos found | May be used as normal.<br> When disposing of LV HRC Fuses treat all fuses as asbestos waste. |

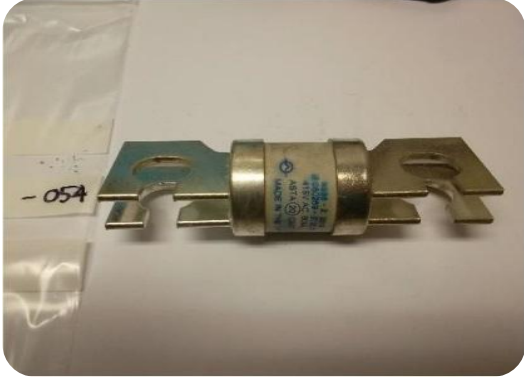
| Manufacturer | Rating | Fuse Body Photographs | Label Markings & Details | Result | Safety Instructions |
|---|---|---|---|---|---|
| Lawson | 200 | | OJSU200A, 415V ac, 80KA, Asta 20 Cert | ✓<br>No Asbestos found | ✓ May be used as normal.<br>✓ When disposing of LV HRC Fuses treat all fuses as asbestos waste. |

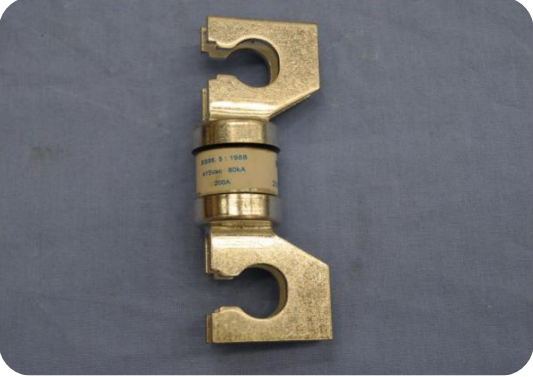
| Manufacturer | Rating | Fuse Body Photographs | Label Markings & Details | Result | Safety Instructions |
|---|---|---|---|---|---|
| Lawson | 200 | | LAWSON OJSU200 | ✓<br>Current Stock Item No. 85688 | ✓ May be used as normal.<br>✓ When disposing of LV HRC Fuses treat all fuses as asbestos waste. |

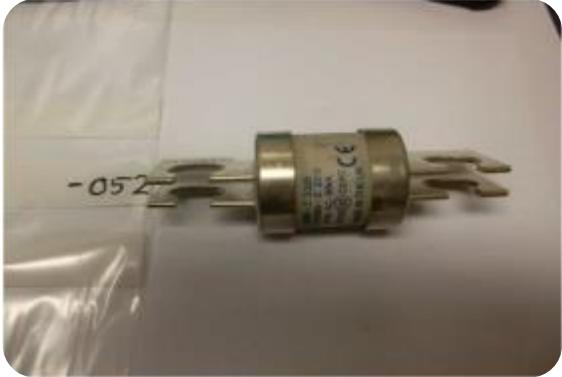
| Manufacturer | Rating | Fuse Body Photographs | Label Markings & Details | Result | Safety Instructions |
|---|---|---|---|---|---|
| Lawson | 200 | | OJSU200A, 415V ac, 80KA, Asta 20 Cert | ✓<br>No Asbestos found | ✓ May be used as normal.<br>✓ When disposing of LV HRC Fuses treat all fuses as asbestos waste. |

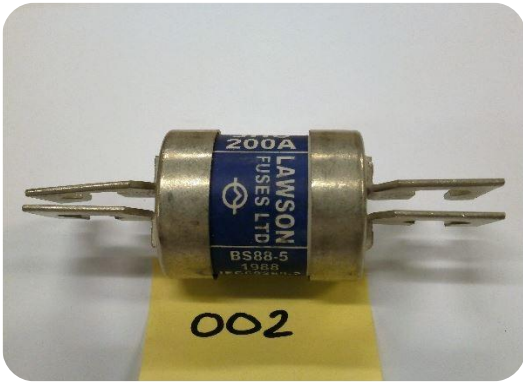
| Manufacturer | Rating | Fuse Body Photographs | Label Markings & Details | Result | Safety Instructions |
|---|---|---|---|---|---|
| Lawson | 200 | | JHU200A, 415V ac, 80kA, Asta 20 Cert<br>55738-001-002 | <br>No Asbestos found, exercise caution and follow safety instructions | Where no manufacturer or date information can be confirmed and/or the fuse was manufactured prior to 2003, the <b>fuses should be presumed to contain asbestos and disposed</b> of in accordance with SWMS - AUS008 - Removal of Friable Asbestos Containing LV HRC Fuses. |

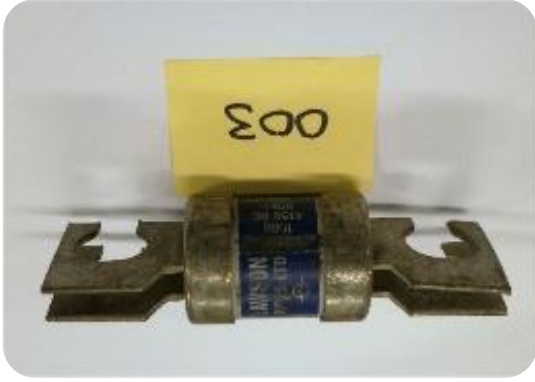
| Manufacturer | Rating | Fuse Body Photographs | Label Markings & Details | Result | Safety Instructions |
|---|---|---|---|---|---|
| Lawson | 200 | | JHU200A, 415V ac, 80kA, Asta 20 Cert<br>55738-001-003 | <br>No Asbestos found, exercise caution and follow safety instructions | Where no manufacturer or date information can be confirmed and/or the fuse was manufactured prior to 2003, the <b>fuses should be presumed to contain asbestos and disposed</b> of in accordance with SWMS - AUS008 - Removal of Friable Asbestos Containing LV HRC Fuses. |

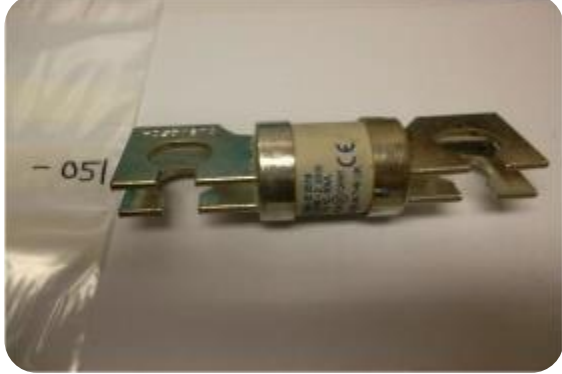
| Manufacturer | Rating | Fuse Body Photographs | Label Markings & Details | Result | Safety Instructions |
|---|---|---|---|---|---|
| Lawson | 250 | | OJSU250A, 415V ac, 80kA, Asta 20 Cert<br>54287-002-051 | <br>No Asbestos found | <ul style="list-style-type: none"> <li>✓ May be used as normal.</li> <li>✓ When disposing of LV HRC Fuses treat all fuses as asbestos waste.</li> </ul> |

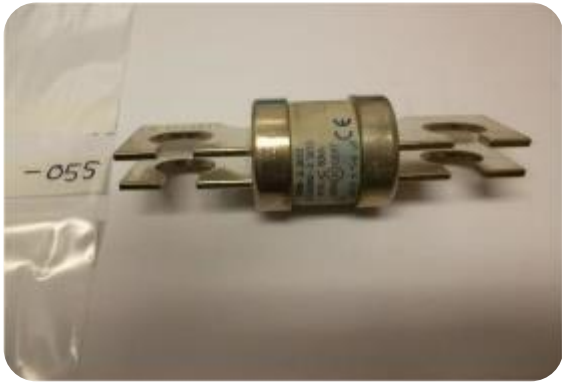
| Manufacturer | Rating | Fuse Body Photographs | Label Markings & Details | Result | Safety Instructions |
|---|---|---|---|---|---|
| Lawson | 315 | | OJSU315A, 415V ac, 80kA, Asta 20 Cert | <br>No Asbestos found | ✓ May be used as normal.<br>✓ When disposing of LV HRC Fuses treat all fuses as asbestos waste. |

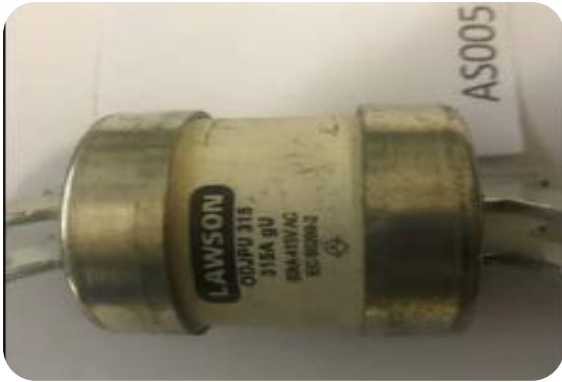
| Manufacturer | Rating | Fuse Body Photographs | Label Markings & Details | Result | Safety Instructions |
|---|---|---|---|---|---|
| Lawson | 315 | | ODJPU 315, 315A gU, 80kA 415V AC, IEC 60269-2, 11/16 | <br>No Asbestos found, exercise caution and follow safety instructions | Where no manufacturer or date information can be confirmed and/or the fuse was manufactured prior to 2003, the <b>fuses should be presumed to contain asbestos and disposed</b> of in accordance with SWMS - AUS008 - Removal of Friable Asbestos Containing LV HRC Fuses. |

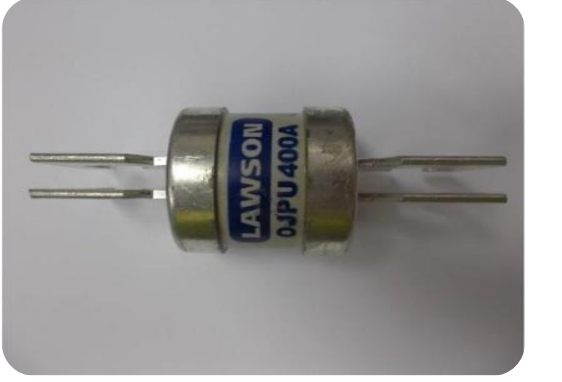
| Manufacturer | Rating | Fuse Body Photographs | Label Markings & Details | Result | Safety Instructions |
|---|---|---|---|---|---|
| Lawson | 400 | | OJSU400A, 415V ac, 80kA, Asta 20 Cert | <br>No Asbestos found | ✓ May be used as normal.<br>✓ When disposing of LV HRC Fuses treat all fuses as asbestos waste. |

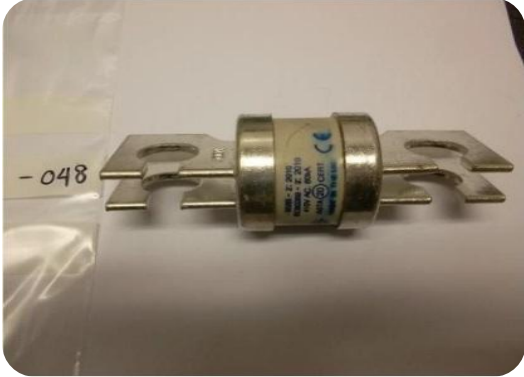
| Manufacturer | Rating | Fuse Body Photographs | Label Markings & Details | Result | Safety Instructions |
|---|---|---|---|---|---|
| Lawson | 400 | | OJSU400A, 415V ac, 80kA,<br>Asta 20 Cert | <br>No<br>Asbestos<br>found | ✓ May be used as normal.<br>✓ When disposing of LV HRC Fuses treat all fuses as<br>asbestos waste. |

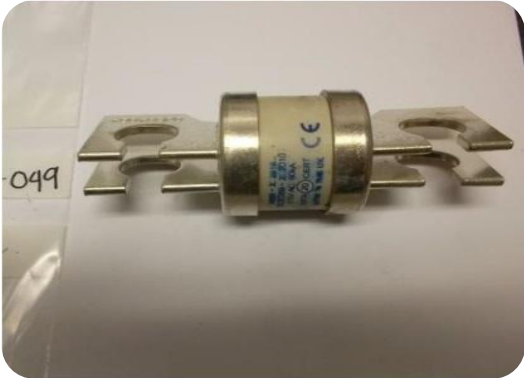
| Manufacturer | Rating | Fuse Body Photographs | Label Markings & Details | Result | Safety Instructions |
|---|---|---|---|---|---|
| Lawson | 400 | | OJSU400A, 415V ac, 80kA,<br>Asta 20 Cert | <br>No<br>Asbestos<br>found | ✓ May be used as normal.<br>✓ When disposing of LV HRC Fuses treat all fuses as<br>asbestos waste. |

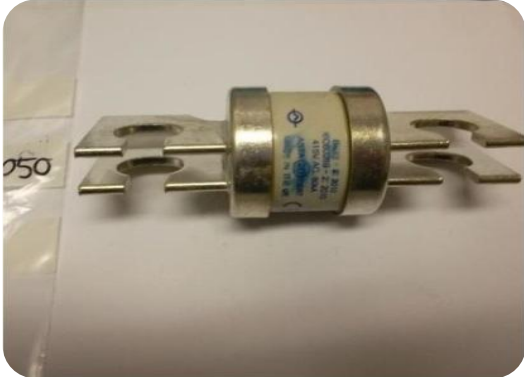
| Manufacturer | Rating | Fuse Body Photographs | Label Markings & Details | Result | Safety Instructions |
|---|---|---|---|---|---|
| Lawson | 400 | | OJSU400A, 415V ac, 80kA,<br>Asta 20 Cert | <br>No<br>Asbestos<br>found | ✓ May be used as normal.<br>✓ When disposing of LV HRC Fuses treat all fuses as<br>asbestos waste. |

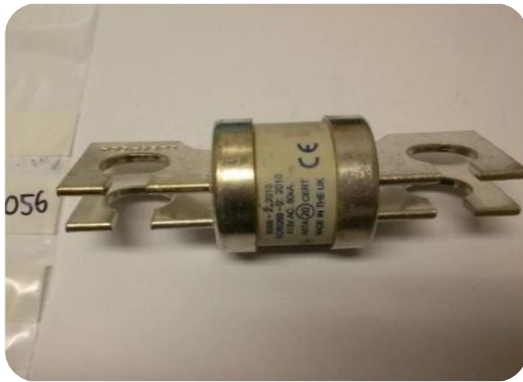
| Manufacturer | Rating | Fuse Body Photographs | Label Markings & Details | Result | Safety Instructions |
|---|---|---|---|---|---|
| Lawson | 400 | | OJSU400A, 415V ac, 80kA,<br>Asta 20 Cert | <br>No<br>Asbestos<br>found | ✓ May be used as normal.<br>✓ When disposing of LV HRC Fuses treat all fuses as<br>asbestos waste. |

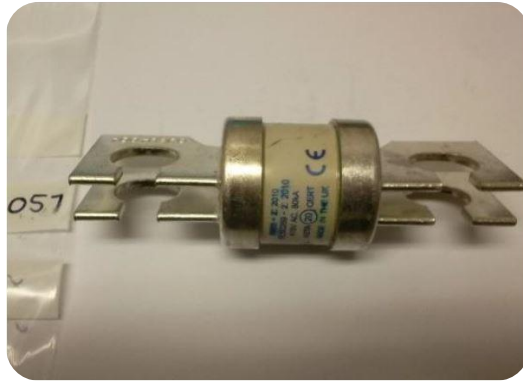
| Manufacturer | Rating | Fuse Body Photographs | Label Markings & Details | Result | Safety Instructions |
|---|---|---|---|---|---|
| Lawson | 400 | | OJSU400A, 415V ac, 80kA,<br>Asta 20 Cert | <br>No<br>Asbestos<br>found | ✓ May be used as normal.<br>✓ When disposing of LV HRC Fuses treat all fuses as<br>asbestos waste. |

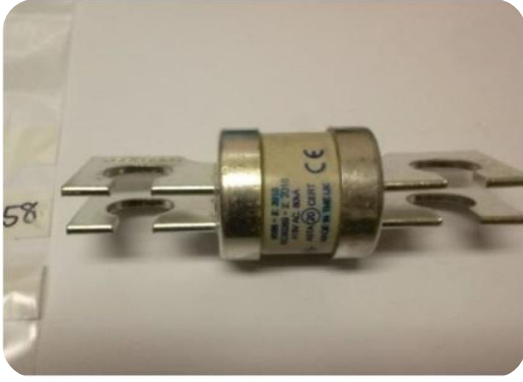
| Manufacturer | Rating | Fuse Body Photographs | Label Markings & Details | Result | Safety Instructions |
|---|---|---|---|---|---|
| Lawson | 400 | | OJSU400A, 415V ac, 80kA,<br>Asta 20 Cert | <br>No<br>Asbestos<br>found | ✓ May be used as normal.<br>✓ When disposing of LV HRC Fuses treat all fuses as<br>asbestos waste. |

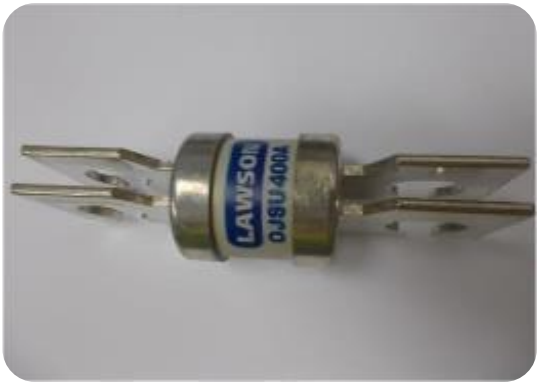
| Manufacturer | Rating | Fuse Body Photographs | Label Markings & Details | Result | Safety Instructions |
|---|---|---|---|---|---|
| Lawson | 400 | | OJSU, 415V, Asta 20 cert,<br>OJSU400A | ✓<br>No Asbestos found | ✓ May be used as normal.<br>✓ When disposing of LV HRC Fuses treat all fuses as asbestos waste. |

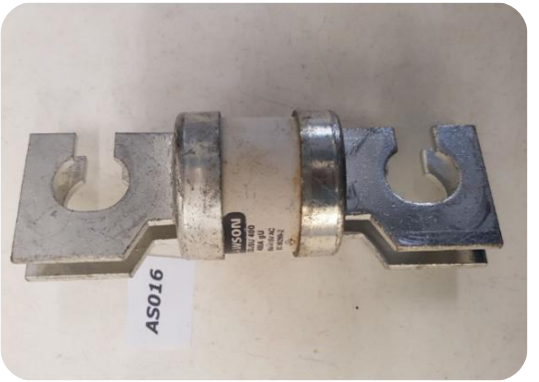
| Manufacturer | Rating | Fuse Body Photographs | Label Markings & Details | Result | Safety Instructions |
|---|---|---|---|---|---|
| Lawson | 400 | | ODJSU400, 400A, gU, 80kA, IEC<br>60269-2 | ⚠<br>No Asbestos found,<br>exercise caution and follow safety instructions | ⚠ Where no manufacturer or date information can be confirmed and/or the fuse was manufactured prior to 2003, the <b>fuses should be presumed to contain asbestos and disposed</b> of in accordance with SWMS - AUS008 - Removal of Friable Asbestos Containing LV HRC Fuses. |

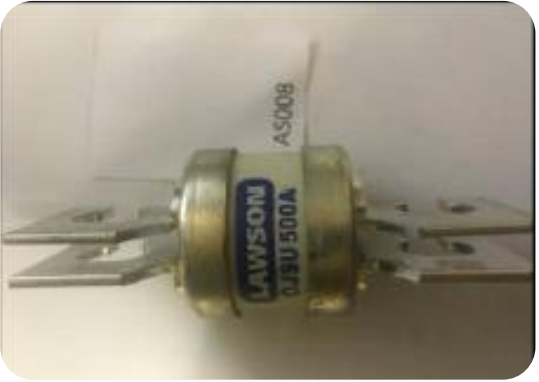
| Manufacturer | Rating | Fuse Body Photographs | Label Markings & Details | Result | Safety Instructions |
|---|---|---|---|---|---|
| Lawson | 500 | | OJSU500A, BS88 - 2: 2010,<br>IEC60269 - 2: 2010, 415V AC.<br>80kA, ASTA 20 CERT | ✓<br>No Asbestos found | ✓ May be used as normal.<br>✓ When disposing of LV HRC Fuses treat all fuses as asbestos waste. |

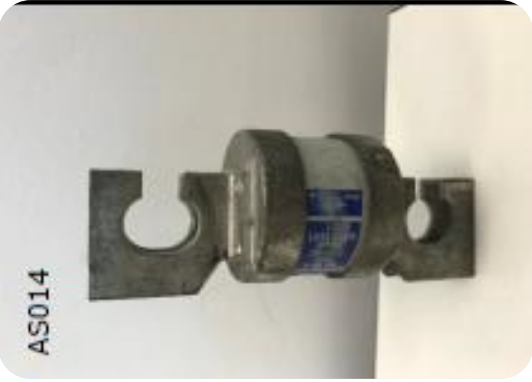
| Manufacturer | Rating | Fuse Body Photographs | Label Markings & Details | Result | Safety Instructions |
|---|---|---|---|---|---|
| Lawson | 500 | <p>AS014</p> <p>PO33786.002-AS012</p> | Lawson Fuses LTD - JSU 500A - Q1, BS88-5: 1980, 415V AC 80 kA, - 415V - United Kingdom - no date | <p>Asbestos found</p> | <b>In-Service Fuses:</b> <ul style="list-style-type: none"> <li> If fuse is damaged, cease work and make safe. Contact the Hazmat Hotline - 02 9394 6961.</li> <li> If the fuse is intact, remove the fuse taking care not to damage in accordance with SWMS - AUS008 Removal of Friable Asbestos Containing LV HRC Fuses.</li> </ul> <b>Stored and Quarantined Fuses:</b> <ul style="list-style-type: none"> <li> Must be disposed of in accordance with SWMS - AUS008 Removal of Friable Asbestos Containing LV HRC Fuses.</li> </ul> |

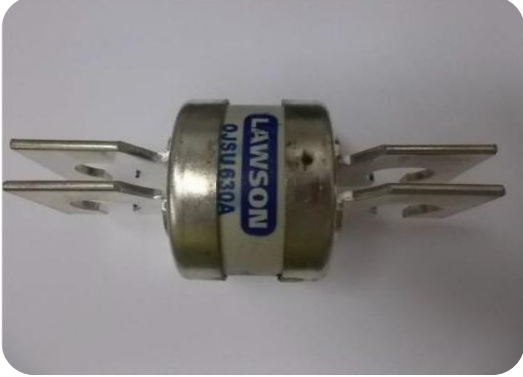
| Manufacturer | Rating | Fuse Body Photographs | Label Markings & Details | Result | Safety Instructions |
|---|---|---|---|---|---|
| Lawson | 630 | <p>54287-002-008</p> | OJSU, Asta 20 cert, OJSU630A | <p>No Asbestos found</p> | <ul style="list-style-type: none"> <li>✓ May be used as normal.</li> <li>✓ When disposing of LV HRC Fuses treat all fuses as asbestos waste.</li> </ul> |

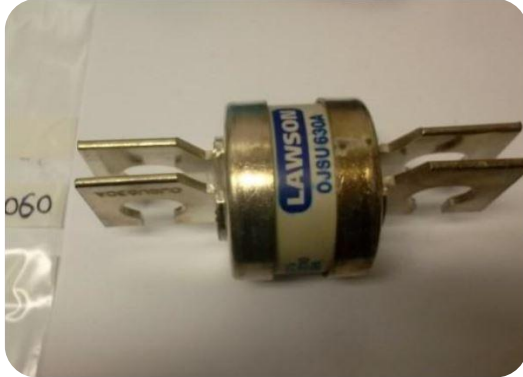
| Manufacturer | Rating | Fuse Body Photographs | Label Markings & Details | Result | Safety Instructions |
|---|---|---|---|---|---|
| Lawson | 630 | <p>060</p> <p>54287-002-060</p> | OJSU630A, 415V ac, 80kA, Asta 20 Cert | <p>No Asbestos found</p> | <ul style="list-style-type: none"> <li>✓ May be used as normal.</li> <li>✓ When disposing of LV HRC Fuses treat all fuses as asbestos waste.</li> </ul> |

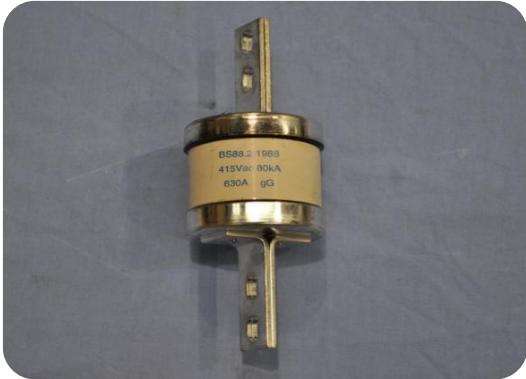
| Manufacturer | Rating | Fuse Body Photographs | Label Markings & Details | Result | Safety Instructions |
|---|---|---|---|---|---|
| Lawson | 630 | | LAWSON | <br>Current Stock Item<br>No. 85589 | May be used as normal.<br> When disposing of LV HRC Fuses treat all fuses as asbestos waste. |

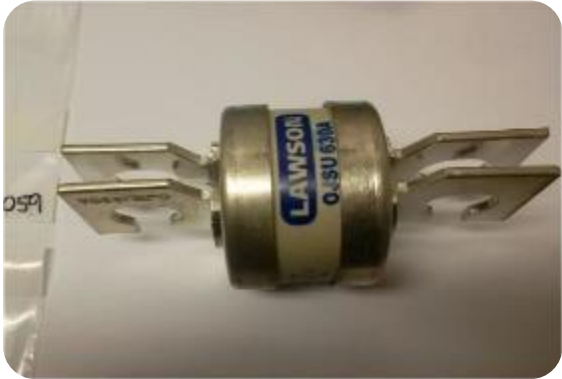
| Manufacturer | Rating | Fuse Body Photographs | Label Markings & Details | Result | Safety Instructions |
|---|---|---|---|---|---|
| Lawson | 630 | <br>54287-002-059 | OJSU630A, 415V ac, 80kA, Asta 20 Cert | <br>No Asbestos found | May be used as normal.<br> When disposing of LV HRC Fuses treat all fuses as asbestos waste. |

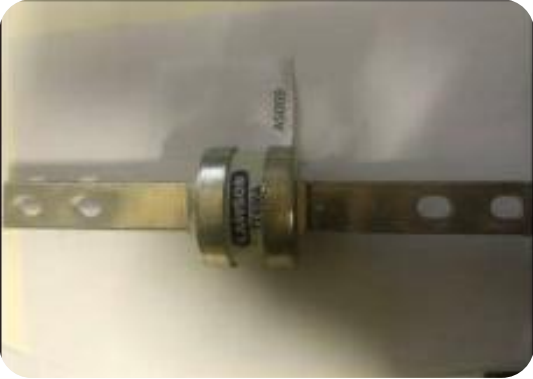
| Manufacturer | Rating | Fuse Body Photographs | Label Markings & Details | Result | Safety Instructions |
|---|---|---|---|---|---|
| Lawson | 630 | <br>P033786.002-AS009 | TT630A BS88 - 2: 1988,<br>IEC60269 - 2, 415V AC. 80kA Gg,<br>ASTA20 CERT, MADE IN THE UK | <br>No Asbestos found,<br>exercise caution and follow safety instructions | Where no manufacturer or date information can be confirmed and/or the fuse was manufactured prior to 2003, the <b>fuses should be presumed to contain asbestos and disposed</b> of in accordance with SWMS - AUS008 - Removal of Friable Asbestos Containing LV HRC Fuses. |

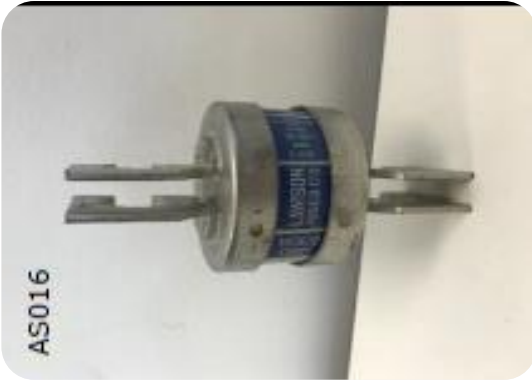
| Manufacturer | Rating | Fuse Body Photographs | Label Markings & Details | Result | Safety Instructions |
|---|---|---|---|---|---|
| Lawson | 630 | <p>AS016</p> | <p>Lawson Fuses LTD - JSU 630A - Q1, BS88-5: 1980 415 AC 80kA, ASTA certified - 415V - United Kingdom - no date</p> <p>PO33786.002-AS012</p> | <p> Asbestos found</p> | <p><b>In-Service Fuses:</b></p> <p> If fuse is damaged, cease work and make safe. Contact the Hazmat Hotline - 02 9394 6961.</p> <p> If the fuse is intact, remove the fuse taking care not to damage in accordance with SWMS - AUS008 Removal of Friable Asbestos Containing LV HRC Fuses.</p> <p><b>Stored and Quarantined Fuses:</b></p> <p> Must be disposed of in accordance with SWMS - AUS008 Removal of Friable Asbestos Containing LV HRC Fuses.</p> |

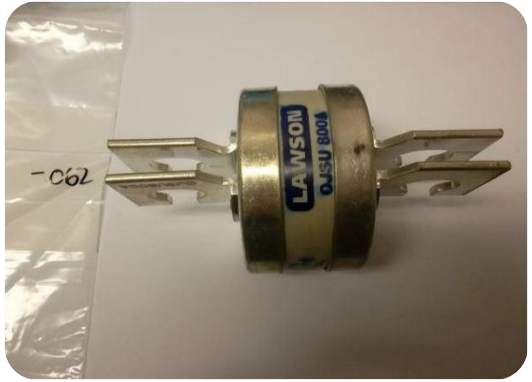
| Manufacturer | Rating | Fuse Body Photographs | Label Markings & Details | Result | Safety Instructions |
|---|---|---|---|---|---|
| Lawson | 800 | <p>-C62</p> | <p>OJSU800A, 415V ac, 80kA,</p> <p>54287-002-062</p> | <p> No Asbestos found</p> | <p> May be used as normal.</p> <p> When disposing of LV HRC Fuses treat all fuses as asbestos waste.</p> |

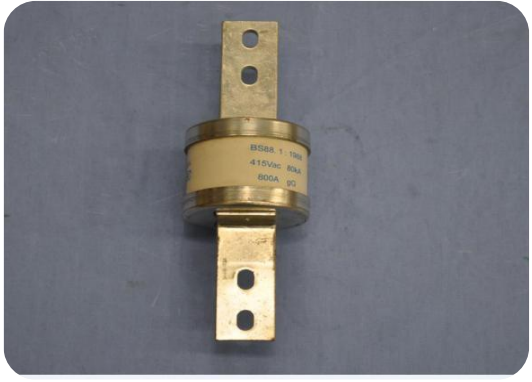
| Manufacturer | Rating | Fuse Body Photographs | Label Markings & Details | Result | Safety Instructions |
|---|---|---|---|---|---|
| Lawson | 800 | | <p>LAWSON TLT800</p> | <p> Current Stock Item No. 85613</p> | <p> May be used as normal.</p> <p> When disposing of LV HRC Fuses treat all fuses as asbestos waste.</p> |

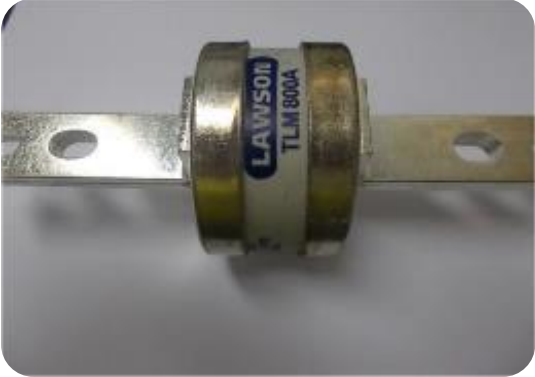
| Manufacturer | Rating | Fuse Body Photographs | Label Markings & Details | Result | Safety Instructions |
|---|---|---|---|---|---|
| Lawson | 800 | <br>54287-002-009 | TLM 800A, Asta 20 cert, 415V, 80KA, gG | ✓<br>No Asbestos found | ✓ May be used as normal.<br>✓ When disposing of LV HRC Fuses treat all fuses as asbestos waste. |

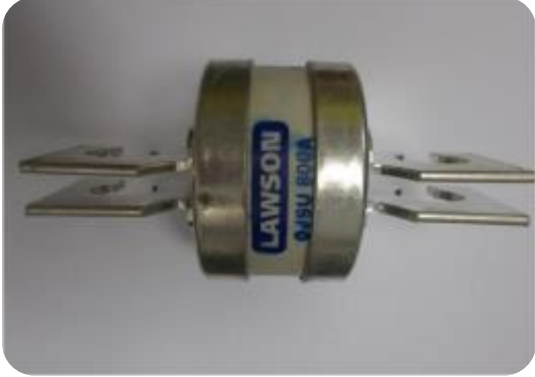
| Manufacturer | Rating | Fuse Body Photographs | Label Markings & Details | Result | Safety Instructions |
|---|---|---|---|---|---|
| Lawson | 800 | <br>54287-002-013 | OJKSU800A, 415V ac, 80kA | ✓<br>No Asbestos found | ✓ May be used as normal.<br>✓ When disposing of LV HRC Fuses treat all fuses as asbestos waste. |

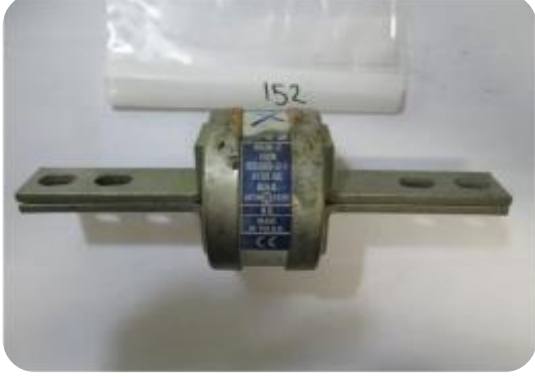
| Manufacturer | Rating | Fuse Body Photographs | Label Markings & Details | Result | Safety Instructions |
|---|---|---|---|---|---|
| Lawson | | <br>54287-001-152 | No Identifying marks | ⚠<br>No Asbestos found, exercise caution and follow safety instructions | ⚠ Where no manufacturer or date information can be confirmed and/or the fuse was manufactured prior to 2003, the <b>fuses should be presumed to contain asbestos and disposed</b> of in accordance with SWMS - AUS008 - Removal of Friable Asbestos Containing LV HRC Fuses. |

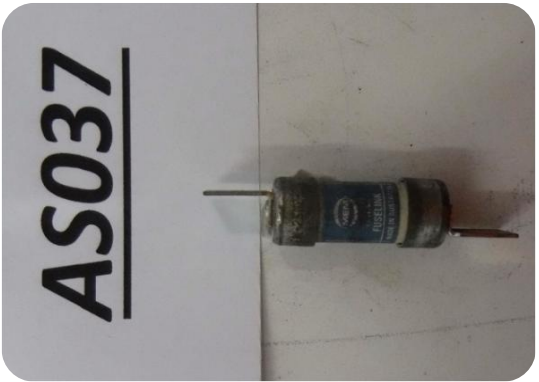
| Manufacturer | Rating | Fuse Body Photographs | Label Markings & Details | Result | Safety Instructions |
|---|---|---|---|---|---|
| MEM | 2 | | 2SN2, 2A, B.S.88-2 1975,<br>IEC269-2/2A, AC80, 250DC40,<br>Complies with AS2005-1:1981 &<br>2:1977, Class Q1 | <br>No Asbestos found,<br>exercise caution and follow safety instructions | Where no manufacturer or date information can be confirmed and/or the fuse was manufactured prior to 2003, the <b>fuses should be presumed to contain asbestos and disposed</b> of in accordance with SWMS - AUS008 - Removal of Friable Asbestos Containing LV HRC Fuses. |

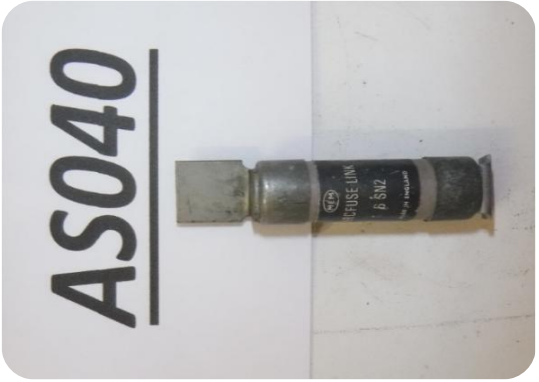
| Manufacturer | Rating | Fuse Body Photographs | Label Markings & Details | Result | Safety Instructions |
|---|---|---|---|---|---|
| MEM | 6 | | 6SN2, 6A, BS88:1967, NS Type,<br>AC80, Class Q1 | <br>No Asbestos found,<br>exercise caution and follow safety instructions | Where no manufacturer or date information can be confirmed and/or the fuse was manufactured prior to 2003, the <b>fuses should be presumed to contain asbestos and disposed</b> of in accordance with SWMS - AUS008 - Removal of Friable Asbestos Containing LV HRC Fuses. |

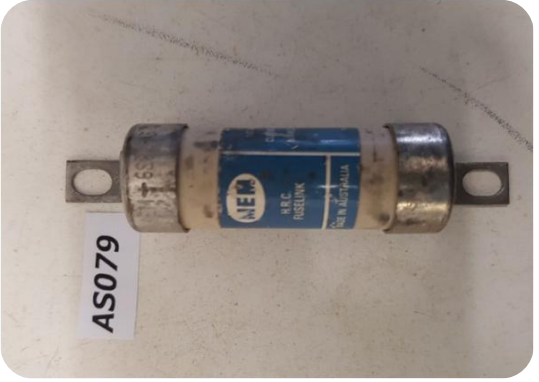
| Manufacturer | Rating | Fuse Body Photographs | Label Markings & Details | Result | Safety Instructions |
|---|---|---|---|---|---|
| MEM | 6 | | 6SB3, 6AA, AC80, AS2005.1:<br>1981 2:1977, BS88.2: 1975,<br>IEC269-2/2A, Class Q1,<br>250DC40 | <br>No Asbestos found,<br>exercise caution and follow safety instructions | Where no manufacturer or date information can be confirmed and/or the fuse was manufactured prior to 2003, the <b>fuses should be presumed to contain asbestos and disposed</b> of in accordance with SWMS - AUS008 - Removal of Friable Asbestos Containing LV HRC Fuses. |

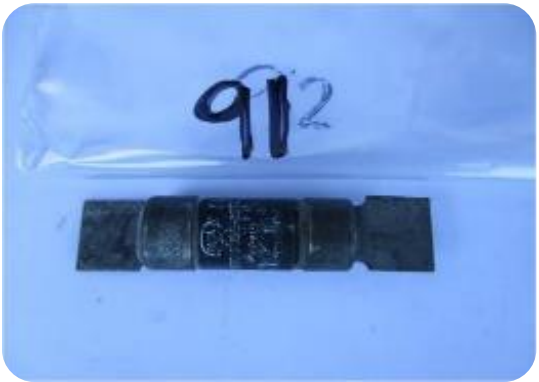
| Manufacturer | Rating | Fuse Body Photographs | Label Markings & Details | Result | Safety Instructions |
|---|---|---|---|---|---|
| MEM | 6 | | SSM2 6A Q1<br>54287-001-091 | <br>No Asbestos found, exercise caution and follow safety instructions | Where no manufacturer or date information can be confirmed and/or the fuse was manufactured prior to 2003, the <b>fuses should be presumed to contain asbestos and disposed</b> of in accordance with SWMS - AUS008 - Removal of Friable Asbestos Containing LV HRC Fuses. |

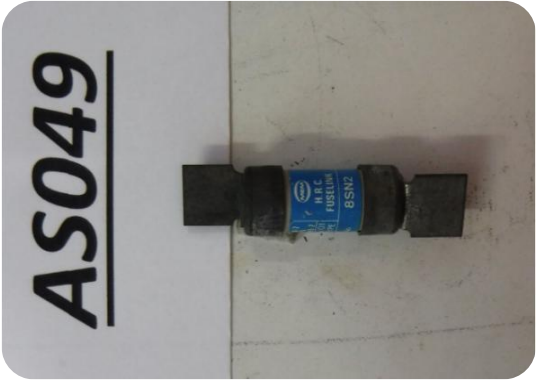
| Manufacturer | Rating | Fuse Body Photographs | Label Markings & Details | Result | Safety Instructions |
|---|---|---|---|---|---|
| MEM | 8 | | 8SN2, 8A, B.S.88-2 1975, IEC269-2, Class Q1, NS Type, AC80, AS 2005-2,1977<br>168215-49 | <br>Asbestos found | <b>In-Service Fuses:</b><br> If fuse is damaged, cease work and make safe. Contact the Hazmat Hotline - 02 9394 6961.<br> If the fuse is intact, remove the fuse taking care not to damage in accordance with SWMS - AUS008 Removal of Friable Asbestos Containing LV HRC Fuses.<br><b>Stored and Quarantined Fuses:</b><br> Must be disposed of in accordance with SWMS - AUS008 Removal of Friable Asbestos Containing LV HRC Fuses. |

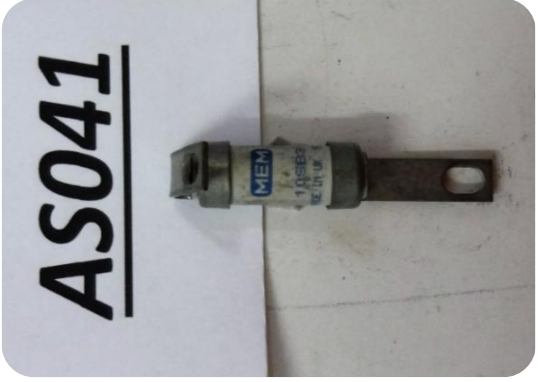
| Manufacturer | Rating | Fuse Body Photographs | Label Markings & Details | Result | Safety Instructions |
|---|---|---|---|---|---|
| MEM | 10 | | 10SB3, 10A, B.S.88: 2:1:1988, AC80, gG<br>168215-41 | <br>No Asbestos found, exercise caution and follow safety instructions | Where no manufacturer or date information can be confirmed and/or the fuse was manufactured prior to 2003, the <b>fuses should be presumed to contain asbestos and disposed</b> of in accordance with SWMS - AUS008 - Removal of Friable Asbestos Containing LV HRC Fuses. |

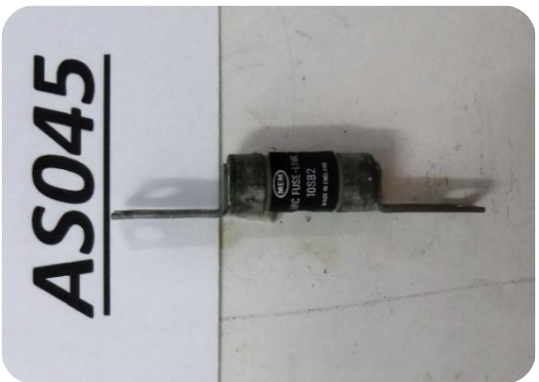
| Manufacturer | Rating | Fuse Body Photographs | Label Markings & Details | Result | Safety Instructions |
|---|---|---|---|---|---|
| MEM | 10 | | 10SB2, 10A, B.S.88 1967, Ref A2, Class Q1, AC 80, 250 DC40 | <br>No Asbestos found, exercise caution and follow safety instructions | Where no manufacturer or date information can be confirmed and/or the fuse was manufactured prior to 2003, the <b>fuses should be presumed to contain asbestos and disposed</b> of in accordance with SWMS - AUS008 - Removal of Friable Asbestos Containing LV HRC Fuses. |

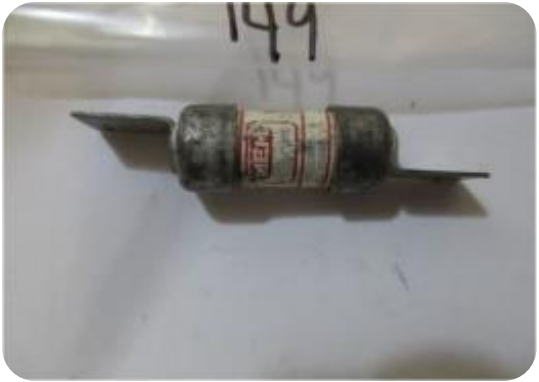
| Manufacturer | Rating | Fuse Body Photographs | Label Markings & Details | Result | Safety Instructions |
|---|---|---|---|---|---|
| MEM | 10 | | 2567DC LIST NO 10SN2 | <br>No Asbestos found, exercise caution and follow safety instructions | Where no manufacturer or date information can be confirmed and/or the fuse was manufactured prior to 2003, the <b>fuses should be presumed to contain asbestos and disposed</b> of in accordance with SWMS - AUS008 - Removal of Friable Asbestos Containing LV HRC Fuses. |

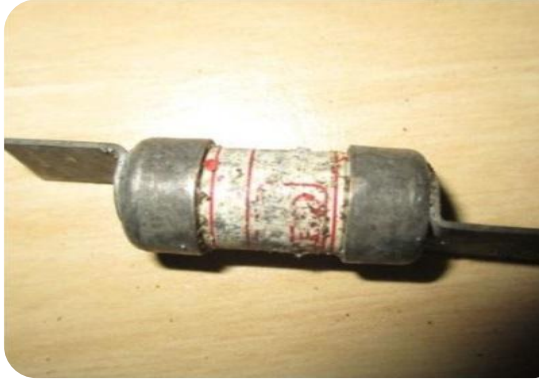
| Manufacturer | Rating | Fuse Body Photographs | Label Markings & Details | Result | Safety Instructions |
|---|---|---|---|---|---|
| MEM | 10 | | 10SN2 10A | <br>No Asbestos found, exercise caution and follow safety instructions | Where no manufacturer or date information can be confirmed and/or the fuse was manufactured prior to 2003, the <b>fuses should be presumed to contain asbestos and disposed</b> of in accordance with SWMS - AUS008 - Removal of Friable Asbestos Containing LV HRC Fuses. |

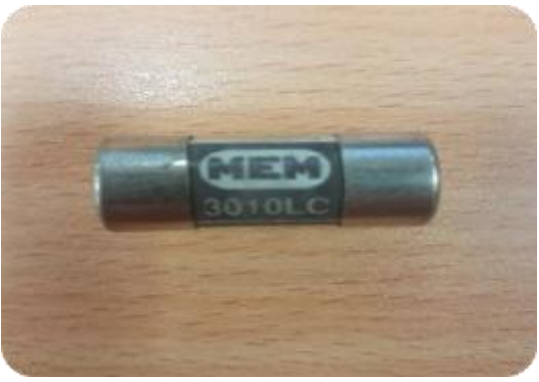
| Manufacturer | Rating | Fuse Body Photographs | Label Markings & Details | Result | Safety Instructions |
|---|---|---|---|---|---|
| MEM | 10 | | 3010LC, BS88, 240V, 10A, made in UK<br>OF00053-120718-AS19 | <br>No Asbestos found, exercise caution and follow safety instructions | Where no manufacturer or date information can be confirmed and/or the fuse was manufactured prior to 2003, the <b>fuses should be presumed to contain asbestos and disposed</b> of in accordance with SWMS - AUS008 - Removal of Friable Asbestos Containing LV HRC Fuses. |

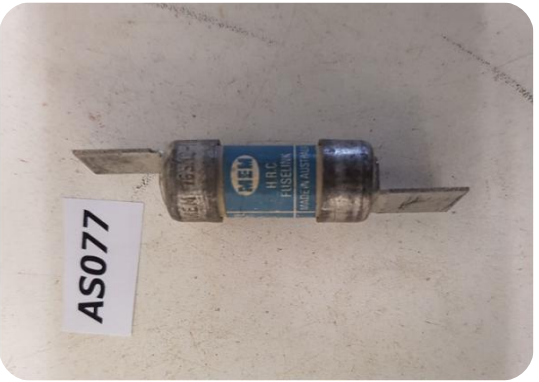
| Manufacturer | Rating | Fuse Body Photographs | Label Markings & Details | Result | Safety Instructions |
|---|---|---|---|---|---|
| MEM | 16 | | 16SN2, 16A, AS2005-1:1981, BS88-1975, IEC269.2/2A, AC80, Class Q1<br>174783-001-AS077 | <br>No Asbestos found, exercise caution and follow safety instructions | Where no manufacturer or date information can be confirmed and/or the fuse was manufactured prior to 2003, the <b>fuses should be presumed to contain asbestos and disposed</b> of in accordance with SWMS - AUS008 - Removal of Friable Asbestos Containing LV HRC Fuses. |

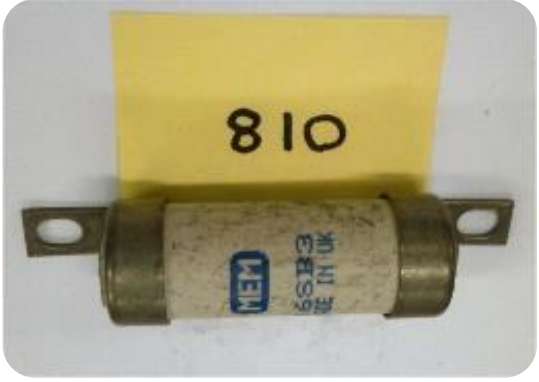
| Manufacturer | Rating | Fuse Body Photographs | Label Markings & Details | Result | Safety Instructions |
|---|---|---|---|---|---|
| MEM | 16 | | 16 SB3, Asta 20 Cert, 415 V ac, 80ka, 1 A, gG<br>55738-001-018 | <br>No Asbestos found, exercise caution and follow safety instructions | Where no manufacturer or date information can be confirmed and/or the fuse was manufactured prior to 2003, the <b>fuses should be presumed to contain asbestos and disposed</b> of in accordance with SWMS - AUS008 - Removal of Friable Asbestos Containing LV HRC Fuses. |

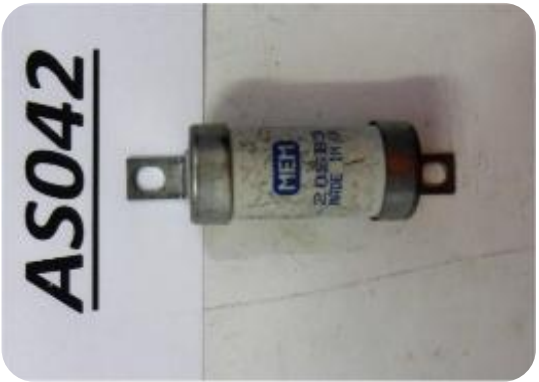
| Manufacturer | Rating | Fuse Body Photographs | Label Markings & Details | Result | Safety Instructions |
|---|---|---|---|---|---|
| MEM | 20 | | 20SB3, 20A, B.S.88:2:1:1988, AC80, gG | <br>No Asbestos found, exercise caution and follow safety instructions | Where no manufacturer or date information can be confirmed and/or the fuse was manufactured prior to 2003, the <b>fuses should be presumed to contain asbestos and disposed</b> of in accordance with SWMS - AUS008 - Removal of Friable Asbestos Containing LV HRC Fuses. |

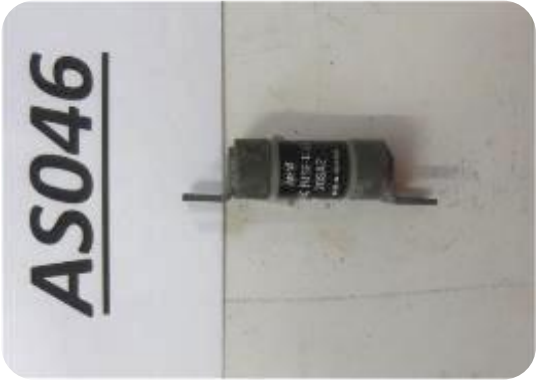
| Manufacturer | Rating | Fuse Body Photographs | Label Markings & Details | Result | Safety Instructions |
|---|---|---|---|---|---|
| MEM | 20 | | 20SA2, 20A, B.S.88 1967, Ref A1, Class 01, AC 80, 250DC40 | <br>No Asbestos found, exercise caution and follow safety instructions | Where no manufacturer or date information can be confirmed and/or the fuse was manufactured prior to 2003, the <b>fuses should be presumed to contain asbestos and disposed</b> of in accordance with SWMS - AUS008 - Removal of Friable Asbestos Containing LV HRC Fuses. |

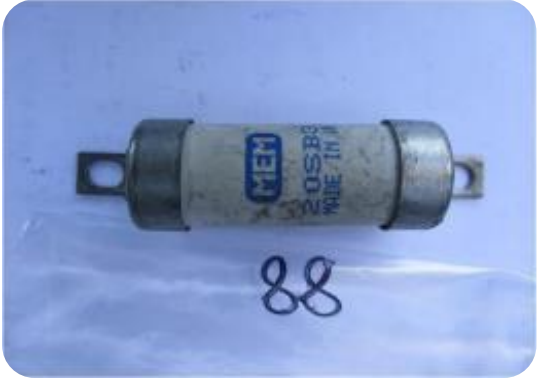
| Manufacturer | Rating | Fuse Body Photographs | Label Markings & Details | Result | Safety Instructions |
|---|---|---|---|---|---|
| MEM | 20 | | 20SB3 | <br>No Asbestos found, exercise caution and follow safety instructions | Where no manufacturer or date information can be confirmed and/or the fuse was manufactured prior to 2003, the <b>fuses should be presumed to contain asbestos and disposed</b> of in accordance with SWMS - AUS008 - Removal of Friable Asbestos Containing LV HRC Fuses. |

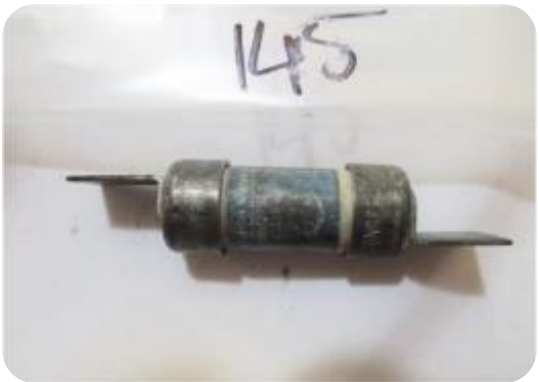
| Manufacturer | Rating | Fuse Body Photographs | Label Markings & Details | Result | Safety Instructions |
|---|---|---|---|---|---|
| MEM | 20 | | MEM-20SN2-20A<br>54287-001-145 | <br>No Asbestos found, exercise caution and follow safety instructions | Where no manufacturer or date information can be confirmed and/or the fuse was manufactured prior to 2003, the <b>fuses should be presumed to contain asbestos and disposed</b> of in accordance with SWMS - AUS008 - Removal of Friable Asbestos Containing LV HRC Fuses. |

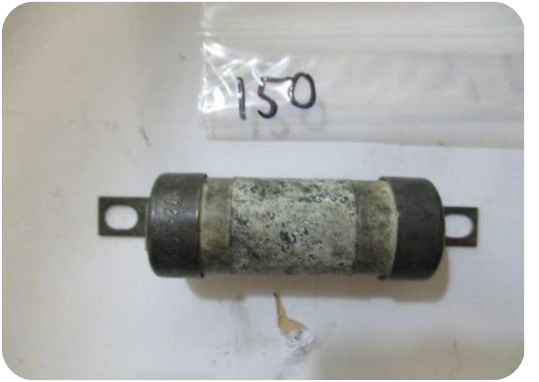
| Manufacturer | Rating | Fuse Body Photographs | Label Markings & Details | Result | Safety Instructions |
|---|---|---|---|---|---|
| MEM | 20 | | 20SB3<br>54087-001-150 | <br>No Asbestos found, exercise caution and follow safety instructions | Where no manufacturer or date information can be confirmed and/or the fuse was manufactured prior to 2003, the <b>fuses should be presumed to contain asbestos and disposed</b> of in accordance with SWMS - AUS008 - Removal of Friable Asbestos Containing LV HRC Fuses. |

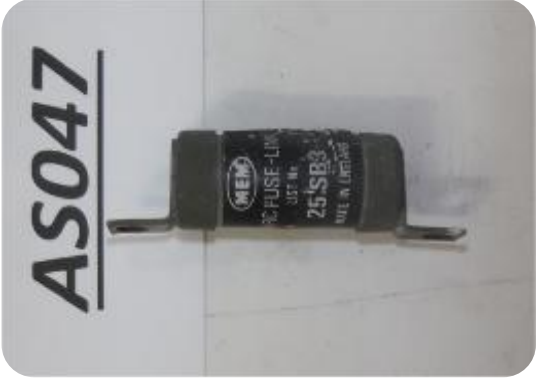
| Manufacturer | Rating | Fuse Body Photographs | Label Markings & Details | Result | Safety Instructions |
|---|---|---|---|---|---|
| MEM | 25 | | 25SB3, 25A, B.S.88 1967, Ref A2, Class Q1, AC 80, 250DC40<br>168215-47 | <br>No Asbestos found, exercise caution and follow safety instructions | Where no manufacturer or date information can be confirmed and/or the fuse was manufactured prior to 2003, the <b>fuses should be presumed to contain asbestos and disposed</b> of in accordance with SWMS - AUS008 - Removal of Friable Asbestos Containing LV HRC Fuses. |

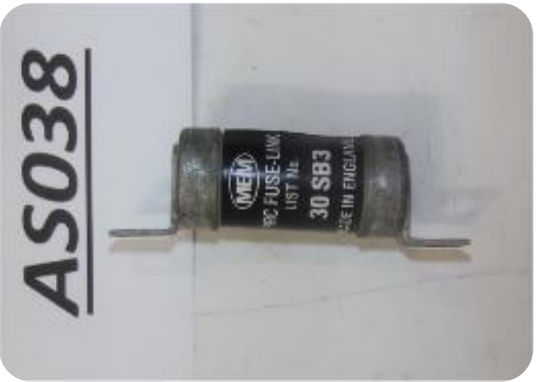
| Manufacturer | Rating | Fuse Body Photographs | Label Markings & Details | Result | Safety Instructions |
|---|---|---|---|---|---|
| MEM | 30 | | 30SB3, 30A, B.S.88, Ref A2, AC80, 250BC40, Class Q1 | <br>No Asbestos found, exercise caution and follow safety instructions | Where no manufacturer or date information can be confirmed and/or the fuse was manufactured prior to 2003, the <b>fuses should be presumed to contain asbestos and disposed</b> of in accordance with SWMS - AUS008 - Removal of Friable Asbestos Containing LV HRC Fuses. |

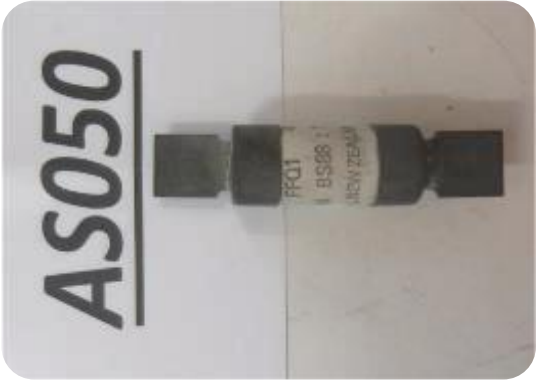
| Manufacturer | Rating | Fuse Body Photographs | Label Markings & Details | Result | Safety Instructions |
|---|---|---|---|---|---|
| MEM | 30 | | 30SN21, 30A, FFQ1, B.S.88:1967 | <br>No Asbestos found, exercise caution and follow safety instructions | Where no manufacturer or date information can be confirmed and/or the fuse was manufactured prior to 2003, the <b>fuses should be presumed to contain asbestos and disposed</b> of in accordance with SWMS - AUS008 - Removal of Friable Asbestos Containing LV HRC Fuses. |

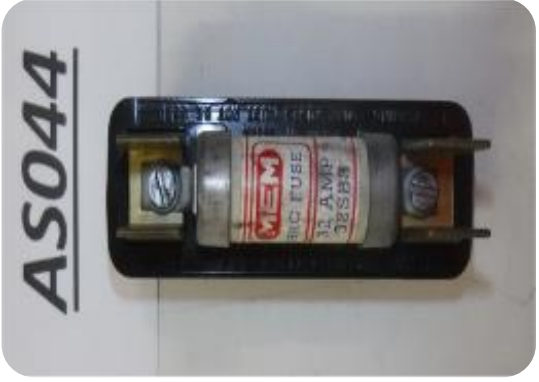
| Manufacturer | Rating | Fuse Body Photographs | Label Markings & Details | Result | Safety Instructions |
|---|---|---|---|---|---|
| MEM | 32 | | 32SB3, 32A, B.S.88:2, IEC269:2, AS 2005, 250V DC40, Class Q1, Ref A2, AC80 | <br>No Asbestos found | May be used as normal.<br> When disposing of LV HRC Fuses treat all fuses as asbestos waste. |

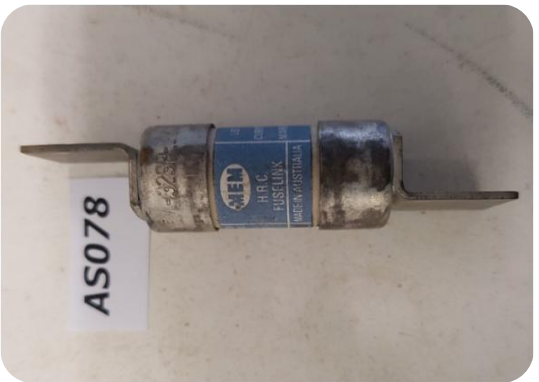
| Manufacturer | Rating | Fuse Body Photographs | Label Markings & Details | Result | Safety Instructions |
|---|---|---|---|---|---|
| MEM | 32 | | 32SP, 32A, AC80, AS2005.1: 1981, BS88.1: 1988, IEC269-2/2A, Class Q1 | <br>No Asbestos found, exercise caution and follow safety instructions | Where no manufacturer or date information can be confirmed and/or the fuse was manufactured prior to 2003, the <b>fuses should be presumed to contain asbestos and disposed</b> of in accordance with SWMS - AUS008 - Removal of Friable Asbestos Containing LV HRC Fuses. |

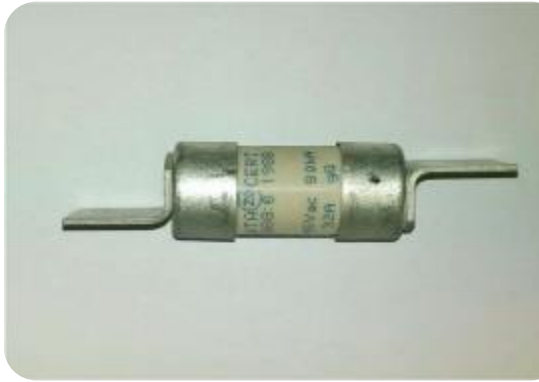
| Manufacturer | Rating | Fuse Body Photographs | Label Markings & Details | Result | Safety Instructions |
|---|---|---|---|---|---|
| MEM | 32 | | AsTA 20 Cet, 415V ac, 80kA, 32A, 9g, 32SP | <br>No Asbestos found, exercise caution and follow safety instructions | Where no manufacturer or date information can be confirmed and/or the fuse was manufactured prior to 2003, the <b>fuses should be presumed to contain asbestos and disposed</b> of in accordance with SWMS - AUS008 - Removal of Friable Asbestos Containing LV HRC Fuses. |

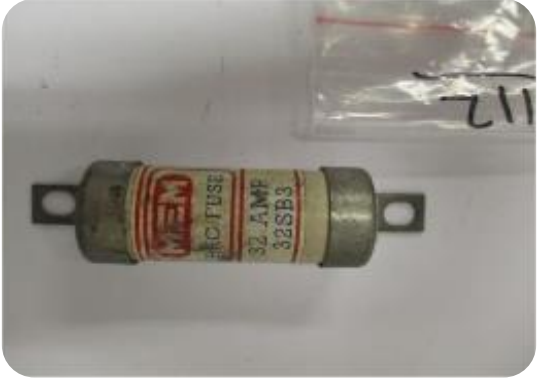
| Manufacturer | Rating | Fuse Body Photographs | Label Markings & Details | Result | Safety Instructions |
|---|---|---|---|---|---|
| MEM | 32 | | 32SB3 | <br>No Asbestos found, exercise caution and follow safety instructions | Where no manufacturer or date information can be confirmed and/or the fuse was manufactured prior to 2003, the <b>fuses should be presumed to contain asbestos and disposed</b> of in accordance with SWMS - AUS008 - Removal of Friable Asbestos Containing LV HRC Fuses. |

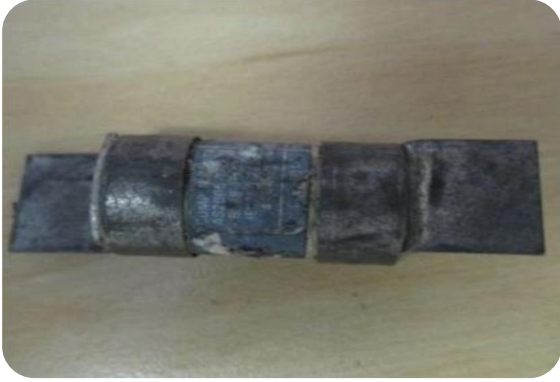
| Manufacturer | Rating | Fuse Body Photographs | Label Markings & Details | Result | Safety Instructions |
|---|---|---|---|---|---|
| MEM | 32 | <br>54087-001-010 | 32SP-32A | <br>No Asbestos found, exercise caution and follow safety instructions | <br>Where no manufacturer or date information can be confirmed and/or the fuse was manufactured prior to 2003, the <b>fuses should be presumed to contain asbestos and disposed</b> of in accordance with SWMS - AUS008 - Removal of Friable Asbestos Containing LV HRC Fuses. |

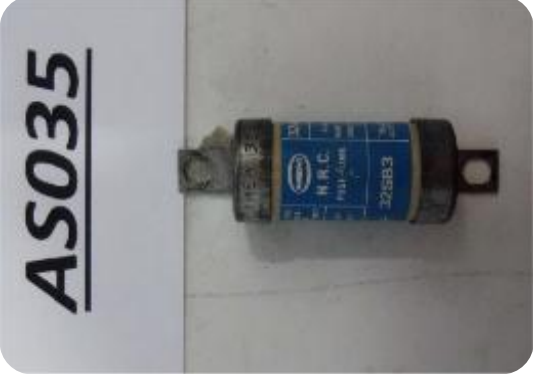
| Manufacturer | Rating | Fuse Body Photographs | Label Markings & Details | Result | Safety Instructions |
|---|---|---|---|---|---|
| MEM | 32 | <br>168215-35 | 32SB3, 32A, B.S.88-2:1975, IEC269-2/2A, 1973/5, AS2005-2:1977, Class Q1, Ref A2, AC80, 250V DC40 | <br>Asbestos found | <b>In-Service Fuses:</b><br> If fuse is damaged, cease work and make safe. Contact the Hazmat Hotline - 02 9394 6961.<br> If the fuse is intact, remove the fuse taking care not to damage in accordance with SWMS - AUS008 Removal of Friable Asbestos Containing LV HRC Fuses.<br><b>Stored and Quarantined Fuses:</b><br> Must be disposed of in accordance with SWMS - AUS008 Removal of Friable Asbestos Containing LV HRC Fuses. |

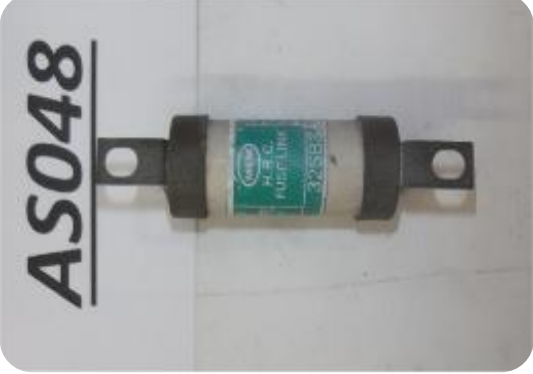
| Manufacturer | Rating | Fuse Body Photographs | Label Markings & Details | Result | Safety Instructions |
|---|---|---|---|---|---|
| MEM | 32 | <br>168215-48 | 32SB3, 32A, B.S.88-2, 1975, 1EC269-2, Class Q1, Ref A2, AC80, 250DC40 | <br>Asbestos found | <b>In-Service Fuses:</b><br> If fuse is damaged, cease work and make safe. Contact the Hazmat Hotline - 02 9394 6961.<br> If the fuse is intact, remove the fuse taking care not to damage in accordance with SWMS - AUS008 Removal of Friable Asbestos Containing LV HRC Fuses.<br><b>Stored and Quarantined Fuses:</b><br> Must be disposed of in accordance with SWMS - AUS008 Removal of Friable Asbestos Containing LV HRC Fuses. |

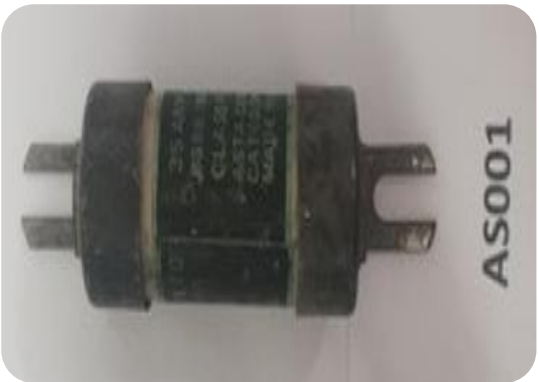
| Manufacturer | Rating | Fuse Body Photographs | Label Markings & Details | Result | Safety Instructions |
|---|---|---|---|---|---|
| MEM | 35 | | EMCO (N.Z.) LTD, List no. 35SB4, 35 AMP, BS88:1967, Ref. A3, Class FF (label torn), ASTA certified, Category 415 AC80, N.Z. Licensee | <br>No Asbestos found, exercise caution and follow safety instructions | Where no manufacturer or date information can be confirmed and/or the fuse was manufactured prior to 2003, the <b>fuses should be presumed to contain asbestos and disposed</b> of in accordance with SWMS - AUS008 - Removal of Friable Asbestos Containing LV HRC Fuses. |

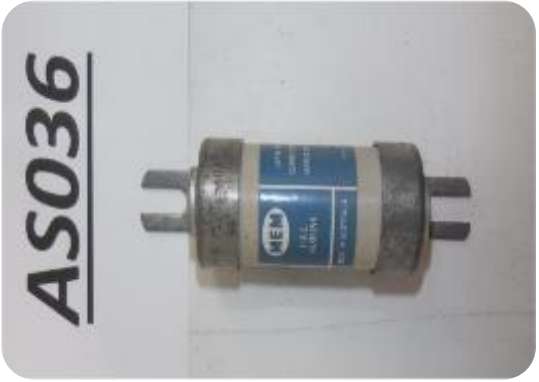
| Manufacturer | Rating | Fuse Body Photographs | Label Markings & Details | Result | Safety Instructions |
|---|---|---|---|---|---|
| MEM | 40 | | 40SB4, 40A, BS88-2:1975, IEC269-2/2A, AC80, 250DC40, Complies with AS2005-1:1981 & 2:1977, Class Q1 | <br>No Asbestos found, exercise caution and follow safety instructions | Where no manufacturer or date information can be confirmed and/or the fuse was manufactured prior to 2003, the <b>fuses should be presumed to contain asbestos and disposed</b> of in accordance with SWMS - AUS008 - Removal of Friable Asbestos Containing LV HRC Fuses. |

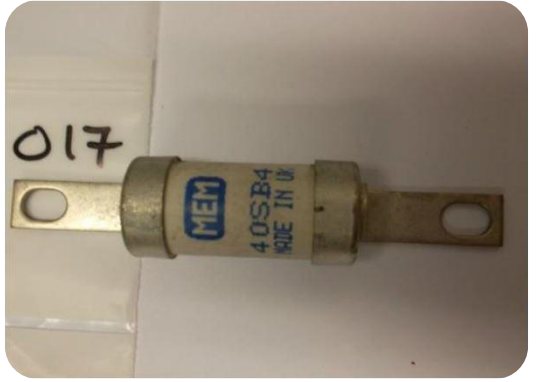
| Manufacturer | Rating | Fuse Body Photographs | Label Markings & Details | Result | Safety Instructions |
|---|---|---|---|---|---|
| MEM | 40 | | 40SB4, Asta 20 cert, 415V ac, 80kA gG, 0505 | <br>No Asbestos found, exercise caution and follow safety instructions | Where no manufacturer or date information can be confirmed and/or the fuse was manufactured prior to 2003, the <b>fuses should be presumed to contain asbestos and disposed</b> of in accordance with SWMS - AUS008 - Removal of Friable Asbestos Containing LV HRC Fuses. |

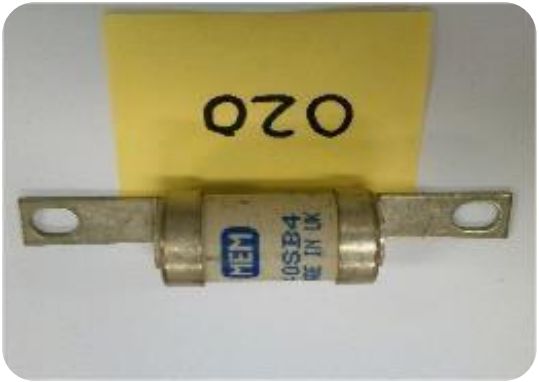
| Manufacturer | Rating | Fuse Body Photographs | Label Markings & Details | Result | Safety Instructions |
|---|---|---|---|---|---|
| MEM | 40 | | 40SB4<br>55738-001-020 | <br>No Asbestos found, exercise caution and follow safety instructions | Where no manufacturer or date information can be confirmed and/or the fuse was manufactured prior to 2003, the <b>fuses should be presumed to contain asbestos and disposed</b> of in accordance with SWMS - AUS008 - Removal of Friable Asbestos Containing LV HRC Fuses. |

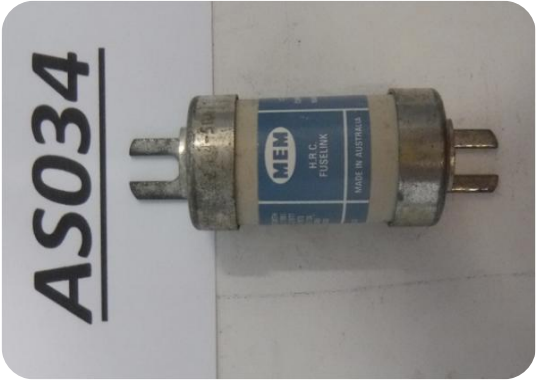
| Manufacturer | Rating | Fuse Body Photographs | Label Markings & Details | Result | Safety Instructions |
|---|---|---|---|---|---|
| MEM | 50 | | 50SB4, 50A, B.S.88-2:1975, IEC269-2/2A, AC80, 250DC40, Complies with AS2005-1:1981 & 2:1977, Class Q1<br>168215-34 | <br>No Asbestos found, exercise caution and follow safety instructions | Where no manufacturer or date information can be confirmed and/or the fuse was manufactured prior to 2003, the <b>fuses should be presumed to contain asbestos and disposed</b> of in accordance with SWMS - AUS008 - Removal of Friable Asbestos Containing LV HRC Fuses. |

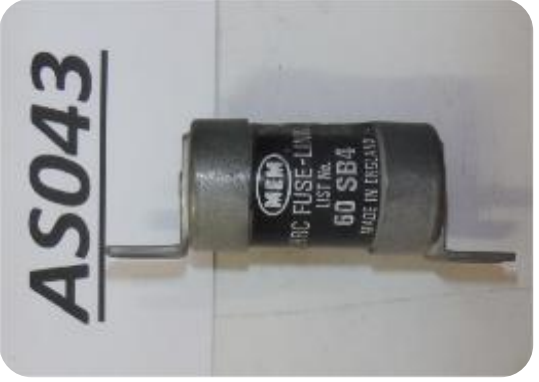
| Manufacturer | Rating | Fuse Body Photographs | Label Markings & Details | Result | Safety Instructions |
|---|---|---|---|---|---|
| MEM | 60 | | 60SB4, 60A, B.S.88:1967, Ref A3, Class Q1, AC80, 250DC40<br>168215-43 | <br>No Asbestos found, exercise caution and follow safety instructions | Where no manufacturer or date information can be confirmed and/or the fuse was manufactured prior to 2003, the <b>fuses should be presumed to contain asbestos and disposed</b> of in accordance with SWMS - AUS008 - Removal of Friable Asbestos Containing LV HRC Fuses. |

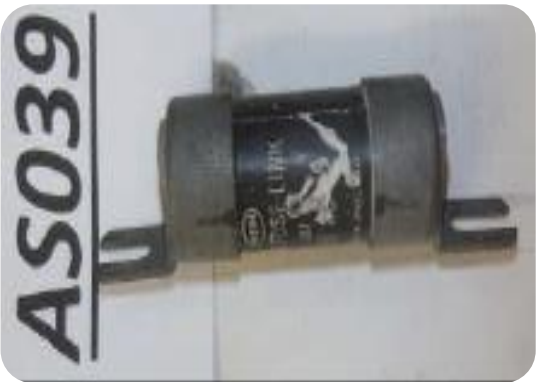
| Manufacturer | Rating | Fuse Body Photographs | Label Markings & Details | Result | Safety Instructions |
|---|---|---|---|---|---|
| MEM | 60 | | 60SB4, 60A, B.S.88:1967, Ref A3, AC80, Class Q1 | <br>No Asbestos found, exercise caution and follow safety instructions | Where no manufacturer or date information can be confirmed and/or the fuse was manufactured prior to 2003, the <b>fuses should be presumed to contain asbestos and disposed</b> of in accordance with SWMS - AUS008 - Removal of Friable Asbestos Containing LV HRC Fuses. |
