## Network Standard

Document No : NW000-S0161

NS211 ANNEXURE G – LV HRC FUSE ASBESTOS PRODUCT GUIDE

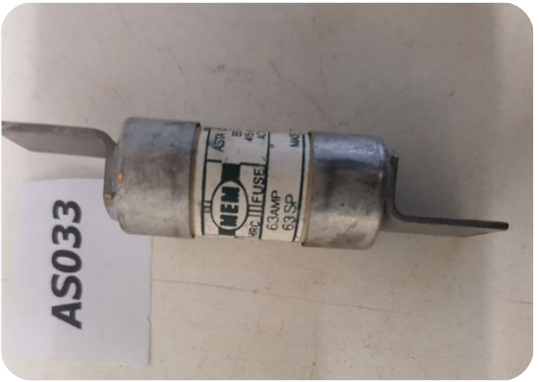
| Manufacturer | Rating | Fuse Body Photographs | Label Markings & Details | Result | Safety Instructions |
|---|---|---|---|---|---|
| MEM | 63 | | 63SP, 63A, IEC 269:1, AS2005, Class Q1, BS 88:1, 80 kA | <br>No Asbestos found, exercise caution and follow safety instructions | Where no manufacturer or date information can be confirmed and/or the fuse was manufactured prior to 2003, the <b>fuses should be presumed to contain asbestos and disposed</b> of in accordance with SWMS - AUS008 - Removal of Friable Asbestos Containing LV HRC Fuses. |

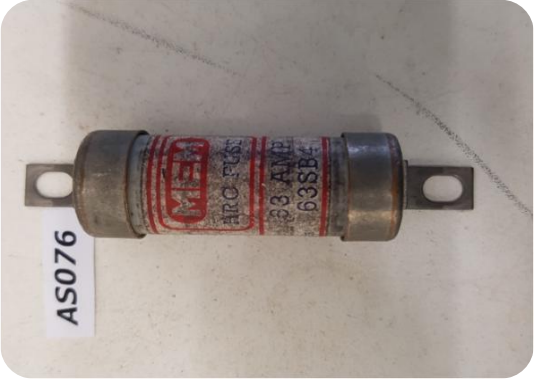
| Manufacturer | Rating | Fuse Body Photographs | Label Markings & Details | Result | Safety Instructions |
|---|---|---|---|---|---|
| MEM | 63 | | 63SB4, 63A, 80kA, Asta 20 certified, BS88.2, Ref A3, IEC 269.2AS.2003, 250VDC40kA, Class Q1 | <br>No Asbestos found, exercise caution and follow safety instructions | Where no manufacturer or date information can be confirmed and/or the fuse was manufactured prior to 2003, the <b>fuses should be presumed to contain asbestos and disposed</b> of in accordance with SWMS - AUS008 - Removal of Friable Asbestos Containing LV HRC Fuses. |

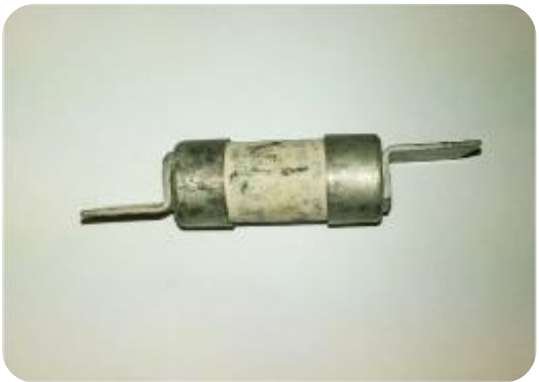
| Manufacturer | Rating | Fuse Body Photographs | Label Markings & Details | Result | Safety Instructions |
|---|---|---|---|---|---|
| MEM | 63 | | 415v ac 80kA<br>SN3 | ⚠<br>No Asbestos found,<br>exercise caution and follow safety instructions | ⚠ Where no manufacturer or date information can be confirmed and/or the fuse was manufactured prior to 2003, the <b>fuses should be presumed to contain asbestos and disposed</b> of in accordance with SWMS - AUS008 - Removal of Friable Asbestos Containing LV HRC Fuses. |

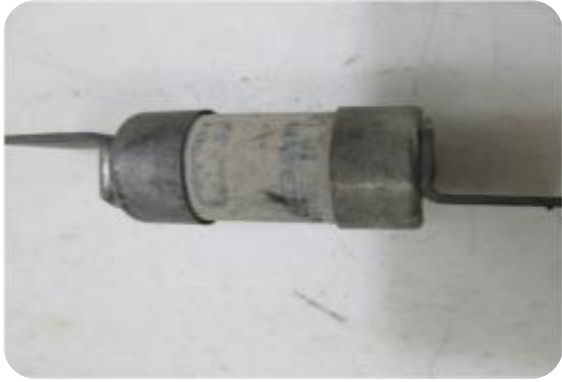
| Manufacturer | Rating | Fuse Body Photographs | Label Markings & Details | Result | Safety Instructions |
|---|---|---|---|---|---|
| MEM | 63 | | 838A 63A | ⚠<br>No Asbestos found,<br>exercise caution and follow safety instructions | ⚠ Where no manufacturer or date information can be confirmed and/or the fuse was manufactured prior to 2003, the <b>fuses should be presumed to contain asbestos and disposed</b> of in accordance with SWMS - AUS008 - Removal of Friable Asbestos Containing LV HRC Fuses. |

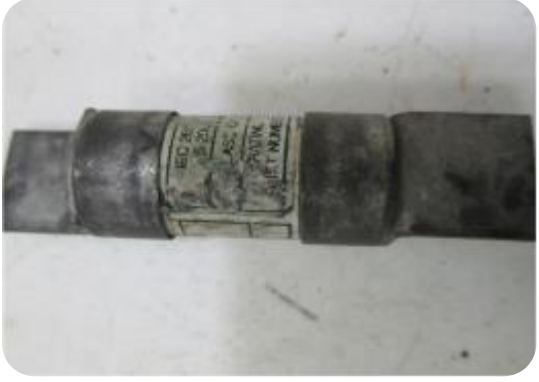
| Manufacturer | Rating | Fuse Body Photographs | Label Markings & Details | Result | Safety Instructions |
|---|---|---|---|---|---|
| MEM | 63 | | Class Q1 63A | ⚠<br>No Asbestos found,<br>exercise caution and follow safety instructions | ⚠ Where no manufacturer or date information can be confirmed and/or the fuse was manufactured prior to 2003, the <b>fuses should be presumed to contain asbestos and disposed</b> of in accordance with SWMS - AUS008 - Removal of Friable Asbestos Containing LV HRC Fuses. |

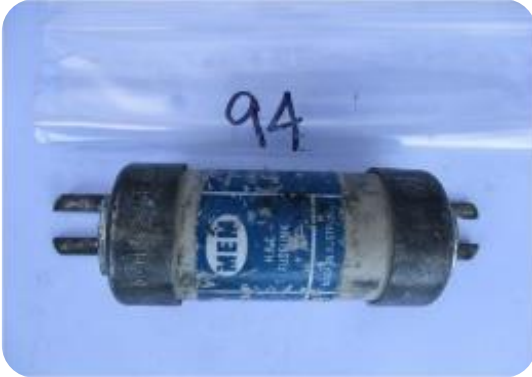
| Manufacturer | Rating | Fuse Body Photographs | Label Markings & Details | Result | Safety Instructions |
|---|---|---|---|---|---|
| MEM | 63 | | 63SB4 64A<br>54287-001-094 | <br>No Asbestos found, exercise caution and follow safety instructions | <br>Where no manufacturer or date information can be confirmed and/or the fuse was manufactured prior to 2003, the <b>fuses should be presumed to contain asbestos and disposed</b> of in accordance with SWMS - AUS008 - Removal of Friable Asbestos Containing LV HRC Fuses. |

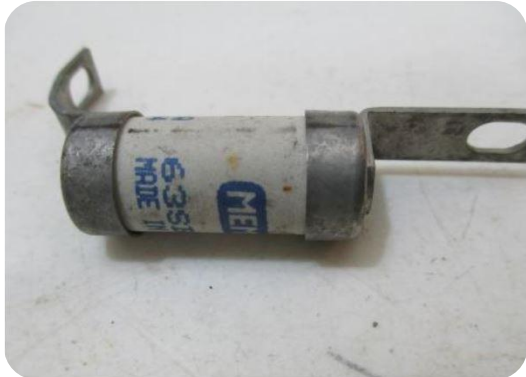
| Manufacturer | Rating | Fuse Body Photographs | Label Markings & Details | Result | Safety Instructions |
|---|---|---|---|---|---|
| MEM | 63 | | 63SB4 63A GG<br>54087-001-036 | <br>No Asbestos found, exercise caution and follow safety instructions | <br>Where no manufacturer or date information can be confirmed and/or the fuse was manufactured prior to 2003, the <b>fuses should be presumed to contain asbestos and disposed</b> of in accordance with SWMS - AUS008 - Removal of Friable Asbestos Containing LV HRC Fuses. |

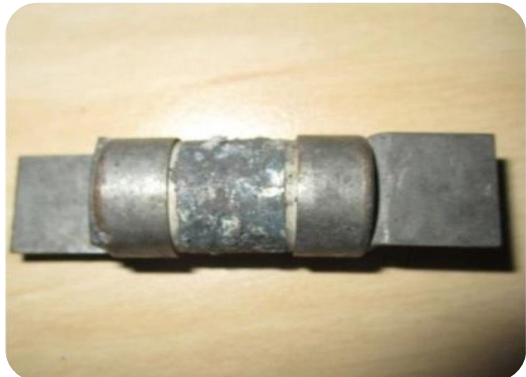
| Manufacturer | Rating | Fuse Body Photographs | Label Markings & Details | Result | Safety Instructions |
|---|---|---|---|---|---|
| MEM | 63 | | 63SP 63A<br>54087-001-008 | <br>No Asbestos found, exercise caution and follow safety instructions | <br>Where no manufacturer or date information can be confirmed and/or the fuse was manufactured prior to 2003, the <b>fuses should be presumed to contain asbestos and disposed</b> of in accordance with SWMS - AUS008 - Removal of Friable Asbestos Containing LV HRC Fuses. |

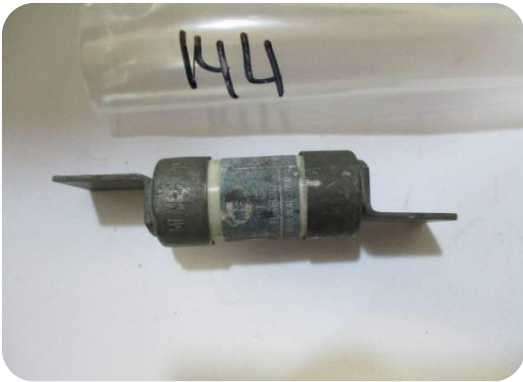
| Manufacturer | Rating | Fuse Body Photographs | Label Markings & Details | Result | Safety Instructions |
|---|---|---|---|---|---|
| MEM | 63 | | 63SP 63A<br><small>54087-001-144</small> | <br>No Asbestos found, exercise caution and follow safety instructions | Where no manufacturer or date information can be confirmed and/or the fuse was manufactured prior to 2003, the <b>fuses should be presumed to contain asbestos and disposed</b> of in accordance with SWMS - AUS008 - Removal of Friable Asbestos Containing LV HRC Fuses. |

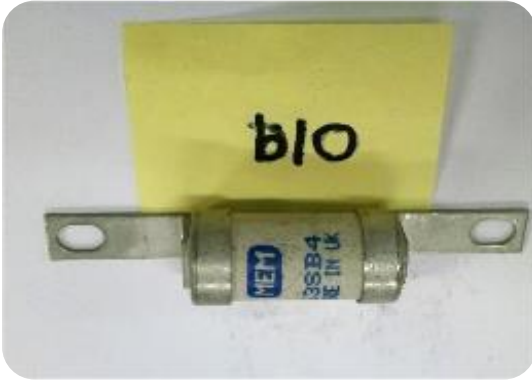
| Manufacturer | Rating | Fuse Body Photographs | Label Markings & Details | Result | Safety Instructions |
|---|---|---|---|---|---|
| MEM | 63 | | 63 SB4, Asta 20 Cert,<br><small>55738-001-019</small> | <br>No Asbestos found, exercise caution and follow safety instructions | Where no manufacturer or date information can be confirmed and/or the fuse was manufactured prior to 2003, the <b>fuses should be presumed to contain asbestos and disposed</b> of in accordance with SWMS - AUS008 - Removal of Friable Asbestos Containing LV HRC Fuses. |

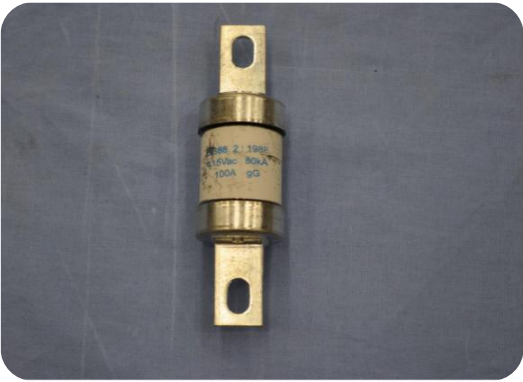
| Manufacturer | Rating | Fuse Body Photographs | Label Markings & Details | Result | Safety Instructions |
|---|---|---|---|---|---|
| MEM | 100 | | MEM 100SF5SWP | <br>Current Stock Item<br>No. 85217 | ✓ May be used as normal.<br>✓ When disposing of LV HRC Fuses treat all fuses as asbestos waste. |

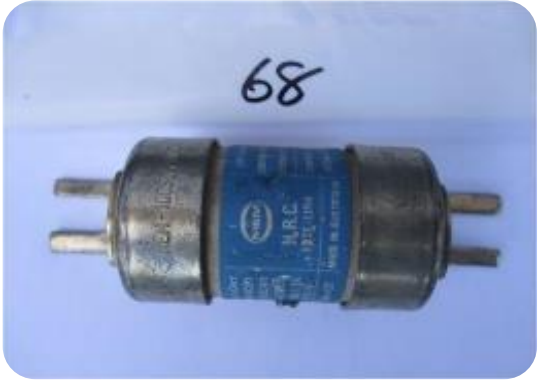
| Manufacturer | Rating | Fuse Body Photographs | Label Markings & Details | Result | Safety Instructions |
|---|---|---|---|---|---|
| MEM | 100 | | 100 SD5 100A | <br>No Asbestos found, exercise caution and follow safety instructions | Where no manufacturer or date information can be confirmed and/or the fuse was manufactured prior to 2003, the <b>fuses should be presumed to contain asbestos and disposed</b> of in accordance with SWMS - AUS008 - Removal of Friable Asbestos Containing LV HRC Fuses. |

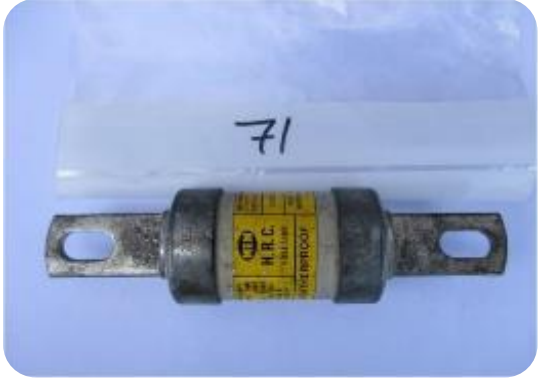
| Manufacturer | Rating | Fuse Body Photographs | Label Markings & Details | Result | Safety Instructions |
|---|---|---|---|---|---|
| MEM | 100 | | ZPLBLFWP 100SFS - 100a | <br>No Asbestos found, exercise caution and follow safety instructions | Where no manufacturer or date information can be confirmed and/or the fuse was manufactured prior to 2003, the <b>fuses should be presumed to contain asbestos and disposed</b> of in accordance with SWMS - AUS008 - Removal of Friable Asbestos Containing LV HRC Fuses. |

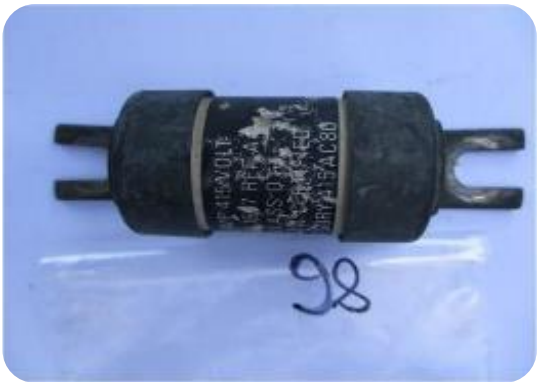
| Manufacturer | Rating | Fuse Body Photographs | Label Markings & Details | Result | Safety Instructions |
|---|---|---|---|---|---|
| MEM | 100 | | 100 SD5<br>54287-001-086 | <br>No Asbestos found, exercise caution and follow safety instructions | Where no manufacturer or date information can be confirmed and/or the fuse was manufactured prior to 2003, the <b>fuses should be presumed to contain asbestos and disposed</b> of in accordance with SWMS - AUS008 - Removal of Friable Asbestos Containing LV HRC Fuses. |

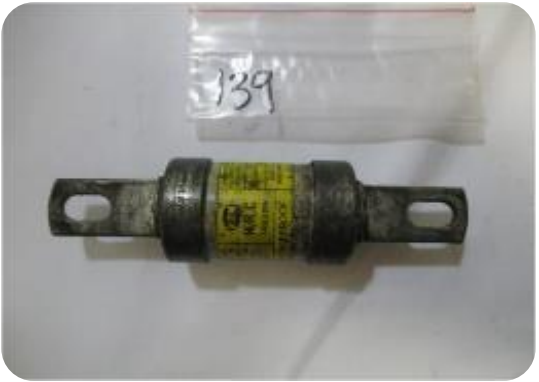
| Manufacturer | Rating | Fuse Body Photographs | Label Markings & Details | Result | Safety Instructions |
|---|---|---|---|---|---|
| MEM | 100 | | 550AC80 250DC 40<br>54287-001-139 | <br>No Asbestos found, exercise caution and follow safety instructions | Where no manufacturer or date information can be confirmed and/or the fuse was manufactured prior to 2003, the <b>fuses should be presumed to contain asbestos and disposed</b> of in accordance with SWMS - AUS008 - Removal of Friable Asbestos Containing LV HRC Fuses. |

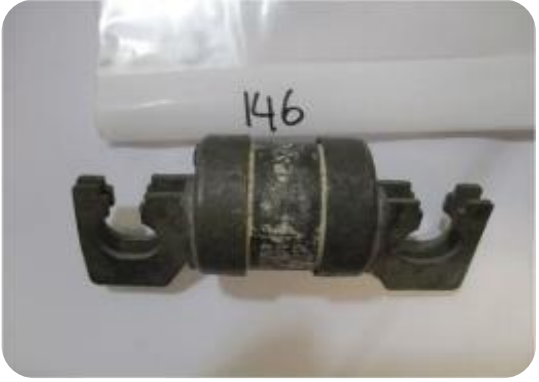
| Manufacturer | Rating | Fuse Body Photographs | Label Markings & Details | Result | Safety Instructions |
|---|---|---|---|---|---|
| MEM | 100 | | 100 JXS6<br>54287-001-146 | <br>No Asbestos found, exercise caution and follow safety instructions | Where no manufacturer or date information can be confirmed and/or the fuse was manufactured prior to 2003, the <b>fuses should be presumed to contain asbestos and disposed</b> of in accordance with SWMS - AUS008 - Removal of Friable Asbestos Containing LV HRC Fuses. |

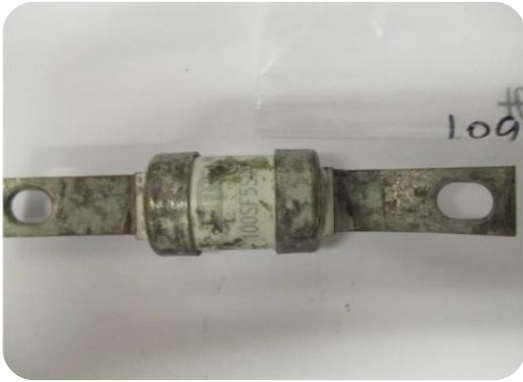
| Manufacturer | Rating | Fuse Body Photographs | Label Markings & Details | Result | Safety Instructions |
|---|---|---|---|---|---|
| MEM | 100 | | 100 SF5SWP<br>54287-001-109 | <br>No Asbestos found, exercise caution and follow safety instructions | Where no manufacturer or date information can be confirmed and/or the fuse was manufactured prior to 2003, the <b>fuses should be presumed to contain asbestos and disposed</b> of in accordance with SWMS - AUS008 - Removal of Friable Asbestos Containing LV HRC Fuses. |

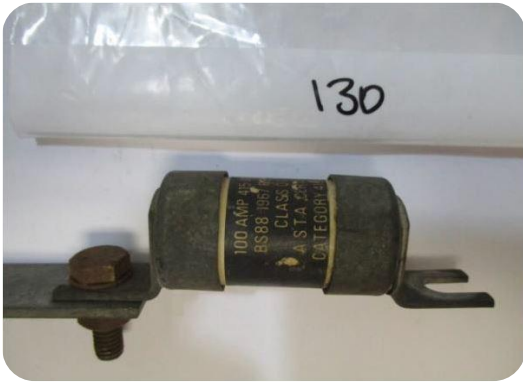
| Manufacturer | Rating | Fuse Body Photographs | Label Markings & Details | Result | Safety Instructions |
|---|---|---|---|---|---|
| MEM | 100 | | LIST NO 100SD5<br>54087-001-130 | <br>No Asbestos found, exercise caution and follow safety instructions | Where no manufacturer or date information can be confirmed and/or the fuse was manufactured prior to 2003, the <b>fuses should be presumed to contain asbestos and disposed</b> of in accordance with SWMS - AUS008 - Removal of Friable Asbestos Containing LV HRC Fuses. |

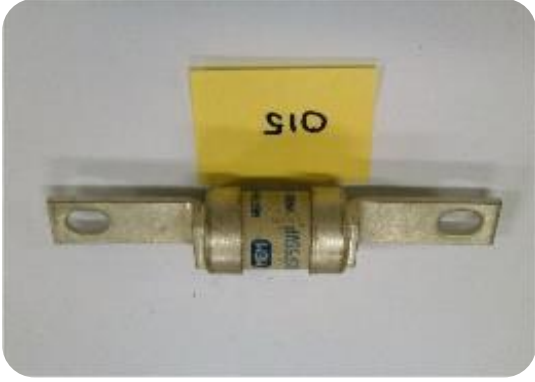
| Manufacturer | Rating | Fuse Body Photographs | Label Markings & Details | Result | Safety Instructions |
|---|---|---|---|---|---|
| MEM | 100 | | 100 SF5SWP 415 V ac, 80kA, gG<br>55738-001-015 | <br>No Asbestos found, exercise caution and follow safety instructions | Where no manufacturer or date information can be confirmed and/or the fuse was manufactured prior to 2003, the <b>fuses should be presumed to contain asbestos and disposed</b> of in accordance with SWMS - AUS008 - Removal of Friable Asbestos Containing LV HRC Fuses. |

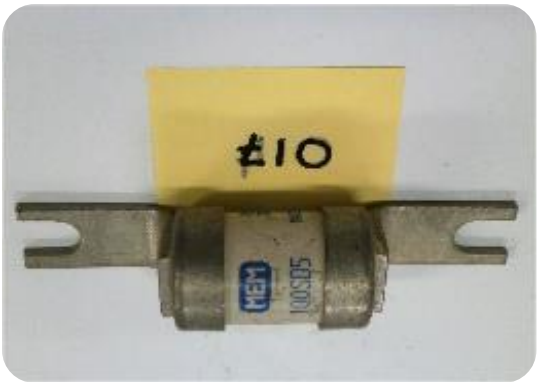
| Manufacturer | Rating | Fuse Body Photographs | Label Markings & Details | Result | Safety Instructions |
|---|---|---|---|---|---|
| MEM | 100 | | 100 S05, Asta 20 Cert, 415 V ac, 80kA, gG<br><small>55738-001-017</small> | <br>No Asbestos found, exercise caution and follow safety instructions | Where no manufacturer or date information can be confirmed and/or the fuse was manufactured prior to 2003, the <b>fuses should be presumed to contain asbestos and disposed</b> of in accordance with SWMS - AUS008 - Removal of Friable Asbestos Containing LV HRC Fuses. |

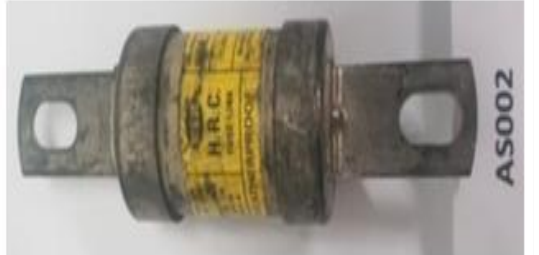
| Manufacturer | Rating | Fuse Body Photographs | Label Markings & Details | Result | Safety Instructions |
|---|---|---|---|---|---|
| MEM | 100 | | HRC Fuse link, 100AF5-100A, 100A, Weatherproof, Class Q1, Complies with AS2005- 1:1981-2:1977, BS88 - 2:1975, IEC 269-2/2A, 550 AC 80, 250 DC 40, When reordering add letters 'WP' to list no. marked on cap, ZPLBLFWP<br><small>P033786.002-AS012</small> | <br>No Asbestos found, exercise caution and follow safety instructions | Where no manufacturer or date information can be confirmed and/or the fuse was manufactured prior to 2003, the <b>fuses should be presumed to contain asbestos and disposed</b> of in accordance with SWMS - AUS008 - Removal of Friable Asbestos Containing LV HRC Fuses. |

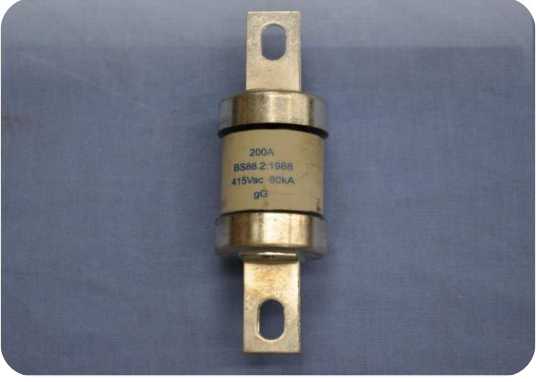
| Manufacturer | Rating | Fuse Body Photographs | Label Markings & Details | Result | Safety Instructions |
|---|---|---|---|---|---|
| MEM | 200 | | MEM 200SF6SWP<br><small>MEM 200SF6SWP</small> | <br>Current Stock Item No. 85423 | <ul style="list-style-type: none"> <li>✓ May be used as normal.</li> <li>✓ When disposing of LV HRC Fuses treat all fuses as asbestos waste.</li> </ul> |

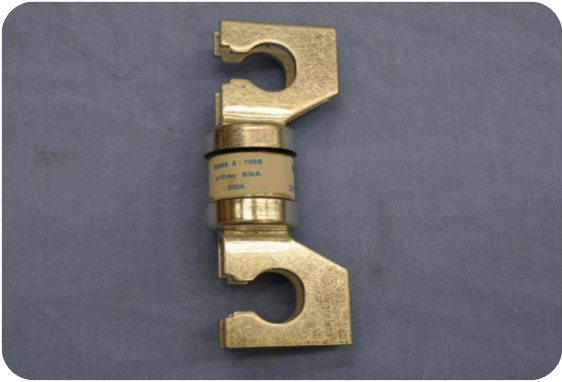
| Manufacturer | Rating | Fuse Body Photographs | Label Markings & Details | Result | Safety Instructions |
|---|---|---|---|---|---|
| MEM | 200 | <br>MEM 200JS92WP | MEM 200JS92WP | <br>Current Stock Item<br>No. 85688 | ✓ May be used as normal.<br>✓ When disposing of LV HRC Fuses treat all fuses as asbestos waste. |

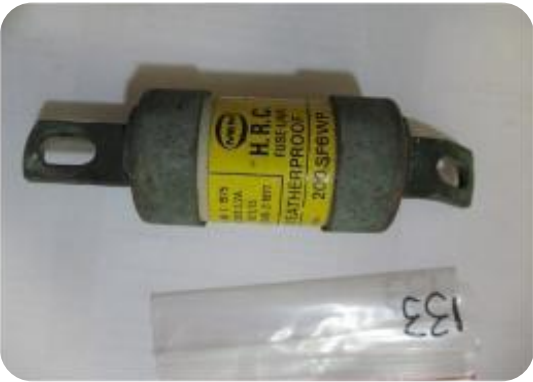
| Manufacturer | Rating | Fuse Body Photographs | Label Markings & Details | Result | Safety Instructions |
|---|---|---|---|---|---|
| MEM | 200 | <br>54287-001-133 | 200 SF6WP | <br>No Asbestos found, exercise caution and follow safety instructions | Where no manufacturer or date information can be confirmed and/or the fuse was manufactured prior to 2003, the <b>fuses should be presumed to contain asbestos and disposed</b> of in accordance with SWMS - AUS008 - Removal of Friable Asbestos Containing LV HRC Fuses. |

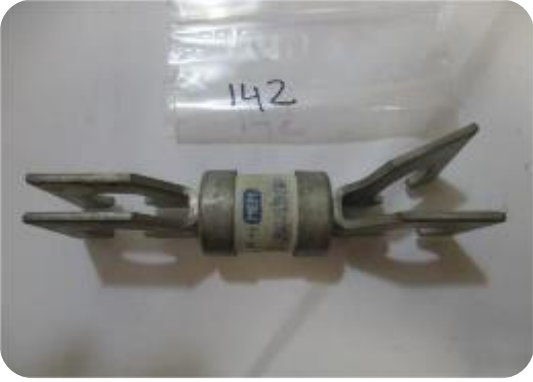
| Manufacturer | Rating | Fuse Body Photographs | Label Markings & Details | Result | Safety Instructions |
|---|---|---|---|---|---|
| MEM | 200 | <br>54287-001-142 | 200 JSS92WP | <br>No Asbestos found, exercise caution and follow safety instructions | Where no manufacturer or date information can be confirmed and/or the fuse was manufactured prior to 2003, the <b>fuses should be presumed to contain asbestos and disposed</b> of in accordance with SWMS - AUS008 - Removal of Friable Asbestos Containing LV HRC Fuses. |

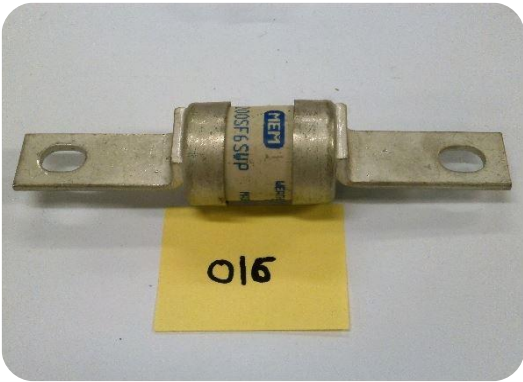
| Manufacturer | Rating | Fuse Body Photographs | Label Markings & Details | Result | Safety Instructions |
|---|---|---|---|---|---|
| MEM | 200 | | 200 SF6SWP 0301 415V ac, 80kA, gG<br>55738-001-016 | <br>No Asbestos found, exercise caution and follow safety instructions | Where no manufacturer or date information can be confirmed and/or the fuse was manufactured prior to 2003, the <b>fuses should be presumed to contain asbestos and disposed</b> of in accordance with SWMS - AUS008 - Removal of Friable Asbestos Containing LV HRC Fuses. |

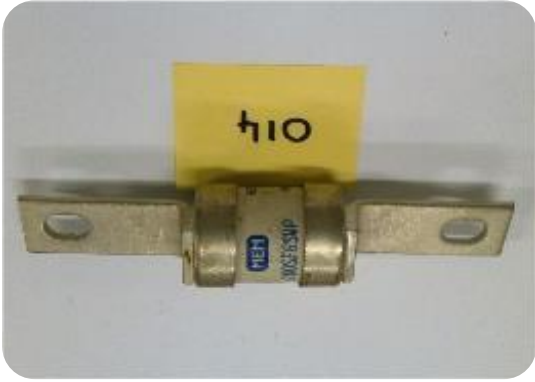
| Manufacturer | Rating | Fuse Body Photographs | Label Markings & Details | Result | Safety Instructions |
|---|---|---|---|---|---|
| MEM | 200 | | 200 SF6SWP 2800 415V ac, 80kA, gG<br>55738-001-014 | <br>No Asbestos found, exercise caution and follow safety instructions | Where no manufacturer or date information can be confirmed and/or the fuse was manufactured prior to 2003, the <b>fuses should be presumed to contain asbestos and disposed</b> of in accordance with SWMS - AUS008 - Removal of Friable Asbestos Containing LV HRC Fuses. |

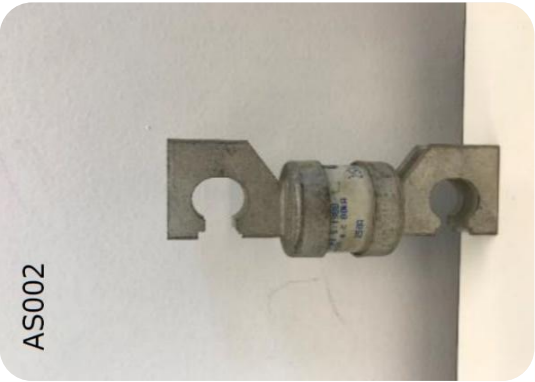
| Manufacturer | Rating | Fuse Body Photographs | Label Markings & Details | Result | Safety Instructions |
|---|---|---|---|---|---|
| MEM | 250 | | MEM - 250JSS92WP - 250A, BS 88: 5: 1988, AC 80 - 415V - United Kingdom - no date - AS002<br>P034242.001 / C0002.AS002 | <br>No Asbestos found, exercise caution and follow safety instructions | Where no manufacturer or date information can be confirmed and/or the fuse was manufactured prior to 2003, the <b>fuses should be presumed to contain asbestos and disposed</b> of in accordance with SWMS - AUS008 - Removal of Friable Asbestos Containing LV HRC Fuses. |

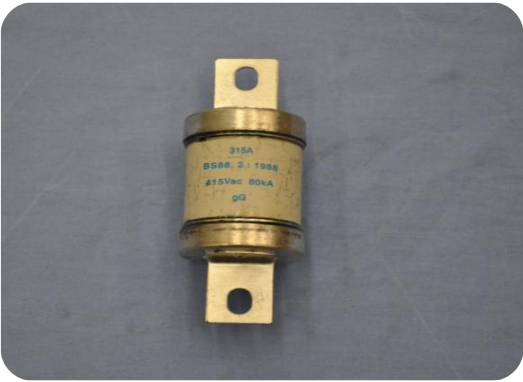
| Manufacturer | Rating | Fuse Body Photographs | Label Markings & Details | Result | Safety Instructions |
|---|---|---|---|---|---|
| MEM | 300 | | MEM 315SF7WP | <br>Current Stock Item<br>No. 85506 | ✓ May be used as normal.<br>✓ When disposing of LV HRC Fuses treat all fuses as asbestos waste. |

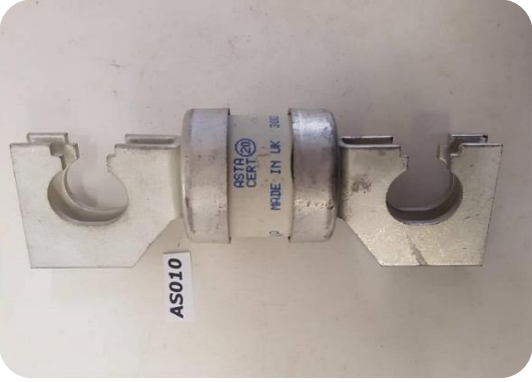
| Manufacturer | Rating | Fuse Body Photographs | Label Markings & Details | Result | Safety Instructions |
|---|---|---|---|---|---|
| MEM | 315 | | 315JSS92WP, 315A, BS88:5:1988, 80kA, Asta cert 20, 3003 | <br>No Asbestos found, exercise caution and follow safety instructions | <br>Where no manufacturer or date information can be confirmed and/or the fuse was manufactured prior to 2003, the <b>fuses should be presumed to contain asbestos and disposed</b> of in accordance with SWMS - AUS008 - Removal of Friable Asbestos Containing LV HRC Fuses. |

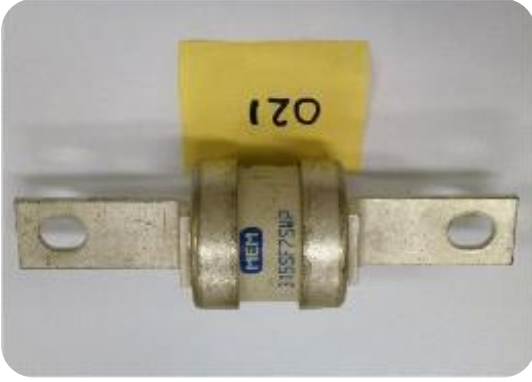
| Manufacturer | Rating | Fuse Body Photographs | Label Markings & Details | Result | Safety Instructions |
|---|---|---|---|---|---|
| MEM | 315 | | 315 SF7SWP | <br>No Asbestos found, exercise caution and follow safety instructions | <br>Where no manufacturer or date information can be confirmed and/or the fuse was manufactured prior to 2003, the <b>fuses should be presumed to contain asbestos and disposed</b> of in accordance with SWMS - AUS008 - Removal of Friable Asbestos Containing LV HRC Fuses. |

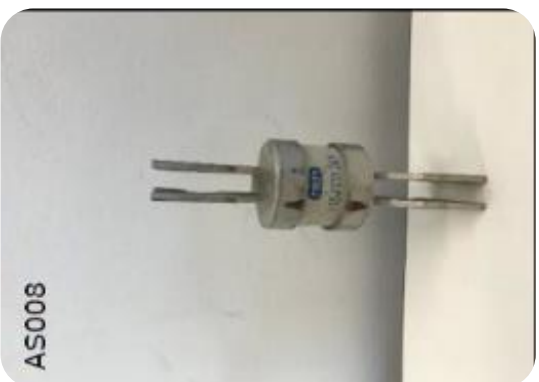
| Manufacturer | Rating | Fuse Body Photographs | Label Markings & Details | Result | Safety Instructions |
|---|---|---|---|---|---|
| MEM | 315 | | MEM - 315JSS92WP - 315A,<br>BS88: 5: 1988 415V AC 80kA,<br>ASTA<br><small>PO33786.002-AS012</small> | <br>No Asbestos found,<br>exercise caution and follow safety instructions | Where no manufacturer or date information can be confirmed and/or the fuse was manufactured prior to 2003, the <b>fuses should be presumed to contain asbestos and disposed</b> of in accordance with SWMS - AUS008 - Removal of Friable Asbestos Containing LV HRC Fuses. |

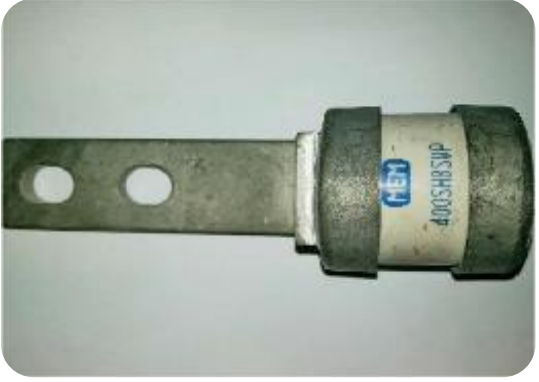
| Manufacturer | Rating | Fuse Body Photographs | Label Markings & Details | Result | Safety Instructions |
|---|---|---|---|---|---|
| MEM | 400 | | 400 SH8SWP 2800, 415V, 80ka,<br>9g<br>(Small Barrel)<br><small>54093-001-012</small> | <br>No Asbestos found,<br>exercise caution and follow safety instructions | Where no manufacturer or date information can be confirmed and/or the fuse was manufactured prior to 2003, the <b>fuses should be presumed to contain asbestos and disposed</b> of in accordance with SWMS - AUS008 - Removal of Friable Asbestos Containing LV HRC Fuses. |

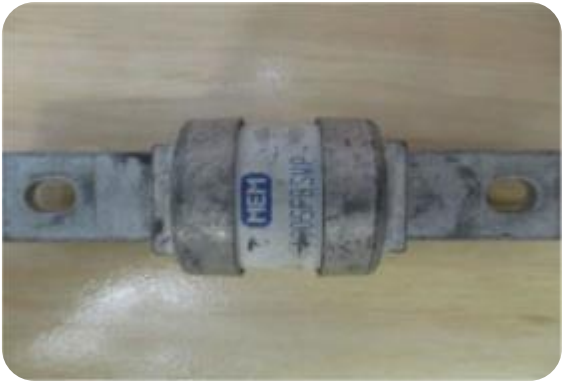
| Manufacturer | Rating | Fuse Body Photographs | Label Markings & Details | Result | Safety Instructions |
|---|---|---|---|---|---|
| MEM | 400 | | 400 SF8WP 400A GG | <br>No Asbestos found, exercise caution and follow safety instructions | <br>Where no manufacturer or date information can be confirmed and/or the fuse was manufactured prior to 2003, the <b>fuses should be presumed to contain asbestos and disposed</b> of in accordance with SWMS - AUS008 - Removal of Friable Asbestos Containing LV HRC Fuses. |

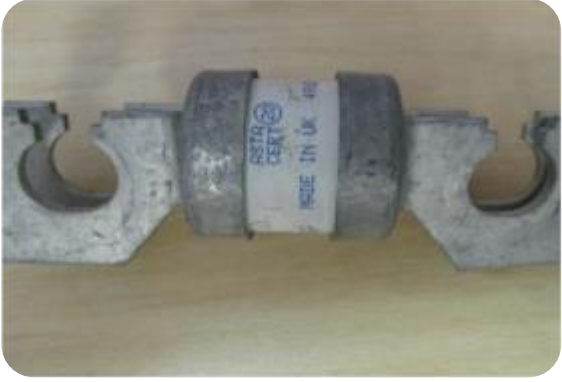
| Manufacturer | Rating | Fuse Body Photographs | Label Markings & Details | Result | Safety Instructions |
|---|---|---|---|---|---|
| MEM | 400 | | 400 JSS92 WP 400A | <br>No Asbestos found, exercise caution and follow safety instructions | <br>Where no manufacturer or date information can be confirmed and/or the fuse was manufactured prior to 2003, the <b>fuses should be presumed to contain asbestos and disposed</b> of in accordance with SWMS - AUS008 - Removal of Friable Asbestos Containing LV HRC Fuses. |

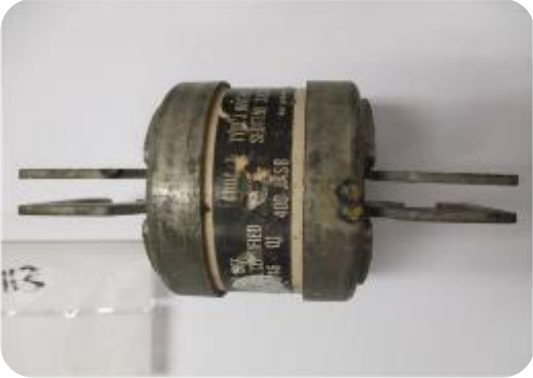
| Manufacturer | Rating | Fuse Body Photographs | Label Markings & Details | Result | Safety Instructions |
|---|---|---|---|---|---|
| MEM | 400 | | Slotted 3 1/3 CTRS<br>400JS.8 | <br>No Asbestos found, exercise caution and follow safety instructions | <br>Where no manufacturer or date information can be confirmed and/or the fuse was manufactured prior to 2003, the <b>fuses should be presumed to contain asbestos and disposed</b> of in accordance with SWMS - AUS008 - Removal of Friable Asbestos Containing LV HRC Fuses. |

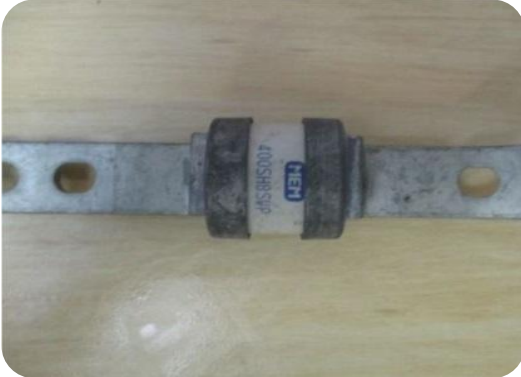
| Manufacturer | Rating | Fuse Body Photographs | Label Markings & Details | Result | Safety Instructions |
|---|---|---|---|---|---|
| MEM | 400 | | 400 SH8SWP 400a GG<br>54287-001-017 | <br>No Asbestos found, exercise caution and follow safety instructions | <br>Where no manufacturer or date information can be confirmed and/or the fuse was manufactured prior to 2003, the <b>fuses should be presumed to contain asbestos and disposed</b> of in accordance with SWMS - AUS008 - Removal of Friable Asbestos Containing LV HRC Fuses. |

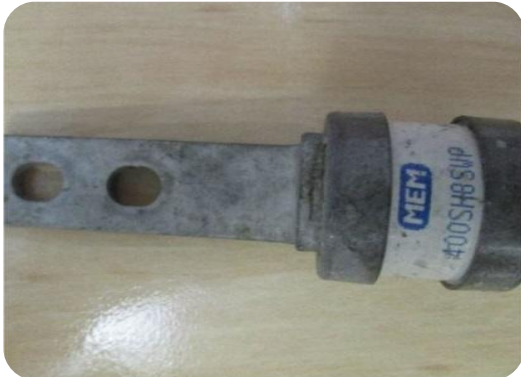
| Manufacturer | Rating | Fuse Body Photographs | Label Markings & Details | Result | Safety Instructions |
|---|---|---|---|---|---|
| MEM | 400 | | 400 SH8SWP 400a GG<br>54087-001-018 | <br>No Asbestos found, exercise caution and follow safety instructions | <br>Where no manufacturer or date information can be confirmed and/or the fuse was manufactured prior to 2003, the <b>fuses should be presumed to contain asbestos and disposed</b> of in accordance with SWMS - AUS008 - Removal of Friable Asbestos Containing LV HRC Fuses. |

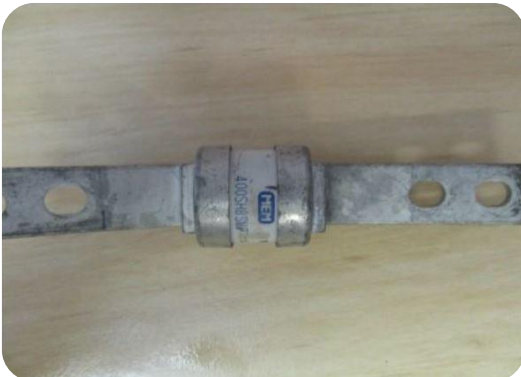
| Manufacturer | Rating | Fuse Body Photographs | Label Markings & Details | Result | Safety Instructions |
|---|---|---|---|---|---|
| MEM | 400 | | 400 SH8SWP 400a GG<br>54087-001-022 | <br>No Asbestos found, exercise caution and follow safety instructions | <br>Where no manufacturer or date information can be confirmed and/or the fuse was manufactured prior to 2003, the <b>fuses should be presumed to contain asbestos and disposed</b> of in accordance with SWMS - AUS008 - Removal of Friable Asbestos Containing LV HRC Fuses. |

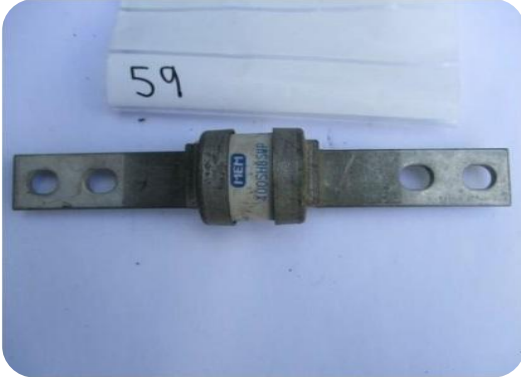
| Manufacturer | Rating | Fuse Body Photographs | Label Markings & Details | Result | Safety Instructions |
|---|---|---|---|---|---|
| MEM | 400 | | 400 SH8SWP 400a GG<br><br>54087-001-059 | <br>No Asbestos found, exercise caution and follow safety instructions | <br>Where no manufacturer or date information can be confirmed and/or the fuse was manufactured prior to 2003, the <b>fuses should be presumed to contain asbestos and disposed</b> of in accordance with SWMS - AUS008 - Removal of Friable Asbestos Containing LV HRC Fuses. |

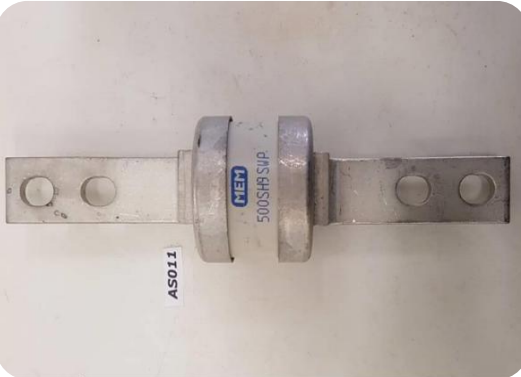
| Manufacturer | Rating | Fuse Body Photographs | Label Markings & Details | Result | Safety Instructions |
|---|---|---|---|---|---|
| MEM | 500 | | 500SH9SWP, 500A,<br>BS88:2:1988, 80kA, gG, 4303<br><br>176207-001-AS011 | <br>No Asbestos found, exercise caution and follow safety instructions | <br>Where no manufacturer or date information can be confirmed and/or the fuse was manufactured prior to 2003, the <b>fuses should be presumed to contain asbestos and disposed</b> of in accordance with SWMS - AUS008 - Removal of Friable Asbestos Containing LV HRC Fuses. |

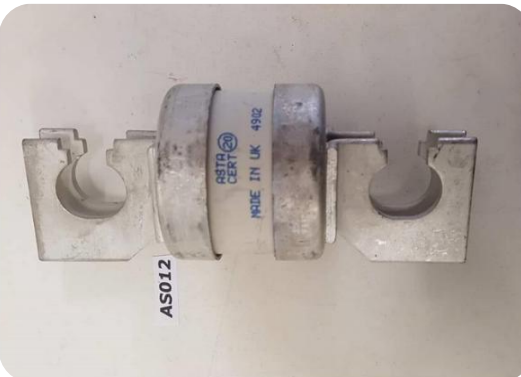
| Manufacturer | Rating | Fuse Body Photographs | Label Markings & Details | Result | Safety Instructions |
|---|---|---|---|---|---|
| MEM | 500 | | 500JSS92WP, 500A,<br>BS88:5:1988, 80kA, Asta cert<br>20, 4902<br><br>176207-001-AS012 | <br>No Asbestos found, exercise caution and follow safety instructions | <br>Where no manufacturer or date information can be confirmed and/or the fuse was manufactured prior to 2003, the <b>fuses should be presumed to contain asbestos and disposed</b> of in accordance with SWMS - AUS008 - Removal of Friable Asbestos Containing LV HRC Fuses. |

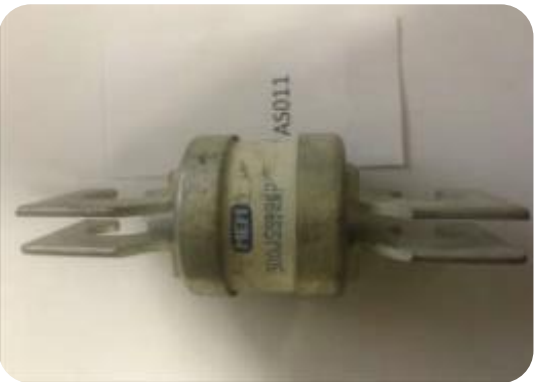
| Manufacturer | Rating | Fuse Body Photographs | Label Markings & Details | Result | Safety Instructions |
|---|---|---|---|---|---|
| MEM | 500 | | 500JSS92WP, BS88:5:1988, 415V a.c., 80kA, Asta cert 20, 0603<br><br>PO33786.002-AS011 | <br>No Asbestos found, exercise caution and follow safety instructions | Where no manufacturer or date information can be confirmed and/or the fuse was manufactured prior to 2003, the <b>fuses should be presumed to contain asbestos and disposed</b> of in accordance with SWMS - AUS008 - Removal of Friable Asbestos Containing LV HRC Fuses. |

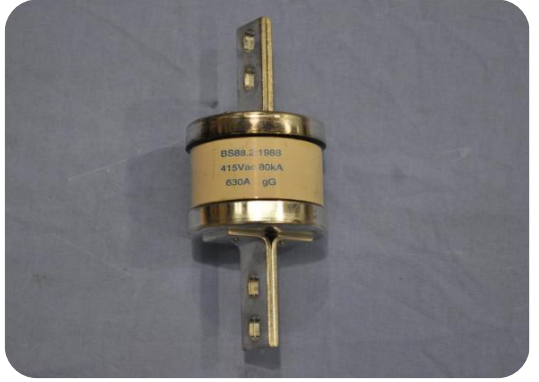
| Manufacturer | Rating | Fuse Body Photographs | Label Markings & Details | Result | Safety Instructions |
|---|---|---|---|---|---|
| MEM | 630 | | MEM 630SH9 | <br>Current Stock Item No. 85597 | |

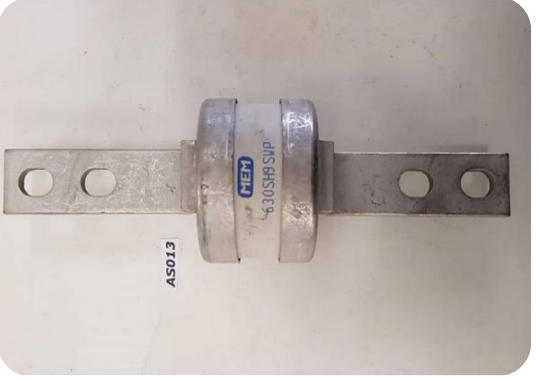
| Manufacturer | Rating | Fuse Body Photographs | Label Markings & Details | Result | Safety Instructions |
|---|---|---|---|---|---|
| MEM | 630 | | 630SH9SWP, 630A, BS88:2:1988, 80kA, gG, 3202<br><br>176207-001-AS013 | <br>No Asbestos found, exercise caution and follow safety instructions | Where no manufacturer or date information can be confirmed and/or the fuse was manufactured prior to 2003, the <b>fuses should be presumed to contain asbestos and disposed</b> of in accordance with SWMS - AUS008 - Removal of Friable Asbestos Containing LV HRC Fuses. |

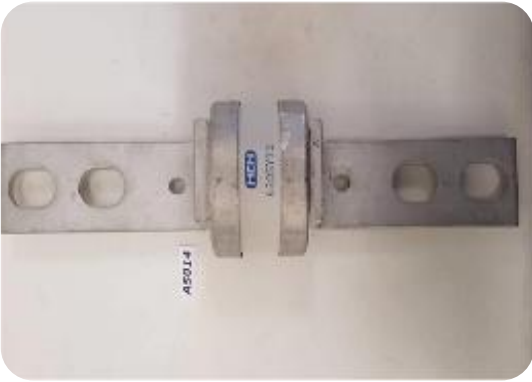
| Manufacturer | Rating | Fuse Body Photographs | Label Markings & Details | Result | Safety Instructions |
|---|---|---|---|---|---|
| MEM | 630 | | 630SY9S, 630A, BS88:2:1988, 80kA, gG, 0504<br>176207-001-AS014 | <br>No Asbestos found, exercise caution and follow safety instructions | <br>Where no manufacturer or date information can be confirmed and/or the fuse was manufactured prior to 2003, the <b>fuses should be presumed to contain asbestos and disposed</b> of in accordance with SWMS - AUS008 - Removal of Friable Asbestos Containing LV HRC Fuses. |

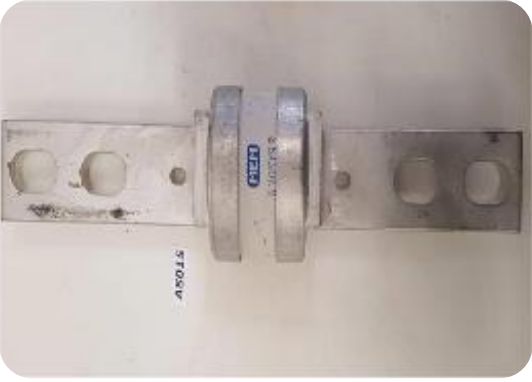
| Manufacturer | Rating | Fuse Body Photographs | Label Markings & Details | Result | Safety Instructions |
|---|---|---|---|---|---|
| MEM | 630 | | 630SY9S, 630A, BS88:2:1988, 80kA, gG, 5204<br>176207-001-AS015 | <br>No Asbestos found, exercise caution and follow safety instructions | <br>Where no manufacturer or date information can be confirmed and/or the fuse was manufactured prior to 2003, the <b>fuses should be presumed to contain asbestos and disposed</b> of in accordance with SWMS - AUS008 - Removal of Friable Asbestos Containing LV HRC Fuses. |

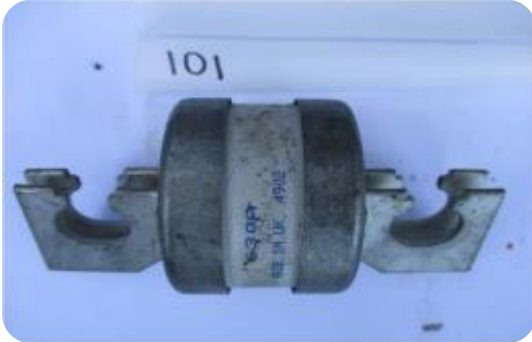
| Manufacturer | Rating | Fuse Body Photographs | Label Markings & Details | Result | Safety Instructions |
|---|---|---|---|---|---|
| MEM | 630 | | 630 JSS9 2WP<br>54287-001-101 | <br>No Asbestos found, exercise caution and follow safety instructions | <br>Where no manufacturer or date information can be confirmed and/or the fuse was manufactured prior to 2003, the <b>fuses should be presumed to contain asbestos and disposed</b> of in accordance with SWMS - AUS008 - Removal of Friable Asbestos Containing LV HRC Fuses. |

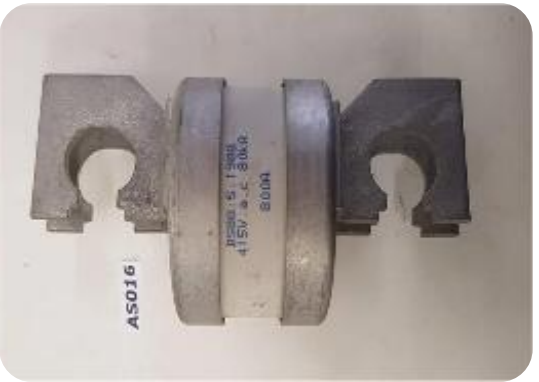
| Manufacturer | Rating | Fuse Body Photographs | Label Markings & Details | Result | Safety Instructions |
|---|---|---|---|---|---|
| MEM | 800 | | 800JSS92, 800A, BS88:5:1988, 80kA, 1203 | <br>No Asbestos found, exercise caution and follow safety instructions | Where no manufacturer or date information can be confirmed and/or the fuse was manufactured prior to 2003, the <b>fuses should be presumed to contain asbestos and disposed</b> of in accordance with SWMS - AUS008 - Removal of Friable Asbestos Containing LV HRC Fuses. |

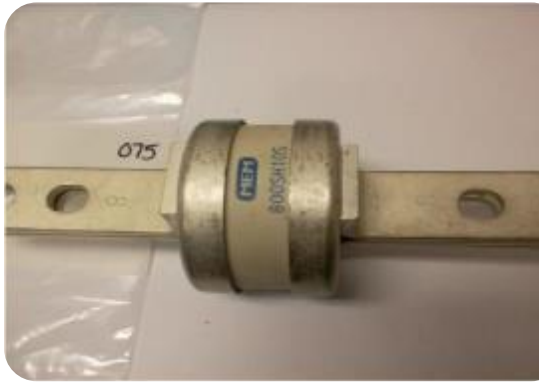
| Manufacturer | Rating | Fuse Body Photographs | Label Markings & Details | Result | Safety Instructions |
|---|---|---|---|---|---|
| MEM | 800 | | 800 SH10S | <br>No Asbestos found, exercise caution and follow safety instructions | Where no manufacturer or date information can be confirmed and/or the fuse was manufactured prior to 2003, the <b>fuses should be presumed to contain asbestos and disposed</b> of in accordance with SWMS - AUS008 - Removal of Friable Asbestos Containing LV HRC Fuses. |

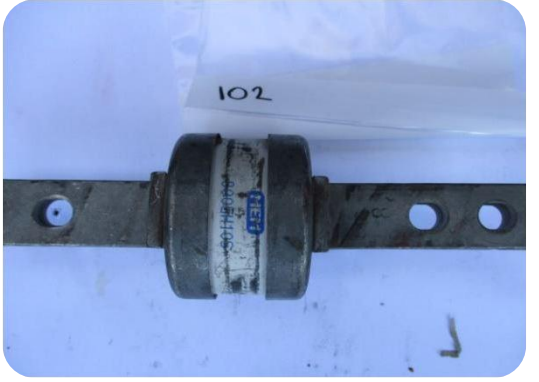
| Manufacturer | Rating | Fuse Body Photographs | Label Markings & Details | Result | Safety Instructions |
|---|---|---|---|---|---|
| MEM | 800 | | 800 SHIOS | <br>No Asbestos found, exercise caution and follow safety instructions | Where no manufacturer or date information can be confirmed and/or the fuse was manufactured prior to 2003, the <b>fuses should be presumed to contain asbestos and disposed</b> of in accordance with SWMS - AUS008 - Removal of Friable Asbestos Containing LV HRC Fuses. |

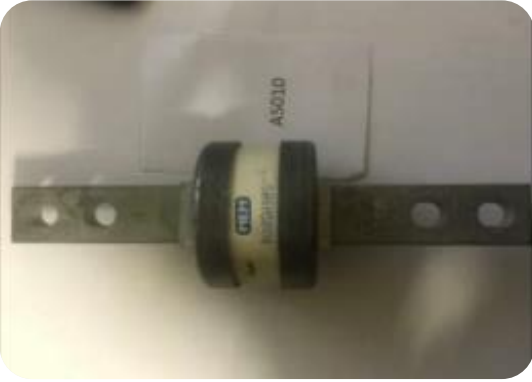
| Manufacturer | Rating | Fuse Body Photographs | Label Markings & Details | Result | Safety Instructions |
|---|---|---|---|---|---|
| MEM | 800 | | 800SH10S, 800A, MADE IN UK,<br>BS88 : 2 : 1988, 415V a.c 80kA,<br>800A gG<br><br>PO33786.002-AS010 | <br><br>No Asbestos found,<br>exercise caution and follow safety instructions | Where no manufacturer or date information can be confirmed and/or the fuse was manufactured prior to 2003, the <b>fuses should be presumed to contain asbestos and disposed</b> of in accordance with SWMS - AUS008 - Removal of Friable Asbestos Containing LV HRC Fuses. |

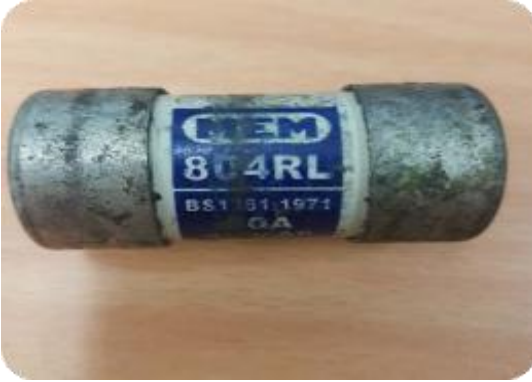
| Manufacturer | Rating | Fuse Body Photographs | Label Markings & Details | Result | Safety Instructions |
|---|---|---|---|---|---|
| MEM | | | 804RL, BS1361:1971, BOA,<br>415V AC, ASTA (20) CERT, made in the UK<br><br>OF00053-120718-AS04 | <br><br>No Asbestos found,<br>exercise caution and follow safety instructions | Where no manufacturer or date information can be confirmed and/or the fuse was manufactured prior to 2003, the <b>fuses should be presumed to contain asbestos and disposed</b> of in accordance with SWMS - AUS008 - Removal of Friable Asbestos Containing LV HRC Fuses. |

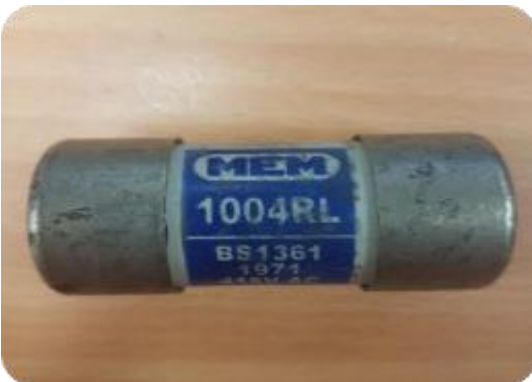
| Manufacturer | Rating | Fuse Body Photographs | Label Markings & Details | Result | Safety Instructions |
|---|---|---|---|---|---|
| MEM | | | 1004RL, BS1361, 1971, 415V AC, ASTA (20) CERT, made in the UK<br><br>OF00053-120718-AS24 | <br><br>No Asbestos found,<br>exercise caution and follow safety instructions | Where no manufacturer or date information can be confirmed and/or the fuse was manufactured prior to 2003, the <b>fuses should be presumed to contain asbestos and disposed</b> of in accordance with SWMS - AUS008 - Removal of Friable Asbestos Containing LV HRC Fuses. |

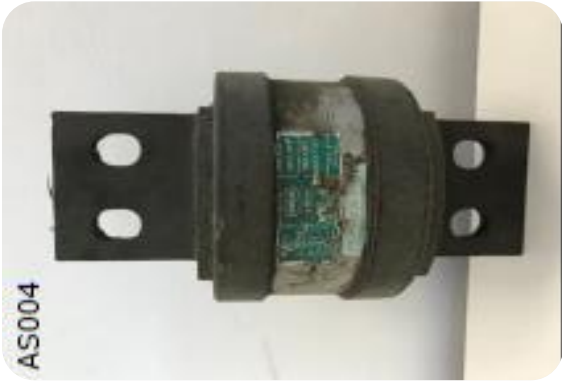
| Manufacturer | Rating | Fuse Body Photographs | Label Markings & Details | Result | Safety Instructions |
|---|---|---|---|---|---|
| MEM | | <p>AS004</p> <p>PO33786.002-AS012</p> | GEC - HRC Fuse Link - Class Q1, BS 88-2: 1975, ASTA certified, 80kA 550V A.C, 40kA 250V D. C. - 550V - Australia - no date | <br>Asbestos found | <b>In-Service Fuses:</b><br> If fuse is damaged, cease work and make safe. Contact the Hazmat Hotline - 02 9394 6961.<br> If the fuse is intact, remove the fuse taking care not to damage in accordance with SWMS - AUS008 Removal of Friable Asbestos Containing LV HRC Fuses.<br><b>Stored and Quarantined Fuses:</b><br> Must be disposed of in accordance with SWMS - AUS008 Removal of Friable Asbestos Containing LV HRC Fuses. |

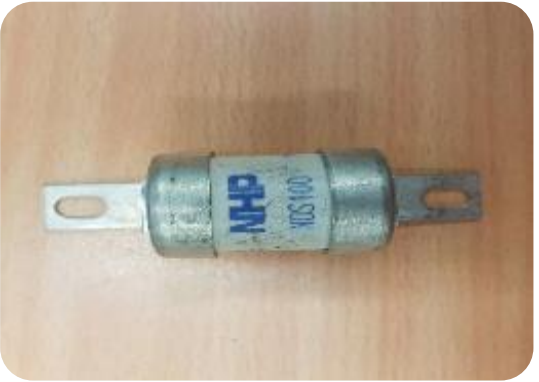
| Manufacturer | Rating | Fuse Body Photographs | Label Markings & Details | Result | Safety Instructions |
|---|---|---|---|---|---|
| NHP | 100 | <p>OF00053-120718-AS27</p> | NOS100, BS88:1:1988, 415V a.c. 80kA, 100A gG, ASTA (20) CERT, made in UK | <br>No Asbestos found, exercise caution and follow safety instructions | Where no manufacturer or date information can be confirmed and/or the fuse was manufactured prior to 2003, the <b>fuses should be presumed to contain asbestos and disposed</b> of in accordance with SWMS - AUS008 - Removal of Friable Asbestos Containing LV HRC Fuses. |

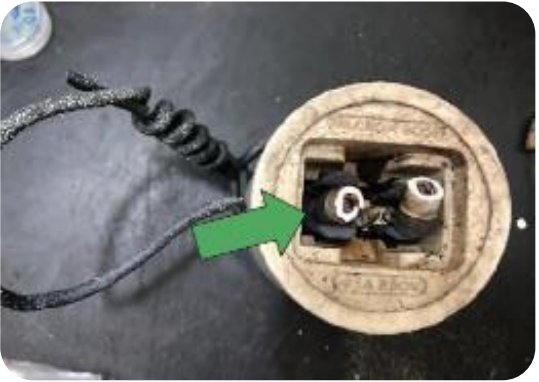
| Manufacturer | Rating | Fuse Body Photographs | Label Markings & Details | Result | Safety Instructions |
|---|---|---|---|---|---|
| Nilcrom | 45 | <p>754-SYDEN202874-AS13</p> | Nilcrom 60SF - 45A 250V | <br>No Asbestos found, exercise caution and follow safety instructions | Where no manufacturer or date information can be confirmed and/or the fuse was manufactured prior to 2003, the <b>fuses should be presumed to contain asbestos and disposed</b> of in accordance with SWMS - AUS008 - Removal of Friable Asbestos Containing LV HRC Fuses. |

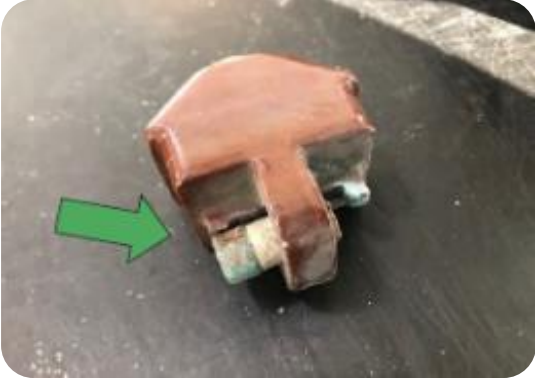
| Manufacturer | Rating | Fuse Body Photographs | Label Markings & Details | Result | Safety Instructions |
|---|---|---|---|---|---|
| Nilcrom | 45 | | 754-SYDEN202874-AS20<br>Nilcrom 605F 45A 250V | <br>No Asbestos found, exercise caution and follow safety instructions | Where no manufacturer or date information can be confirmed and/or the fuse was manufactured prior to 2003, the <b>fuses should be presumed to contain asbestos and disposed</b> of in accordance with SWMS - AUS008 - Removal of Friable Asbestos Containing LV HRC Fuses. |

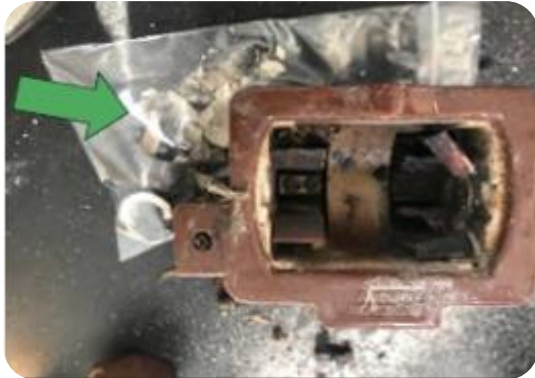
| Manufacturer | Rating | Fuse Body Photographs | Label Markings & Details | Result | Safety Instructions |
|---|---|---|---|---|---|
| Nilcrom | 45 | | 754-SYDEN202874-AS14<br>Nilcrom 605F 45A 250V | <br>No Asbestos found, exercise caution and follow safety instructions | Where no manufacturer or date information can be confirmed and/or the fuse was manufactured prior to 2003, the <b>fuses should be presumed to contain asbestos and disposed</b> of in accordance with SWMS - AUS008 - Removal of Friable Asbestos Containing LV HRC Fuses. |

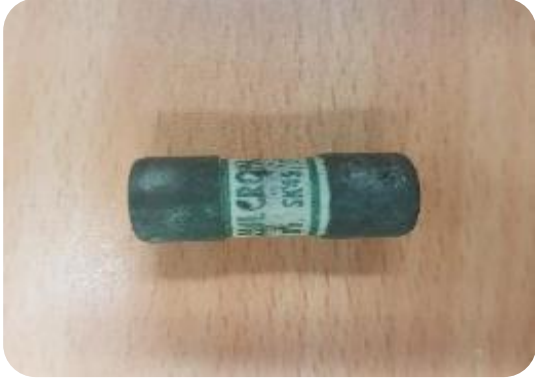
| Manufacturer | Rating | Fuse Body Photographs | Label Markings & Details | Result | Safety Instructions |
|---|---|---|---|---|---|
| Nilcrom | 45 | | OF00053-120718-AS20<br>SK45/C, 45A, 250V, A.C.2 | <br>No Asbestos found, exercise caution and follow safety instructions | Where no manufacturer or date information can be confirmed and/or the fuse was manufactured prior to 2003, the <b>fuses should be presumed to contain asbestos and disposed</b> of in accordance with SWMS - AUS008 - Removal of Friable Asbestos Containing LV HRC Fuses. |

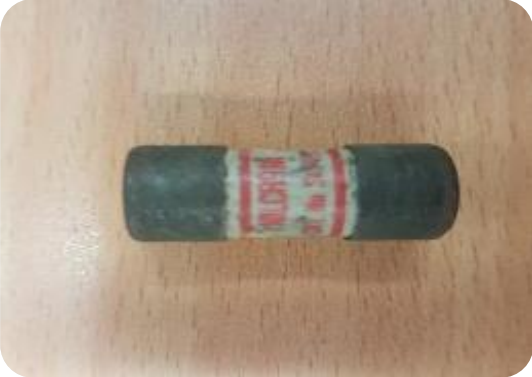
| Manufacturer | Rating | Fuse Body Photographs | Label Markings & Details | Result | Safety Instructions |
|---|---|---|---|---|---|
| Nilcrom | 45 | <br>OF00053-120718-AS22 | SK45C1, 45A, 250V, AC2 | <br>No Asbestos found, exercise caution and follow safety instructions | Where no manufacturer or date information can be confirmed and/or the fuse was manufactured prior to 2003, the <b>fuses should be presumed to contain asbestos and disposed</b> of in accordance with SWMS - AUS008 - Removal of Friable Asbestos Containing LV HRC Fuses. |

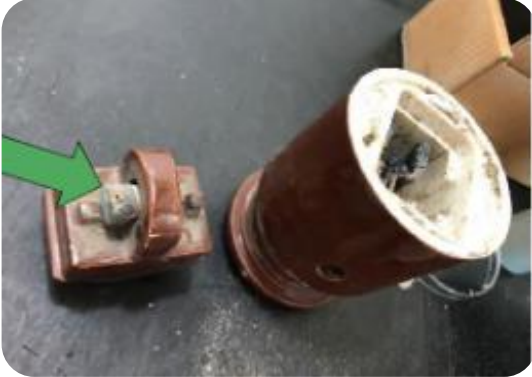
| Manufacturer | Rating | Fuse Body Photographs | Label Markings & Details | Result | Safety Instructions |
|---|---|---|---|---|---|
| Nilcrom | 45 | <br>754-SYDEN202874-AS04 | Nilcrom 60SF - 45A 250V | <br>No Asbestos found, exercise caution and follow safety instructions | Where no manufacturer or date information can be confirmed and/or the fuse was manufactured prior to 2003, the <b>fuses should be presumed to contain asbestos and disposed</b> of in accordance with SWMS - AUS008 - Removal of Friable Asbestos Containing LV HRC Fuses. |

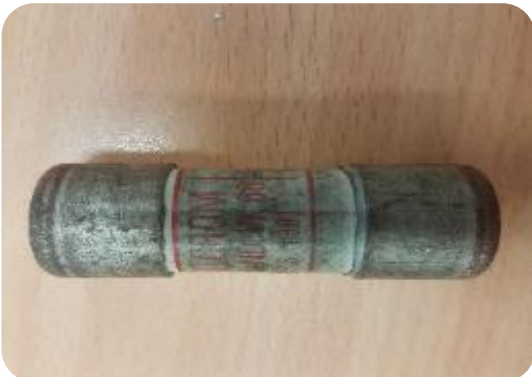
| Manufacturer | Rating | Fuse Body Photographs | Label Markings & Details | Result | Safety Instructions |
|---|---|---|---|---|---|
| Nilcrom | 60 | <br>OF00053-120718-AS17 | VK60, B.S.1361, 60A, 440V AC5, F.F. "R" | <br>No Asbestos found, exercise caution and follow safety instructions | Where no manufacturer or date information can be confirmed and/or the fuse was manufactured prior to 2003, the <b>fuses should be presumed to contain asbestos and disposed</b> of in accordance with SWMS - AUS008 - Removal of Friable Asbestos Containing LV HRC Fuses. |
