## Network Standard

Document No : NW000-S0161

NS211 ANNEXURE G – LV HRC FUSE ASBESTOS PRODUCT GUIDE

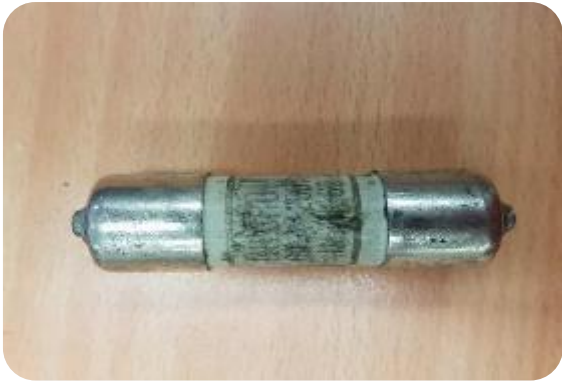
| Manufacturer | Rating | Fuse Body Photographs | Label Markings & Details | Result | Safety Instructions |
|---|---|---|---|---|---|
| Nilcrom | 60 | | BK-60, 60A, 250V, Rewireable Fuse, ACI F.F. "R" | <br>Asbestos found | <b>In-Service Fuses:</b><br> If fuse is damaged, cease work and make safe. Contact the Hazmat Hotline - 02 9394 6961.<br> If the fuse is intact, remove the fuse taking care not to damage in accordance with SWMS - AUS008 Removal of Friable Asbestos Containing LV HRC Fuses.<br><b>Stored and Quarantined Fuses:</b><br> Must be disposed of in accordance with SWMS - AUS008 Removal of Friable Asbestos Containing LV HRC Fuses. |

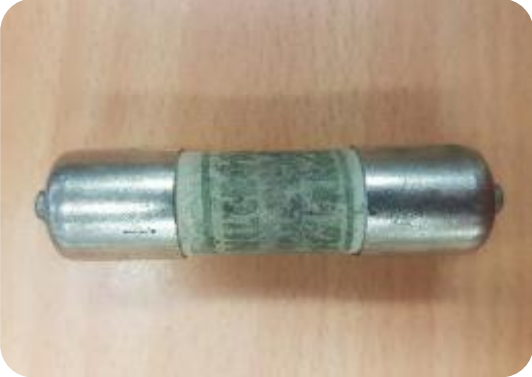
| Manufacturer | Rating | Fuse Body Photographs | Label Markings & Details | Result | Safety Instructions |
|---|---|---|---|---|---|
| Nilcrom | 60 | | RK60, 60A, 250V, illegible | <br>Asbestos found | <b>In-Service Fuses:</b><br> If fuse is damaged, cease work and make safe. Contact the Hazmat Hotline - 02 9394 6961.<br> If the fuse is intact, remove the fuse taking care not to damage in accordance with SWMS - AUS008 Removal of Friable Asbestos Containing LV HRC Fuses.<br><b>Stored and Quarantined Fuses:</b><br> Must be disposed of in accordance with SWMS - AUS008 Removal of Friable Asbestos Containing LV HRC Fuses. |

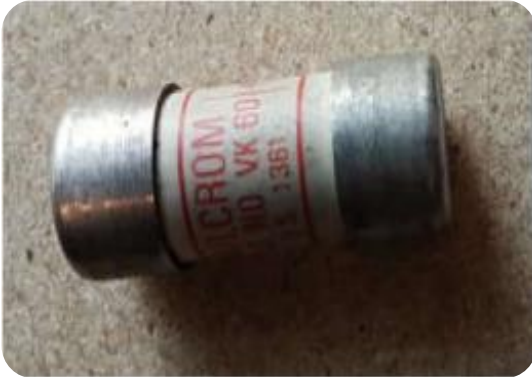
| Manufacturer | Rating | Fuse Body Photographs | Label Markings & Details | Result | Safety Instructions |
|---|---|---|---|---|---|
| Nilcrom | 60 | | CAT.No.VK60, B.S1361, 60A, 440V-AC6, F.??R?? | <br>Asbestos found | <b>In-Service Fuses:</b><br> If fuse is damaged, cease work and make safe. Contact the Hazmat Hotline - 02 9394 6961.<br> If the fuse is intact, remove the fuse taking care not to damage in accordance with SWMS - AUS008 Removal of Friable Asbestos Containing LV HRC Fuses.<br><b>Stored and Quarantined Fuses:</b><br> Must be disposed of in accordance with SWMS - AUS008 Removal of Friable Asbestos Containing LV HRC Fuses. |

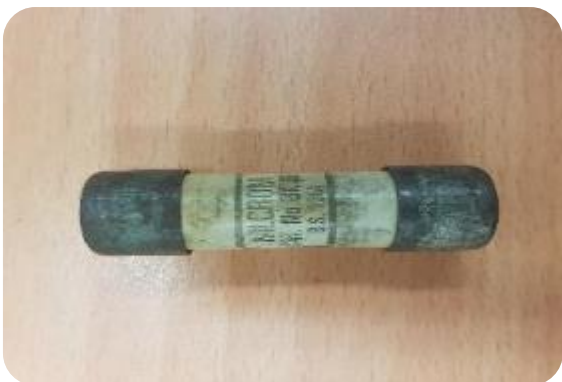
| Manufacturer | Rating | Fuse Body Photographs | Label Markings & Details | Result | Safety Instructions |
|---|---|---|---|---|---|
| Nilcrom | 65 | | UK65, BS1361, 65A, 440V-AC, F.F. "R" | <br>Asbestos found | <b>In-Service Fuses:</b><br> If fuse is damaged, cease work and make safe. Contact the Hazmat Hotline - 02 9394 6961.<br> If the fuse is intact, remove the fuse taking care not to damage in accordance with SWMS - AUS008 Removal of Friable Asbestos Containing LV HRC Fuses.<br><b>Stored and Quarantined Fuses:</b><br> Must be disposed of in accordance with SWMS - AUS008 Removal of Friable Asbestos Containing LV HRC Fuses. |

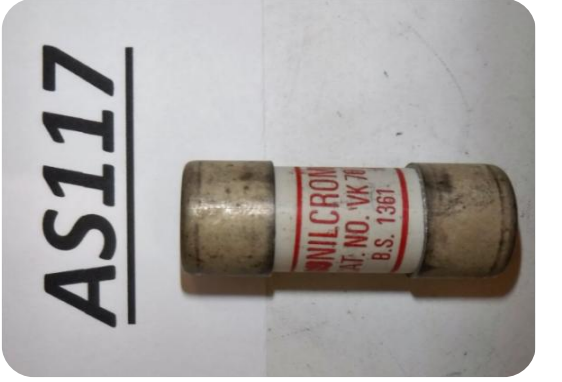
| Manufacturer | Rating | Fuse Body Photographs | Label Markings & Details | Result | Safety Instructions |
|---|---|---|---|---|---|
| Nilcrom | 70 | | VK70, 70A, AC5, F.F., 'R', B.S.1361 | <br>No Asbestos found, exercise caution and follow safety instructions | Where no manufacturer or date information can be confirmed and/or the fuse was manufactured prior to 2003, the <b>fuses should be presumed to contain asbestos and disposed</b> of in accordance with SWMS - AUS008 - Removal of Friable Asbestos Containing LV HRC Fuses. |

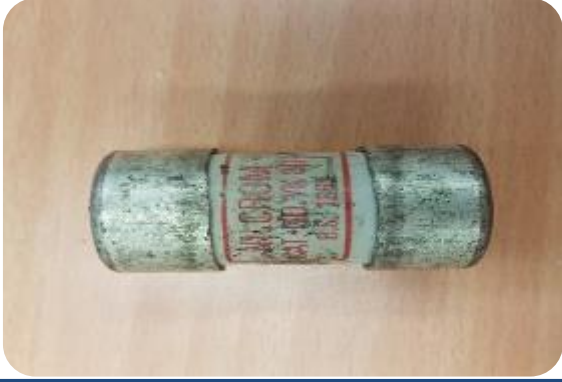
| Manufacturer | Rating | Fuse Body Photographs | Label Markings & Details | Result | Safety Instructions |
|---|---|---|---|---|---|
| Nilcrom | 80 | | YK80, B.S. 1361, 80A, 440V-AC5, F.F. "R" | <br>No Asbestos found, exercise caution and follow safety instructions | Where no manufacturer or date information can be confirmed and/or the fuse was manufactured prior to 2003, the <b>fuses should be presumed to contain asbestos and disposed</b> of in accordance with SWMS - AUS008 - Removal of Friable Asbestos Containing LV HRC Fuses. |

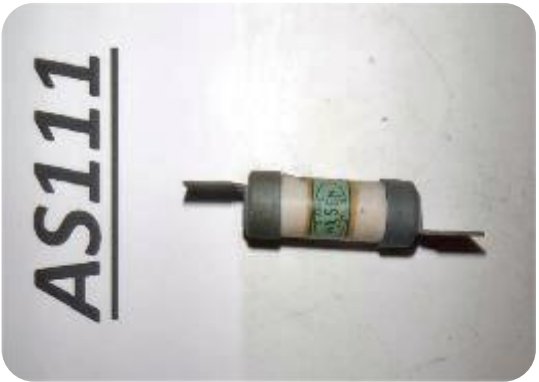
| Manufacturer | Rating | Fuse Body Photographs | Label Markings & Details | Result | Safety Instructions |
|---|---|---|---|---|---|
| Nilsen | 8 | <br>168273-111 | N8, 8A, AC 5, B.S.88 | <br>Asbestos found | <b>In-Service Fuses:</b><br> If fuse is damaged, cease work and make safe. Contact the Hazmat Hotline - 02 9394 6961.<br> If the fuse is intact, remove the fuse taking care not to damage in accordance with SWMS - AUS008 Removal of Friable Asbestos Containing LV HRC Fuses.<br><b>Stored and Quarantined Fuses:</b><br> Must be disposed of in accordance with SWMS - AUS008 Removal of Friable Asbestos Containing LV HRC Fuses. |

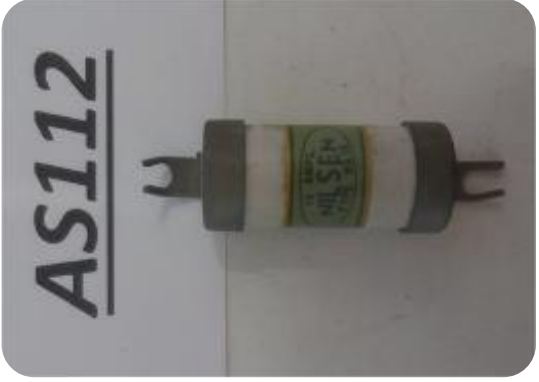
| Manufacturer | Rating | Fuse Body Photographs | Label Markings & Details | Result | Safety Instructions |
|---|---|---|---|---|---|
| Nilsen | 10 | <br>168273-112 | NA 10, 10A, AC 5, B.S.88 | <br>Asbestos found | <b>In-Service Fuses:</b><br> If fuse is damaged, cease work and make safe. Contact the Hazmat Hotline - 02 9394 6961.<br> If the fuse is intact, remove the fuse taking care not to damage in accordance with SWMS - AUS008 Removal of Friable Asbestos Containing LV HRC Fuses.<br><b>Stored and Quarantined Fuses:</b><br> Must be disposed of in accordance with SWMS - AUS008 Removal of Friable Asbestos Containing LV HRC Fuses. |

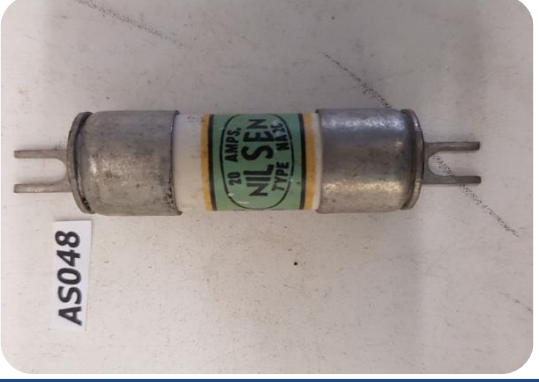
| Manufacturer | Rating | Fuse Body Photographs | Label Markings & Details | Result | Safety Instructions |
|---|---|---|---|---|---|
| Nilsen | 20 | <br>174783-001-AS048 | NA20, 20A, Patents Aust 161149<br>Brit 132428, AC5, BS 88 1952 | <br>No Asbestos found, exercise caution and follow safety instructions | Where no manufacturer or date information can be confirmed and/or the fuse was manufactured prior to 2003, the <b>fuses should be presumed to contain asbestos and disposed</b> of in accordance with SWMS - AUS008 - Removal of Friable Asbestos Containing LV HRC Fuses. |

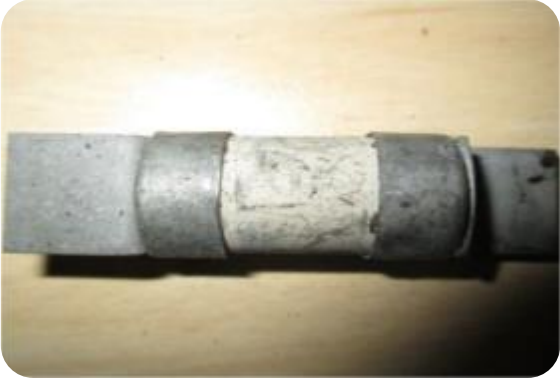
| Manufacturer | Rating | Fuse Body Photographs | Label Markings & Details | Result | Safety Instructions |
|---|---|---|---|---|---|
| No Brand | 63 | <br>54287-001-012 | 63A 63SP | <br>No Asbestos found, exercise caution and follow safety instructions | Where no manufacturer or date information can be confirmed and/or the fuse was manufactured prior to 2003, the <b>fuses should be presumed to contain asbestos and disposed</b> of in accordance with SWMS - AUS008 - Removal of Friable Asbestos Containing LV HRC Fuses. |

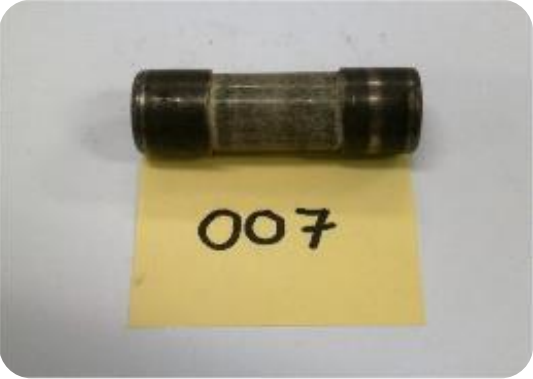
| Manufacturer | Rating | Fuse Body Photographs | Label Markings & Details | Result | Safety Instructions |
|---|---|---|---|---|---|
| No Brand | 63 | <br>55738-001-007 | No Identifying marks | <br>No Asbestos found, exercise caution and follow safety instructions | Where no manufacturer or date information can be confirmed and/or the fuse was manufactured prior to 2003, the <b>fuses should be presumed to contain asbestos and disposed</b> of in accordance with SWMS - AUS008 - Removal of Friable Asbestos Containing LV HRC Fuses. |

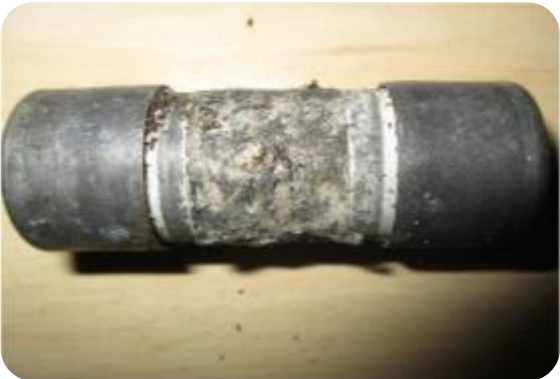
| Manufacturer | Rating | Fuse Body Photographs | Label Markings & Details | Result | Safety Instructions |
|---|---|---|---|---|---|
| No Brand | 80 | <br>54287-001-009 | 80A | <br>No Asbestos found, exercise caution and follow safety instructions | Where no manufacturer or date information can be confirmed and/or the fuse was manufactured prior to 2003, the <b>fuses should be presumed to contain asbestos and disposed</b> of in accordance with SWMS - AUS008 - Removal of Friable Asbestos Containing LV HRC Fuses. |

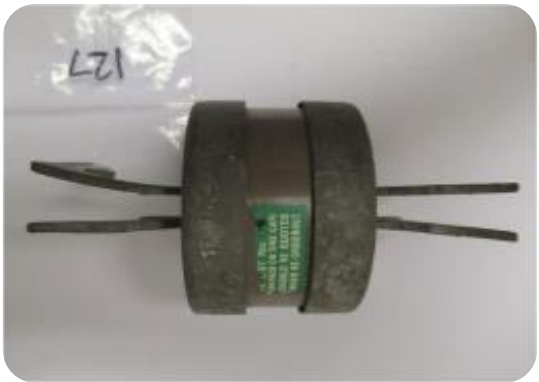
| Manufacturer | Rating | Fuse Body Photographs | Label Markings & Details | Result | Safety Instructions |
|---|---|---|---|---|---|
| No Brand | 400 | | L17ITN | <br>Asbestos found | <b>In-Service Fuses:</b><br> If fuse is damaged, cease work and make safe. Contact the Hazmat Hotline - 02 9394 6961.<br> If the fuse is intact, remove the fuse taking care not to damage in accordance with SWMS - AUS008 Removal of Friable Asbestos Containing LV HRC Fuses.<br><b>Stored and Quarantined Fuses:</b><br> Must be disposed of in accordance with SWMS - AUS008 Removal of Friable Asbestos Containing LV HRC Fuses. |

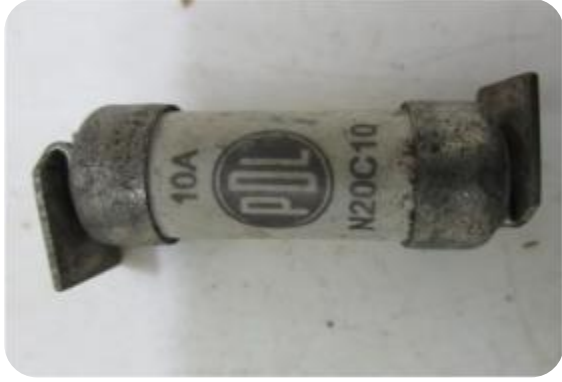
| Manufacturer | Rating | Fuse Body Photographs | Label Markings & Details | Result | Safety Instructions |
|---|---|---|---|---|---|
| PDL | 10 | | 10A n20c10 | <br>No Asbestos found, exercise caution and follow safety instructions | Where no manufacturer or date information can be confirmed and/or the fuse was manufactured prior to 2003, the <b>fuses should be presumed to contain asbestos and disposed</b> of in accordance with SWMS - AUS008 - Removal of Friable Asbestos Containing LV HRC Fuses. |

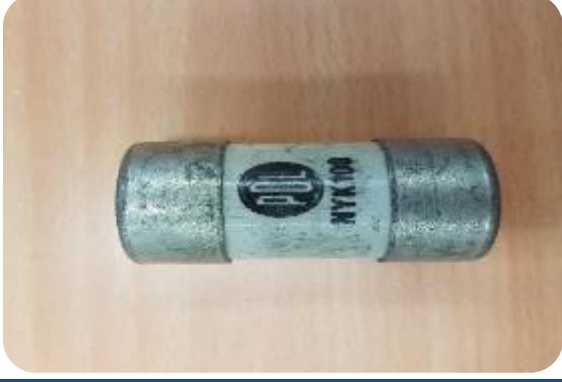
| Manufacturer | Rating | Fuse Body Photographs | Label Markings & Details | Result | Safety Instructions |
|---|---|---|---|---|---|
| PDL | 100 | | NYK100, certified, BS1361, 415VAC, made in UK, 100 AMP | <br>No Asbestos found, exercise caution and follow safety instructions | Where no manufacturer or date information can be confirmed and/or the fuse was manufactured prior to 2003, the <b>fuses should be presumed to contain asbestos and disposed</b> of in accordance with SWMS - AUS008 - Removal of Friable Asbestos Containing LV HRC Fuses. |

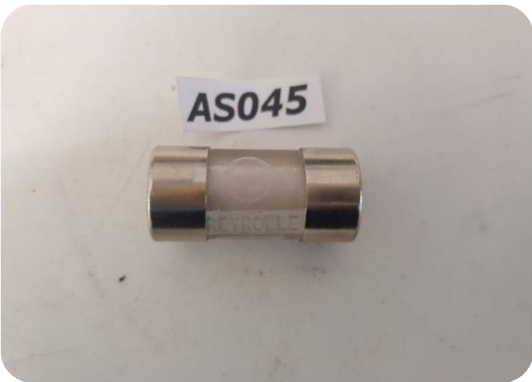
| Manufacturer | Rating | Fuse Body Photographs | Label Markings & Details | Result | Safety Instructions |
|---|---|---|---|---|---|
| Reyrolle | 30 | <br>174783-001-AS045 | MD, 30A, AC5, BS 88, Asta 20 | <br>Asbestos found | <b>In-Service Fuses:</b><br> If fuse is damaged, cease work and make safe. Contact the Hazmat Hotline - 02 9394 6961.<br> If the fuse is intact, remove the fuse taking care not to damage in accordance with SWMS - AUS008 Removal of Friable Asbestos Containing LV HRC Fuses.<br><b>Stored and Quarantined Fuses:</b><br> Must be disposed of in accordance with SWMS - AUS008 Removal of Friable Asbestos Containing LV HRC Fuses. |

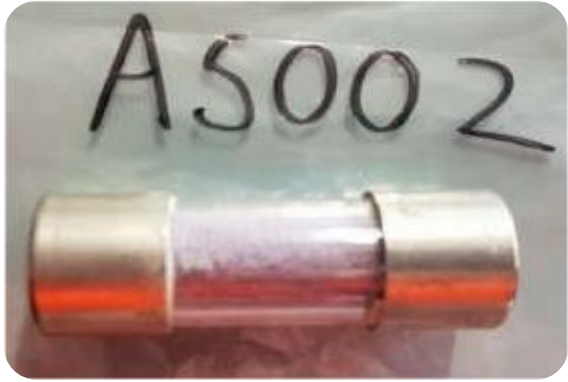
| Manufacturer | Rating | Fuse Body Photographs | Label Markings & Details | Result | Safety Instructions |
|---|---|---|---|---|---|
| Reyrolle | 60 | <br>P033768.003 - AS002 | 60A, markings worn | <br>Asbestos found | <b>In-Service Fuses:</b><br> If fuse is damaged, cease work and make safe. Contact the Hazmat Hotline - 02 9394 6961.<br> If the fuse is intact, remove the fuse taking care not to damage in accordance with SWMS - AUS008 Removal of Friable Asbestos Containing LV HRC Fuses.<br><b>Stored and Quarantined Fuses:</b><br> Must be disposed of in accordance with SWMS - AUS008 Removal of Friable Asbestos Containing LV HRC Fuses. |

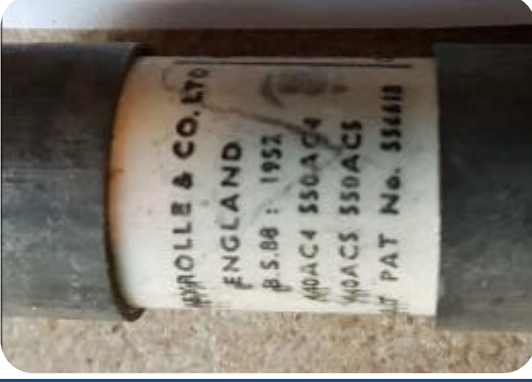
| Manufacturer | Rating | Fuse Body Photographs | Label Markings & Details | Result | Safety Instructions |
|---|---|---|---|---|---|
| Reyrolle | 60 | <br>P033768.003-AS017 | GPE-20E, ORDERING REFERENCE, 60A, CARTRIDGE FUSE LINK, F.F. Class "Q", ENGLAND, BS.88.1952, 440AC4 550AC4, AA0ACS 550ACS, BRIT PAT No. 556618 | <br>Asbestos found | <b>In-Service Fuses:</b><br> If fuse is damaged, cease work and make safe. Contact the Hazmat Hotline - 02 9394 6961.<br> If the fuse is intact, remove the fuse taking care not to damage in accordance with SWMS - AUS008 Removal of Friable Asbestos Containing LV HRC Fuses.<br><b>Stored and Quarantined Fuses:</b><br> Must be disposed of in accordance with SWMS - AUS008 Removal of Friable Asbestos Containing LV HRC Fuses. |

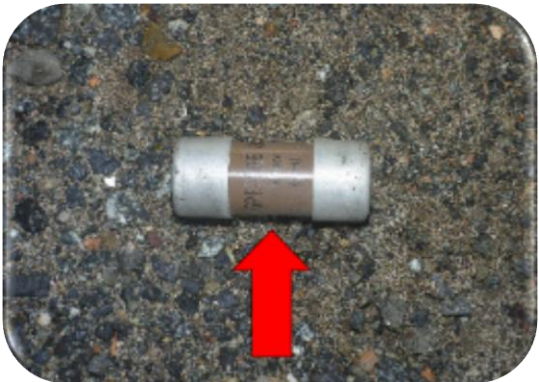
| Manufacturer | Rating | Fuse Body Photographs | Label Markings & Details | Result | Safety Instructions |
|---|---|---|---|---|---|
| Reyrolle | 60 | <br>754-SYDEN202874-002 | Reyrolle GPE-20E 60A | <br>Asbestos found | <b>In-Service Fuses:</b><br> If fuse is damaged, cease work and make safe. Contact the Hazmat Hotline - 02 9394 6961.<br> If the fuse is intact, remove the fuse taking care not to damage in accordance with SWMS - AUS008 Removal of Friable Asbestos Containing LV HRC Fuses.<br><b>Stored and Quarantined Fuses:</b><br> Must be disposed of in accordance with SWMS - AUS008 Removal of Friable Asbestos Containing LV HRC Fuses. |

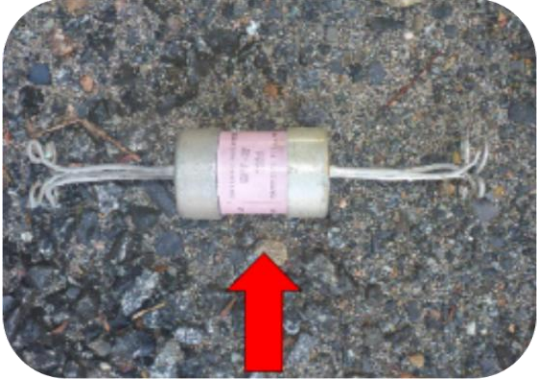
| Manufacturer | Rating | Fuse Body Photographs | Label Markings & Details | Result | Safety Instructions |
|---|---|---|---|---|---|
| Reyrolle | 100 | <br>754-SYDEN202874-001 | Reyrolle GPF-2F 100A | <br>Asbestos found | <b>In-Service Fuses:</b><br> If fuse is damaged, cease work and make safe. Contact the Hazmat Hotline - 02 9394 6961.<br> If the fuse is intact, remove the fuse taking care not to damage in accordance with SWMS - AUS008 Removal of Friable Asbestos Containing LV HRC Fuses.<br><b>Stored and Quarantined Fuses:</b><br> Must be disposed of in accordance with SWMS - AUS008 Removal of Friable Asbestos Containing LV HRC Fuses. |

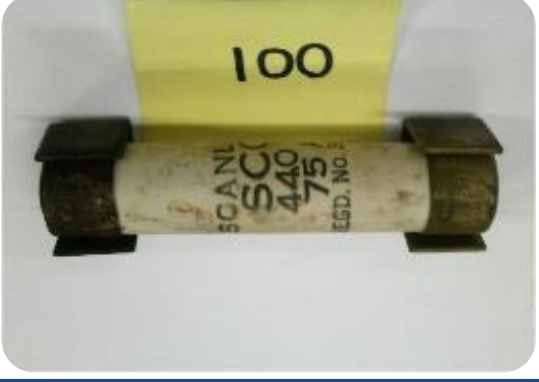
| Manufacturer | Rating | Fuse Body Photographs | Label Markings & Details | Result | Safety Instructions |
|---|---|---|---|---|---|
| Scanlan | 75 | <br>55738-001-001 | SCC 400V, 75A, Reg. No. 36, 699 | <br>Asbestos found | <b>In-Service Fuses:</b><br> If fuse is damaged, cease work and make safe. Contact the Hazmat Hotline - 02 9394 6961.<br> If the fuse is intact, remove the fuse taking care not to damage in accordance with SWMS - AUS008 Removal of Friable Asbestos Containing LV HRC Fuses.<br><b>Stored and Quarantined Fuses:</b><br> Must be disposed of in accordance with SWMS - AUS008 Removal of Friable Asbestos Containing LV HRC Fuses. |

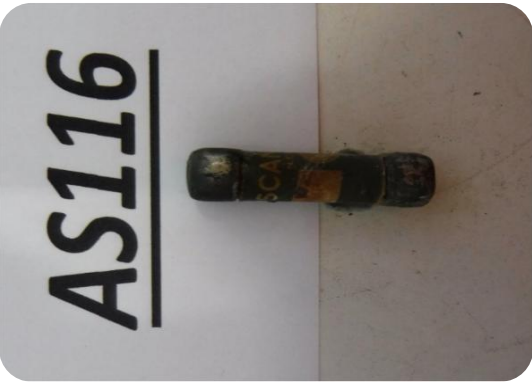
| Manufacturer | Rating | Fuse Body Photographs | Label Markings & Details | Result | Safety Instructions |
|---|---|---|---|---|---|
| Scanlan | | <br><small>168273-65</small> | NECS, no other markings | <br>No Asbestos found, exercise caution and follow safety instructions | Where no manufacturer or date information can be confirmed and/or the fuse was manufactured prior to 2003, the <b>fuses should be presumed to contain asbestos and disposed</b> of in accordance with SWMS - AUS008 - Removal of Friable Asbestos Containing LV HRC Fuses. |

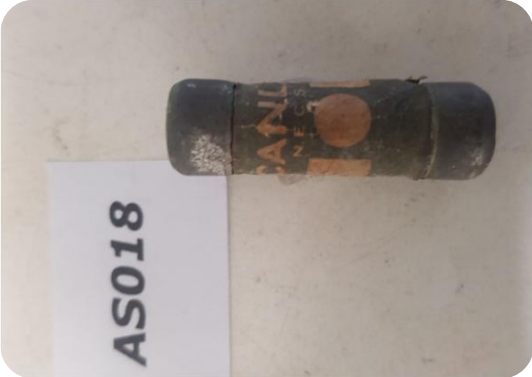
| Manufacturer | Rating | Fuse Body Photographs | Label Markings & Details | Result | Safety Instructions |
|---|---|---|---|---|---|
| Scanlan | | <br><small>174102-001-AS018</small> | NECS, no markings | <br>No Asbestos found, exercise caution and follow safety instructions | Where no manufacturer or date information can be confirmed and/or the fuse was manufactured prior to 2003, the <b>fuses should be presumed to contain asbestos and disposed</b> of in accordance with SWMS - AUS008 - Removal of Friable Asbestos Containing LV HRC Fuses. |

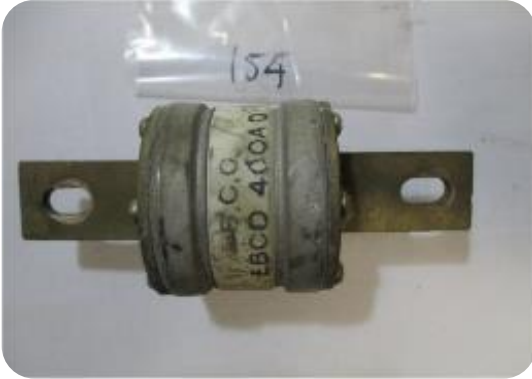
| Manufacturer | Rating | Fuse Body Photographs | Label Markings & Details | Result | Safety Instructions |
|---|---|---|---|---|---|
| SCC | 400 | <br><small>54287-001-154</small> | EBCD 400A O | <br>Asbestos found | <b>In-Service Fuses:</b> <ul style="list-style-type: none"> <li> If fuse is damaged, cease work and make safe. Contact the Hazmat Hotline - 02 9394 6961.</li> <li> If the fuse is intact, remove the fuse taking care not to damage in accordance with SWMS - AUS008 Removal of Friable Asbestos Containing LV HRC Fuses.</li> </ul> <b>Stored and Quarantined Fuses:</b> <ul style="list-style-type: none"> <li> Must be disposed of in accordance with SWMS - AUS008 Removal of Friable Asbestos Containing LV HRC Fuses.</li> </ul> |

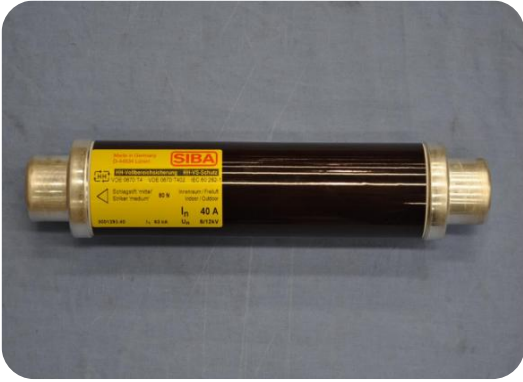
| Manufacturer | Rating | Fuse Body Photographs | Label Markings & Details | Result | Safety Instructions |
|---|---|---|---|---|---|
| SIBA | 40 | | SIBA 300.12.93/40 | <br>Current Stock Item No. 88005 | ✓ May be used as normal.<br>✓ When disposing of LV HRC Fuses treat all fuses as asbestos waste. |

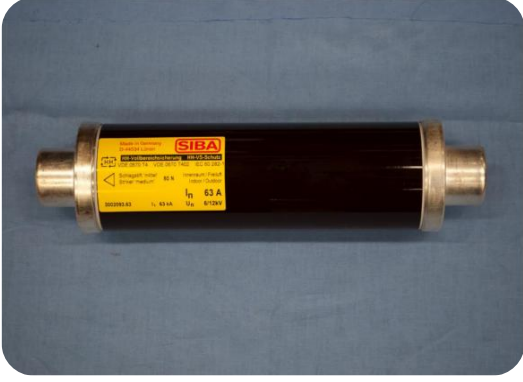
| Manufacturer | Rating | Fuse Body Photographs | Label Markings & Details | Result | Safety Instructions |
|---|---|---|---|---|---|
| SIBA | 63 | | SIBA 300.12.93/40 | <br>Current Stock Item No. 89623 | ✓ May be used as normal.<br>✓ When disposing of LV HRC Fuses treat all fuses as asbestos waste. |

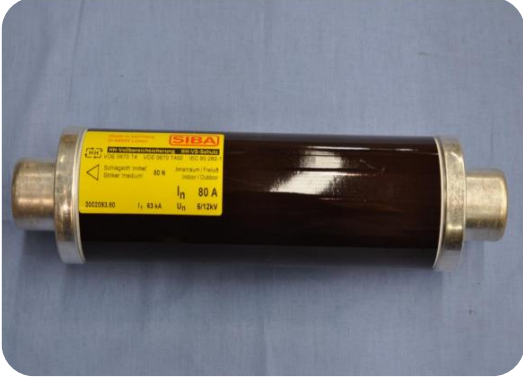
| Manufacturer | Rating | Fuse Body Photographs | Label Markings & Details | Result | Safety Instructions |
|---|---|---|---|---|---|
| SIBA | 80 | | SIBA 300.20.93/80 | <br>Current Stock Item No. 89631 | ✓ May be used as normal.<br>✓ When disposing of LV HRC Fuses treat all fuses as asbestos waste. |

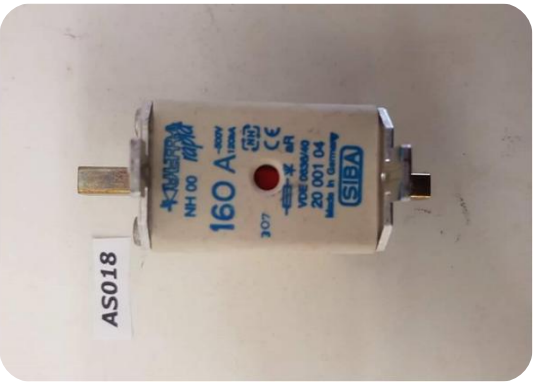
| Manufacturer | Rating | Fuse Body Photographs | Label Markings & Details | Result | Safety Instructions |
|---|---|---|---|---|---|
| SIBA | 160 | <p>AS018</p> <p>176207-001-A5018</p> | Ultra Rapid, NH00, VDE 0636/40, 20 001 004, 160A, 120kA, aR, Siba | <br>No Asbestos found, exercise caution and follow safety instructions | Where no manufacturer or date information can be confirmed and/or the fuse was manufactured prior to 2003, the <b>fuses should be presumed to contain asbestos and disposed</b> of in accordance with SWMS - AUS008 - Removal of Friable Asbestos Containing LV HRC Fuses. |

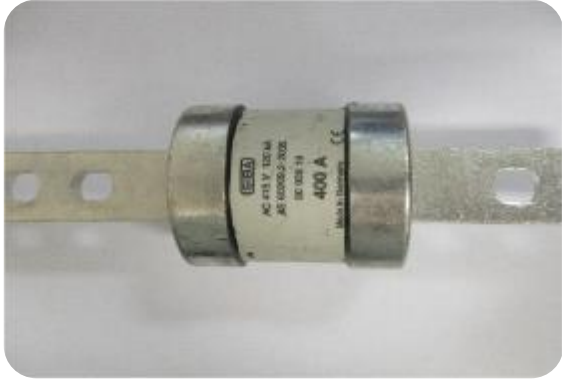
| Manufacturer | Rating | Fuse Body Photographs | Label Markings & Details | Result | Safety Instructions |
|---|---|---|---|---|---|
| SIBA | 400 | <p>54287-001-043</p> | 5003919, AC415V, 120kA, 215 | <br>No Asbestos found | May be used as normal.<br> When disposing of LV HRC Fuses treat all fuses as asbestos waste. |

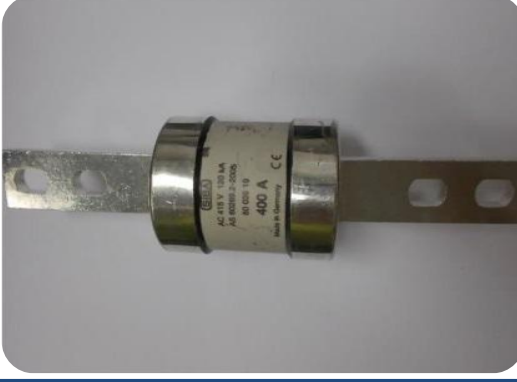
| Manufacturer | Rating | Fuse Body Photographs | Label Markings & Details | Result | Safety Instructions |
|---|---|---|---|---|---|
| SIBA | 400 | <p>54287-002-014</p> | 5003919, AC415V, 120kA, 215 | <br>No Asbestos found | May be used as normal.<br> When disposing of LV HRC Fuses treat all fuses as asbestos waste. |

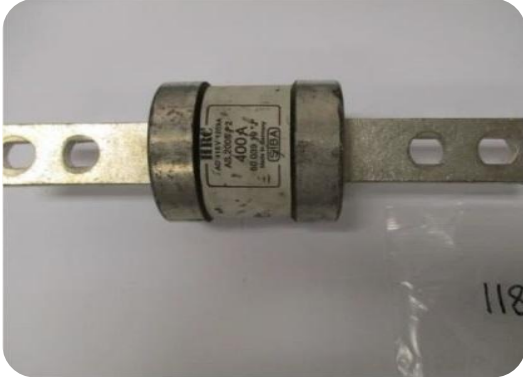
| Manufacturer | Rating | Fuse Body Photographs | Label Markings & Details | Result | Safety Instructions |
|---|---|---|---|---|---|
| SIBA | 400 | | 5003919, AO415V | <br>No Asbestos found, exercise caution and follow safety instructions | <br>Where no manufacturer or date information can be confirmed and/or the fuse was manufactured prior to 2003, the <b>fuses should be presumed to contain asbestos and disposed</b> of in accordance with SWMS - AUS008 - Removal of Friable Asbestos Containing LV HRC Fuses. |

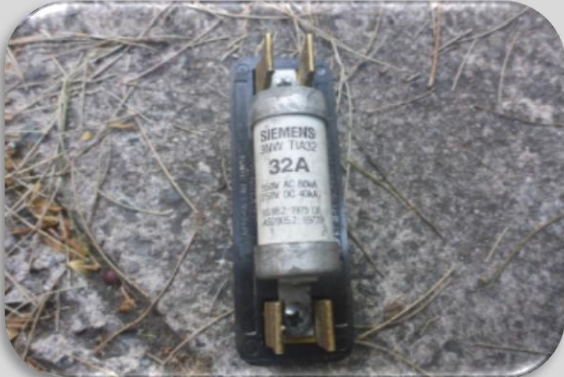
| Manufacturer | Rating | Fuse Body Photographs | Label Markings & Details | Result | Safety Instructions |
|---|---|---|---|---|---|
| Siemens | 32 | | TIA32 550V 32 Amp 80 kA | <br>No Asbestos found, exercise caution and follow safety instructions | <br>Where no manufacturer or date information can be confirmed and/or the fuse was manufactured prior to 2003, the <b>fuses should be presumed to contain asbestos and disposed</b> of in accordance with SWMS - AUS008 - Removal of Friable Asbestos Containing LV HRC Fuses. |

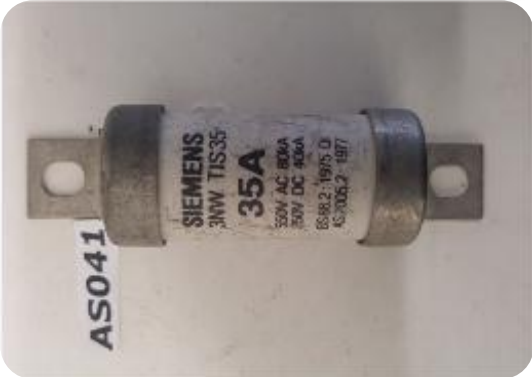
| Manufacturer | Rating | Fuse Body Photographs | Label Markings & Details | Result | Safety Instructions |
|---|---|---|---|---|---|
| Siemens | 35 | | 2NW TIS35, 35A, 80kA, 250VDC20kA, BS 88.2:1975, Q1, AS2005.2:1977 | <br>No Asbestos found, exercise caution and follow safety instructions | <br>Where no manufacturer or date information can be confirmed and/or the fuse was manufactured prior to 2003, the <b>fuses should be presumed to contain asbestos and disposed</b> of in accordance with SWMS - AUS008 - Removal of Friable Asbestos Containing LV HRC Fuses. |

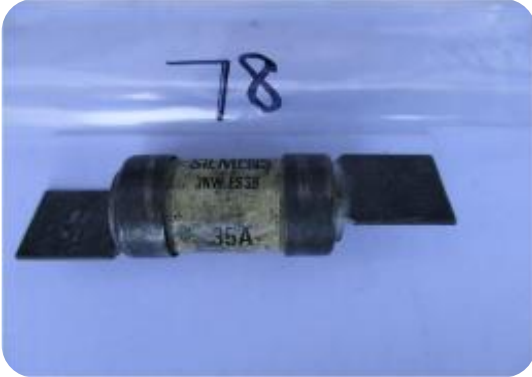
| Manufacturer | Rating | Fuse Body Photographs | Label Markings & Details | Result | Safety Instructions |
|---|---|---|---|---|---|
| Siemens | 35 | | 3NWES35<br>54287-001-078 | <br>No Asbestos found, exercise caution and follow safety instructions | Where no manufacturer or date information can be confirmed and/or the fuse was manufactured prior to 2003, the <b>fuses should be presumed to contain asbestos and disposed</b> of in accordance with SWMS - AUS008 - Removal of Friable Asbestos Containing LV HRC Fuses. |

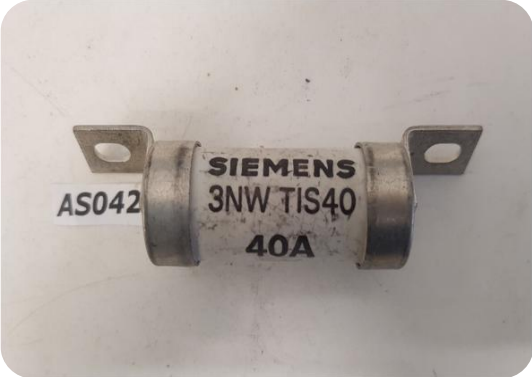
| Manufacturer | Rating | Fuse Body Photographs | Label Markings & Details | Result | Safety Instructions |
|---|---|---|---|---|---|
| Siemens | 40 | | 3NW TIS40, 40A, 80kA,<br>BS88.2:1988, AS2005.2:1977,<br>Q1, gG<br>174783-001-AS042 | <br>No Asbestos found, exercise caution and follow safety instructions | Where no manufacturer or date information can be confirmed and/or the fuse was manufactured prior to 2003, the <b>fuses should be presumed to contain asbestos and disposed</b> of in accordance with SWMS - AUS008 - Removal of Friable Asbestos Containing LV HRC Fuses. |

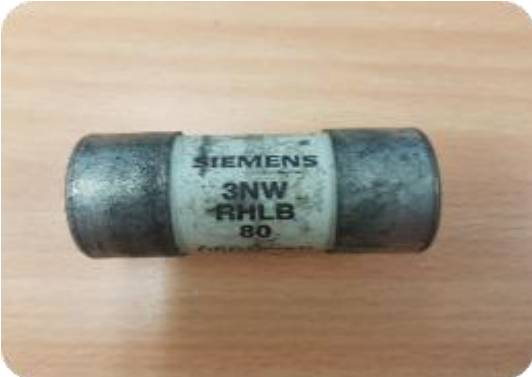
| Manufacturer | Rating | Fuse Body Photographs | Label Markings & Details | Result | Safety Instructions |
|---|---|---|---|---|---|
| Siemens | 80 | | 3NW RHLB80, Certified BS1361,<br>415V a.c. 80A, made in U.K.<br>OF00053-120718-AS12 | <br>No Asbestos found, exercise caution and follow safety instructions | Where no manufacturer or date information can be confirmed and/or the fuse was manufactured prior to 2003, the <b>fuses should be presumed to contain asbestos and disposed</b> of in accordance with SWMS - AUS008 - Removal of Friable Asbestos Containing LV HRC Fuses. |

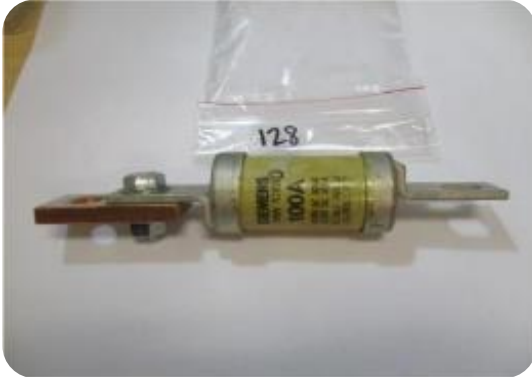
| Manufacturer | Rating | Fuse Body Photographs | Label Markings & Details | Result | Safety Instructions |
|---|---|---|---|---|---|
| Siemens | 100 | | 3NW TC1000<br>54287-001-128 | <br>No Asbestos found, exercise caution and follow safety instructions | <br>Where no manufacturer or date information can be confirmed and/or the fuse was manufactured prior to 2003, the <b>fuses should be presumed to contain asbestos and disposed</b> of in accordance with SWMS - AUS008 - Removal of Friable Asbestos Containing LV HRC Fuses. |

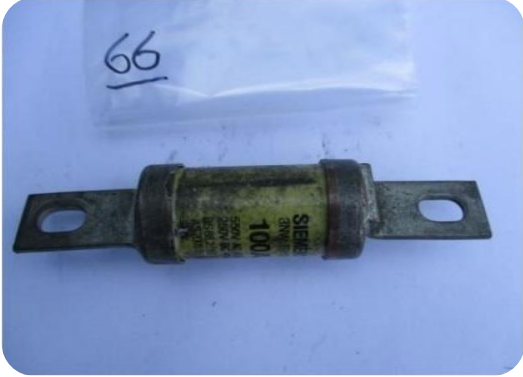
| Manufacturer | Rating | Fuse Body Photographs | Label Markings & Details | Result | Safety Instructions |
|---|---|---|---|---|---|
| Siemens | 100 | | 3NW TC1000<br>54087-001-066 | <br>No Asbestos found, exercise caution and follow safety instructions | <br>Where no manufacturer or date information can be confirmed and/or the fuse was manufactured prior to 2003, the <b>fuses should be presumed to contain asbestos and disposed</b> of in accordance with SWMS - AUS008 - Removal of Friable Asbestos Containing LV HRC Fuses. |

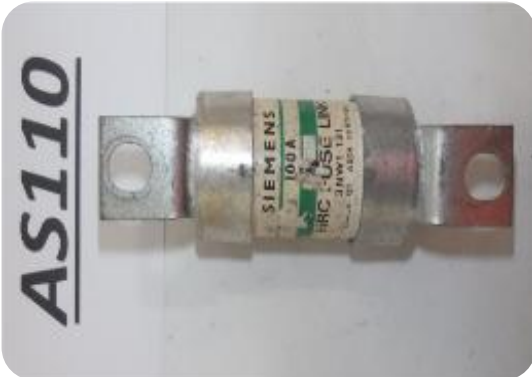
| Manufacturer | Rating | Fuse Body Photographs | Label Markings & Details | Result | Safety Instructions |
|---|---|---|---|---|---|
| Siemens | 100 | | 3NW1 131, 100A, B.S.88, AC80, Class Q1<br>168273-110 | <br>Asbestos found | <b>In-Service Fuses:</b><br> If fuse is damaged, cease work and make safe. Contact the Hazmat Hotline - 02 9394 6961.<br> If the fuse is intact, remove the fuse taking care not to damage in accordance with SWMS - AUS008 Removal of Friable Asbestos Containing LV HRC Fuses.<br><b>Stored and Quarantined Fuses:</b><br> Must be disposed of in accordance with SWMS - AUS008 Removal of Friable Asbestos Containing LV HRC Fuses. |

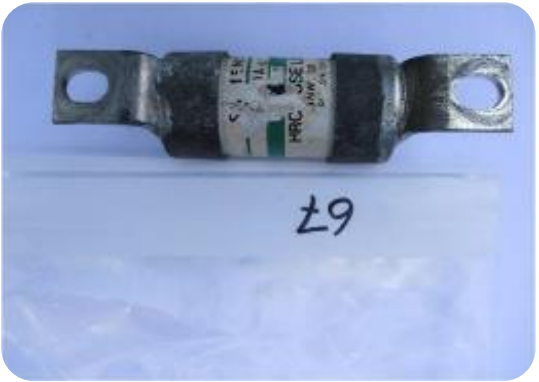
| Manufacturer | Rating | Fuse Body Photographs | Label Markings & Details | Result | Safety Instructions |
|---|---|---|---|---|---|
| Siemens | 100 | | 3NW 131<br>54287-001-067 | <br>Asbestos found | <b>In-Service Fuses:</b><br> If fuse is damaged, cease work and make safe. Contact the Hazmat Hotline - 02 9394 6961.<br> If the fuse is intact, remove the fuse taking care not to damage in accordance with SWMS - AUS008 Removal of Friable Asbestos Containing LV HRC Fuses.<br><b>Stored and Quarantined Fuses:</b><br> Must be disposed of in accordance with SWMS - AUS008 Removal of Friable Asbestos Containing LV HRC Fuses. |

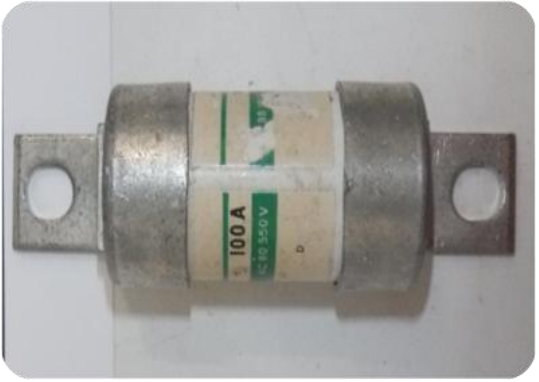
| Manufacturer | Rating | Fuse Body Photographs | Label Markings & Details | Result | Safety Instructions |
|---|---|---|---|---|---|
| Siemens | 100 | | 3NW1 131, 100A, B.S.88, AC80, Class Q1<br>168273-109 | <br>Asbestos found | <b>In-Service Fuses:</b><br> If fuse is damaged, cease work and make safe. Contact the Hazmat Hotline - 02 9394 6961.<br> If the fuse is intact, remove the fuse taking care not to damage in accordance with SWMS - AUS008 Removal of Friable Asbestos Containing LV HRC Fuses.<br><b>Stored and Quarantined Fuses:</b><br> Must be disposed of in accordance with SWMS - AUS008 Removal of Friable Asbestos Containing LV HRC Fuses. |

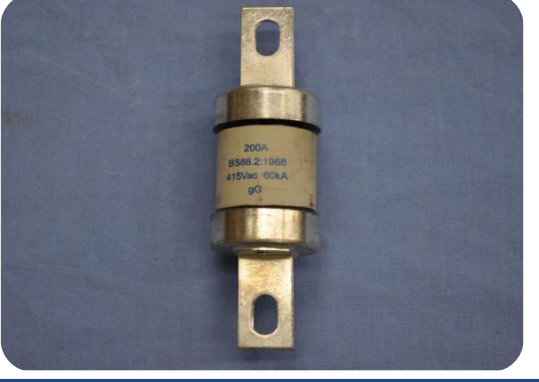
| Manufacturer | Rating | Fuse Body Photographs | Label Markings & Details | Result | Safety Instructions |
|---|---|---|---|---|---|
| Siemens | 200 | | Siemens 3NW1-232/SO, DS OSD | <br>Current Stock Item No. 85423 | May be used as normal.<br> When disposing of LV HRC Fuses treat all fuses as asbestos waste. |

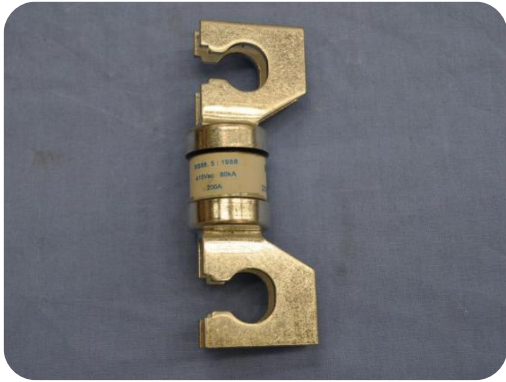
| Manufacturer | Rating | Fuse Body Photographs | Label Markings & Details | Result | Safety Instructions |
|---|---|---|---|---|---|
| Siemens | 200 | | Siemens 3NW5-746/S-O | <br>Current Stock Item No. 85688 | May be used as normal.<br> When disposing of LV HRC Fuses treat all fuses as asbestos waste. |

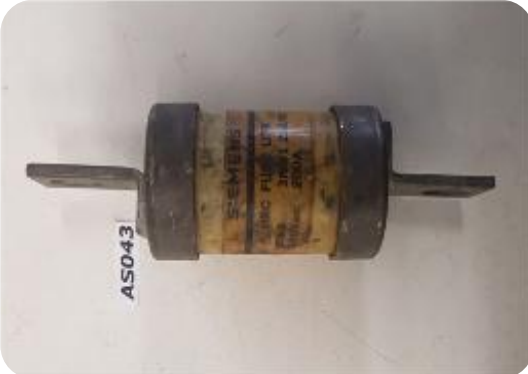
| Manufacturer | Rating | Fuse Body Photographs | Label Markings & Details | Result | Safety Instructions |
|---|---|---|---|---|---|
| Siemens | 200 | <div>AS043</div> <div>174783-001-AS043</div> | 3NW1 232/ SO, 200A, HRC Fuse Link, 80kA | <br>No Asbestos found, exercise caution and follow safety instructions | Where no manufacturer or date information can be confirmed and/or the fuse was manufactured prior to 2003, the <b>fuses should be presumed to contain asbestos and disposed</b> of in accordance with SWMS - AUS008 - Removal of Friable Asbestos Containing LV HRC Fuses. |

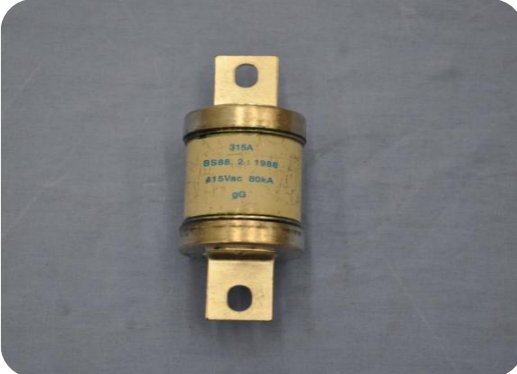
| Manufacturer | Rating | Fuse Body Photographs | Label Markings & Details | Result | Safety Instructions |
|---|---|---|---|---|---|
| Siemens | 300 | | Siemens 3NW1-241-SO, | <br>Current Stock Item No. 85506 | May be used as normal.<br> When disposing of LV HRC Fuses treat all fuses as asbestos waste. |

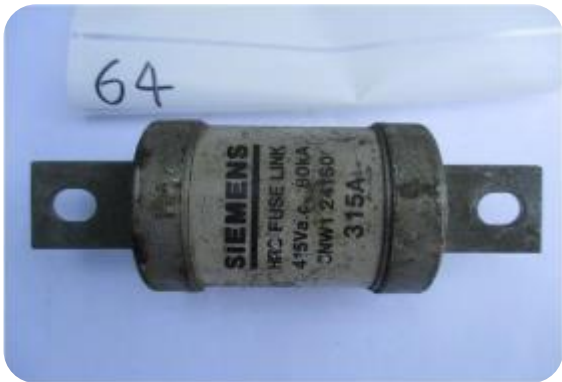
| Manufacturer | Rating | Fuse Body Photographs | Label Markings & Details | Result | Safety Instructions |
|---|---|---|---|---|---|
| Siemens | 315 | <br>54287-001-064 | 3NW 241SO 315A | <br>No Asbestos found, exercise caution and follow safety instructions | Where no manufacturer or date information can be confirmed and/or the fuse was manufactured prior to 2003, the <b>fuses should be presumed to contain asbestos and disposed</b> of in accordance with SWMS - AUS008 - Removal of Friable Asbestos Containing LV HRC Fuses. |

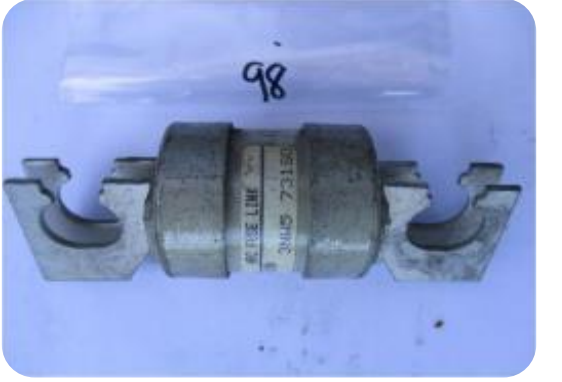
| Manufacturer | Rating | Fuse Body Photographs | Label Markings & Details | Result | Safety Instructions |
|---|---|---|---|---|---|
| Siemens | 315 | <br>54287-001-098 | Class Q1 3NW5731SO | <br>No Asbestos found, exercise caution and follow safety instructions | Where no manufacturer or date information can be confirmed and/or the fuse was manufactured prior to 2003, the <b>fuses should be presumed to contain asbestos and disposed</b> of in accordance with SWMS - AUS008 - Removal of Friable Asbestos Containing LV HRC Fuses. |

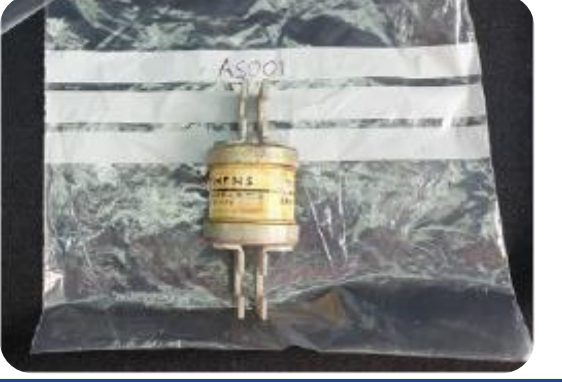
| Manufacturer | Rating | Fuse Body Photographs | Label Markings & Details | Result | Safety Instructions |
|---|---|---|---|---|---|
| Siemens | 315 | <br>P033786.002-AS012 | HRC fuse Link 3 NW t, 7 1Y O<br>(Label torn0, 315A, Class Q1,<br>BS88:Part 5 (Lable torn), AC80 | <br>Asbestos found | <b>In-Service Fuses:</b><br> If fuse is damaged, cease work and make safe. Contact the Hazmat Hotline - 02 9394 6961.<br> If the fuse is intact, remove the fuse taking care not to damage in accordance with SWMS - AUS008 Removal of Friable Asbestos Containing LV HRC Fuses.<br><b>Stored and Quarantined Fuses:</b><br> Must be disposed of in accordance with SWMS - AUS008 Removal of Friable Asbestos Containing LV HRC Fuses. |

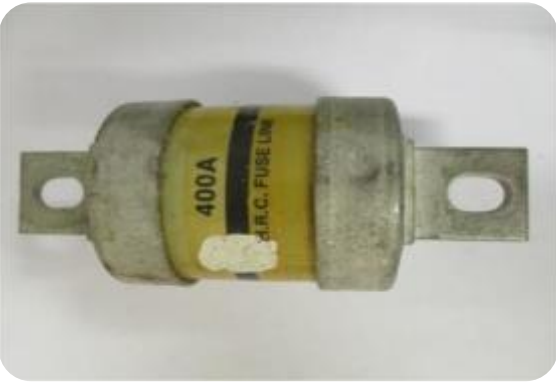
| Manufacturer | Rating | Fuse Body Photographs | Label Markings & Details | Result | Safety Instructions |
|---|---|---|---|---|---|
| Siemens | 400 | <br>54287-001-048 | 3NW1 251 SO 400A | <br>No Asbestos found, exercise caution and follow safety instructions | Where no manufacturer or date information can be confirmed and/or the fuse was manufactured prior to 2003, the <b>fuses should be presumed to contain asbestos and disposed</b> of in accordance with SWMS - AUS008 - Removal of Friable Asbestos Containing LV HRC Fuses. |

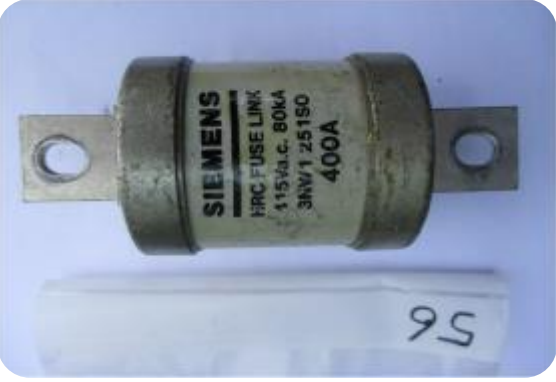
| Manufacturer | Rating | Fuse Body Photographs | Label Markings & Details | Result | Safety Instructions |
|---|---|---|---|---|---|
| Siemens | 400 | <br>54287-001-056 | 3NW1 251 SO 400A | <br>No Asbestos found, exercise caution and follow safety instructions | Where no manufacturer or date information can be confirmed and/or the fuse was manufactured prior to 2003, the <b>fuses should be presumed to contain asbestos and disposed</b> of in accordance with SWMS - AUS008 - Removal of Friable Asbestos Containing LV HRC Fuses. |

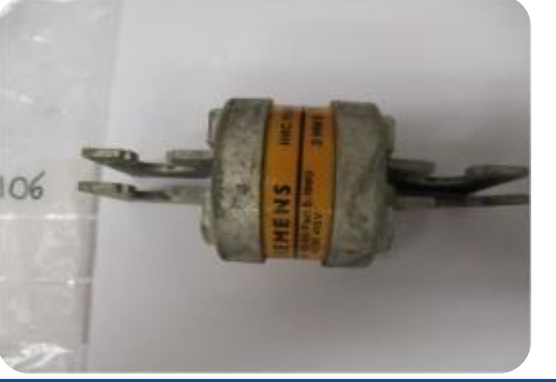
| Manufacturer | Rating | Fuse Body Photographs | Label Markings & Details | Result | Safety Instructions |
|---|---|---|---|---|---|
| Siemens | 400 | <br>54287-001-106 | D 3NW5 753YO | <br>No Asbestos found, exercise caution and follow safety instructions | Where no manufacturer or date information can be confirmed and/or the fuse was manufactured prior to 2003, the <b>fuses should be presumed to contain asbestos and disposed</b> of in accordance with SWMS - AUS008 - Removal of Friable Asbestos Containing LV HRC Fuses. |

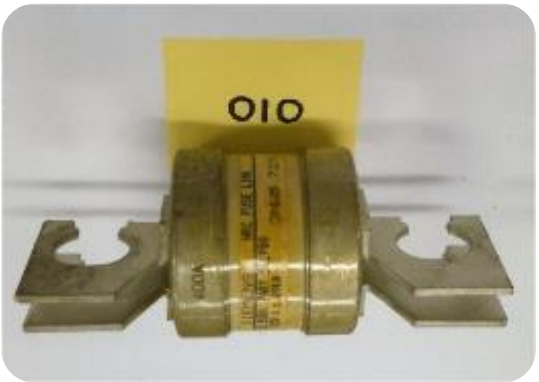
| Manufacturer | Rating | Fuse Body Photographs | Label Markings & Details | Result | Safety Instructions |
|---|---|---|---|---|---|
| Siemens | 400 | | 3NW5 733SO, HRC Fuse Link, Class Q1,<br><br>55738-001-010 | <br>No Asbestos found, exercise caution and follow safety instructions | Where no manufacturer or date information can be confirmed and/or the fuse was manufactured prior to 2003, the <b>fuses should be presumed to contain asbestos and disposed</b> of in accordance with SWMS - AUS008 - Removal of Friable Asbestos Containing LV HRC Fuses. |

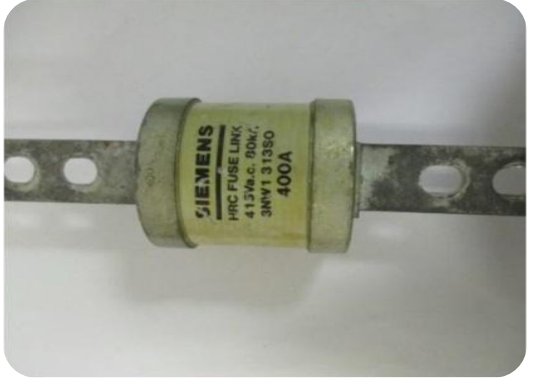
| Manufacturer | Rating | Fuse Body Photographs | Label Markings & Details | Result | Safety Instructions |
|---|---|---|---|---|---|
| Siemens | 400 | | 3NW1 313SO 400A<br><br>54087-001-046 | <br>No Asbestos found, exercise caution and follow safety instructions | Where no manufacturer or date information can be confirmed and/or the fuse was manufactured prior to 2003, the <b>fuses should be presumed to contain asbestos and disposed</b> of in accordance with SWMS - AUS008 - Removal of Friable Asbestos Containing LV HRC Fuses. |

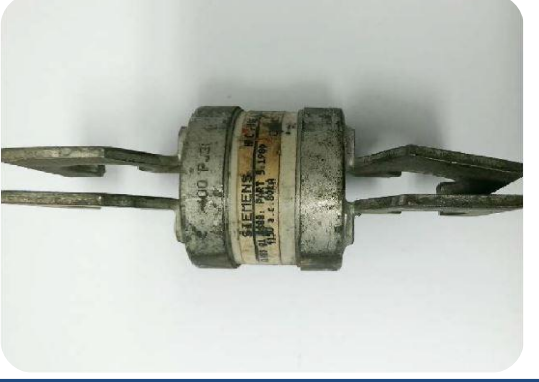
| Manufacturer | Rating | Fuse Body Photographs | Label Markings & Details | Result | Safety Instructions |
|---|---|---|---|---|---|
| Siemens | 400 | | 3NWS 753SO, HRC Fuse link, Class Q1,<br><br>54093-001-006 | <br>No Asbestos found, exercise caution and follow safety instructions | Where no manufacturer or date information can be confirmed and/or the fuse was manufactured prior to 2003, the <b>fuses should be presumed to contain asbestos and disposed</b> of in accordance with SWMS - AUS008 - Removal of Friable Asbestos Containing LV HRC Fuses. |

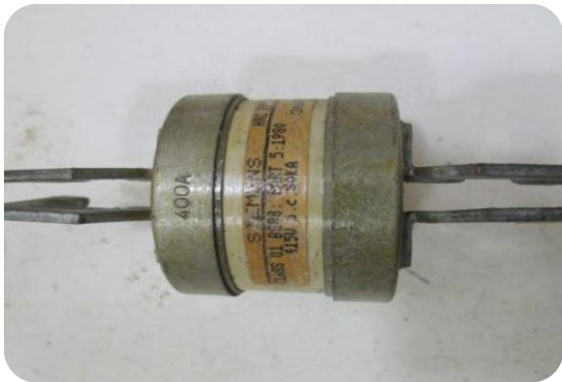
| Manufacturer | Rating | Fuse Body Photographs | Label Markings & Details | Result | Safety Instructions |
|---|---|---|---|---|---|
| Siemens | 400 | <br>54287-001-038 | 3NW5 733SO 400A | <br>No Asbestos found, exercise caution and follow safety instructions | Where no manufacturer or date information can be confirmed and/or the fuse was manufactured prior to 2003, the <b>fuses should be presumed to contain asbestos and disposed</b> of in accordance with SWMS - AUS008 - Removal of Friable Asbestos Containing LV HRC Fuses. |

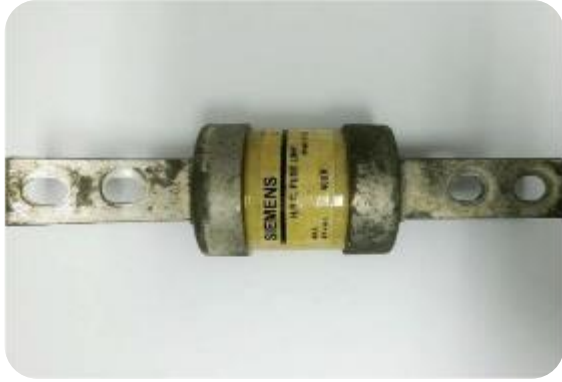
| Manufacturer | Rating | Fuse Body Photographs | Label Markings & Details | Result | Safety Instructions |
|---|---|---|---|---|---|
| Siemens | 400 | <br>54093-001-007 | 3NW1 313/S, O, HRC fuse link, 400A | <br>Asbestos found | <b>In-Service Fuses:</b><br> If fuse is damaged, cease work and make safe. Contact the Hazmat Hotline - 02 9394 6961.<br> If the fuse is intact, remove the fuse taking care not to damage in accordance with SWMS - AUS008 Removal of Friable Asbestos Containing LV HRC Fuses.<br><b>Stored and Quarantined Fuses:</b><br> Must be disposed of in accordance with SWMS - AUS008 Removal of Friable Asbestos Containing LV HRC Fuses. |

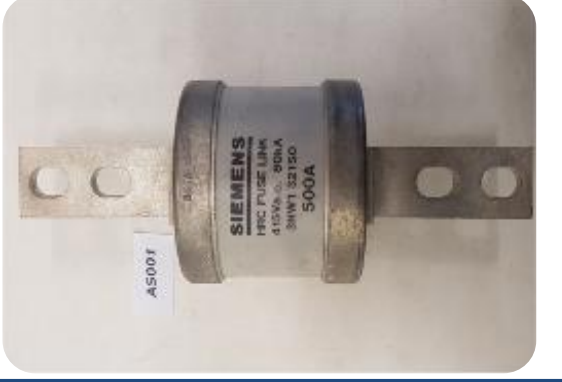
| Manufacturer | Rating | Fuse Body Photographs | Label Markings & Details | Result | Safety Instructions |
|---|---|---|---|---|---|
| Siemens | 500 | <br>174102-001-AS001 | 3NW1 321SO, 500A, 80kA | <br>No Asbestos found, exercise caution and follow safety instructions | Where no manufacturer or date information can be confirmed and/or the fuse was manufactured prior to 2003, the <b>fuses should be presumed to contain asbestos and disposed</b> of in accordance with SWMS - AUS008 - Removal of Friable Asbestos Containing LV HRC Fuses. |

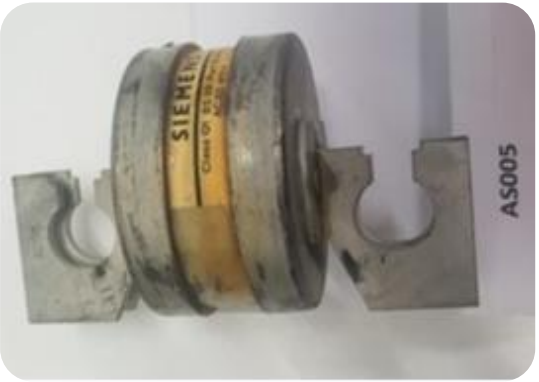
| Manufacturer | Rating | Fuse Body Photographs | Label Markings & Details | Result | Safety Instructions |
|---|---|---|---|---|---|
| Siemens | 500 | | HRC Fuse link, 3NW5 761YO, 500A, Class Q1, BS88: Part 5: 1980, A.C. 80kA<br><small>P033786.002-AS012</small> | <br>No Asbestos found, exercise caution and follow safety instructions | Where no manufacturer or date information can be confirmed and/or the fuse was manufactured prior to 2003, the <b>fuses should be presumed to contain asbestos and disposed</b> of in accordance with SWMS - AUS008 - Removal of Friable Asbestos Containing LV HRC Fuses. |

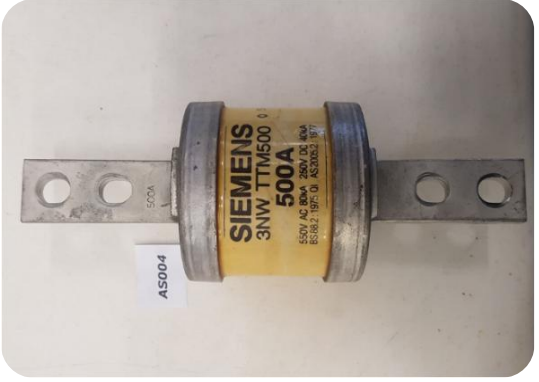
| Manufacturer | Rating | Fuse Body Photographs | Label Markings & Details | Result | Safety Instructions |
|---|---|---|---|---|---|
| Siemens | 500 | | 3NW TTM500 OS, 500A, AC80kA, 250VDC40kA, BS 88.2:1975, Q1, AS 2005.2:1977<br><small>174102-001-AS004</small> | <br>Asbestos found | <b>In-Service Fuses:</b><br> If fuse is damaged, cease work and make safe. Contact the Hazmat Hotline - 02 9394 6961.<br> If the fuse is intact, remove the fuse taking care not to damage in accordance with SWMS - AUS008 Removal of Friable Asbestos Containing LV HRC Fuses.<br><b>Stored and Quarantined Fuses:</b><br> Must be disposed of in accordance with SWMS - AUS008 Removal of Friable Asbestos Containing LV HRC Fuses. |

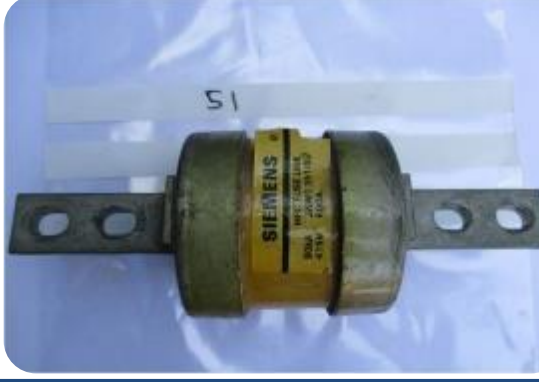
| Manufacturer | Rating | Fuse Body Photographs | Label Markings & Details | Result | Safety Instructions |
|---|---|---|---|---|---|
| Siemens | 600 | | 3NW1 351SO 600A<br><small>54287-001-051</small> | <br>Asbestos found | <b>In-Service Fuses:</b><br> If fuse is damaged, cease work and make safe. Contact the Hazmat Hotline - 02 9394 6961.<br> If the fuse is intact, remove the fuse taking care not to damage in accordance with SWMS - AUS008 Removal of Friable Asbestos Containing LV HRC Fuses.<br><b>Stored and Quarantined Fuses:</b><br> Must be disposed of in accordance with SWMS - AUS008 Removal of Friable Asbestos Containing LV HRC Fuses. |

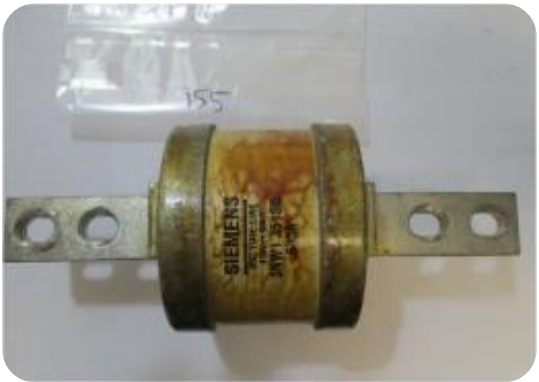
| Manufacturer | Rating | Fuse Body Photographs | Label Markings & Details | Result | Safety Instructions |
|---|---|---|---|---|---|
| Siemens | 630 | | 3NW1 351SO<br>54287-001-155 | <br>No Asbestos found, exercise caution and follow safety instructions | Where no manufacturer or date information can be confirmed and/or the fuse was manufactured prior to 2003, the <b>fuses should be presumed to contain asbestos and disposed</b> of in accordance with SWMS - AUS008 - Removal of Friable Asbestos Containing LV HRC Fuses. |
