## Network Standard

Document No : NW000-S0161

NS211 ANNEXURE G – LV HRC FUSE ASBESTOS PRODUCT GUIDE

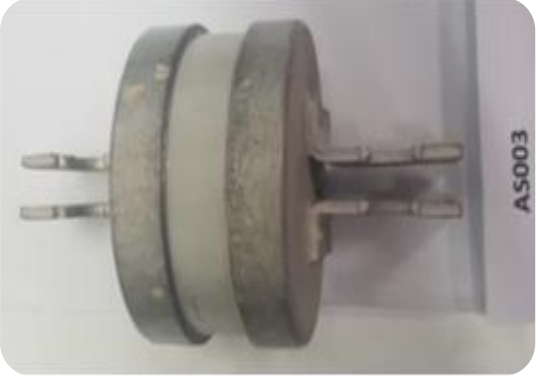
| Manufacturer | Rating | Fuse Body Photographs | Label Markings & Details | Result | Safety Instructions |
|---|---|---|---|---|---|
| Siemens | 630 | | HRC Fuse link, 3NW5 763SO, 630A, Class Q1, BS88: Part 5: 1980, A.C. 80kA<br>P033786.002-AS012 | <br>No Asbestos found, exercise caution and follow safety instructions | Where no manufacturer or date information can be confirmed and/or the fuse was manufactured prior to 2003, the <b>fuses should be presumed to contain asbestos and disposed</b> of in accordance with SWMS - AUS008 - Removal of Friable Asbestos Containing LV HRC Fuses. |

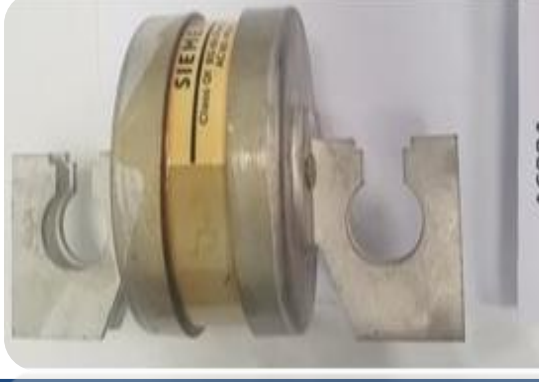
| Manufacturer | Rating | Fuse Body Photographs | Label Markings & Details | Result | Safety Instructions |
|---|---|---|---|---|---|
| Siemens | 630 | | HRC Fuse link, 3NW5 763YO, 630A, Class Q1, BS88: Part 5: 1980, A.C. 80kA<br>P033786.002-AS012 | <br>No Asbestos found, exercise caution and follow safety instructions | Where no manufacturer or date information can be confirmed and/or the fuse was manufactured prior to 2003, the <b>fuses should be presumed to contain asbestos and disposed</b> of in accordance with SWMS - AUS008 - Removal of Friable Asbestos Containing LV HRC Fuses. |

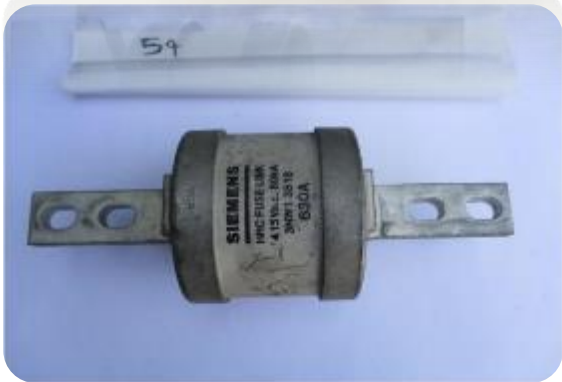
| Manufacturer | Rating | Fuse Body Photographs | Label Markings & Details | Result | Safety Instructions |
|---|---|---|---|---|---|
| Siemens | 630 | <br>54287-001-054 | 3NW1 351S 630A | <br>Asbestos found | <b>In-Service Fuses:</b><br> If fuse is damaged, cease work and make safe. Contact the Hazmat Hotline - 02 9394 6961.<br> If the fuse is intact, remove the fuse taking care not to damage in accordance with SWMS - AUS008 Removal of Friable Asbestos Containing LV HRC Fuses.<br><b>Stored and Quarantined Fuses:</b><br> Must be disposed of in accordance with SWMS - AUS008 Removal of Friable Asbestos Containing LV HRC Fuses. |

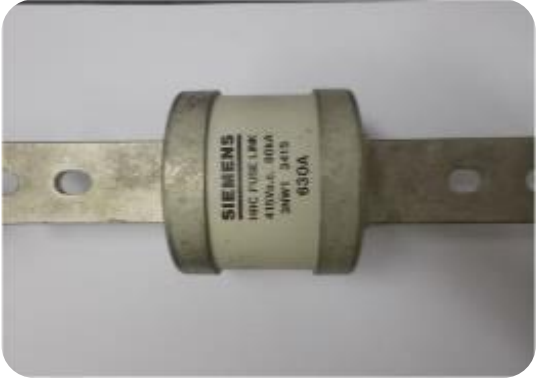
| Manufacturer | Rating | Fuse Body Photographs | Label Markings & Details | Result | Safety Instructions |
|---|---|---|---|---|---|
| Siemens | 630 | <br>54287-002-011 | 3NW1, 341S, HRC Fuse link,<br>415V ac, 80kA, | <br>Asbestos found | <b>In-Service Fuses:</b><br> If fuse is damaged, cease work and make safe. Contact the Hazmat Hotline - 02 9394 6961.<br> If the fuse is intact, remove the fuse taking care not to damage in accordance with SWMS - AUS008 Removal of Friable Asbestos Containing LV HRC Fuses.<br><b>Stored and Quarantined Fuses:</b><br> Must be disposed of in accordance with SWMS - AUS008 Removal of Friable Asbestos Containing LV HRC Fuses. |

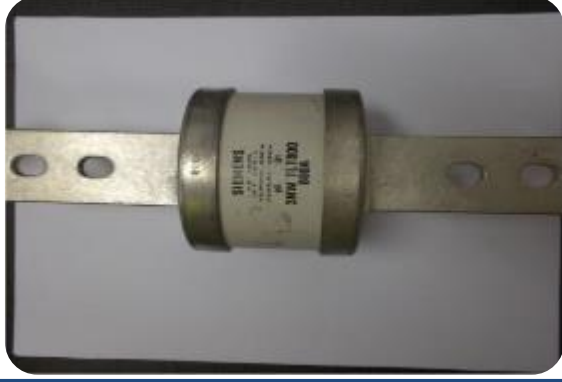
| Manufacturer | Rating | Fuse Body Photographs | Label Markings & Details | Result | Safety Instructions |
|---|---|---|---|---|---|
| Siemens | 800 | <br>54287-002-012 | 3NW TLT800, 550V ac-80kA,<br>250VDC, 40kA, gG, Q1 | <br>No Asbestos found | May be used as normal.<br> When disposing of LV HRC Fuses treat all fuses as asbestos waste. |

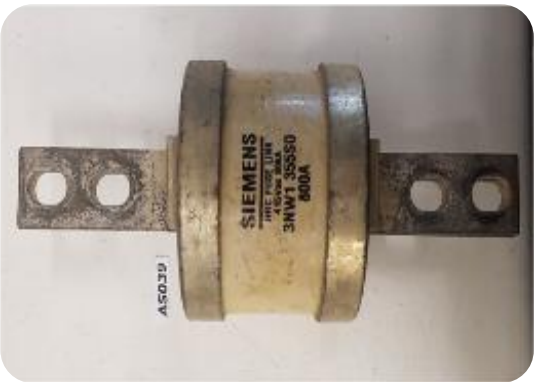
| Manufacturer | Rating | Fuse Body Photographs | Label Markings & Details | Result | Safety Instructions |
|---|---|---|---|---|---|
| Siemens | 800 | | 3NW1 355SO, 800A, HRC fuse link, 80kA<br>174783-001-AS039 | <br>No Asbestos found, exercise caution and follow safety instructions | Where no manufacturer or date information can be confirmed and/or the fuse was manufactured prior to 2003, the <b>fuses should be presumed to contain asbestos and disposed</b> of in accordance with SWMS - AUS008 - Removal of Friable Asbestos Containing LV HRC Fuses. |

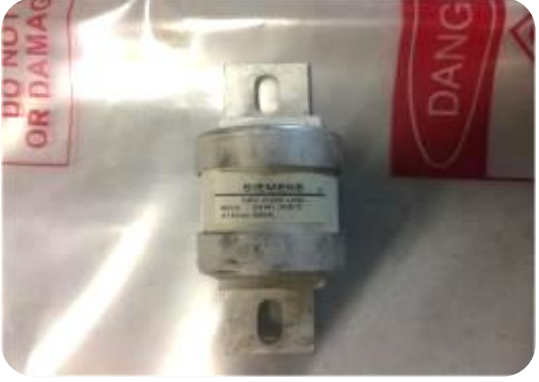
| Manufacturer | Rating | Fuse Body Photographs | Label Markings & Details | Result | Safety Instructions |
|---|---|---|---|---|---|
| Siemens | 800 | | 3NW1 355/Z, 800A, D, HRC Fuse link<br>Offset tags - Network Protector fuse<br>50753-001-001 | <br>No Asbestos found, exercise caution and follow safety instructions | Where no manufacturer or date information can be confirmed and/or the fuse was manufactured prior to 2003, the <b>fuses should be presumed to contain asbestos and disposed</b> of in accordance with SWMS - AUS008 - Removal of Friable Asbestos Containing LV HRC Fuses. |

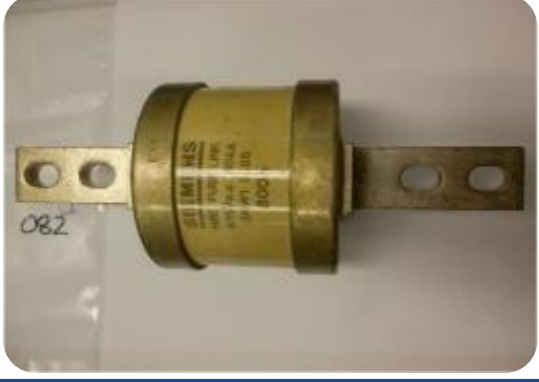
| Manufacturer | Rating | Fuse Body Photographs | Label Markings & Details | Result | Safety Instructions |
|---|---|---|---|---|---|
| Siemens | 800 | | 3NW1 355S HRC Fuse Link, 415V ac, 80kA,<br>54287-002-082 | <br>No Asbestos found, exercise caution and follow safety instructions | Where no manufacturer or date information can be confirmed and/or the fuse was manufactured prior to 2003, the <b>fuses should be presumed to contain asbestos and disposed</b> of in accordance with SWMS - AUS008 - Removal of Friable Asbestos Containing LV HRC Fuses. |

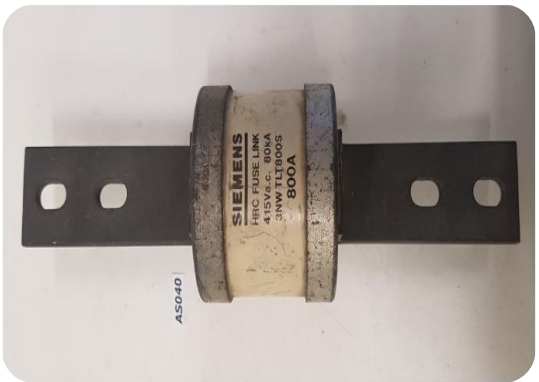
| Manufacturer | Rating | Fuse Body Photographs | Label Markings & Details | Result | Safety Instructions |
|---|---|---|---|---|---|
| Siemens | 800 | | 3NW TLT 800S, 800A, HRC fuse link, 80kA<br>174783-001-A5040 | <br>No Asbestos found, exercise caution and follow safety instructions | Where no manufacturer or date information can be confirmed and/or the fuse was manufactured prior to 2003, the <b>fuses should be presumed to contain asbestos and disposed</b> of in accordance with SWMS - AUS008 - Removal of Friable Asbestos Containing LV HRC Fuses. |

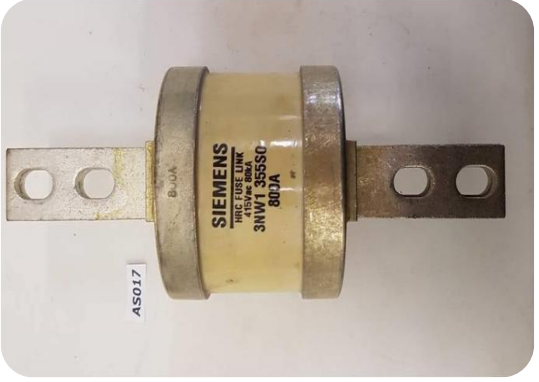
| Manufacturer | Rating | Fuse Body Photographs | Label Markings & Details | Result | Safety Instructions |
|---|---|---|---|---|---|
| Siemens | 800 | | 3NW1 355SO, 800A, HRC Fuse link, 80kA<br>176207-001-AS017 | <br>No Asbestos found, exercise caution and follow safety instructions | Where no manufacturer or date information can be confirmed and/or the fuse was manufactured prior to 2003, the <b>fuses should be presumed to contain asbestos and disposed</b> of in accordance with SWMS - AUS008 - Removal of Friable Asbestos Containing LV HRC Fuses. |

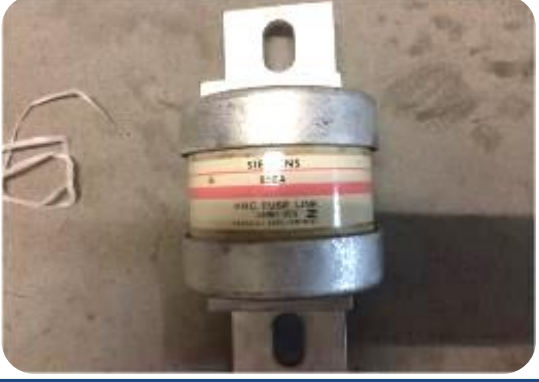
| Manufacturer | Rating | Fuse Body Photographs | Label Markings & Details | Result | Safety Instructions |
|---|---|---|---|---|---|
| Siemens | 800 | | 3NW1 355 Z, HRC Fuse link, Class Q1, Asta Cert (Pink Label)<br>Offset tags - Network Protector fuse<br>50753-001-002 | <br>Asbestos found | <b>In-Service Fuses:</b><br> If fuse is damaged, cease work and make safe. Contact the Hazmat Hotline - 02 9394 6961.<br> If the fuse is intact, remove the fuse taking care not to damage in accordance with SWMS - AUS008 Removal of Friable Asbestos Containing LV HRC Fuses.<br><b>Stored and Quarantined Fuses:</b><br> Must be disposed of in accordance with SWMS - AUS008 Removal of Friable Asbestos Containing LV HRC Fuses. |

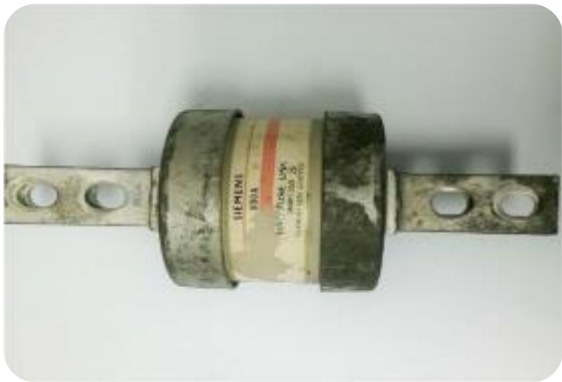
| Manufacturer | Rating | Fuse Body Photographs | Label Markings & Details | Result | Safety Instructions |
|---|---|---|---|---|---|
| Siemens | 800 | | 3NW1 355 S, Class Q1, Asti cert, 500V ac, 80kA, 250V dc, 40kA, 13.s.88.2:1995 D (Pink Label) | <br>Asbestos found | <b>In-Service Fuses:</b><br> If fuse is damaged, cease work and make safe. Contact the Hazmat Hotline - 02 9394 6961.<br> If the fuse is intact, remove the fuse taking care not to damage in accordance with SWMS - AUS008 Removal of Friable Asbestos Containing LV HRC Fuses.<br><b>Stored and Quarantined Fuses:</b><br> Must be disposed of in accordance with SWMS - AUS008 Removal of Friable Asbestos Containing LV HRC Fuses. |

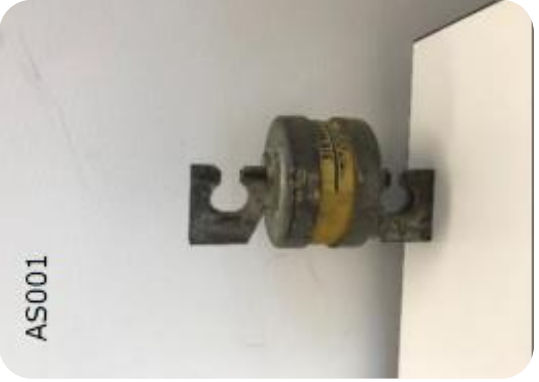
| Manufacturer | Rating | Fuse Body Photographs | Label Markings & Details | Result | Safety Instructions |
|---|---|---|---|---|---|
| Siemens | | | HRC Fuse Link 3 NW 5, 7 63 SO - Class Q1, BS88: Part 5: 1980, AC 80 (label torn) - 415V - no country - no date - AS001 | <br>No Asbestos found, exercise caution and follow safety instructions | Where no manufacturer or date information can be confirmed and/or the fuse was manufactured prior to 2003, the <b>fuses should be presumed to contain asbestos and disposed</b> of in accordance with SWMS - AUS008 - Removal of Friable Asbestos Containing LV HRC Fuses. |

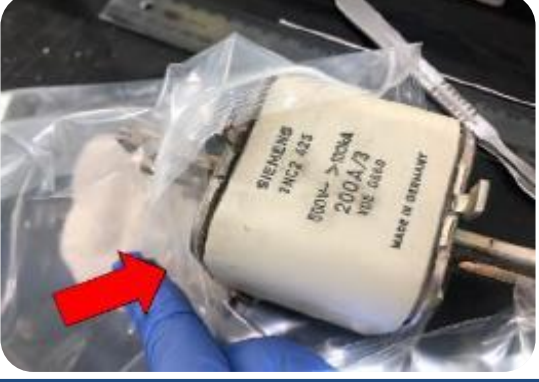
| Manufacturer | Rating | Fuse Body Photographs | Label Markings & Details | Result | Safety Instructions |
|---|---|---|---|---|---|
| Siemens | | | Siemens 3NC2 425/500V ~>100kA VDE 0660 | <br>Asbestos found | <b>In-Service Fuses:</b><br> If fuse is damaged, cease work and make safe. Contact the Hazmat Hotline - 02 9394 6961.<br> If the fuse is intact, remove the fuse taking care not to damage in accordance with SWMS - AUS008 Removal of Friable Asbestos Containing LV HRC Fuses.<br><b>Stored and Quarantined Fuses:</b><br> Must be disposed of in accordance with SWMS - AUS008 Removal of Friable Asbestos Containing LV HRC Fuses. |

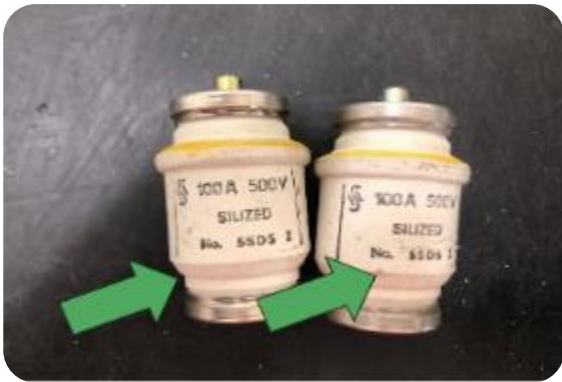
| Manufacturer | Rating | Fuse Body Photographs | Label Markings & Details | Result | Safety Instructions |
|---|---|---|---|---|---|
| Silized | 100 | | 100A 500V Silized No. 5S5 2)<br><small>754-SYDEN202874-AS07 and AS08</small> | <br>No Asbestos found, exercise caution and follow safety instructions | Where no manufacturer or date information can be confirmed and/or the fuse was manufactured prior to 2003, the <b>fuses should be presumed to contain asbestos and disposed</b> of in accordance with SWMS - AUS008 - Removal of Friable Asbestos Containing LV HRC Fuses. |

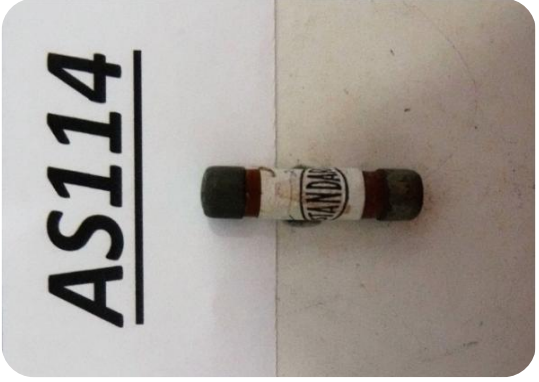
| Manufacturer | Rating | Fuse Body Photographs | Label Markings & Details | Result | Safety Instructions |
|---|---|---|---|---|---|
| Standard | 2 | | no markings, 2A<br><small>168273-114</small> | <br>No Asbestos found, exercise caution and follow safety instructions | Where no manufacturer or date information can be confirmed and/or the fuse was manufactured prior to 2003, the <b>fuses should be presumed to contain asbestos and disposed</b> of in accordance with SWMS - AUS008 - Removal of Friable Asbestos Containing LV HRC Fuses. |

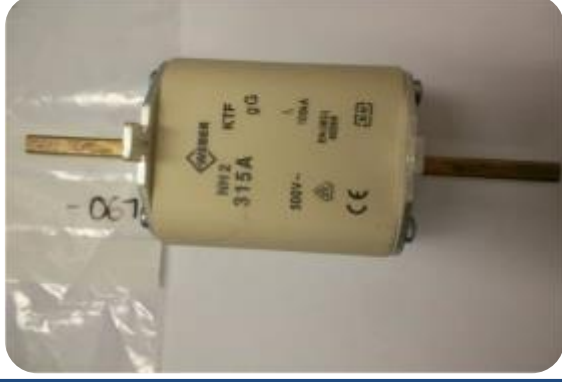
| Manufacturer | Rating | Fuse Body Photographs | Label Markings & Details | Result | Safety Instructions |
|---|---|---|---|---|---|
| Weber | 315 | | NH2, KTF, gG, 500V ac, 100kA, EN(iE)60269, NH, 48<br><small>54287-002-067</small> | <br>No Asbestos found, exercise caution and follow safety instructions | Where no manufacturer or date information can be confirmed and/or the fuse was manufactured prior to 2003, the <b>fuses should be presumed to contain asbestos and disposed</b> of in accordance with SWMS - AUS008 - Removal of Friable Asbestos Containing LV HRC Fuses. |

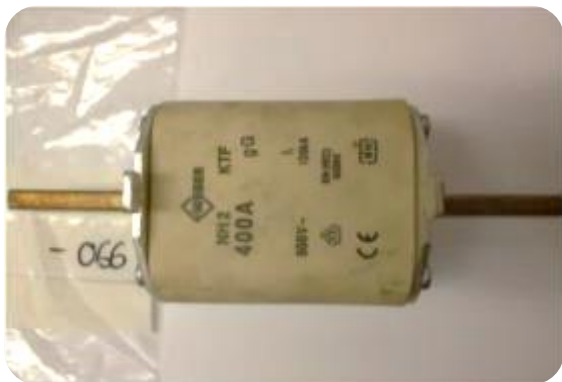
| Manufacturer | Rating | Fuse Body Photographs | Label Markings & Details | Result | Safety Instructions |
|---|---|---|---|---|---|
| Weber | 400 | | NH2, KTF, gG, 500V ac, 120kA, EN(I)E60269, NH, 57 | <br>No Asbestos found, exercise caution and follow safety instructions | Where no manufacturer or date information can be confirmed and/or the fuse was manufactured prior to 2003, the <b>fuses should be presumed to contain asbestos and disposed</b> of in accordance with SWMS - AUS008 - Removal of Friable Asbestos Containing LV HRC Fuses. |

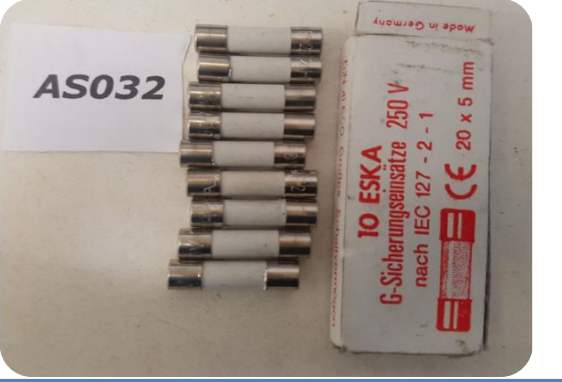
| Manufacturer | Rating | Fuse Body Photographs | Label Markings & Details | Result | Safety Instructions |
|---|---|---|---|---|---|
| Weidmuller | 2 | | DIN 41 600 , 2A, IEC127-2-1, 250 v, Germany | <br>No Asbestos found, exercise caution and follow safety instructions | Where no manufacturer or date information can be confirmed and/or the fuse was manufactured prior to 2003, the <b>fuses should be presumed to contain asbestos and disposed</b> of in accordance with SWMS - AUS008 - Removal of Friable Asbestos Containing LV HRC Fuses. |
