## Network Performance Report

2010/2011

This report focuses on the performance of Ausgrid's network business which is responsible for the distribution of electricity within our network area (Figure 1).

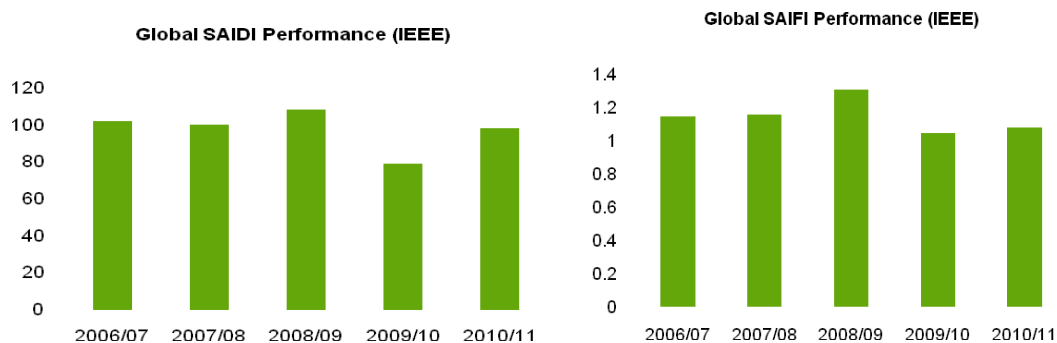
Year	Previous Years				Current Year
	2006/07	2007/08	2008/09	2009/10	2010/11
SAIDI	102	100.3	108.5	79	98.59
SAIFI	1.15	1.16	1.31	1.05	1.08

Table 4.1 data representing SAIDI and SAIFI is also shown graphically below.

2010/11 reliability performance has returned, as expected, to more normal variations around the longer term underlying reliability performance trends in comparison with the exceptionally good performance in 2009/10. However, the record heat wave in early February 2011 caused a Major Event Day on 2 February 2011. That 7 day period contributed an additional 7.8 Normalised SAIDI more than the equivalent February period in 2009/10 (after Major Event Day excluded). The heat wave mainly impacted Urban SAIDI as 86% of Ausgrid's customers are in the Urban feeder category.
