Electricity Network Performance Report 2015/16

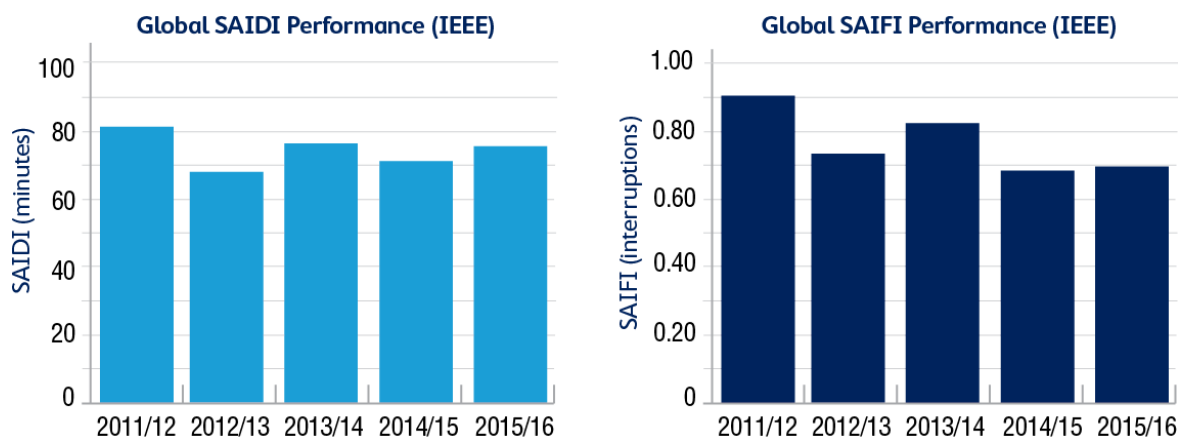
Figure 4.1 – Organisational Performance Trends (Normalised)

Table 4.1 data representing SAIDI and SAIFI is also shown graphically below.

Ausgrid's reliability performance for 2015/16 is compliant with the NSW Reliability and Performance Licence Conditions (July 2014). Ausgrid has maintained reliability performance at approximately the level of the past five years. Between October and January, as well as June, the network was impacted by an above average number of intense wind, rain and lightning storms, which had a negative impact on reliability. There were eight (8) Major Event Days in total for the year, mostly due to adverse weather impacting the network.
