# Alert Number: SA05\_20

# Subject: Incident - Incorrect Disposal of Asbestos Containing Meters

# Alert Number: SA04\_19

# Subject: Asbestos in Electrical Meters and Relays

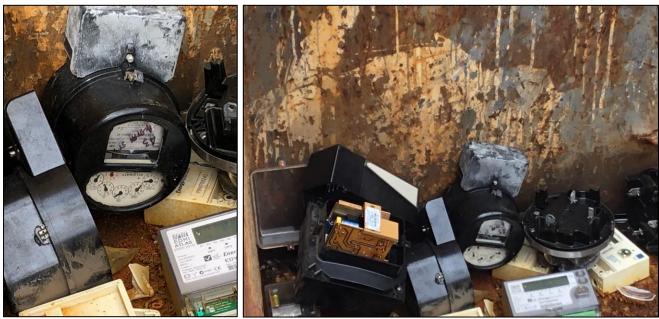
Figure 1

Ausgrid recently had an incident where asbestos containing metering equipment was incorrectly returned to Ausgrid's Wallsend Depot by an Authorised ASP/2. The metering equipment was the type identified to potentially contain asbestos, as detailed in Ausgrid's Safety Alert '<u>SA04\_19 Asbestos in Electrical Meters and Relays</u>' (attached below) and was found in the regular meter returns bin at Ausgrid's Wallsend Depot.

- Identify the asbestos containing metering equipment;
- Double bag the asbestos containing metering equipment; and
- Correctly dispose of the asbestos containing metering equipment in the required asbestos waste facilities at Ausgrid's depot.

Figures 1 and 2 below show the meter incorrectly disposed of in Ausgrid's Wallsend Depot meter returns bin. In this case the ASP/2 was issued a formal warning for the incident and advised that if any additional incidents occur Ausgrid will look to take further disciplinary action.

Meters and relays of the types listed in Ausgrid's Safety Alert '<u>SA04\_19 Asbestos in Electrical Meters and Relays</u>' removed from customer installations are <u>to be double bagged at site and disposed of as asbestos waste</u>; refer to NS211 for Asbestos waste disposal requirements.
