# **Review of Environmental Factors**

## **Hunter-Central Coast REZ Network Infrastructure**

**Appendix H – Bushfire Assessment Reports**

# BUSH FIRE THREAT REPORT

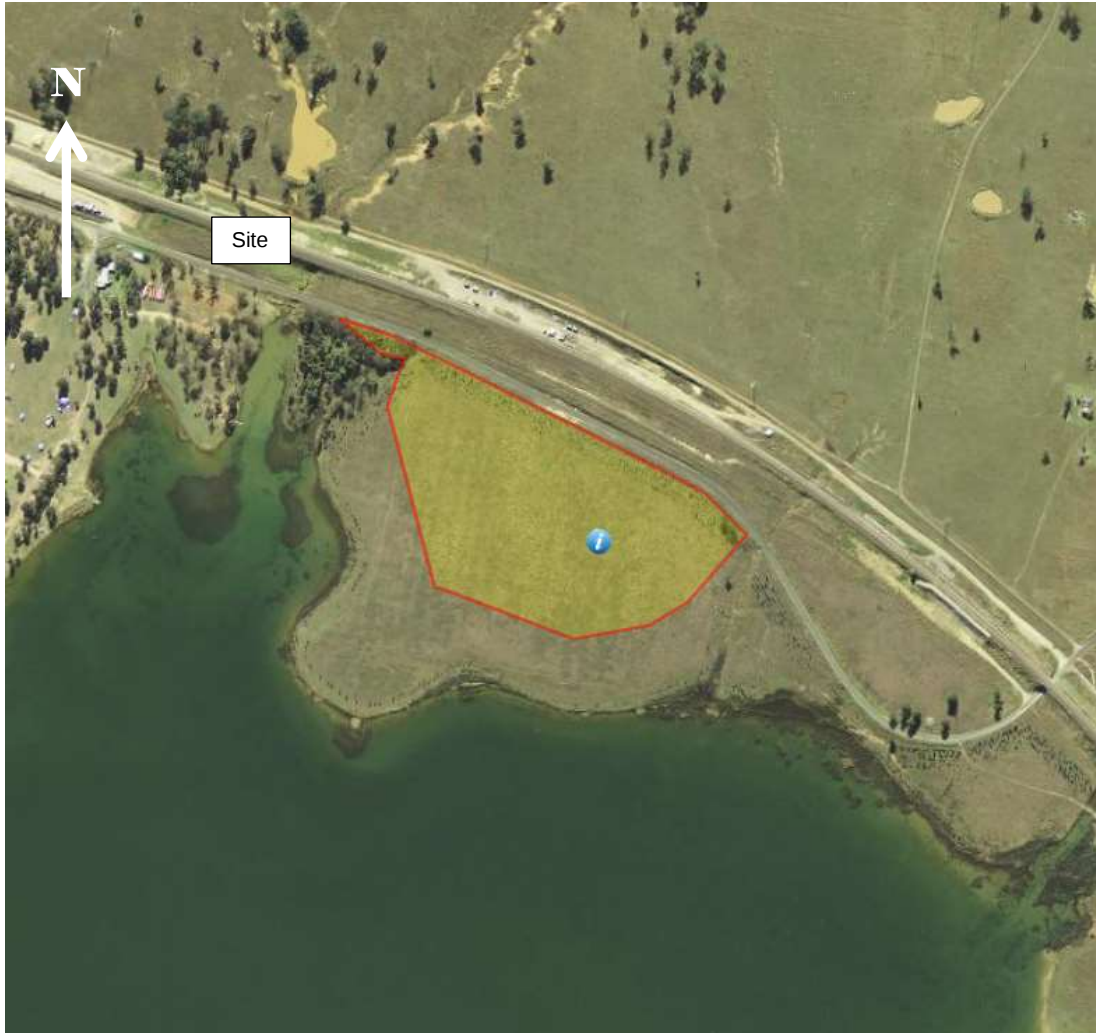
Figure 2: Site and surrounds (source: <https://maps.six.nsw.gov.au/>)

Aerial photographs of the site and surrounds are included below (refer figures 2 and 3) and photographs of the site have been included; the approximate location and direction of these photographs has been included on the aerial photograph (Figure 3). It is noted that the aerial photographs (Figures 2 and 3) are not accurate in that they don't show the vegetation which has been planted along the northern edge of the site; an aerial photograph which shows this vegetation has been included as Figure 4, however, this does not show the lot boundaries.

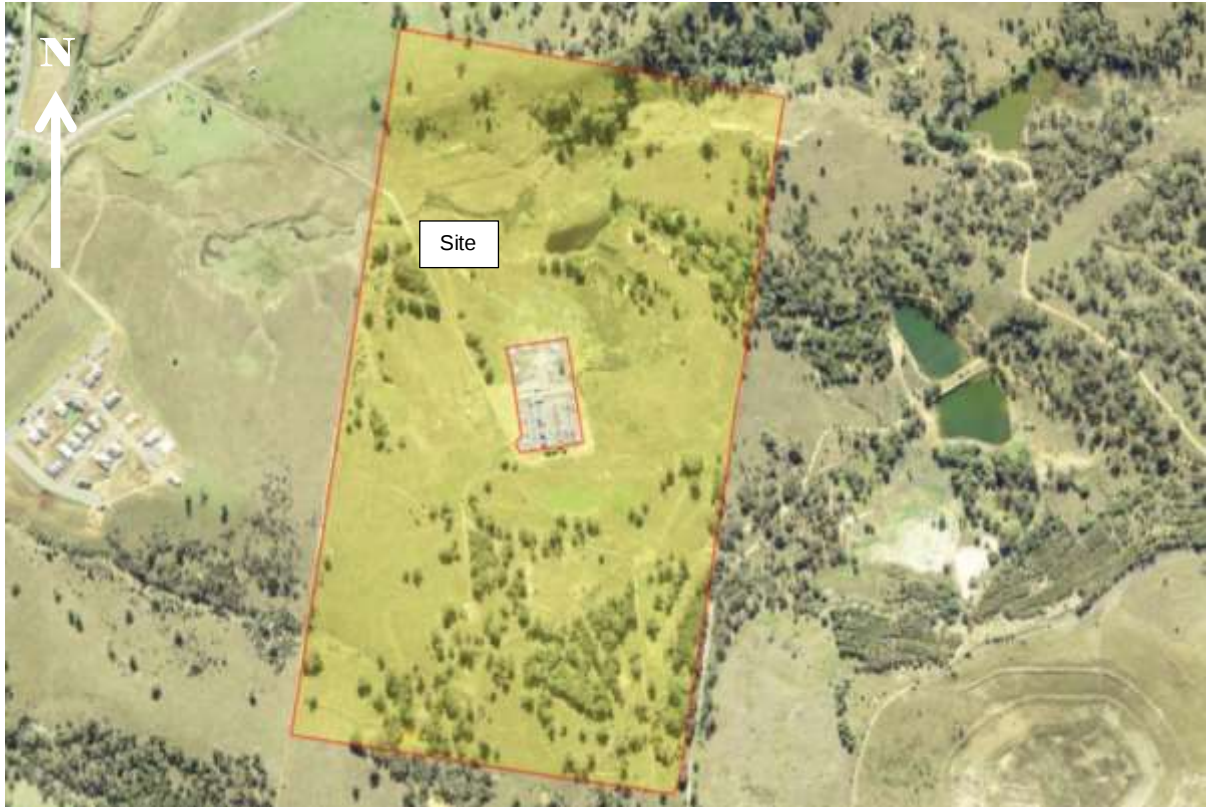
Figure 2: Site and surrounds (source: <https://maps.six.nsw.gov.au/>)

Aerial photographs of the site and surrounds are included below (refer figures 2 and 3) and photographs of the site have been included; the approximate location and direction of these photographs has been included on the aerial photograph (Figure 3).

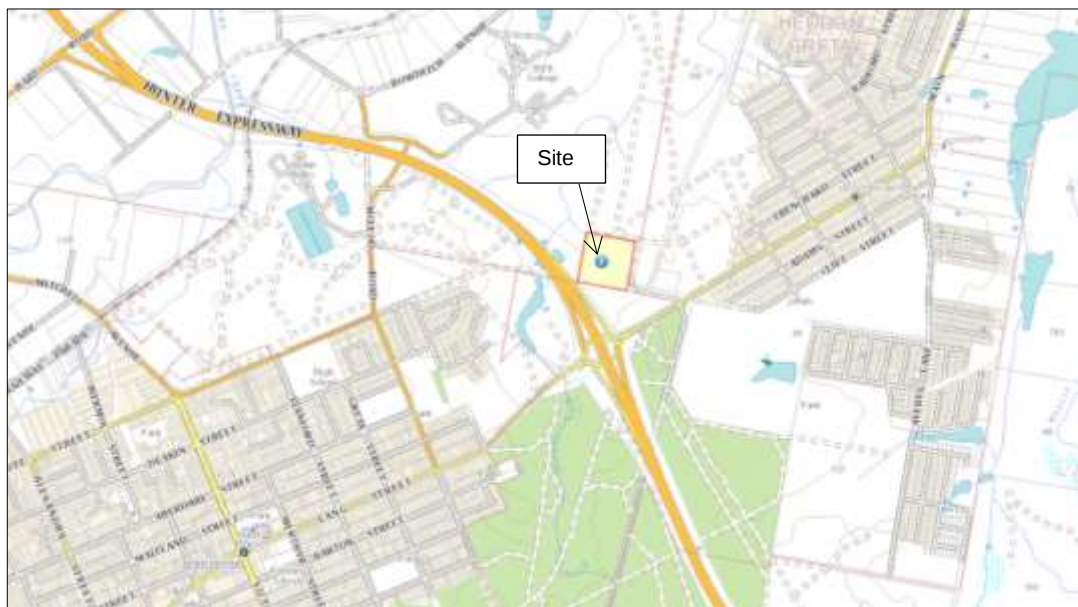
Figure 1 – Site Location

In the event of a bush fire emergency, access and egress will be via the existing access road at the south eastern corner of the site and as shown in Figure 1. As this development and access is existing, it is to be considered acceptable and no further investigation is required.

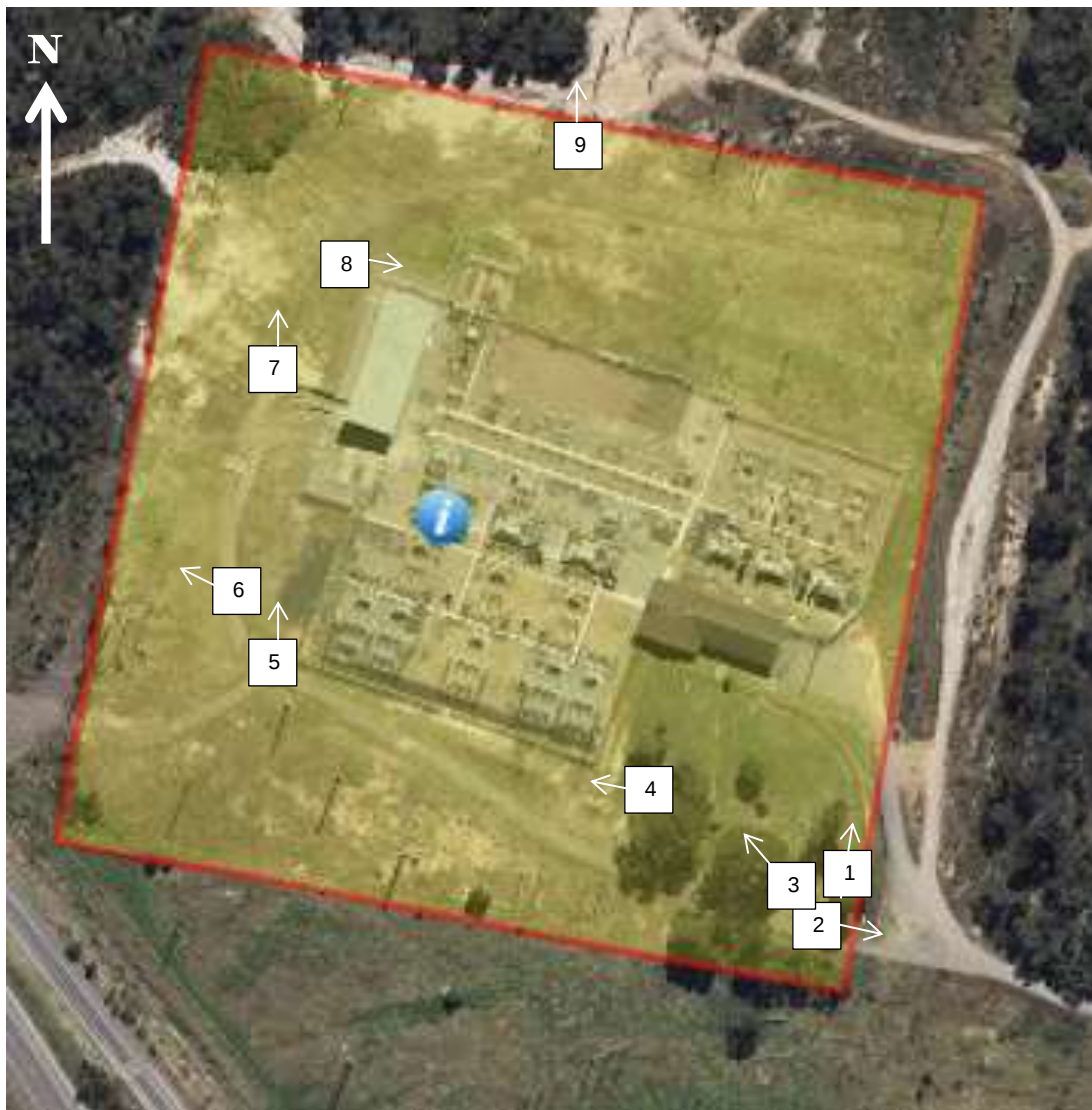
Figure 3: Site and surrounds (source: <https://maps.six.nsw.gov.au/>)

Aerial photographs of the site and surrounds are included below (refer figures 2 and 3) and photographs of the site have been included; the approximate location and direction of these photographs has been included on the aerial photograph (Figure 3).

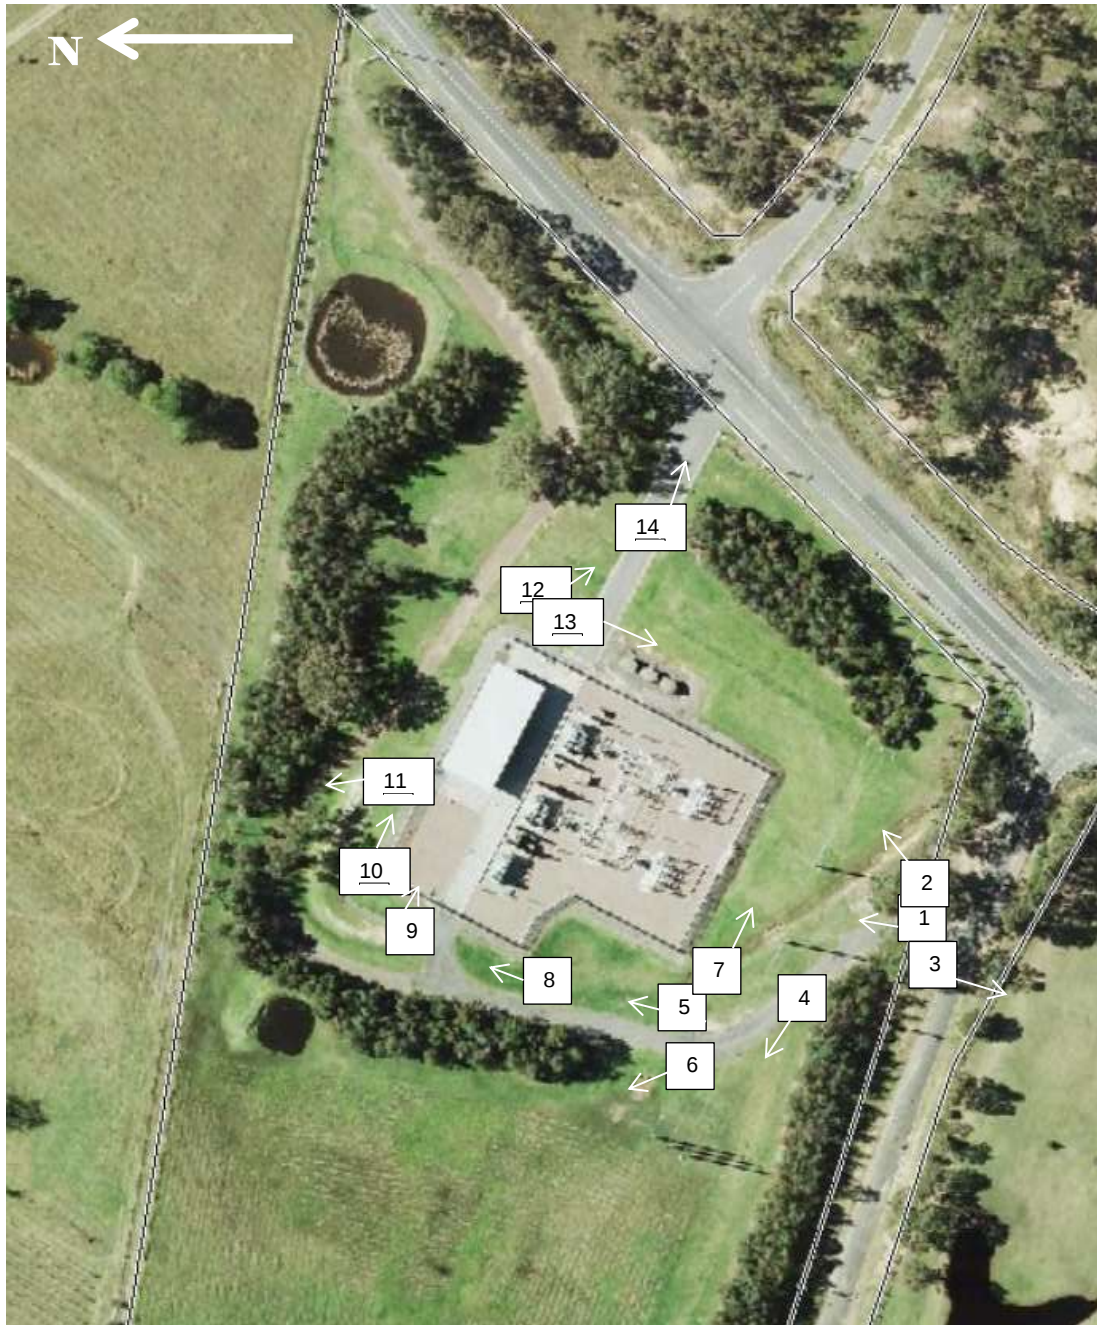
Figure 3: Site and surrounds (source: <https://maps.six.nsw.gov.au/>)

Aerial photographs of the site and surrounds are included below (refer figures 2 and 3) and photographs of the site have been included; the approximate location and direction of these photographs has been included on the aerial photograph (Figure 3).
